# Hurricane Lili's Impact On Fixed Platforms

**June 2004**

**Minerals Management Service**

**ABSC Project No.: 1200044**

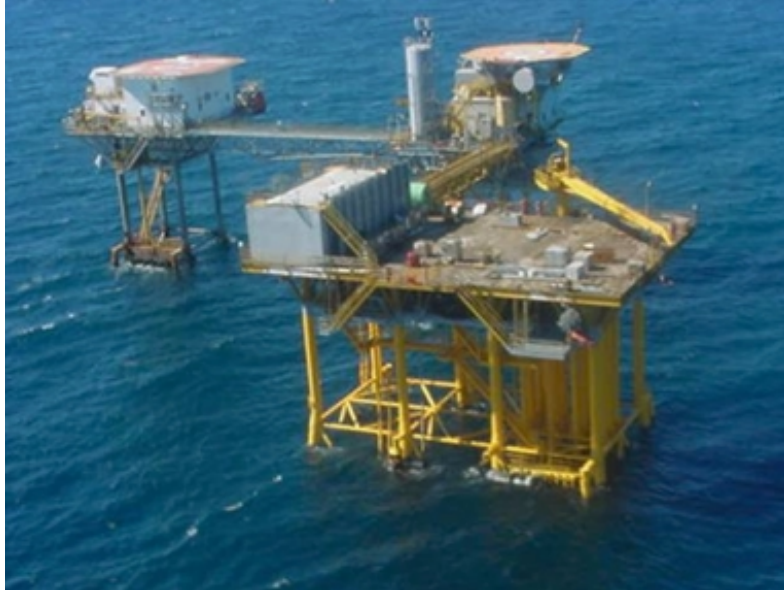
**EI-276-B-Aux shown in the rear left of this photo before Hurricane Lili**

- Replacement of the damaged vertical diagonal using a doubler/slip-sleeve attachment at the leg below water and direct welding to the leg above water.
- Grouting of all jacket legs and the installation of a grouted clamp around the buckled portion of Leg B2 near El. (-)26'
- Removal of the sump casing and the framing elements at El. (-)26' and installation of two clamps over the holes on the remaining horizontal perimeter framing.

These repairs were completed in May 2003 and the platform is again operational. In order to limit exposure of personnel during the repairs to possible platform failure due to large waves, , the AUX facility was operated only during periods when a 12-hour weather forecast showed no seas greater than 12.5 feet.

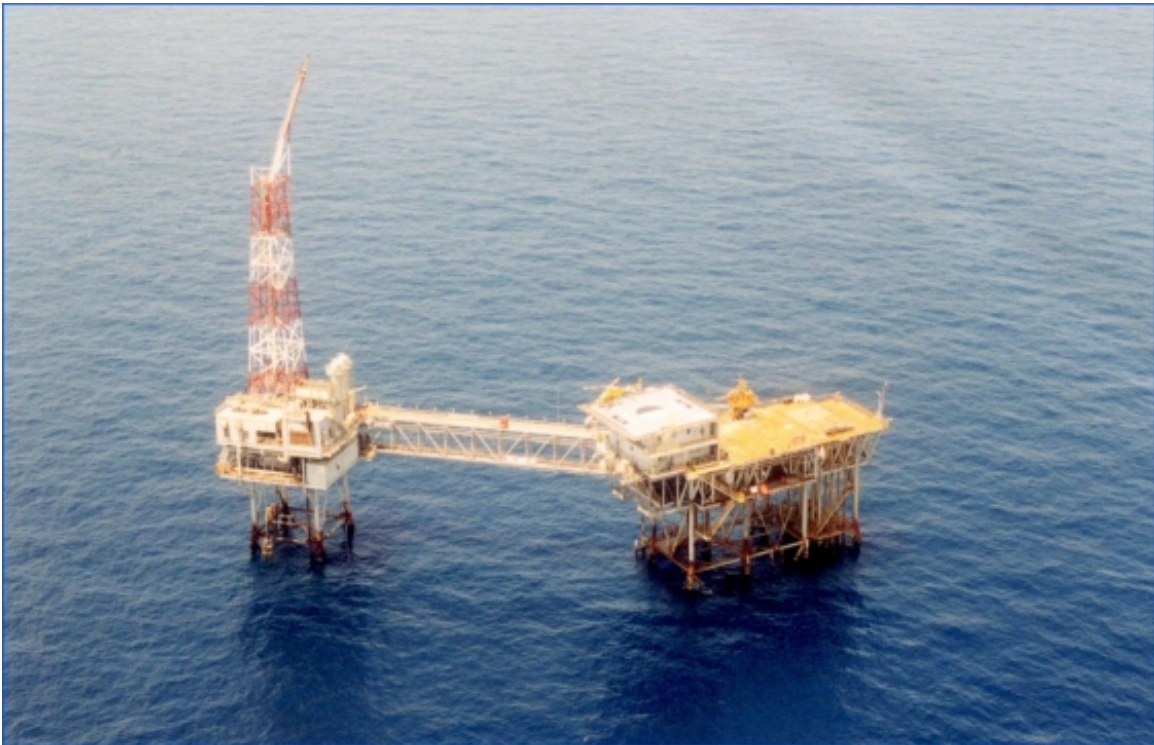
**EI-295-A-PRD is shown in a pre-storm photo on the left. The drilling platform is on the right.**

During assessment, production operations on the “A-PRD” platform were halted and temporary production was established on the “A” platform. After reviewing repair alternatives, the decision was made to permanently abandon operations on the “A-PRD” platform and establish permanent production facilities on the “A” platform including relocation of two risers from “A-PRD” to “A”. The platform and bridge were removed in the summer of 2003.

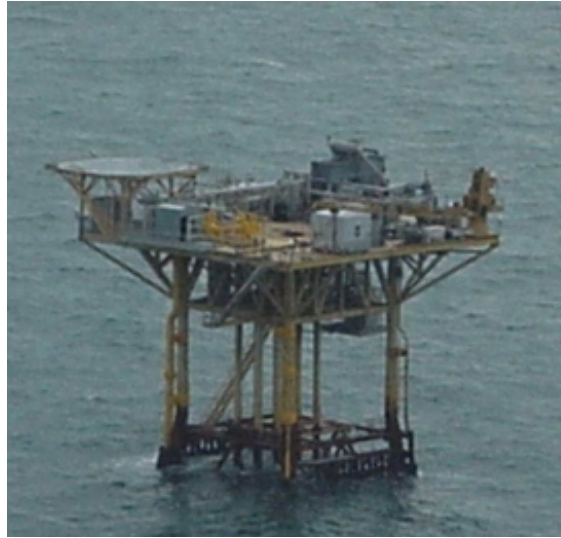
This structure was toppled by Lili.

**EI-309-C is shown in this pre-storm photo.**

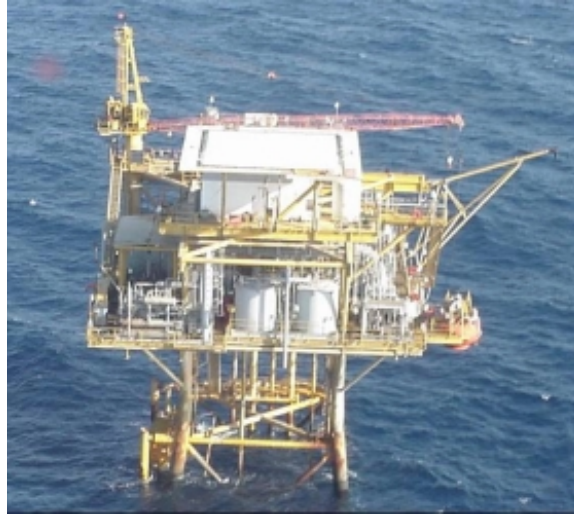
The damage this platform sustained during Lili was considered significant enough to warrant removal of the structure and this was accomplished during the summer of 2003.

**EI-324-A shown in a pre-storm photograph.**

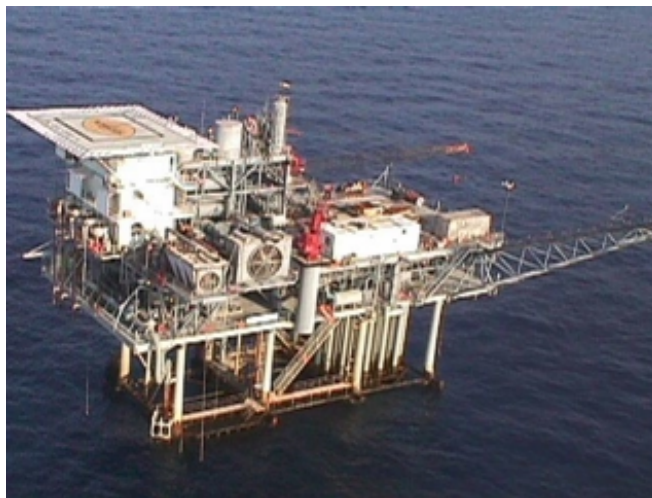
Three flooded members were identified during the post Lili underwater surveys, two at the (-)29' elevation and one at the (-)73' elevation. Several visual indications and MPI indications were identified at both these levels.

**EI-330-A shown in a pre-storm photograph.**

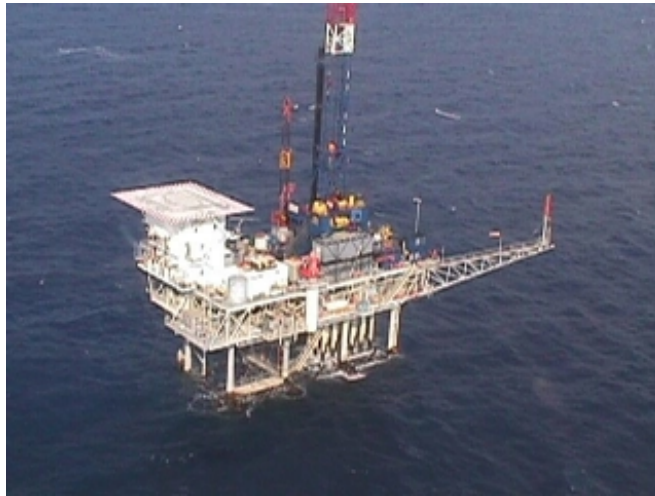
No evidence of wave-in-deck was identified during post-Lili inspections.

**EI-330-B shown in a pre-storm photograph.**

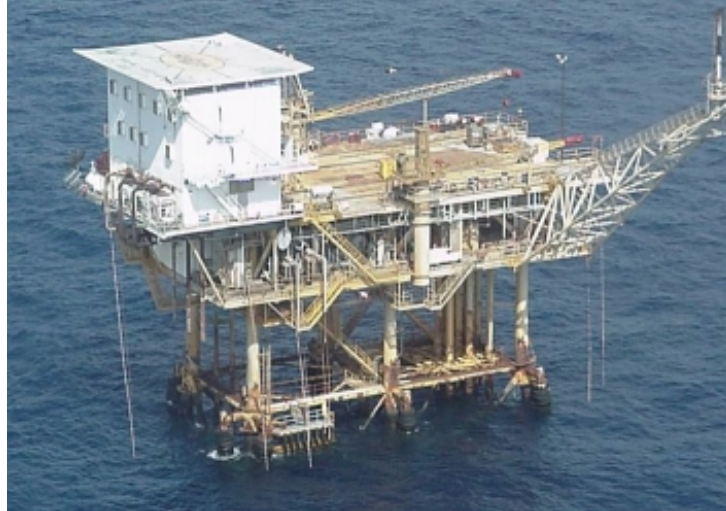
The damage noted during post-storm underwater surveys included a hole in a horizontal member caused by a secondary brace supporting a sump casing being pulled out.

**EI-337-A shown in a pre-storm photograph.**

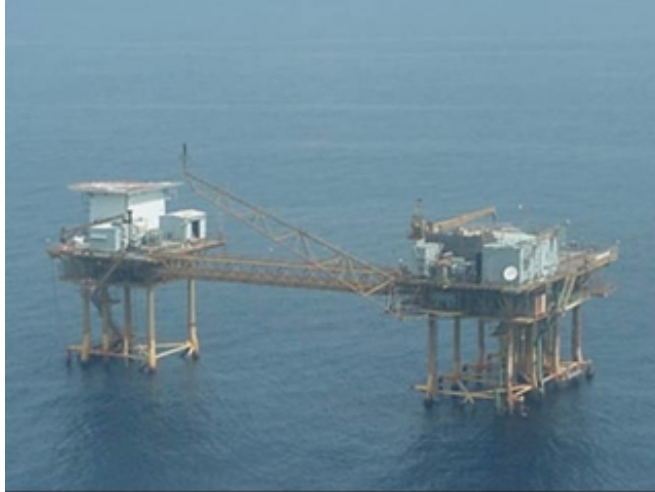
Damage to this facility was not apparent prior to the post-storm underwater survey. The survey discovered several separated and missing members, primarily vertical diagonals between El. (+)10' and El. (-)30'. Assessments were performed to determine the appropriate course of action and develop plans to repair the damage and continue to use the platform.

SS-269-A shown in a pre-storm photograph

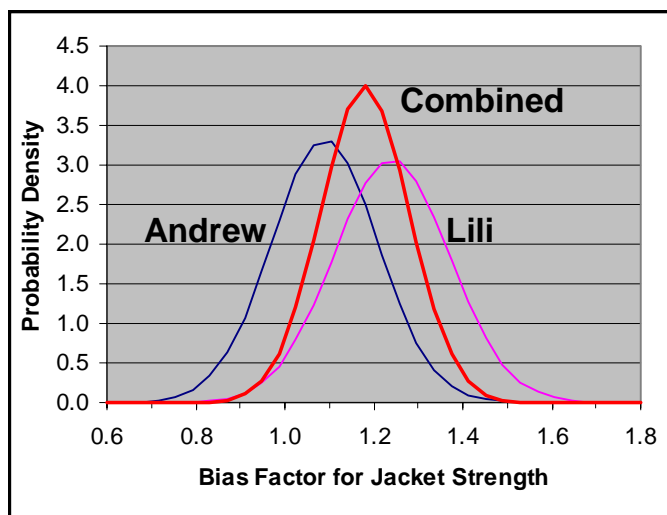
Figure 13 – Bias Curves for Andrew, Lili and Combined

The Bias factors of the individual Lili platforms shown in Table 2, were combined to develop a single set of Bias factors as shown in Table 3. Also shown are the Hurricane Andrew Bias factors (nine platforms involved) from the Andrew JIP Phase II results, as well as the Lili and Andrew Bias factors combined. Figure 13 shows a graphical representation of the distributions. Results are generally similar for both Andrew and Lili – with an overall observation that API RP 2A does an excellent, somewhat conservative, job of determining platform performance.
