Existing Condition of the Leadville Mine Drainage Tunnel

Leadville Mine and Drainage Tunnel Project, Colorado
Great Plains Region

FINAL DRAFT June 2008

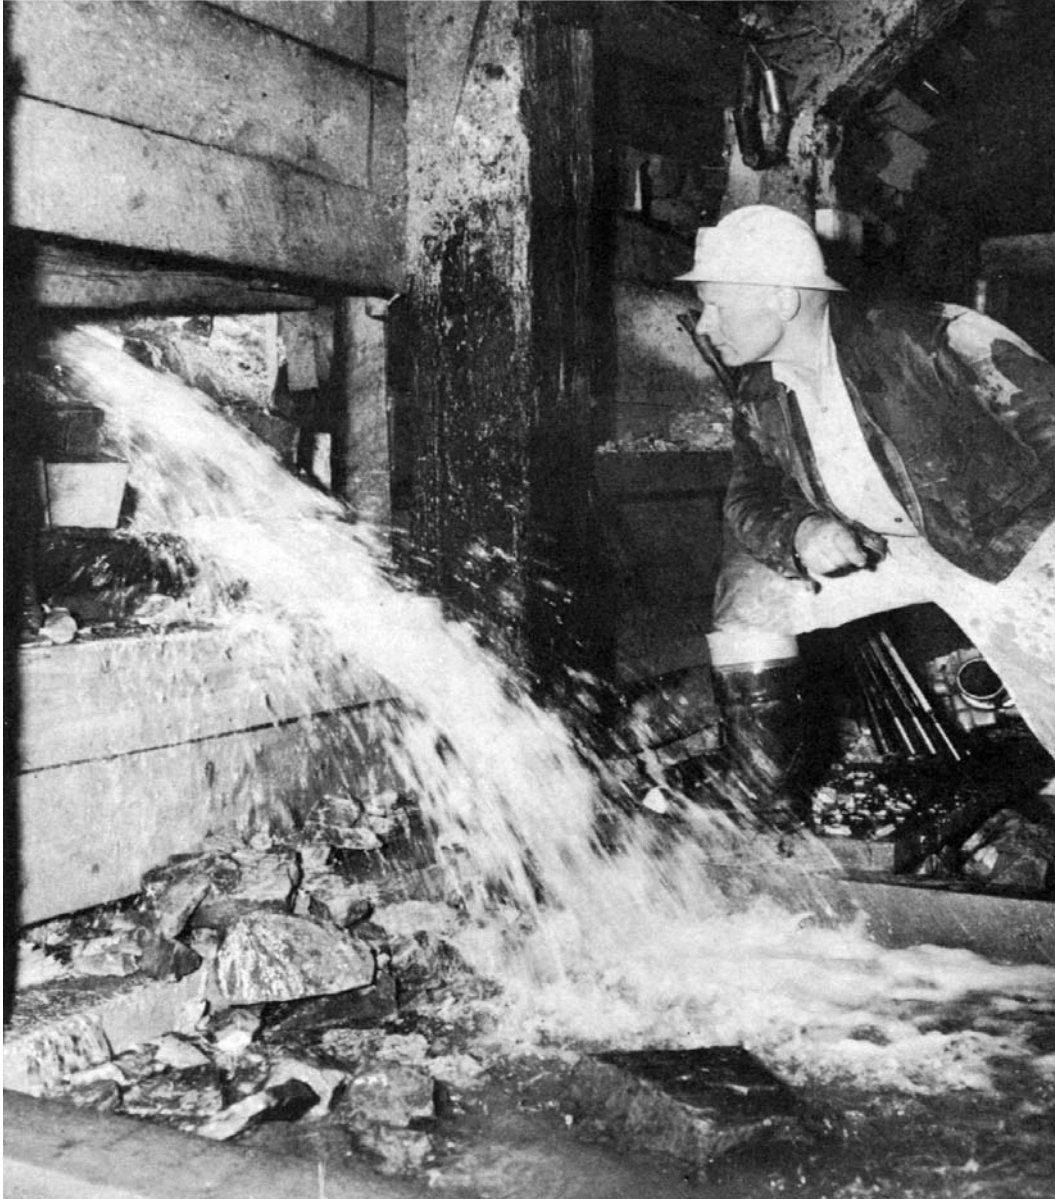
Figure 12. Photograph showing the inflow to the LMDT through a drillhole connected to the Robert Emmet shaft, taken from (Salsbury, 1956). This is prior to driving the Robert Emmet lateral.

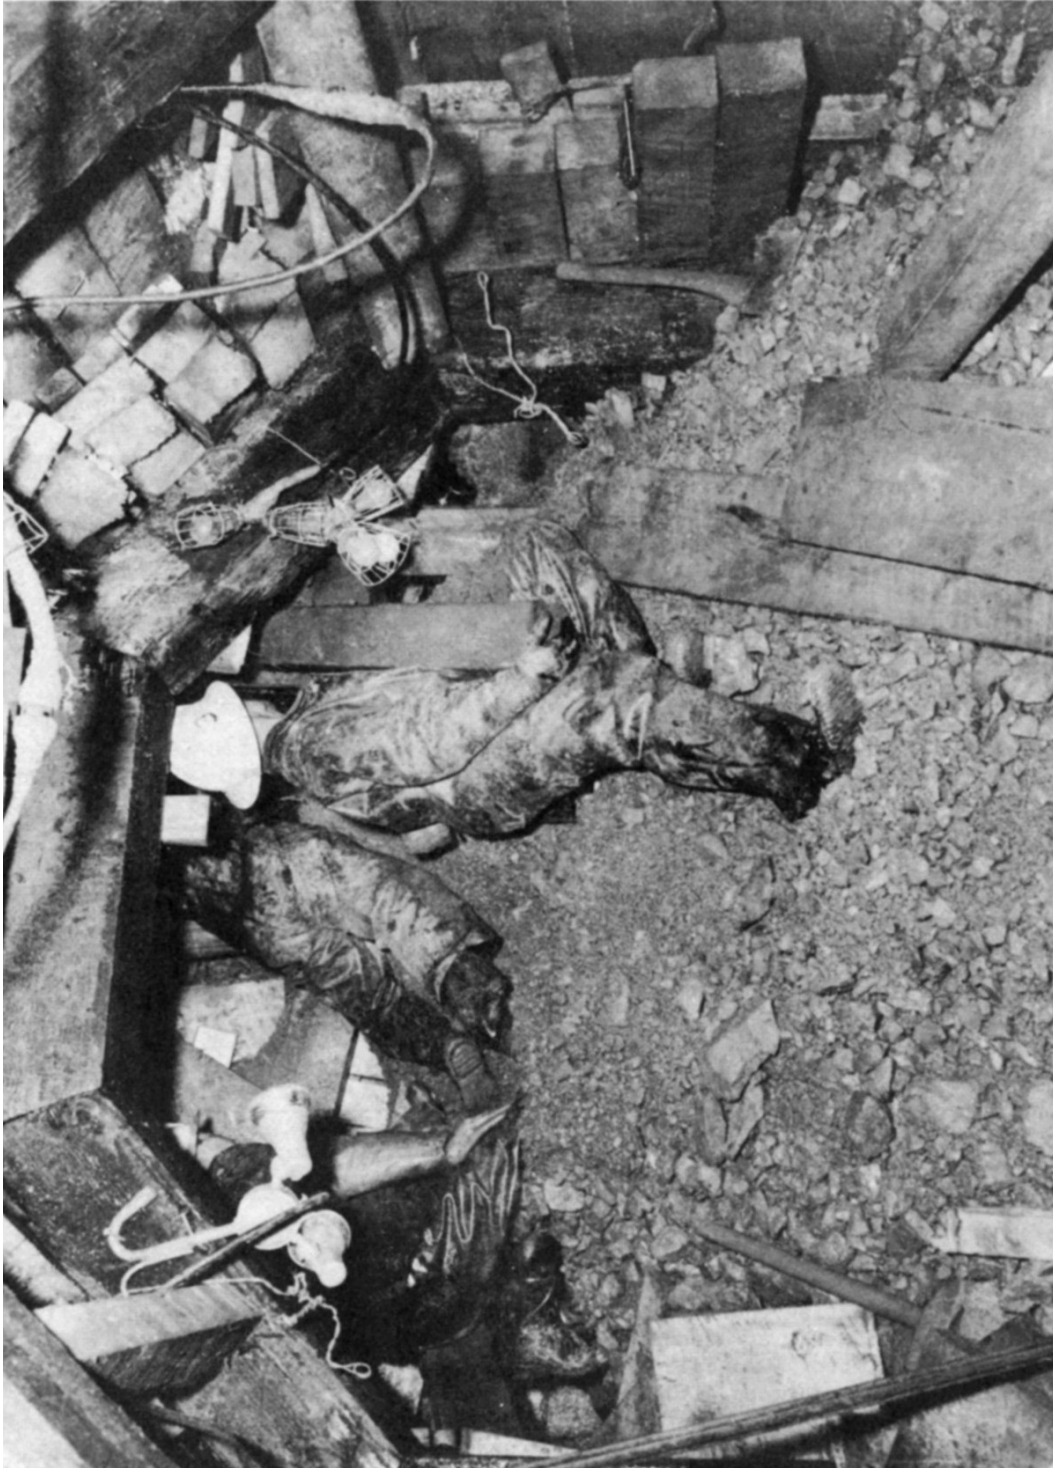
Figure 13. Workers digging out a boulder embedded in running ground in sheared quartzite, taken from (Salsbury, 1956). The boulder prevented spiles from being driven.

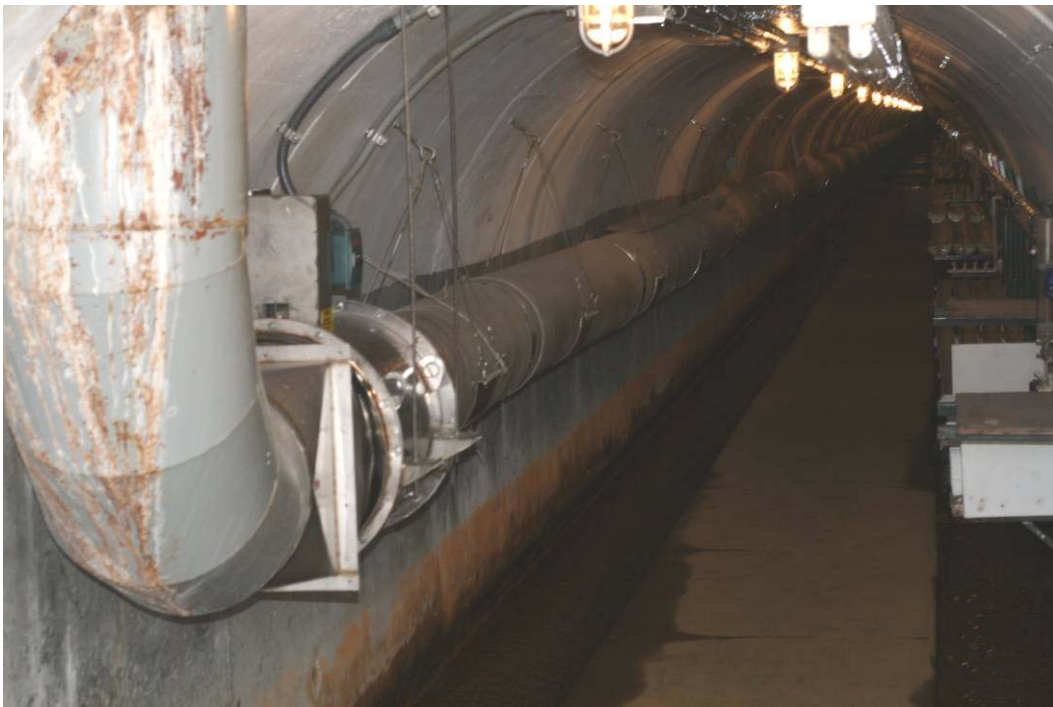
Entrance to the portal is controlled by a steel door which is normally kept closed and locked. Just inside the LMDT portal is a floor grating with removable panels to allow access to the sump at the end of the two drainage ditches; a concrete walkway divides the ditches, see Figure 18. Beyond the grating, electrical equipment is located on the right side (looking downtunnel) for operation of the lights and ventilation system. The overhead lights, ventilation fan, and ventilation pipeline are shown in Figure 19. All of the equipment was in operating condition at the time of the inspection.

Figure 19. Photograph taken on March 25, 2008 looking upstream from the Portal area in the LMDT showing the ventilation fan, motor controls, and vent pipe at left, and the electric lights at the upper right.

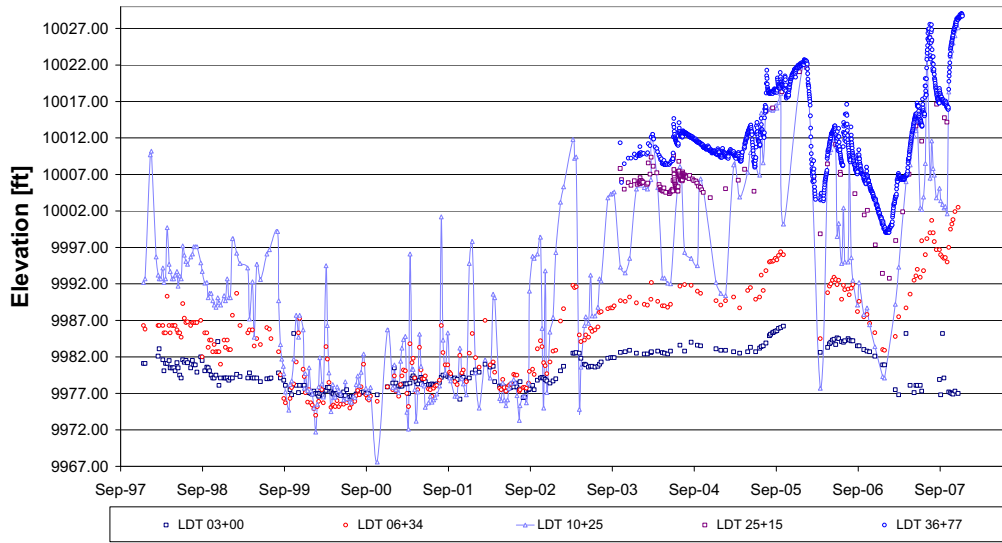
Figure 24. Plot of water levels in wells along the lower portion of the LMDT alignment.

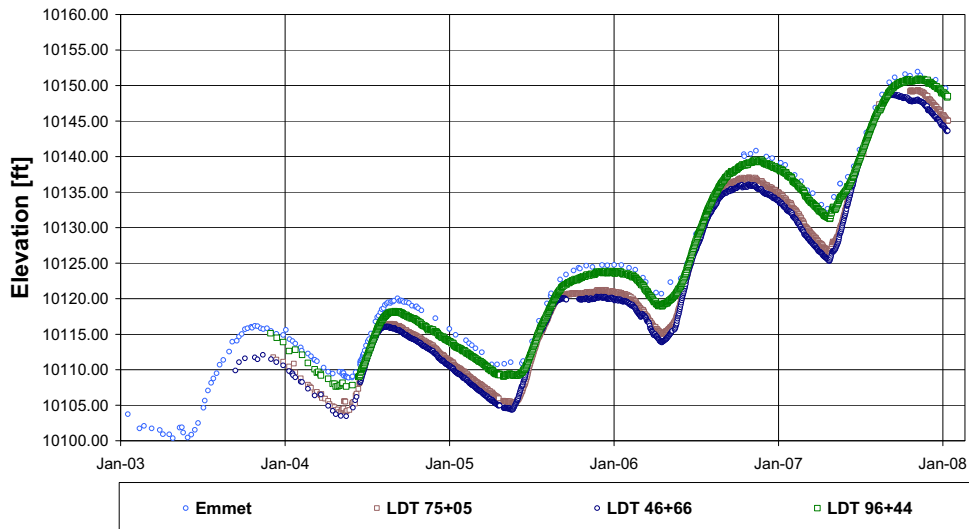
Figure 25. Plot of water levels in wells along the upper portions of the LMDT alignment

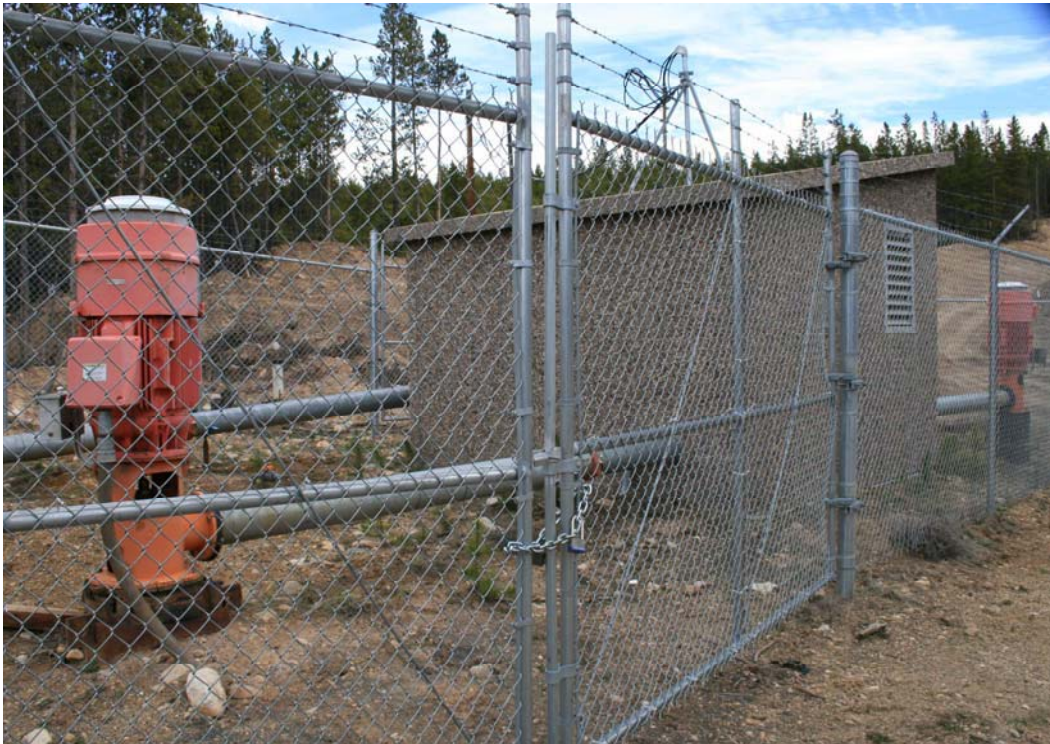
When sinkholes developed above the tunnel and adjacent to State Highway 91 in the 1970s, Reclamation responded by installing a dewatering well in 1977. The well was replaced by two new wells in 1991 (a primary and backup well), the wells are located at approximate tunnel Station 10+25. The wells and pumps at Station 10+25 provide the primary source of water input to the treatment plant. Stainless steel turbine pumps run by a motors sitting on top of the wells are used to extract water from the LMDT. The pumps have 1500 gpm capacity, but are limited by inflows to the LMDT at this time to around 750 gpm. A control house is located inside a fenced yard area which contains the well heads (see Figure 29). Only one of the wells and pumps is operated at a time. The other is a backup system. The control house contains the programmable motor controls for the pump motors and electronics for relaying data signals from the well and pump sensors to the water treatment plant.

Figure 29. View of Pumphouse and Extraction Wells in the vicinity of Station 10+25. May 28, 2008.
