## Potential Failure Modes and Effects Analysis Leadville Mine Drainage Tunnel

Leadville, Colorado  
Great Plains Region

FINAL DRAFT June 2008

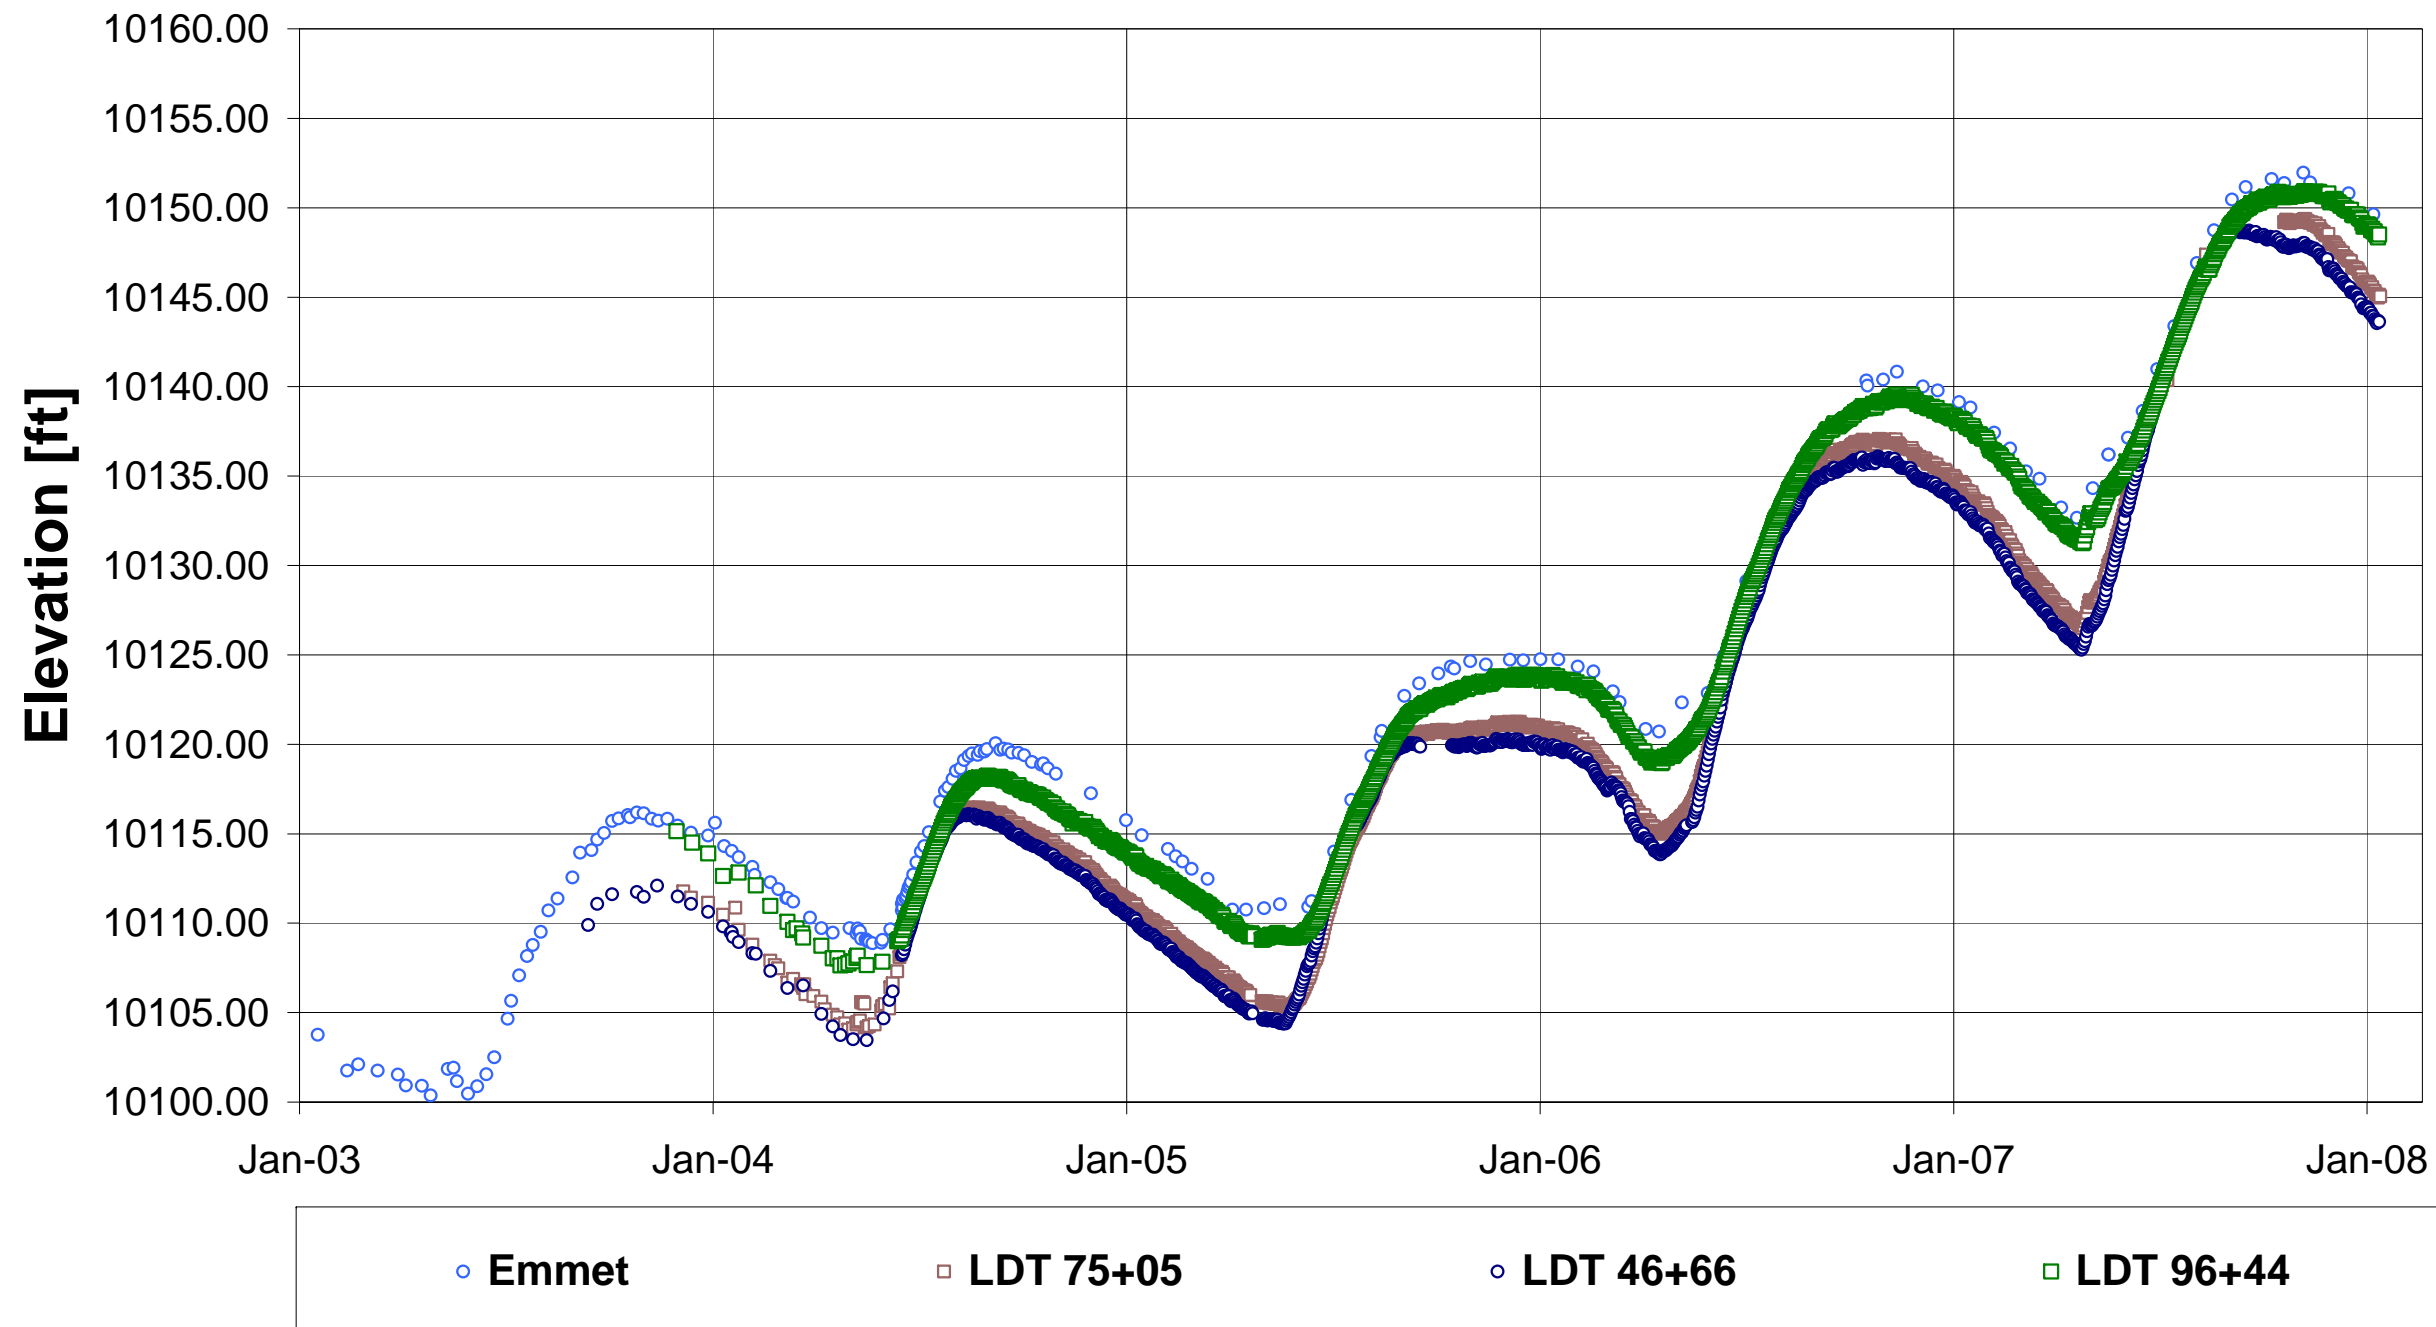
Figure 3. Water Levels in the Upstream Tunnel

The water treatment plant has operated successfully since its construction, providing clean discharge to the river. However, since about 2003, there has been a gradual rise in the water level near the old mine workings (referred to as the “Mine Pool”), as illustrated in Figure 3. Based on monitoring wells, this higher water level is transmitted down the tunnel at least as far as Station 46+66 (monitoring well LDT 46+66), below which the water level drops (monitoring well LDT 36+77). The water level along the tunnel is also shown in Figure 1. Concerns have been raised that if the difference in water level is due to a blockage caused by tunnel collapse, rupture of the blockage under a continued increase in the Mine Pool level could lead to adverse consequences near the tunnel portal. These concerns prompted this PFMEA study.

- There is potential for further increases in the Mine Pool head, which would provide an even greater differential head across a tunnel blockage.
- There could be interconnection between the Mine Pool and the tunnel as evidenced by the water levels in the Robert Emmet Shaft closely following the tunnel monitoring wells (Figure 3).

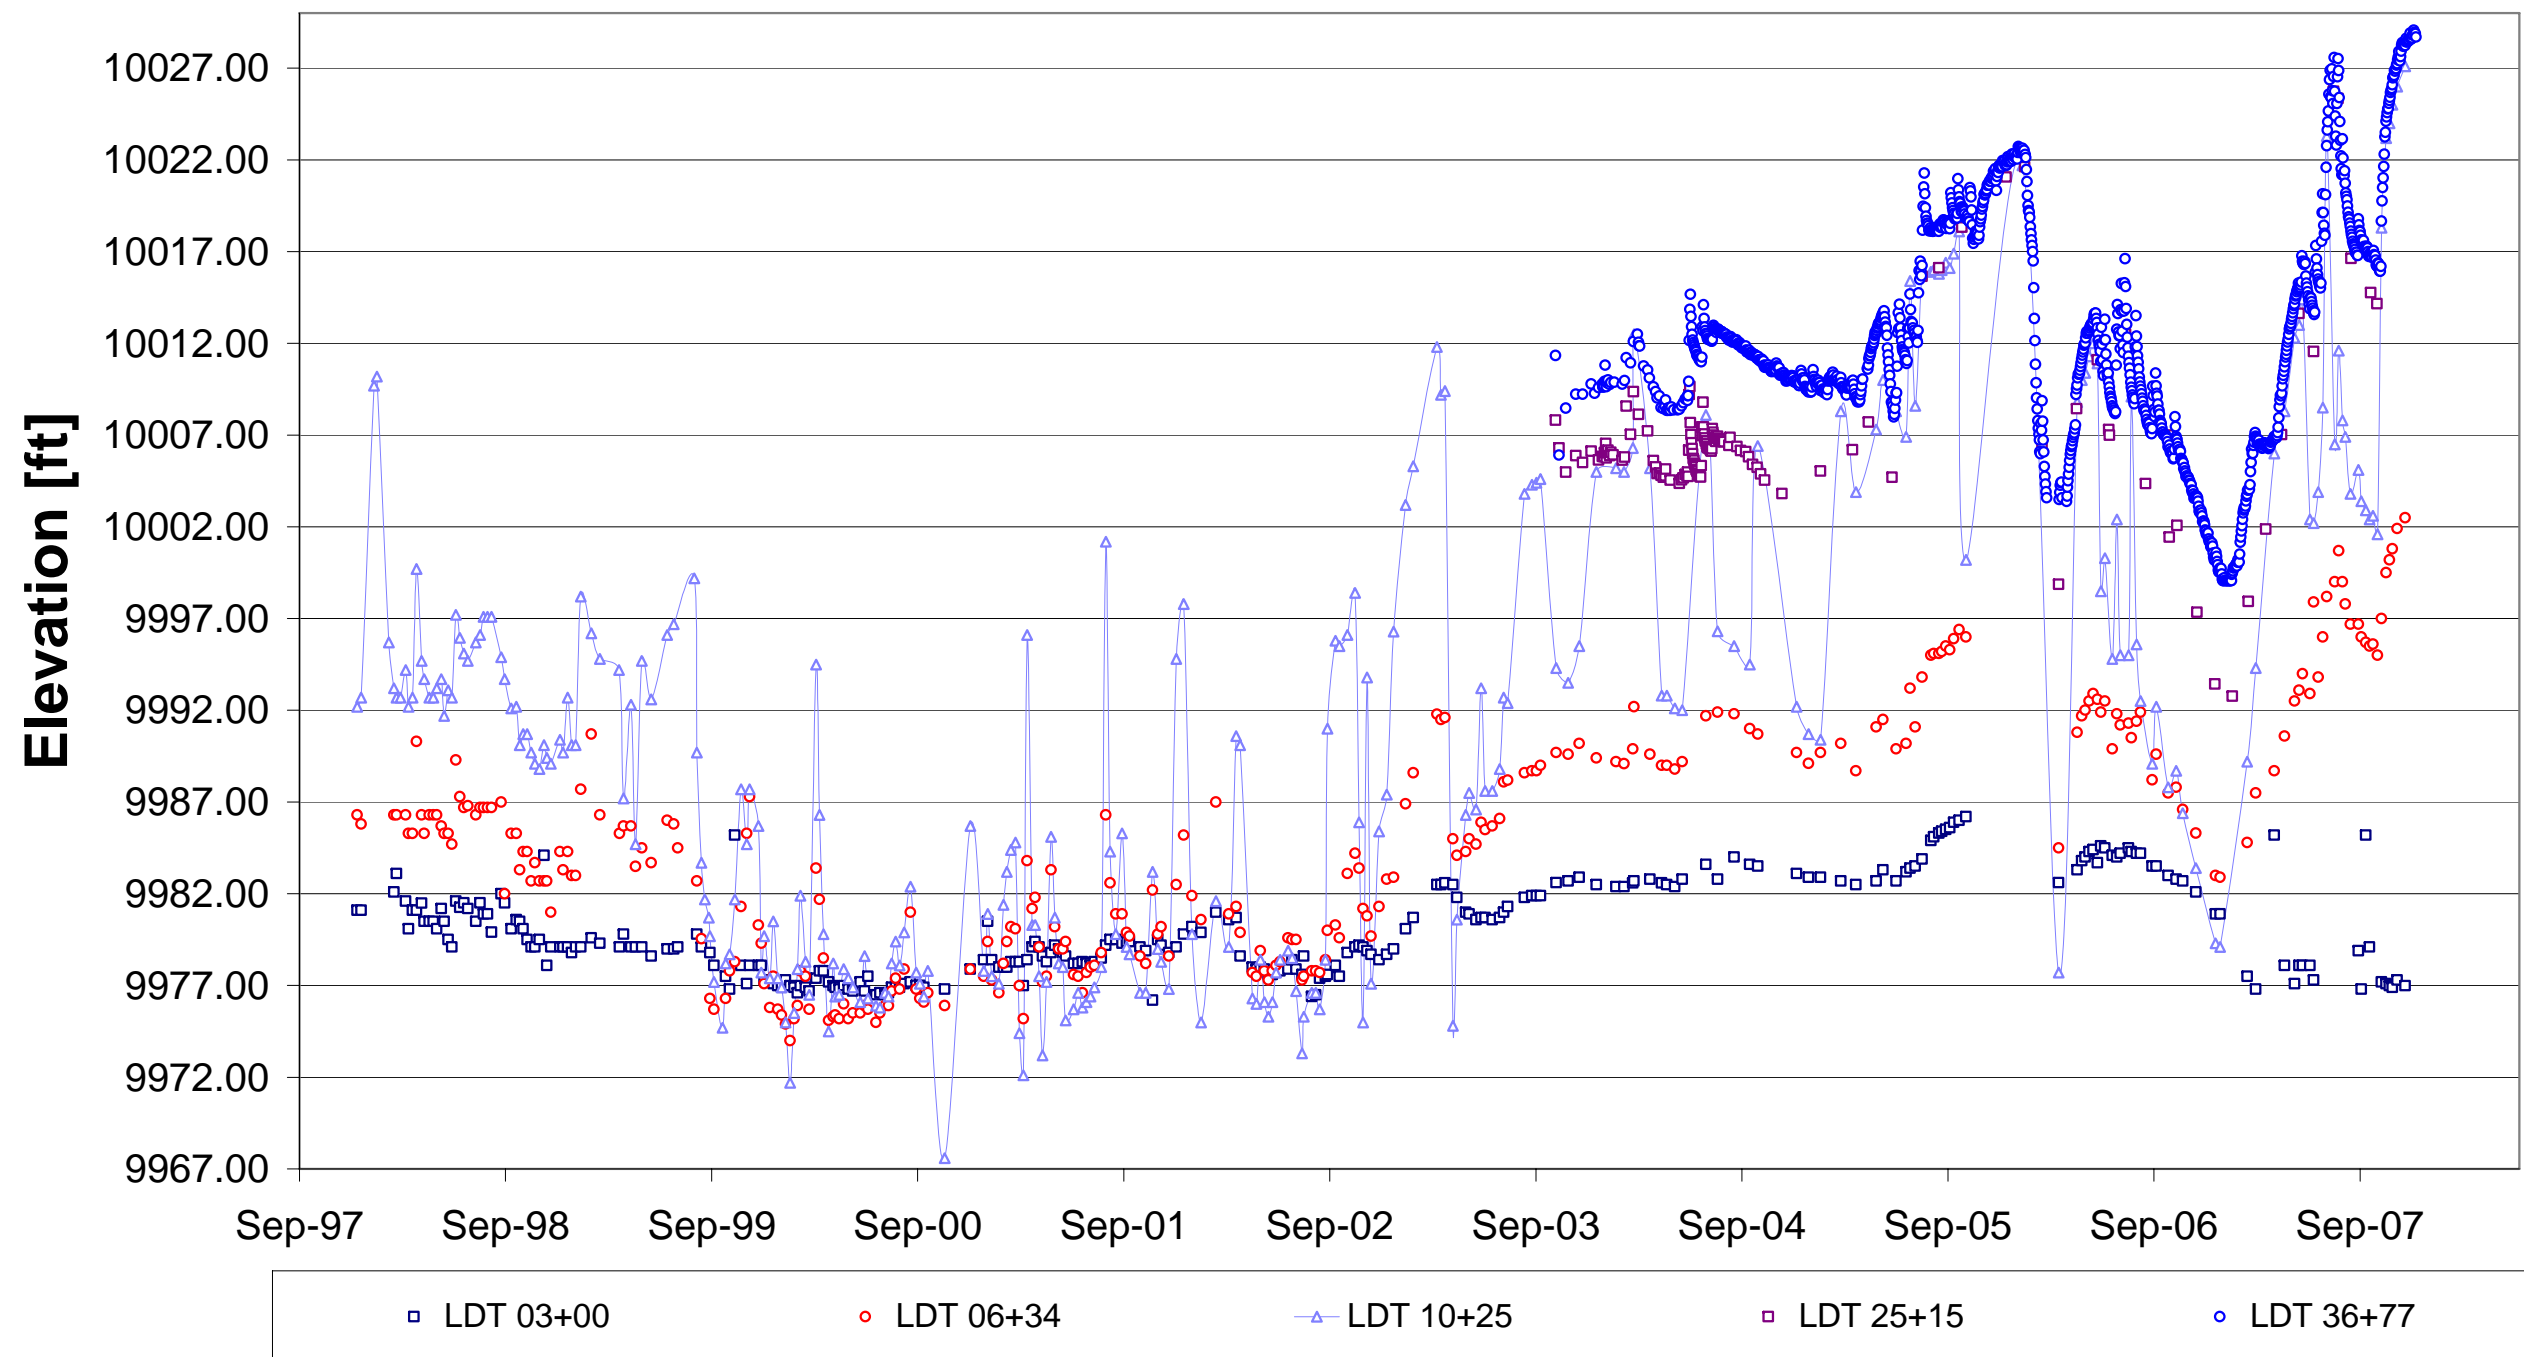
Figure 4. Water Levels in the Downstream Tunnel

- There is no reason to believe the LMDT is completely open in other areas. Additional collapsed areas and blockages of the tunnel would limit flows to the downstream tunnel reaches from the Mine Pool even if a blockage near the Pendery Fault were to breach. For example, based on the water level data in Figure 4, there may be resistance to flow between Stations 10+25 and 6+34 (both intercept the tunnel but appear to record different elevations, although the well at 10+25 is pumped). In addition, in 1979 a well at Station 6+65 was drilled to 98 feet into the tunnel where water 6 feet deep was seen to be flowing. While waiting for well screen, a sinkhole appeared adjacent to the drill rig and the hole was lost.
