U.S. CHEMICAL SAFETY AND HAZARD INVESTIGATION BOARD

## CHLORINE RELEASE

**DPC ENTERPRISES, L.P.**

REPORT NO. 2004-02-I-AZ

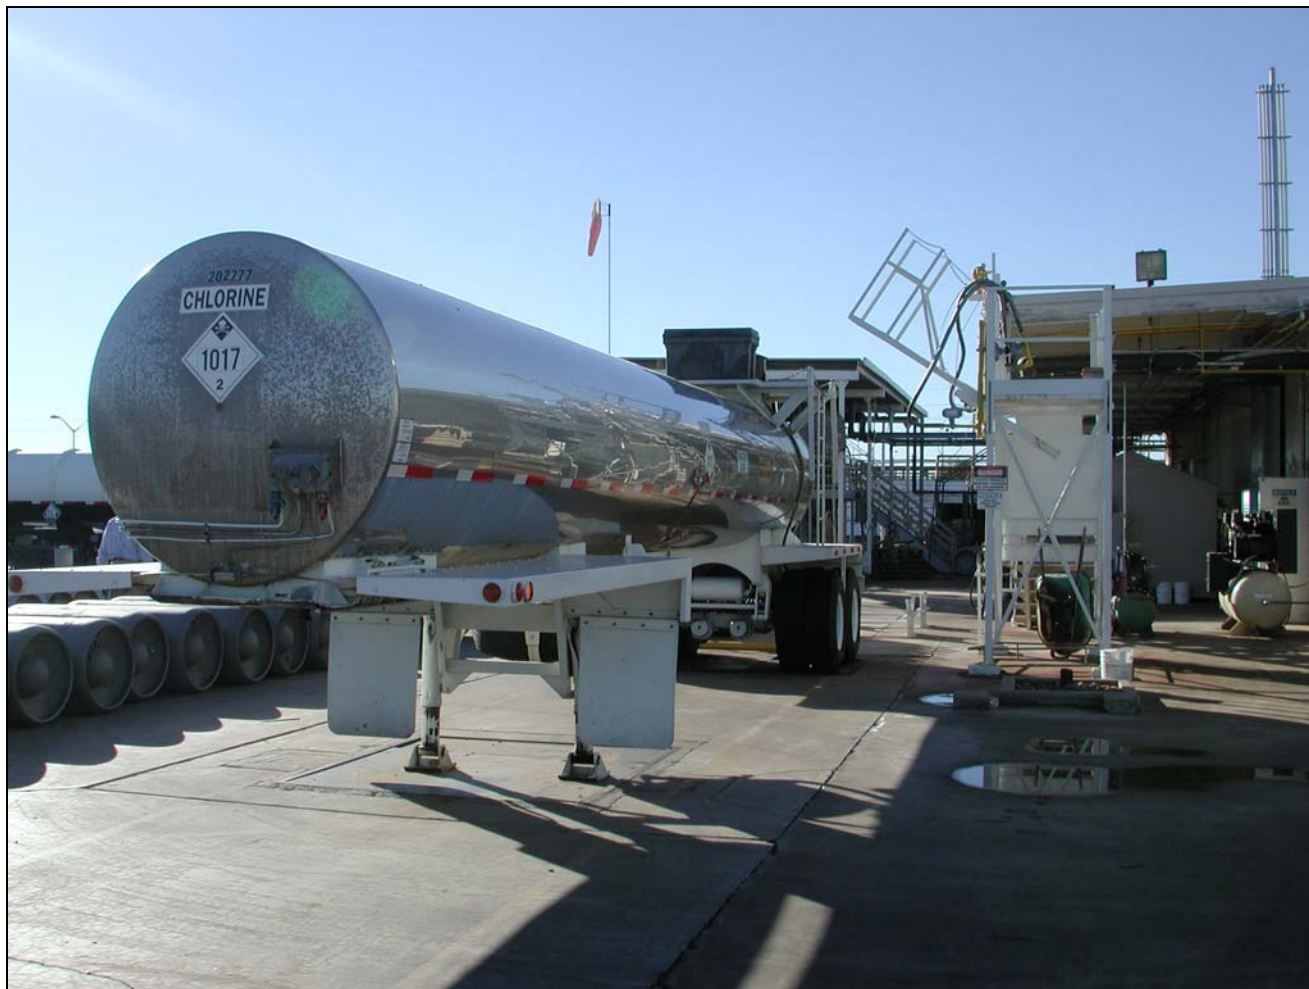
Figure 4. Chlorine bulk road trailer

About once a month, DPC supplies a bulk road trailer of chlorine to a local municipal water treatment facility. To transfer the chlorine, hoses specifically designed for chlorine service connect the chlorine railcar and the bulk road trailer (Figure 3 and Figure 4) to the transfer piping system. Remotely operated valves on each end of the hoses shut off chlorine flows in an emergency.<sup>6</sup> The railcar initially contains

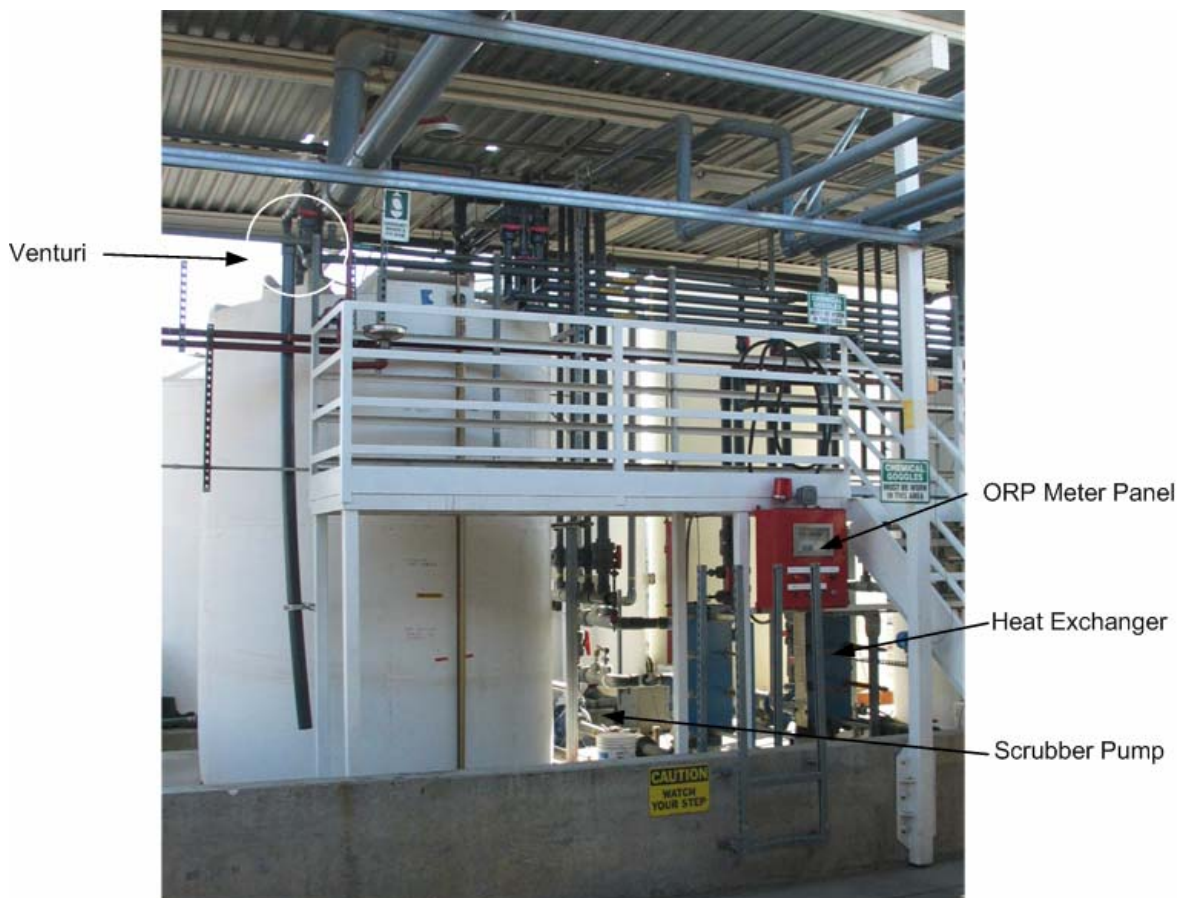
Figure 5. Caustic scrubber (typical)

The two Glendale scrubbers are 4,000 gallon, fiberglass reinforced plastic tanks (Figure 5). They operate as batch chemical reactors, with one unit receiving chlorine (the online scrubber), and the other operating as a backup (the standby scrubber).<sup>8</sup> Operators initially fill a scrubber with an aqueous solution containing 21 percent caustic.<sup>9</sup> Chlorine vented from repackaging operations is fed to the scrubber until the caustic concentration reaches 0.2-0.5 percent, as required by customer specifications for bleach.<sup>10</sup> The chlorine flow is then manually switched to the standby unit, the product bleach transferred to storage, and the depleted scrubber charged with fresh caustic solution.

on a local panel (Figure 5). The ORP meter readings increase as the residual caustic concentration in the scrubber solution decreases. The correlation between ORP readings and caustic concentration is normally highly repeatable, but can be affected by a variety of factors, such as temperature, fouling, and the initial caustic concentration (see section 4.1). Each ORP meter is equipped with two alarms to help operators track the depletion of caustic in the bleach batch (Table 2); however, no automated control actions occur based on the ORP meters' outputs.
