November 3, 1997

**Space Shuttle
External Tank**

**STS-87/ET-89
Flight Readiness
Review**

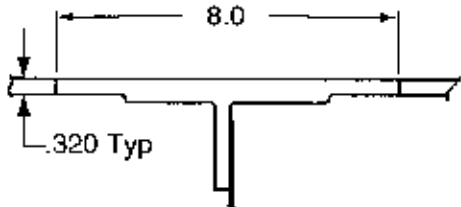
Section A-A (Typical)

- Located in extrusion heat affected zone adjacent to initial weld
 - First time occurrence - Considered to be out of family
- Fault tree initiated - Investigation indicated root cause was low material strength due to re-crystallized grain structure
 - Proof test facility integrity verified by instrumentation
 - Parent extrusion strength and integrity verified by test
- Complete assessment of vehicle revealed multiple first-time events
 - First use of extrusion “buy” at Station 1871
 - First use of revised tooling for SLWT welding
 - First full use of revised proof test facility
 - First failure of supporting jack stands

- Weakened microstructure ground out and replaced with weld wire (including reported x-ray indications)
 - Process fully replaced the extrusion weld heat affected zone
 - Resulting mechanical and fracture properties were typical of allowables established for plate-plate welds
 - Process returned hardware integrity to acceptable levels for proof and flight
- Extensive test program on other extrusions indicated adequate strength at other weld stations
 - Large vertical grain structure not noted
 - Additional post-proof inspections successfully performed to verify integrity
