REPORT OF APOLLO 13 REVIEW BOARD

APPENDIX F - SPECIAL TESTS AND ANALYSES

NATIONAL AERONAUTICS AND SPACE ADMINISTRATION

APPENDIX F
SPECIAL TESTS AND ANALYSES

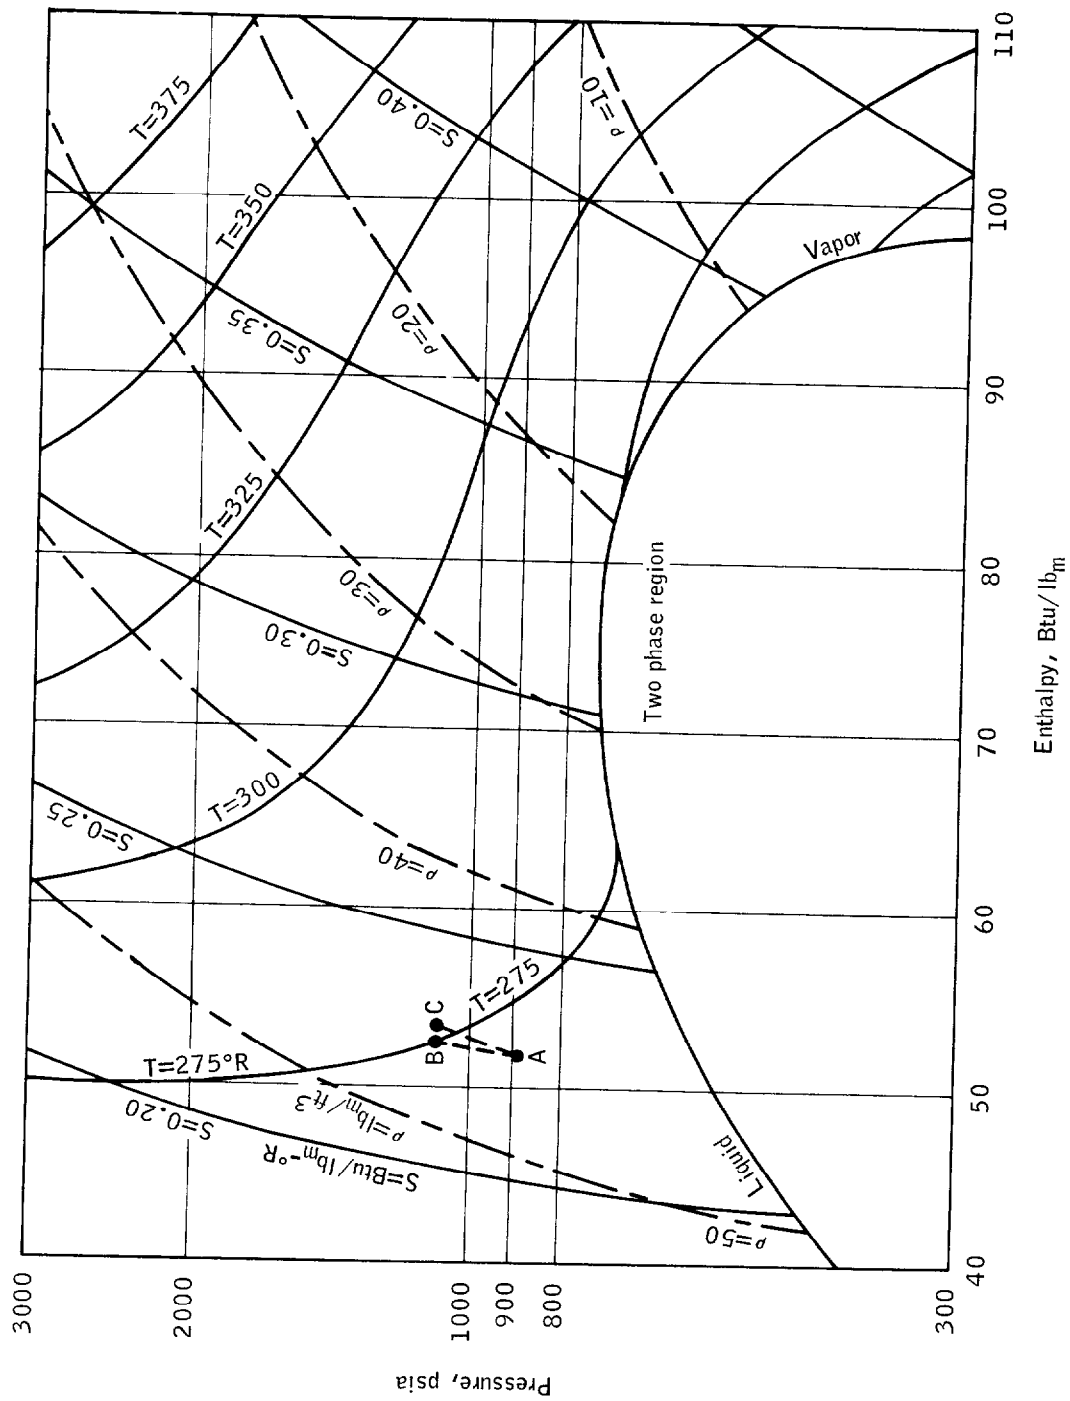
Figure F3.3-1.- Thermodynamic processes on pressure-enthalpy diagram.

Figure F3.3-1 also shows the constant density path along line AC from 887 psia to 1008 psia. This process could be achieved by complete mixing of the tank contents. The internal energy increase for this case (maximum energy) is about 130 Btu. The temperature increase for this process is 2.6° F. It should be noted that this energy addition is to the oxygen in the tank. It does not include energy that might be added to other tank components such as metal parts.

either of the above-mentioned thermodynamic processes because they give a rise of only 1.8° and 2.6° F. As figure B5-3 shows, the measured temperature rise lagged the pressure rise. Both this lag and the magnitude of the temperature rise can be explained by the passage of a combustion front near the temperature sensor.

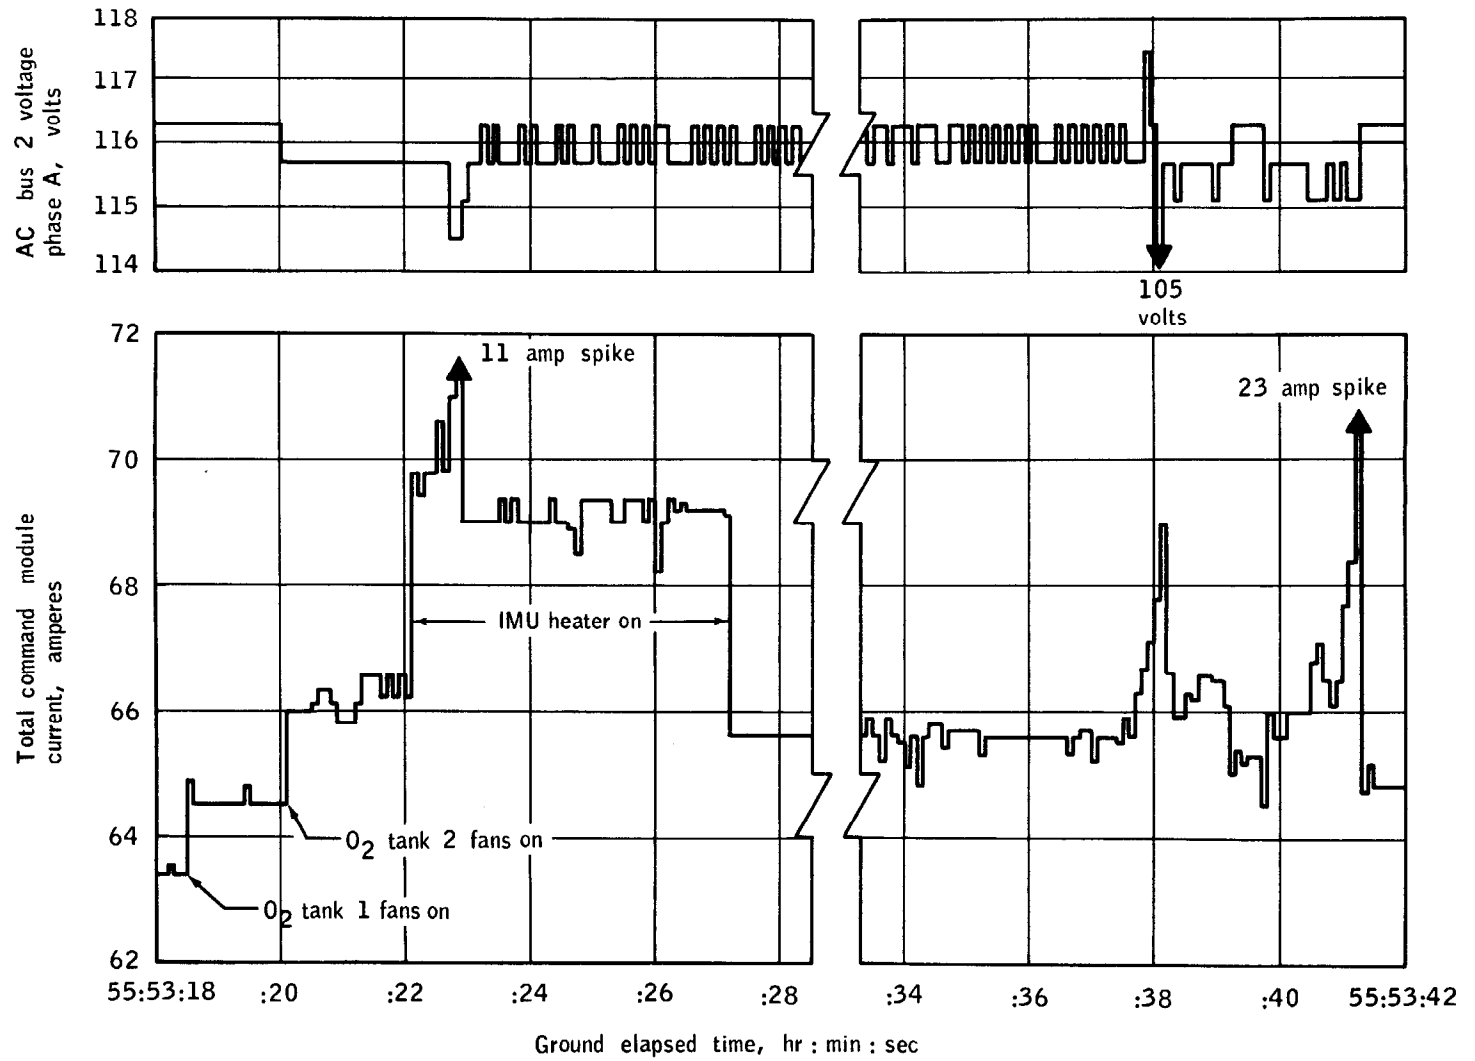
Figure F3.3-2.- Telemetry data for ac bus 2 voltage phase A and total CM current.

1. Fan turnon occurs at 55:53:20 g.e.t. and the phase A voltage drops from 116.3 to 115.7 volts. This is normal. The telemetry granularity is ± 0.3 volt.
2. At 55:53:23, an ac voltage drop from 115.7 to 114.5 volts is observed, coincident with a fuel cell current increase of 11 amperes. This is the first short circuit that occurred after fan turnon. Since the ac voltage rose from 115.7 to 116.0 volts (as indicated by "togging"

between 115.7 and 116.3 volts) after the event, it is probable that the short circuit involved phase A of the motor drive circuit, and all power may have been lost to one of the two fan motors at this time. This hypothesis is further supported by the coincident decrease in fuel cell current of 0.7 ampere, approximately half of the 1.5 amperes drawn by both motors.

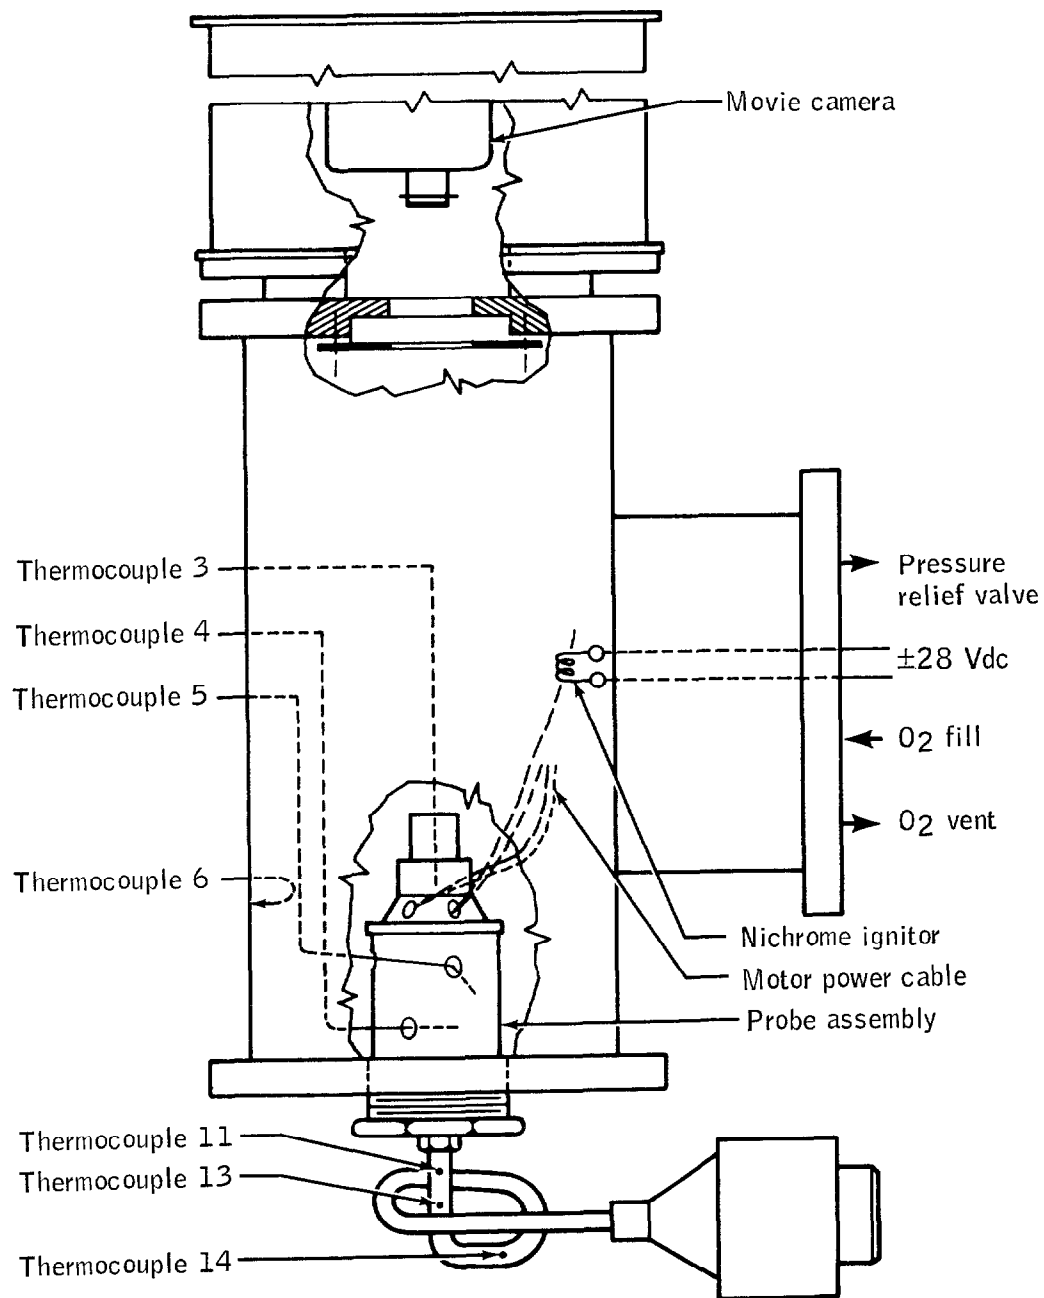
Figure F3.5-1.- Quantity probe and conduit assembly apparatus.

A test which contained an upper portion of the quantity probe and conduit showed that ignition of the motor lead bundle in supercritical oxygen results in flame propagation through the quantity probe insulator and into the conduit. Posttest examination showed an approximately 2-inch diameter hole had been burned out of a 3/8-inch thick stainless steel simulated tank closure plate.

The test item consisted of an upper portion of the quantity probe interfaced with a conduit assembly shown in figure F3.5-2. The quantity probe used was Block I hardware which had been sectioned for demonstration purposes. An additional hole was drilled in the probe insulator to modify it to Block II and wire was routed through it and the conduit assembly to represent the Apollo 13 configuration. Stainless steel sections were welded onto the probe to close the demonstration ports. Wiring with insulation was allowed to extend beyond the Teflon insulator approximately 4 inches. This wiring was also routed through the conduit and connected to the feedthrough pins through which power, 115 volts at 400 cycles, was supplied to both fan motor bundles by a system which had been
