LOSS OF OXYGEN TANK NO. 2 SYSTEM INTEGRITY

PART 5. APOLLO 13 RECOVERY

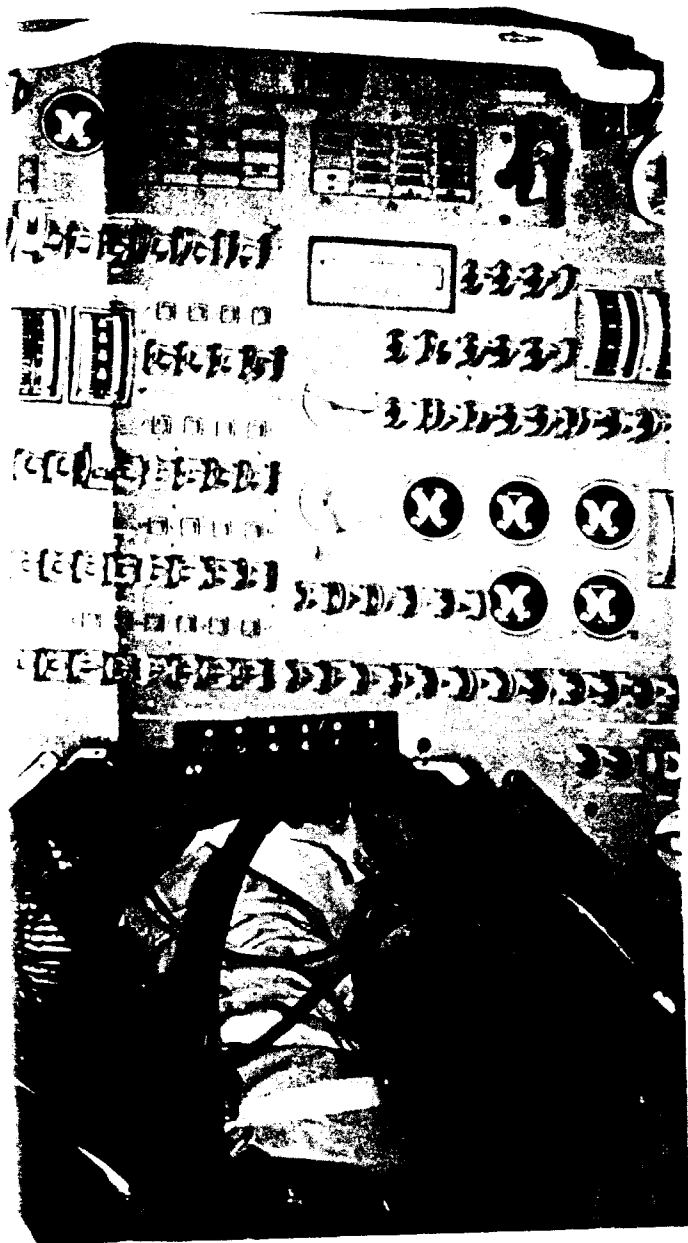
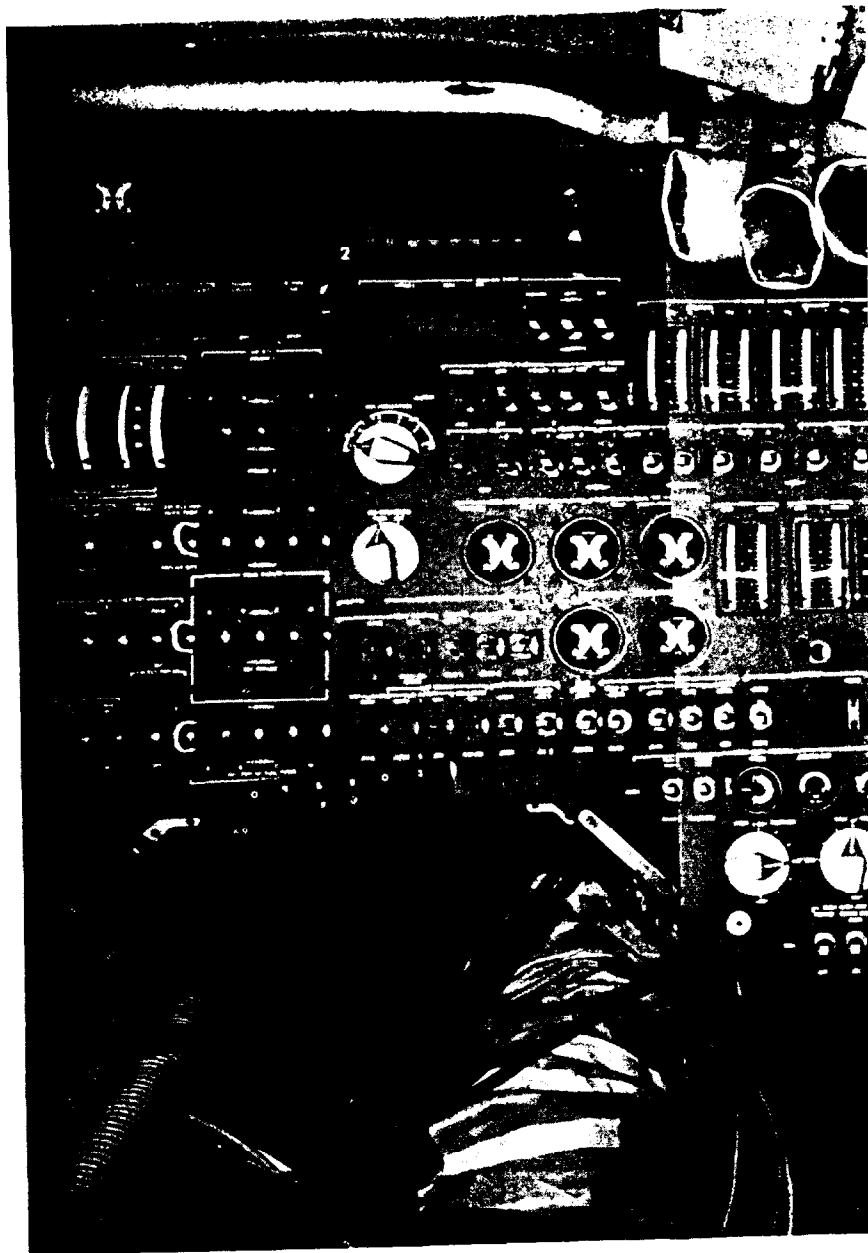
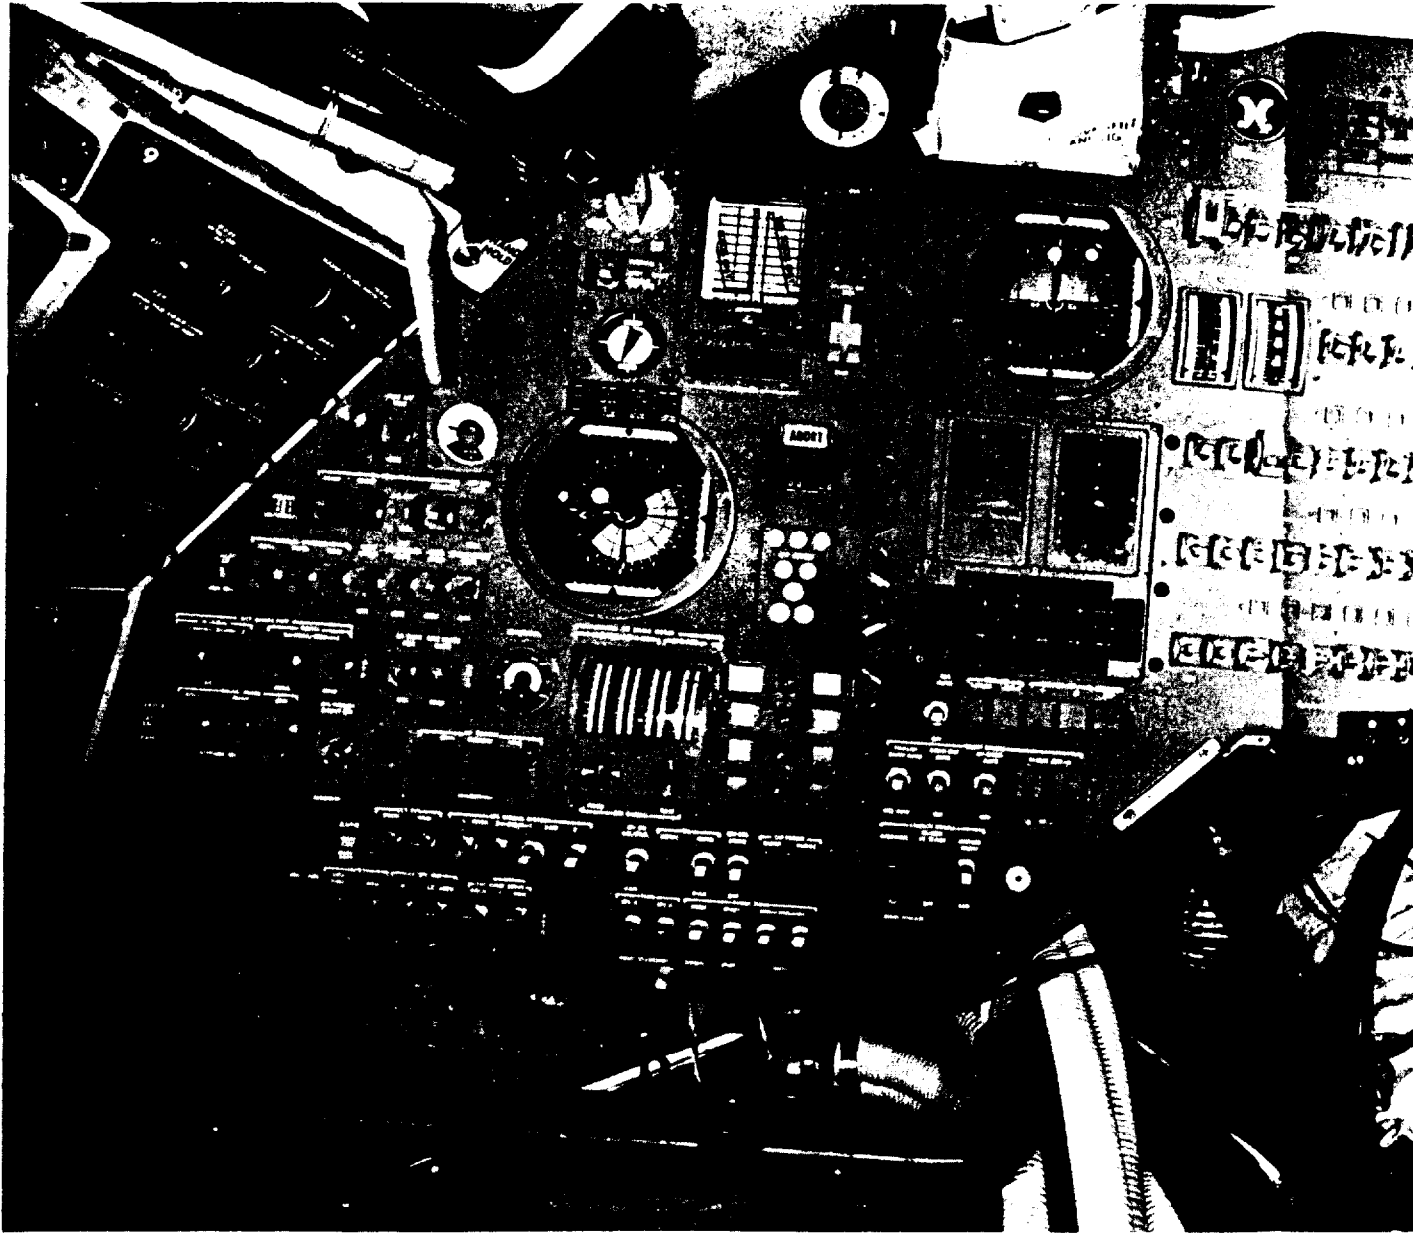
Figure 4-13.- Main display panel.

The Lunar Module Pilot was in the tunnel between the CSM and the LM, returning to the CSM. The Command Module Pilot was in the left-hand couch, monitoring spacecraft performance. Because of the master alarm indicating low voltage, the CMP moved across to the right-hand couch where CSM voltages can be observed. He reported that voltages were "looking good" at 55:56:10. At this time, main bus B had recovered and fuel cell 3 did not fail for another 1-1/2 minutes. He also reported fluctuations in the oxygen tank no. 2 quantity, followed by a return to the off-scale high position. (See fig. 4-13 for CM panel arrangement).

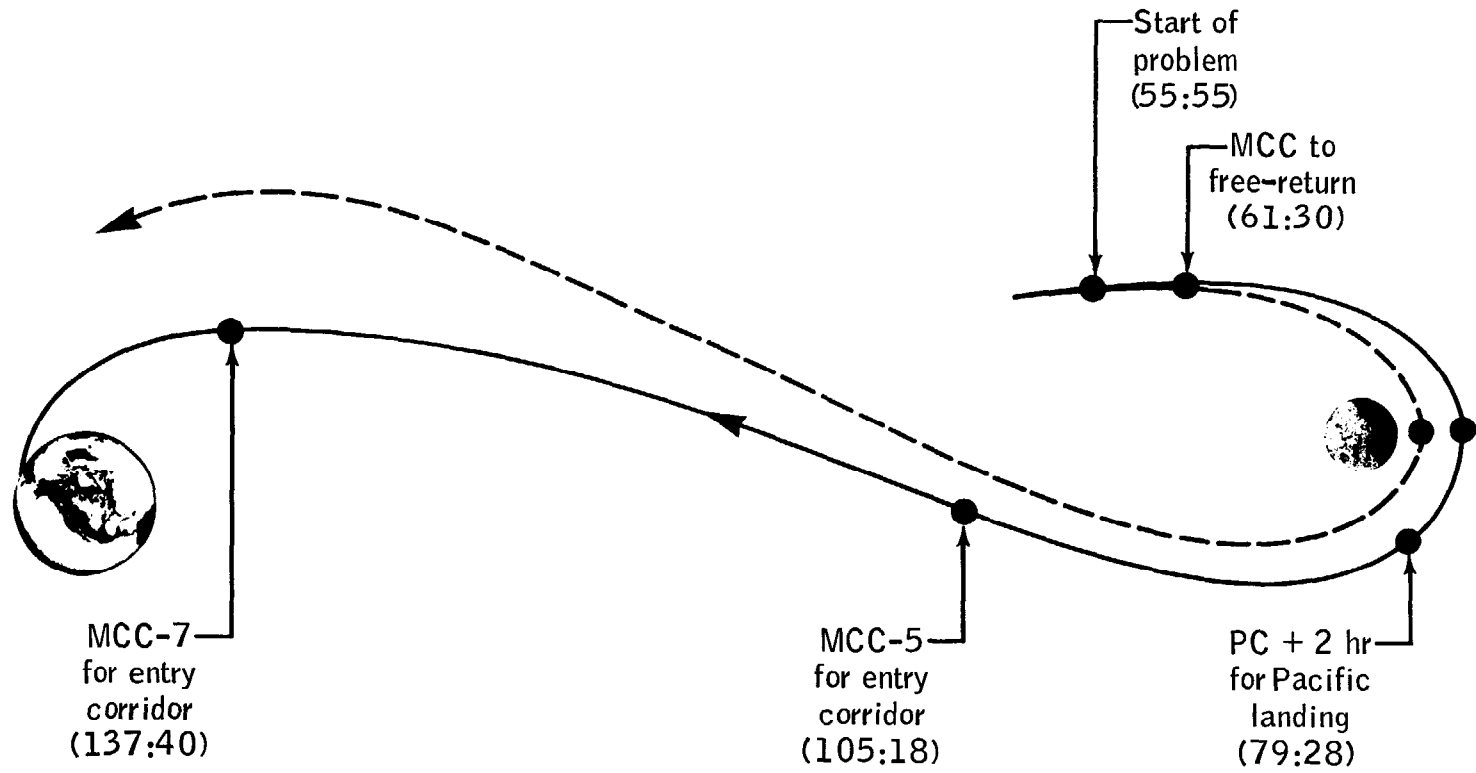
Figure 4-14.- Translunar trajectory phase.

The minimum practical return time was 133 hours g.e.t. to the Atlantic Ocean, and the maximum was 152 hours g.e.t. to the Indian Ocean. Recovery forces were deployed in the Pacific. The return path selected was for splashdown in the Pacific Ocean at 142:40 g.e.t. This required a minimum of two burns of the LM descent engine. A third burn was subsequently made to correct the normal maneuver execution variations in the first two burns. One small velocity adjustment was also made with reaction control system thrusters. All burns were satisfactory. Figures 4-14 and 4-15 depict the flight plan followed from the time of the accident to splashdown.

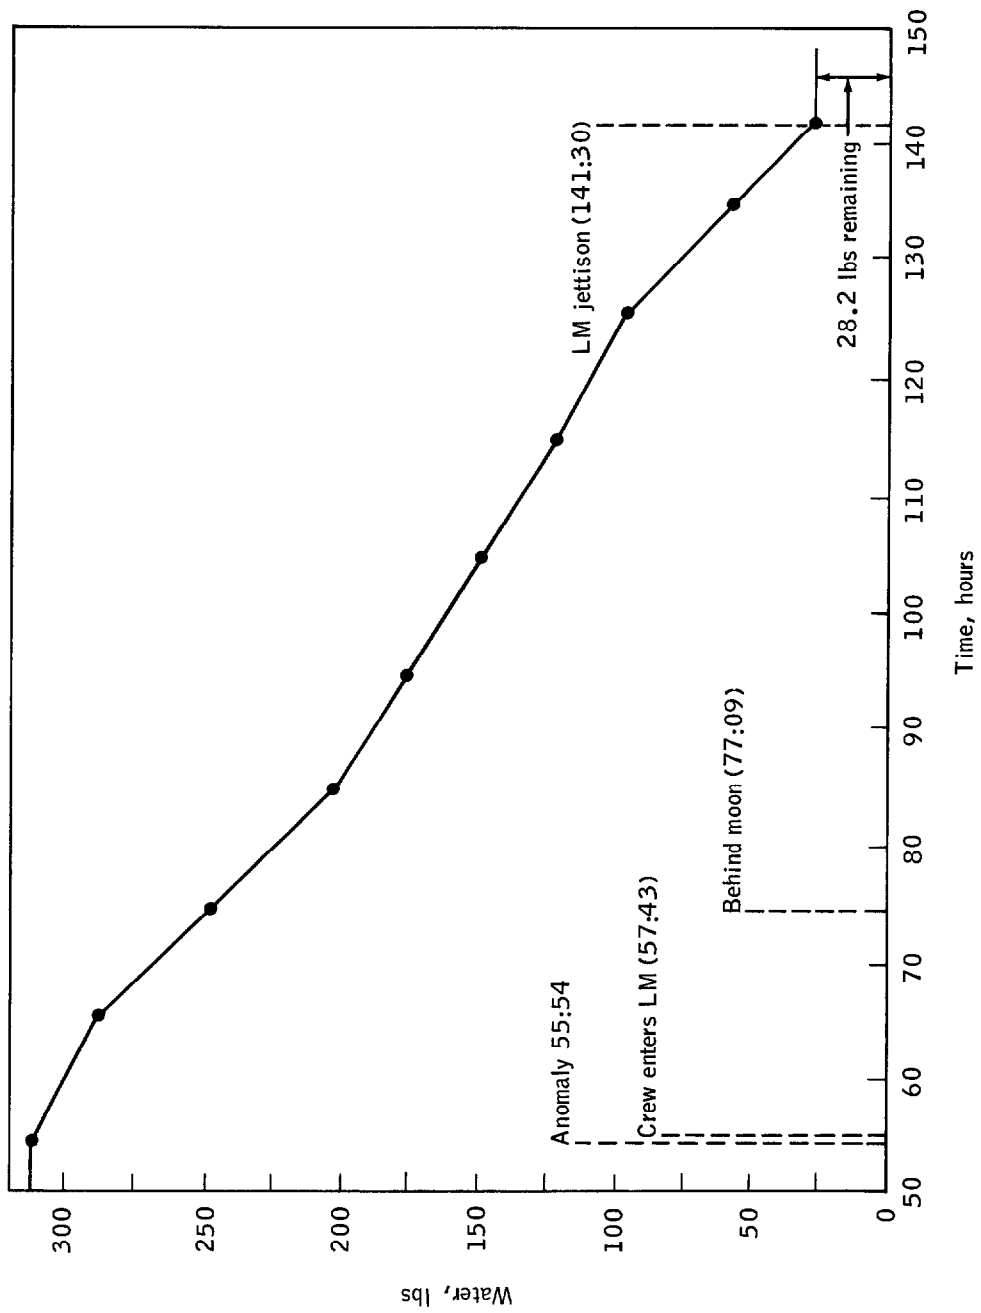
Figure 4-17.- Usable remaining water.

The most critical consumables were water, used to cool the CSM and LM systems during use; CSM and LM battery power, the CSM batteries being for use during reentry and the LM batteries being needed for the rest of the mission; LM oxygen for breathing; and lithium hydroxide (LiOH) filter cannisters used to remove carbon dioxide from the spacecraft cabin atmosphere. These consumables, and in particular the water and LiOH cannisters, appeared to be extremely marginal in quantity shortly after the accident, but once the LM was powered down to conserve electric power and to generate less heat and thus use less water, the situation improved greatly. Engineers at MSC developed a method which allowed the crew to use materials on board to fashion a device allowing use of the CM LiOH cannisters in the LM cabin atmosphere cleaning system (see fig. 4-16). At splashdown, many hours of each consumable remained available (see figs. 4-17 through 4-19 and table 4-III).
