**FINAL REPORT TO BP EXPLORATION
FOR DETERMINING INTERIM
CRITERIA FOR REPLACING
DAMAGED POLYESTER
MOORING ROPE**

**Prepared For
BP America, Inc.
Upstream Technology Group
Deepwater Technology Unit**

December 13, 2001

**FINAL REPORT TO BP FOR DETERMINING INTERIM CRITERIA FOR
REPLACING DAMAGED POLYESTER MOORING ROPE**

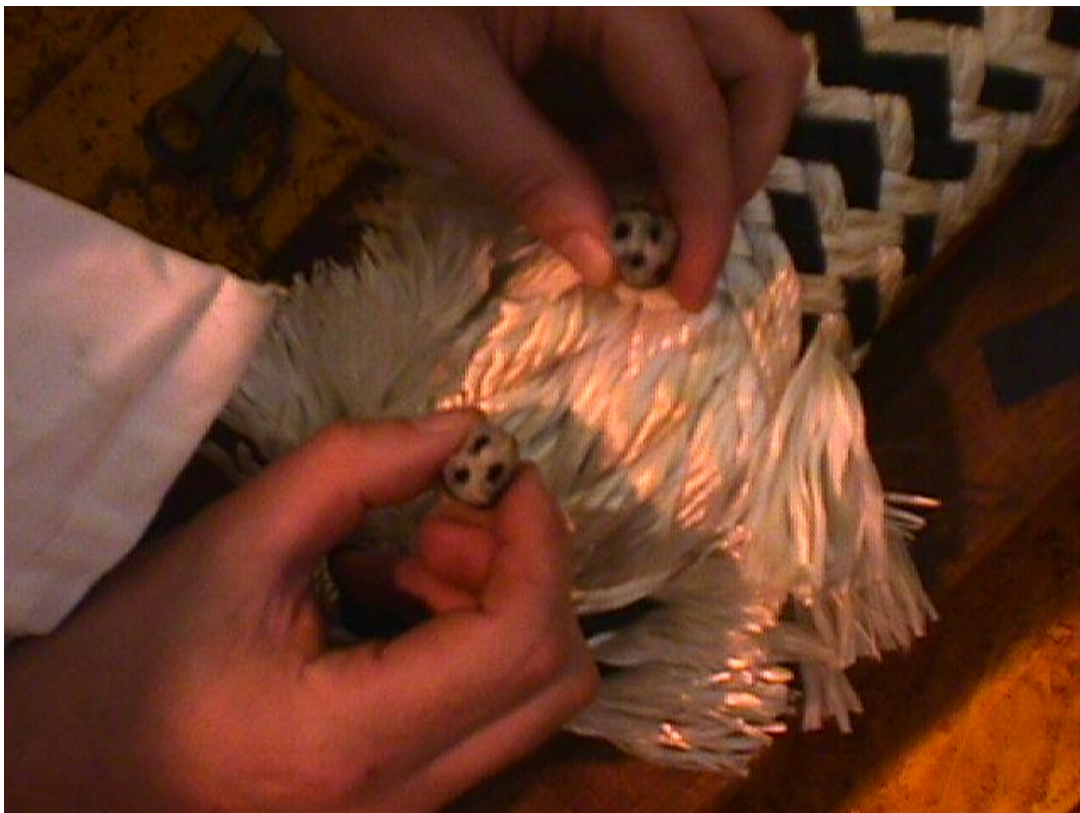
Figure A4. Cut Subrope Showing Black Marker in Each Element.

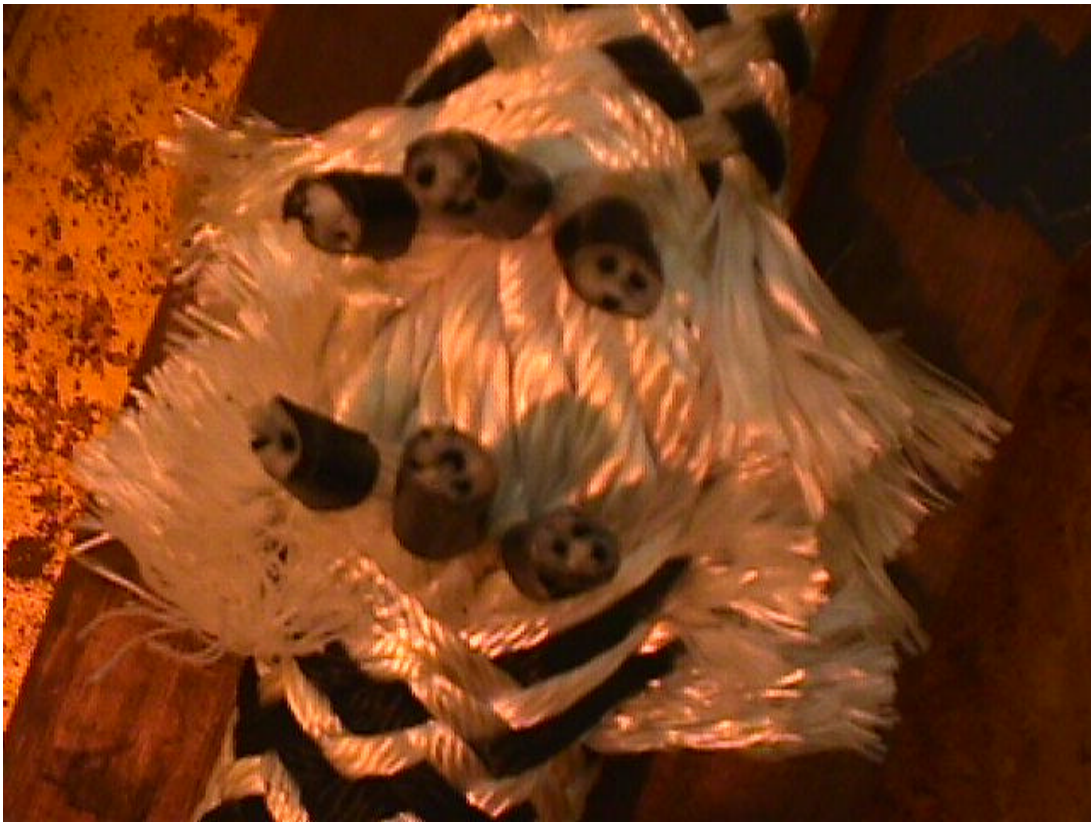
Figure A5. MQDE 4 With 3 Subropes Cut

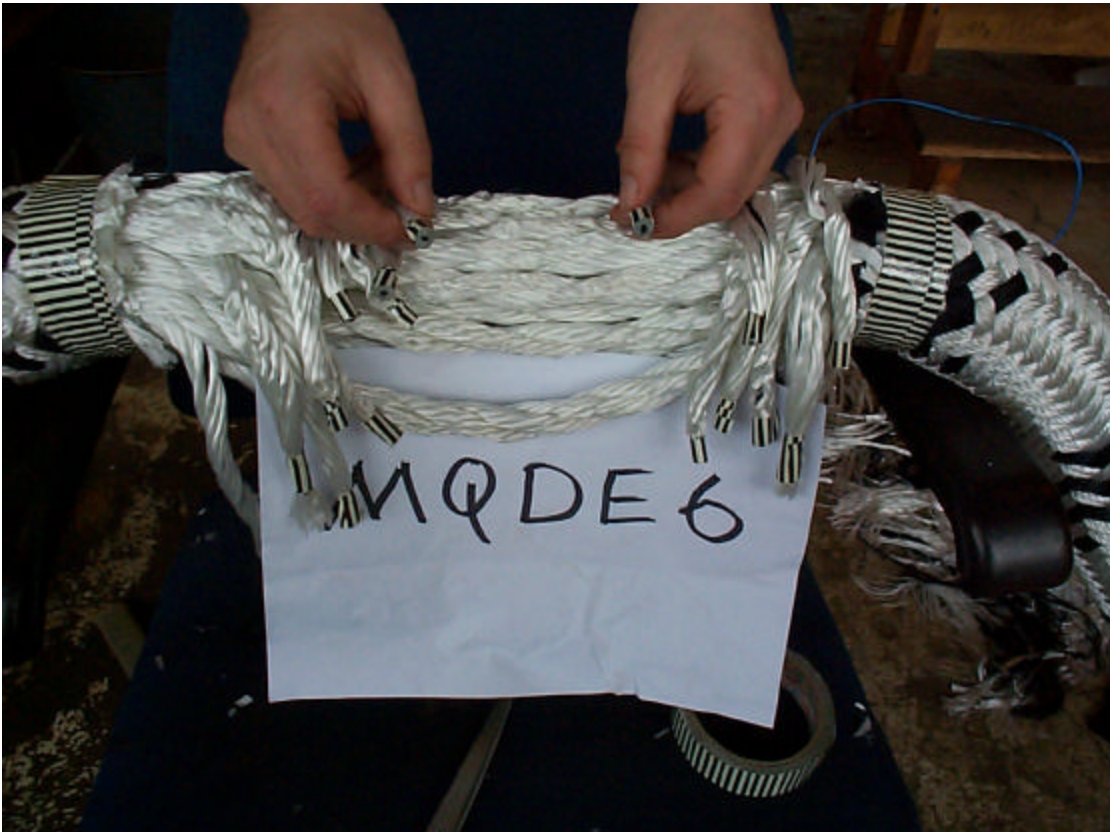
Figure A10. One Element of Nine 3-Part Subropes Cut.

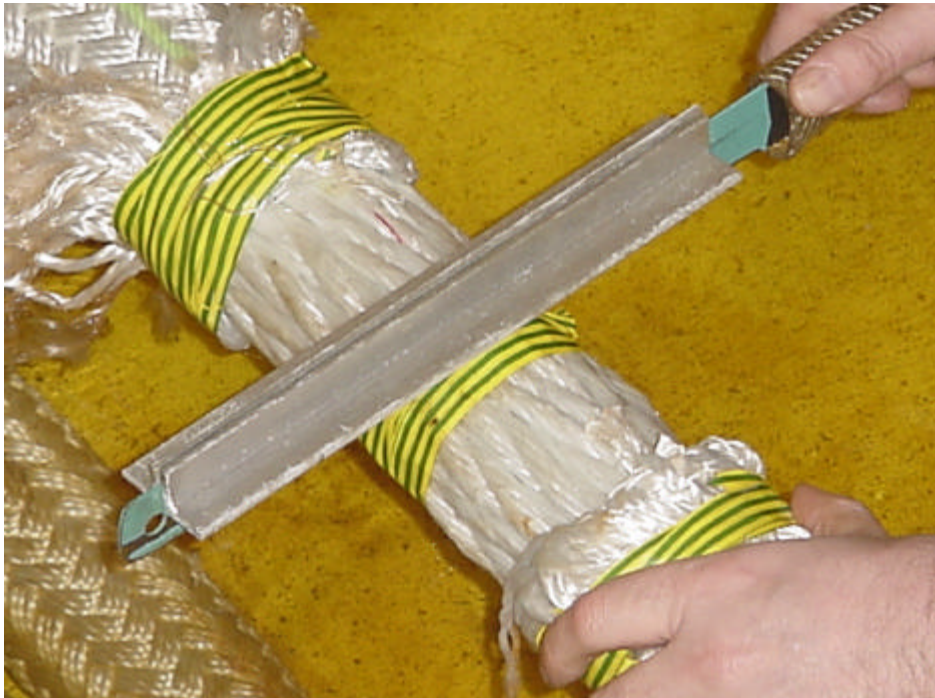
For the cut at NEL: Figure B3 shows a 0.7-inch deep cut being made on sample MQIQ 4. The jacket was removed around the area of induced damage. The cut was made with a sharpened hacksaw blade (teeth removed). Either side of the blade aluminum angle was glued to the blade with the distance from the base of the angle plate to the blade edge set at 18 mm. Care was taken

Figure B3. Knife Cut of Rope at NEL.

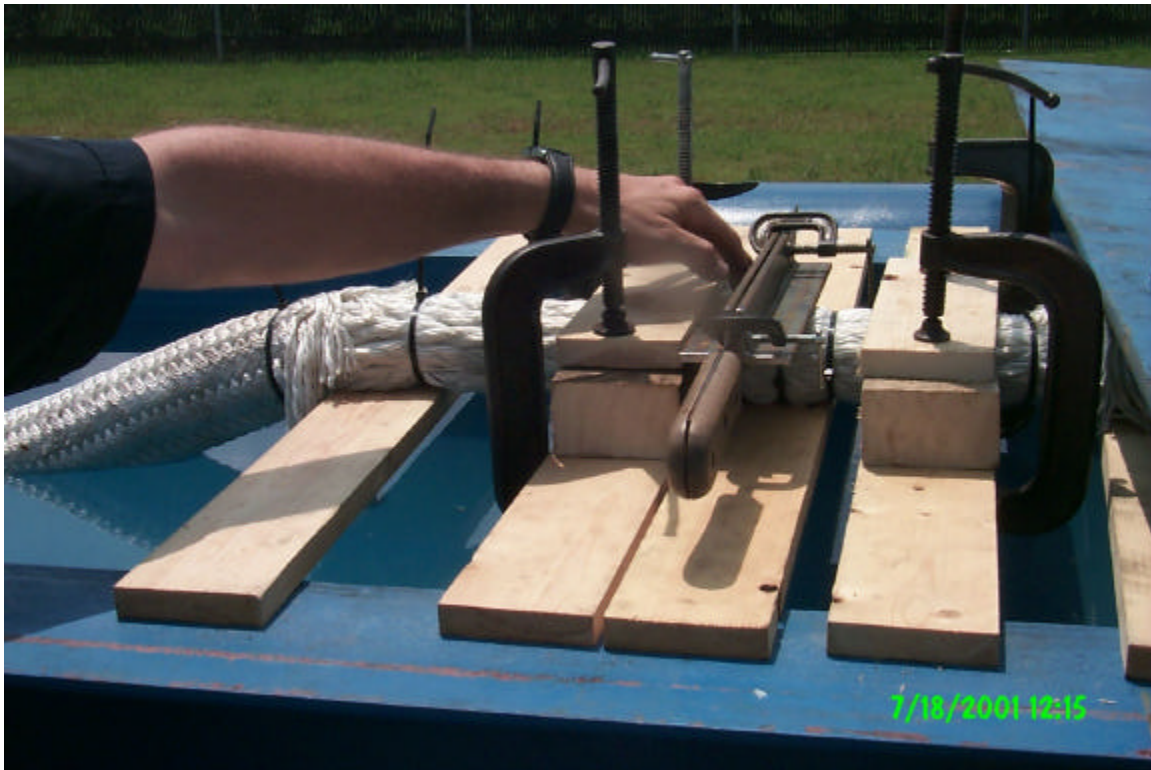
Figure B4. Butcher Knife Cuts at SES.

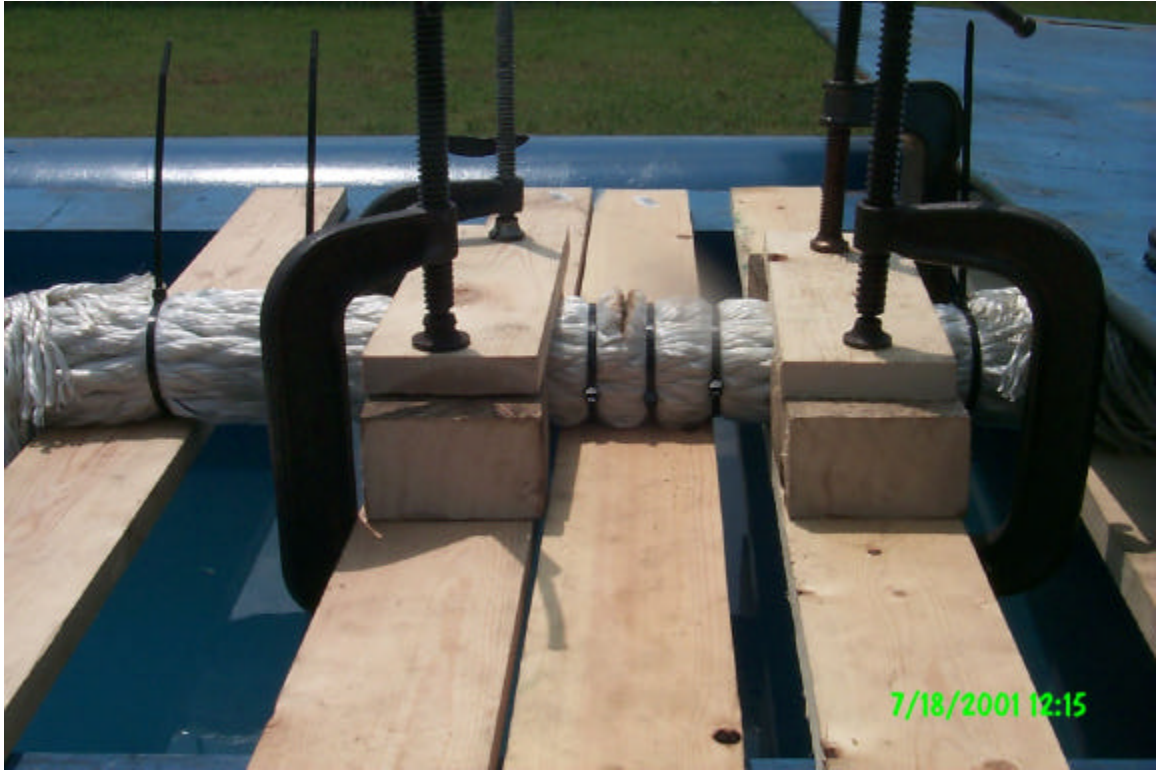
The first finding was not completely a surprise to us. Although we tried to maintain a round cross section during the cutting, the pressure of the cut probably flattened the rope cross section such that more subropes were cut than a % area calculation would show. Secondly, we found (see Figure B-5) that the cut fibers would want to expand outward, tending to raise the angle iron cut- depth supports on the butcher knife, and restrict the blade from cutting so deep.

Figure B5. Close-Up of the Cut Rope. Note Raised Cut Region.

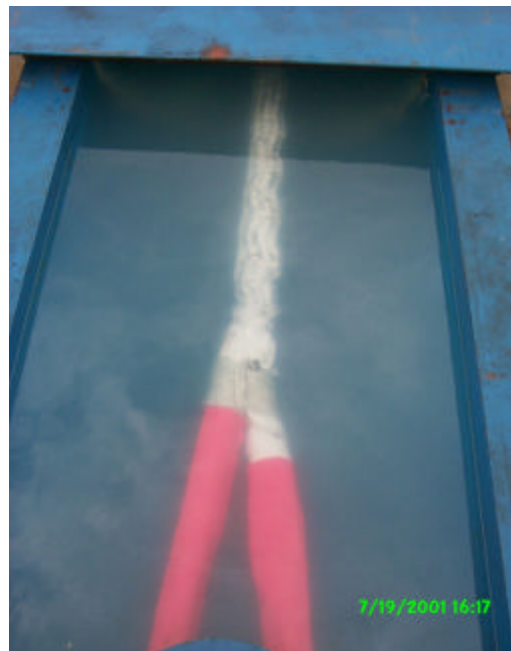
Figure B12. Photograph of Splice Rotation on SES 2.
Note Lack of Symmetry.

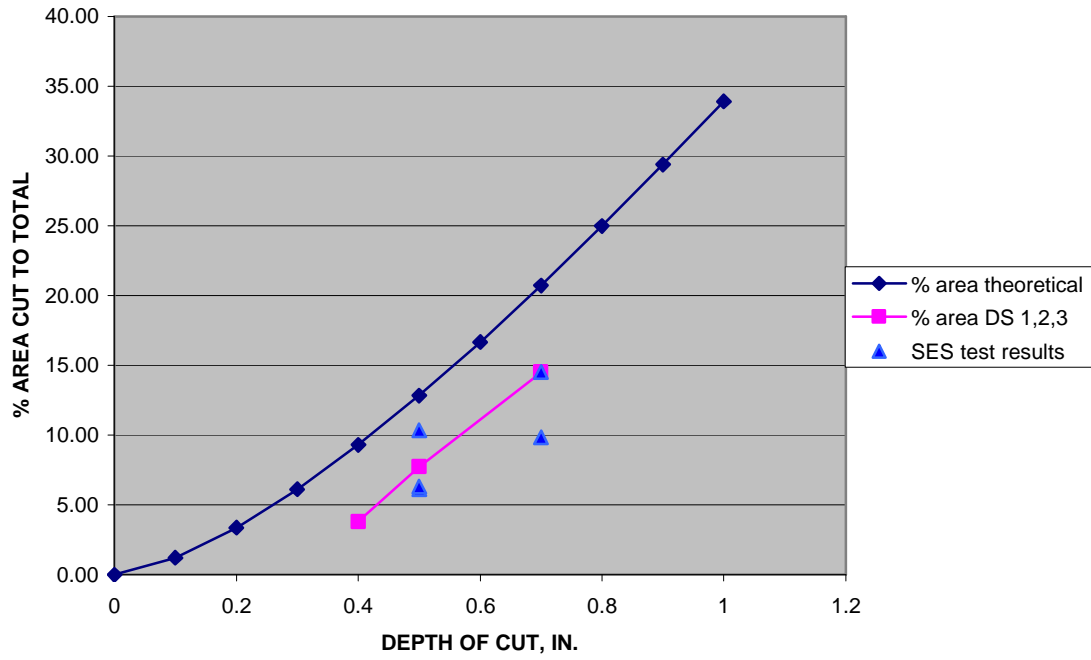
Figure B27. Comparison of Knife Cut % Area Theory vs. Test Data.

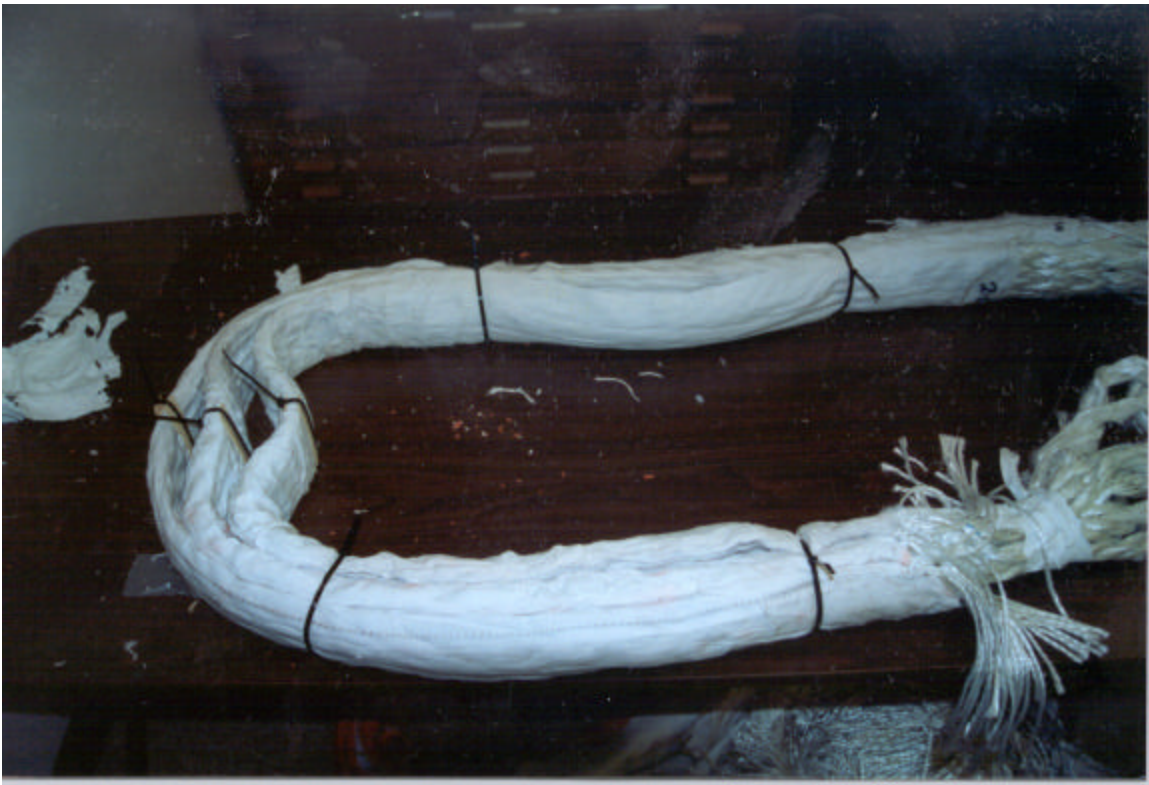
**Figure C6. SES 2 Eye Splice Region with Outer Jackets Removed.
Note Subrope Bundles in Three Layers.**

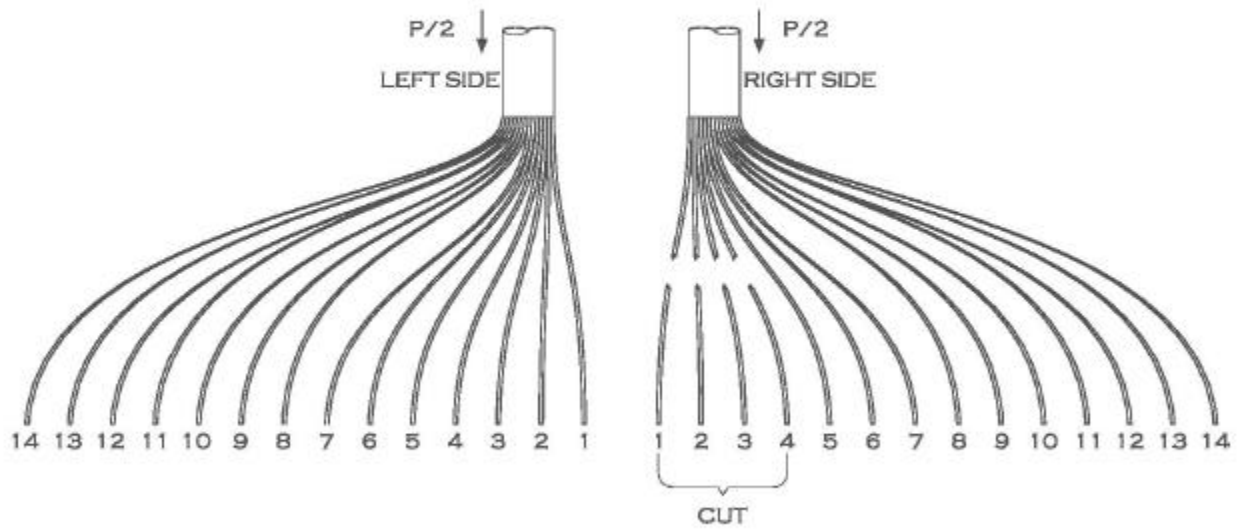
Figure 10. Sketch Showing Effect of Cut Subropes.

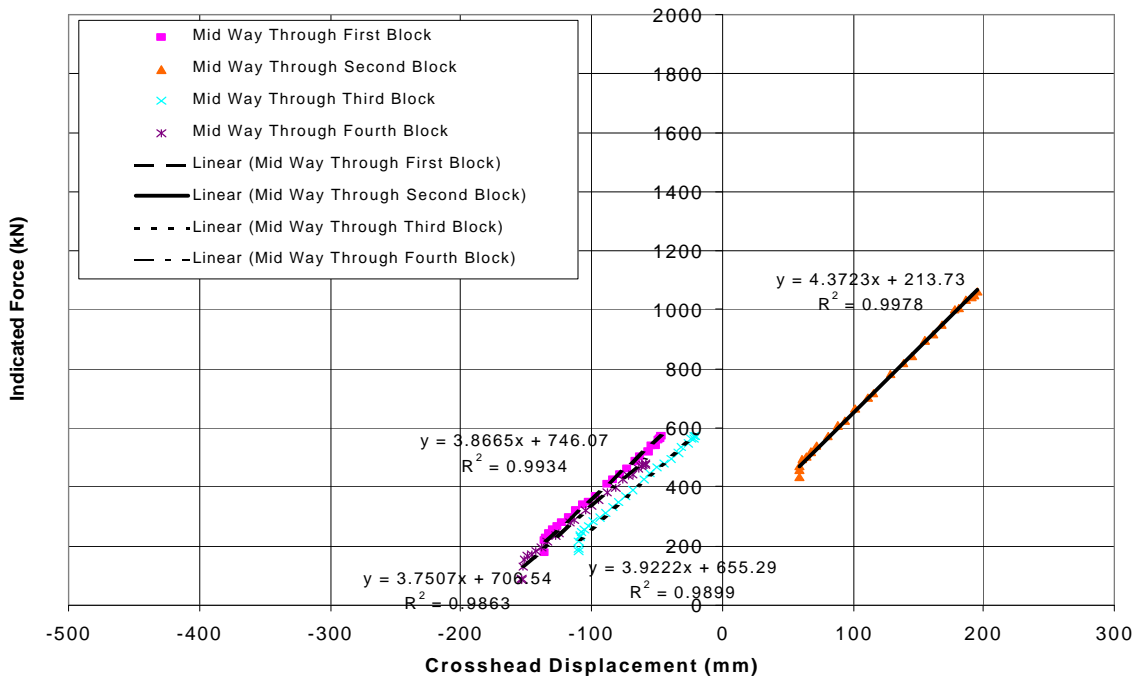
Figure 7.11a Example Load-Displacement Plots During First Sequence: MQDE 6

- Again it can be seen from Figures 7.6a-7.11a that from mid way through the first block of the first sequence to mid way through the second block (40±15%) of the first sequence there is an increase in length of around 450 mm (~3.5%).

- However, from mid way through the second block (again Figures 7.6a-7.11a) to mid way through the third block (20±10%) the ropes have reduced in length typically in the order of 100 mm (~1%).

- A comparison between Figures 7.6a-7.11a and Figures 7.6b-7.11b reveals that, only between the first run of each sequence (the 20±10% runs), are the changes in length during the second sequence much less than those in the first sequence. This again shows that bedding-in is marked during the first run (block) of the first sequence.

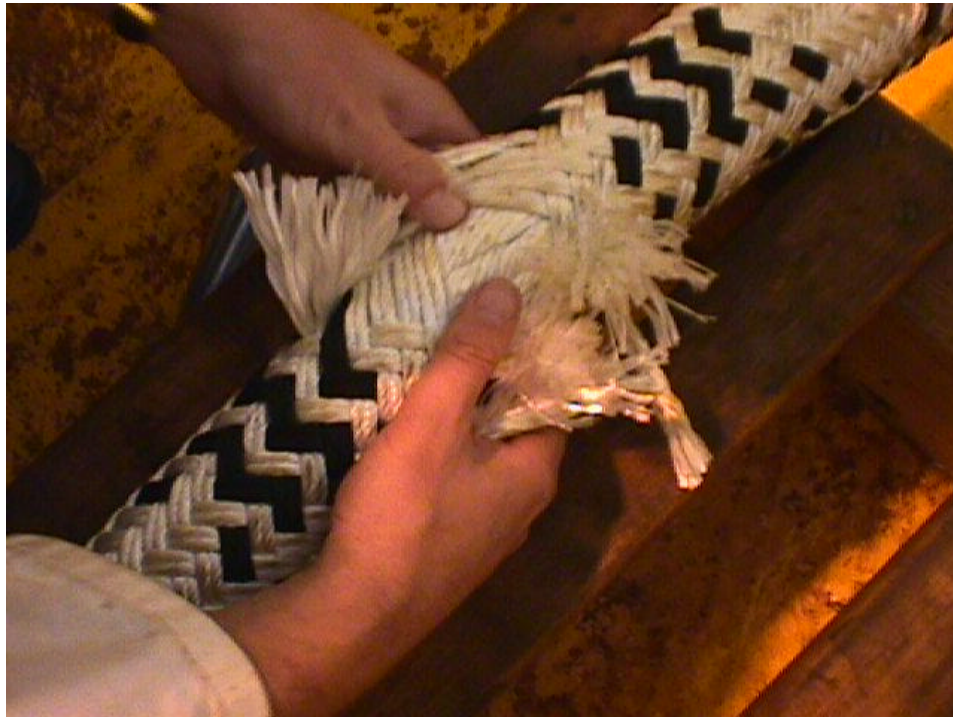
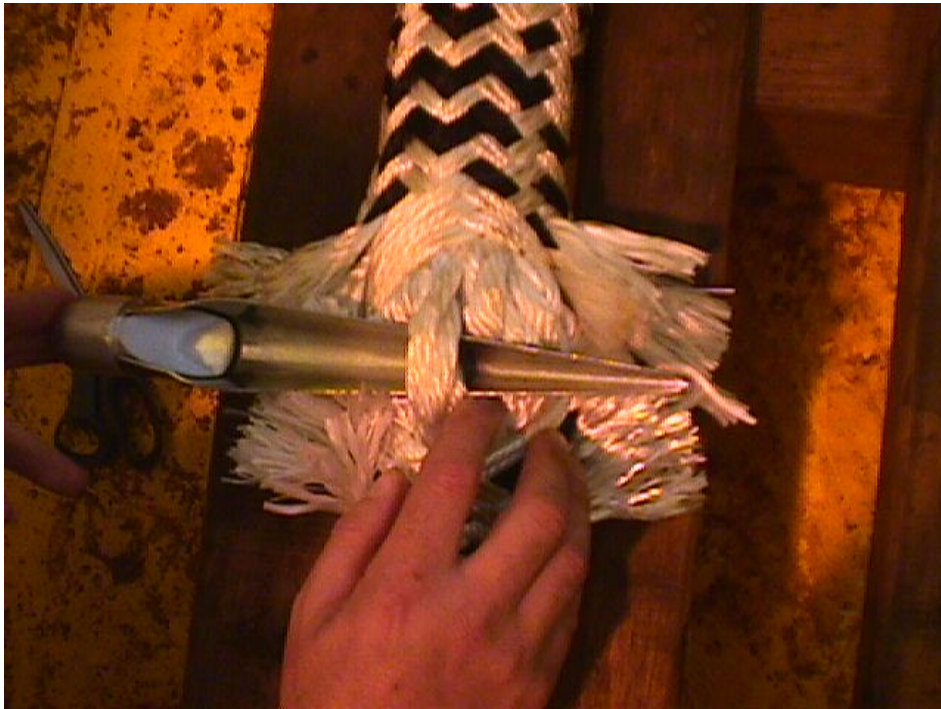
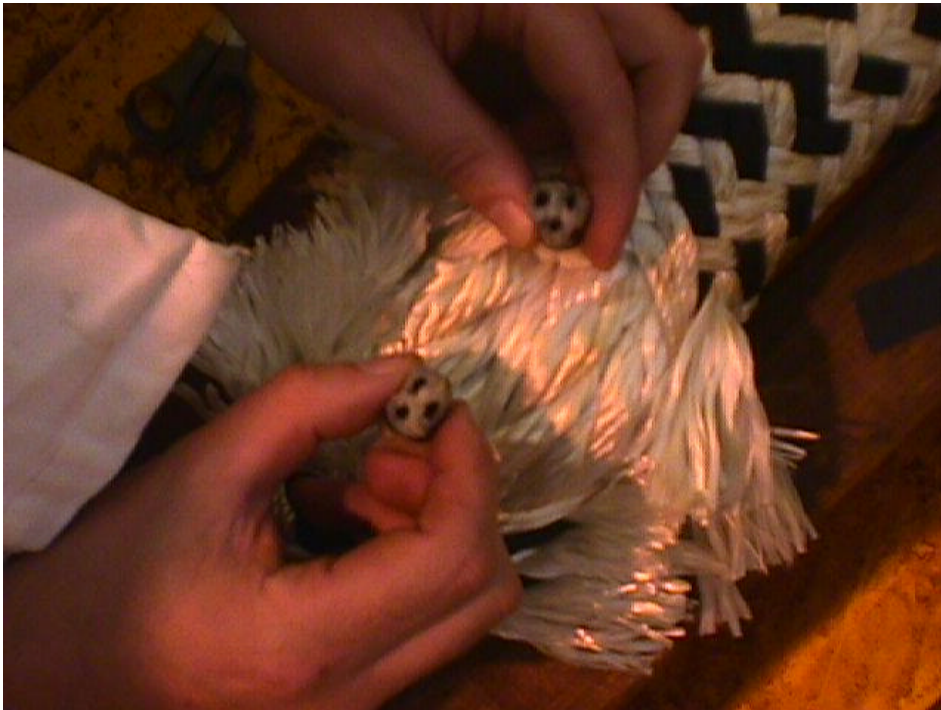
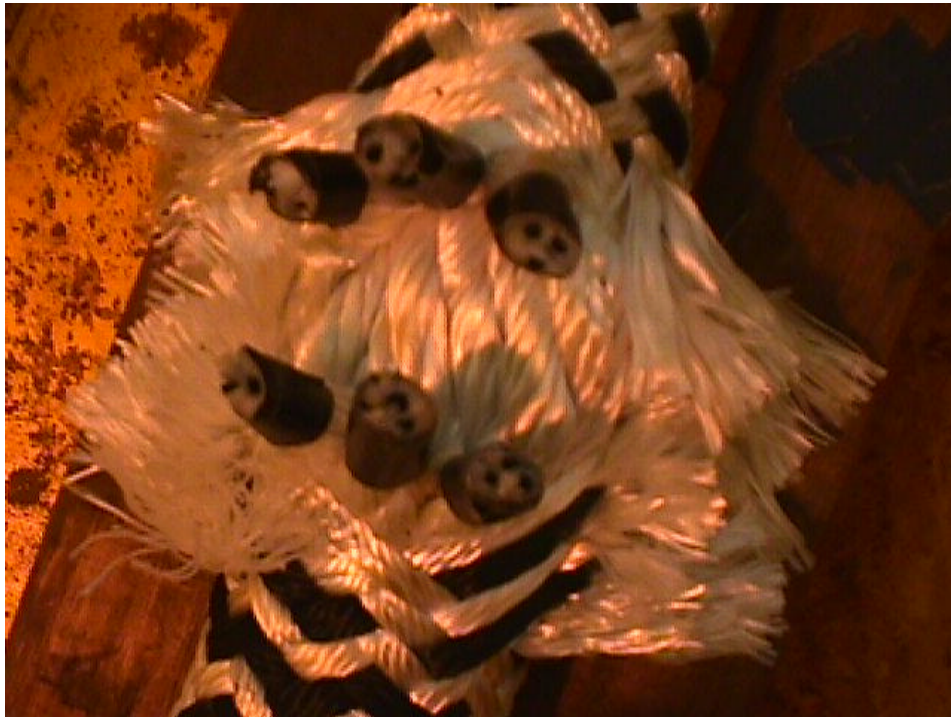
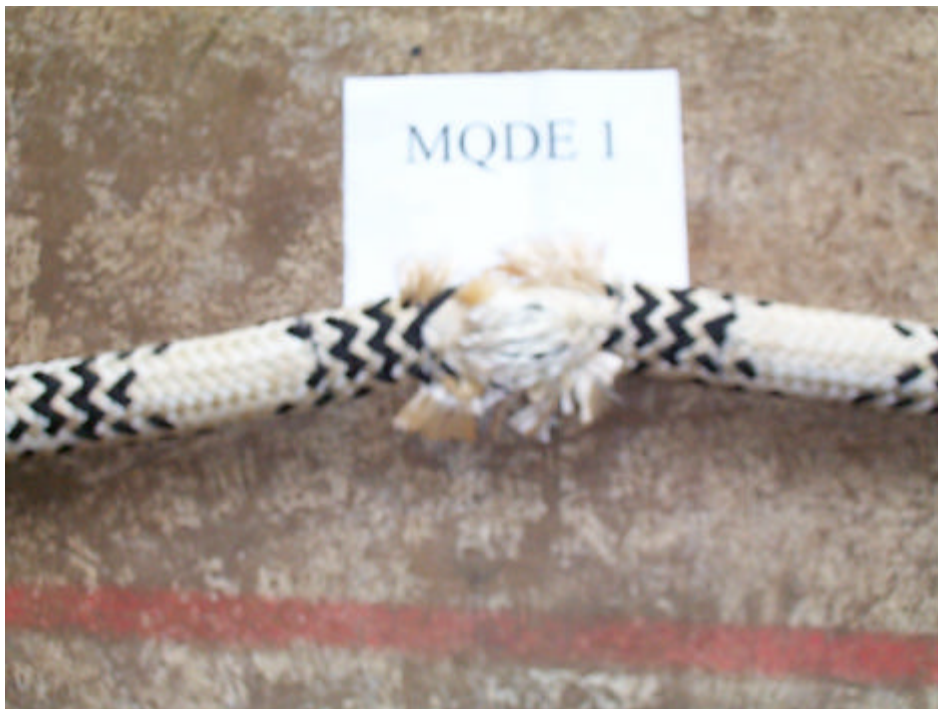
Shown in Figures 7.12-7.16 (MQDE 1) and Figures 7.22-7.26 (MQDE 6), is a photographic record of the procedure adopted to induce damage. In the case of MQDE 1, where only 3 subropes were cut, the jacket was partially removed. However, for MQDE 6 where one strand was cut from 9 subropes (equivalent to 3 cut subropes) the entire jacket had to be removed locally for access.

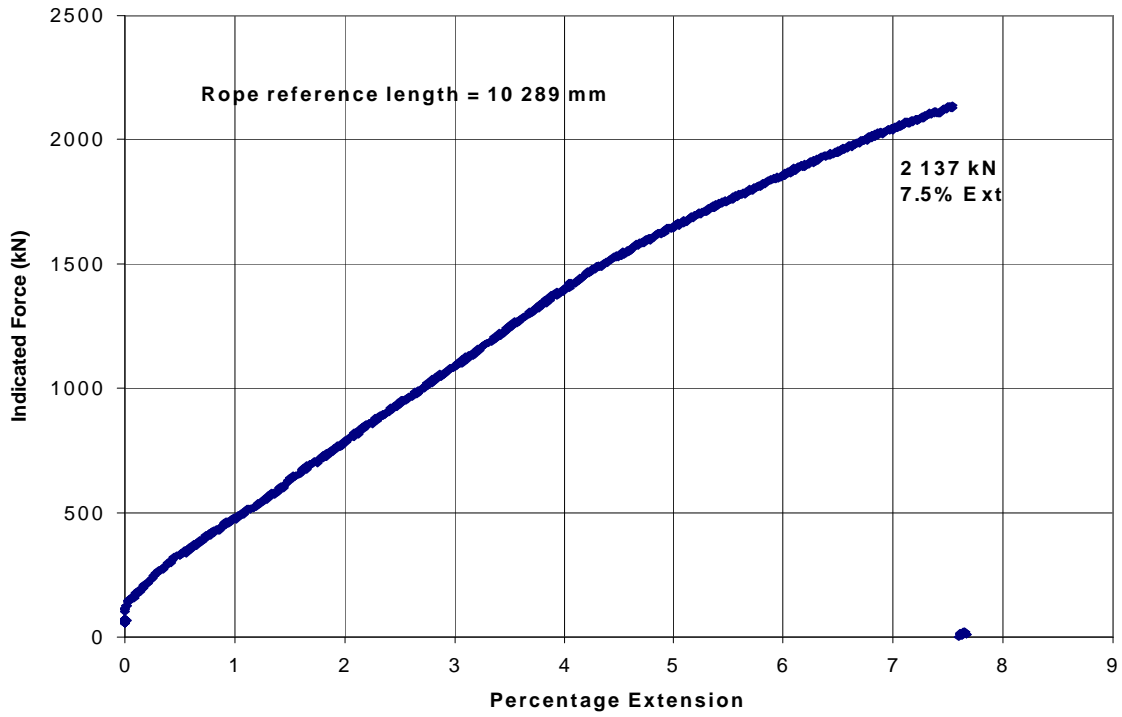
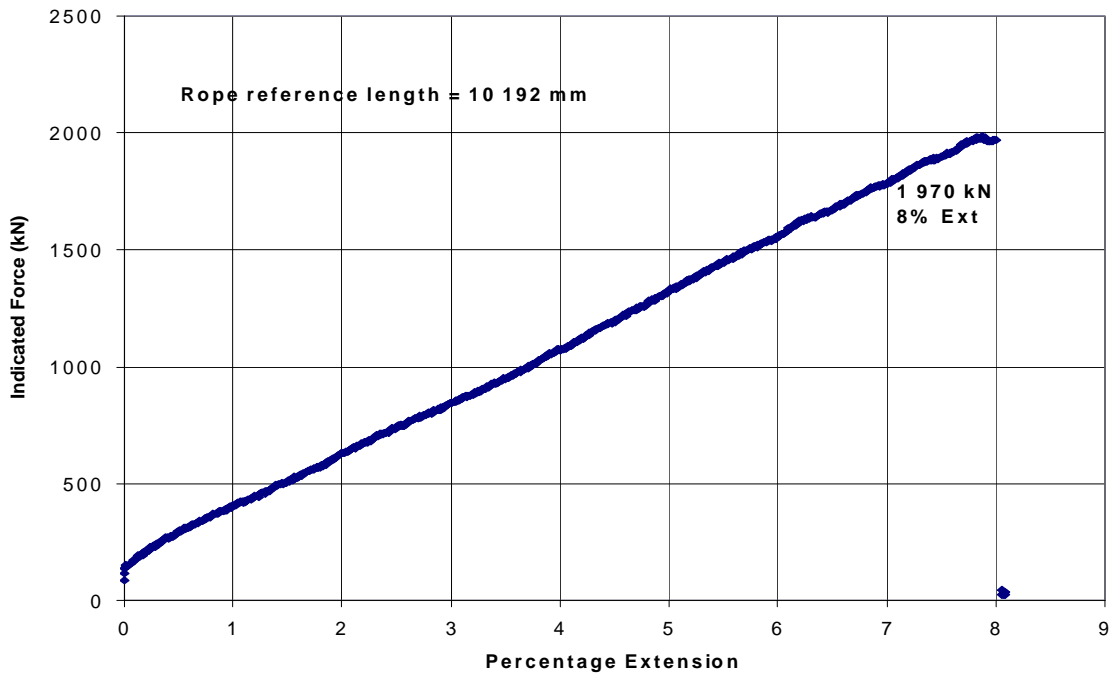
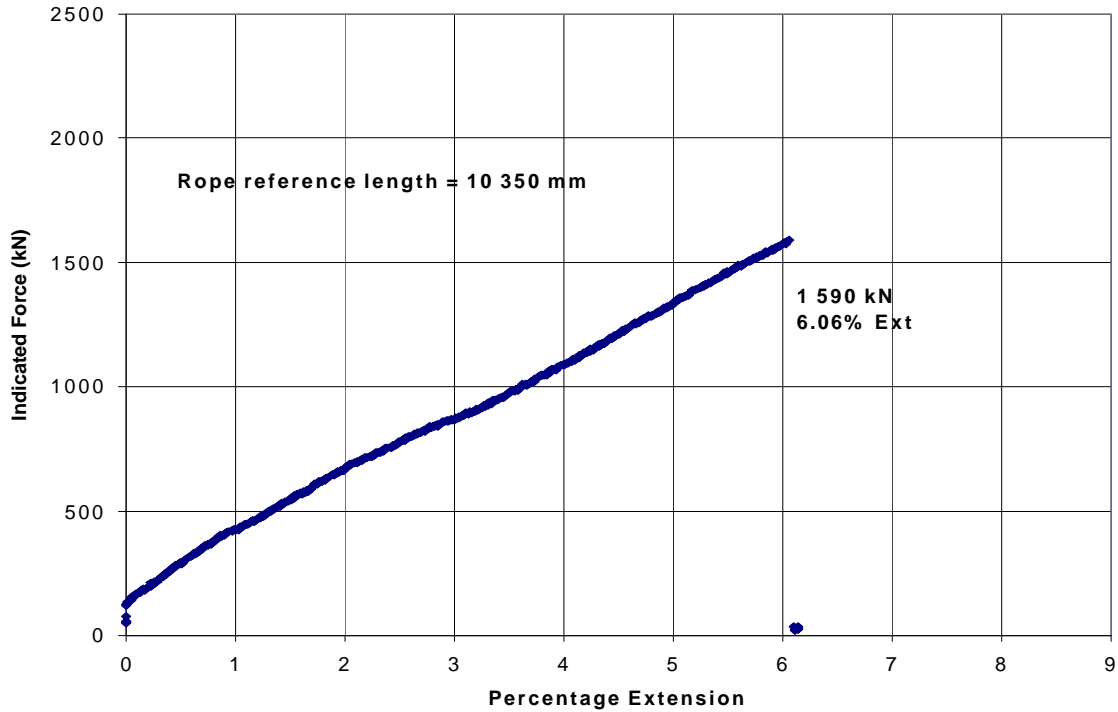
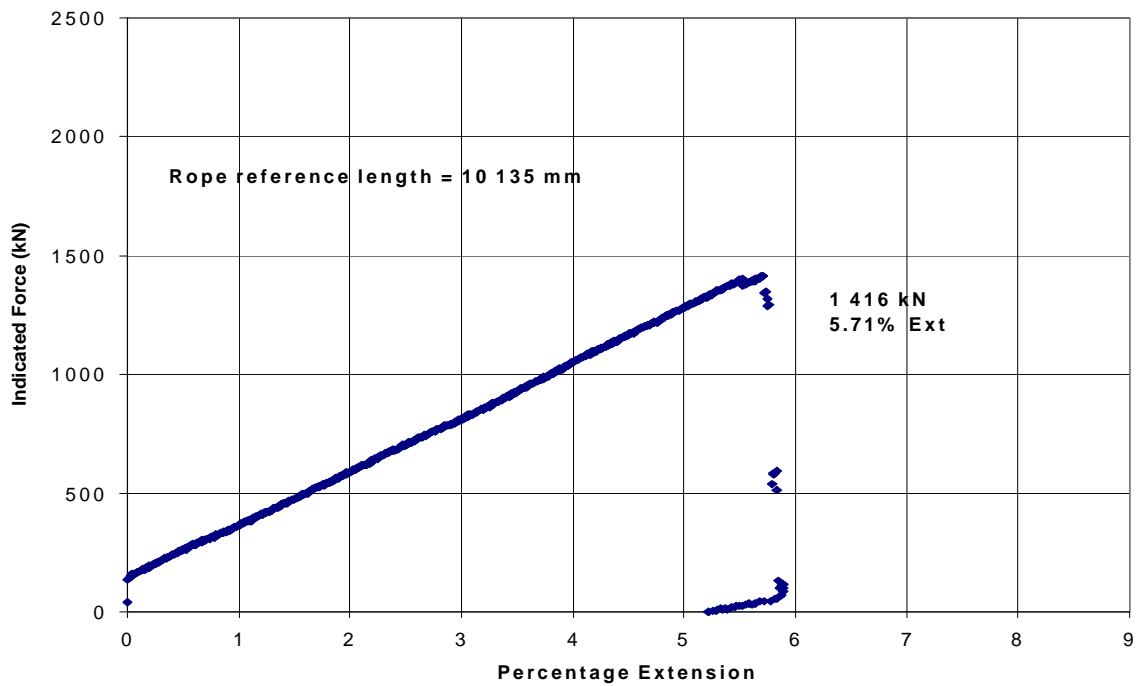
The associated load-extension plots for the break tests are given in Figures 8.1-8.4. It can be seen from the plots (and the table) that, as was the case for the MQDE test series, the undamaged ropes yielded the highest loads and extension to break values. With regard to the undamaged reference tests, it can be seen from Table 8.1 that whilst MQIQ 1 exceeded the theoretical rope strength of 2 091 kN with a value of 2 137 kN, MQIQ 2 did not with a value of 1 970 kN. There is around an 8.5% difference between the two break strength values. As with the case of the MQDE series of tests, once damage has been introduced (MQIQ 4) both the breaking strength and extension to break values reduce.

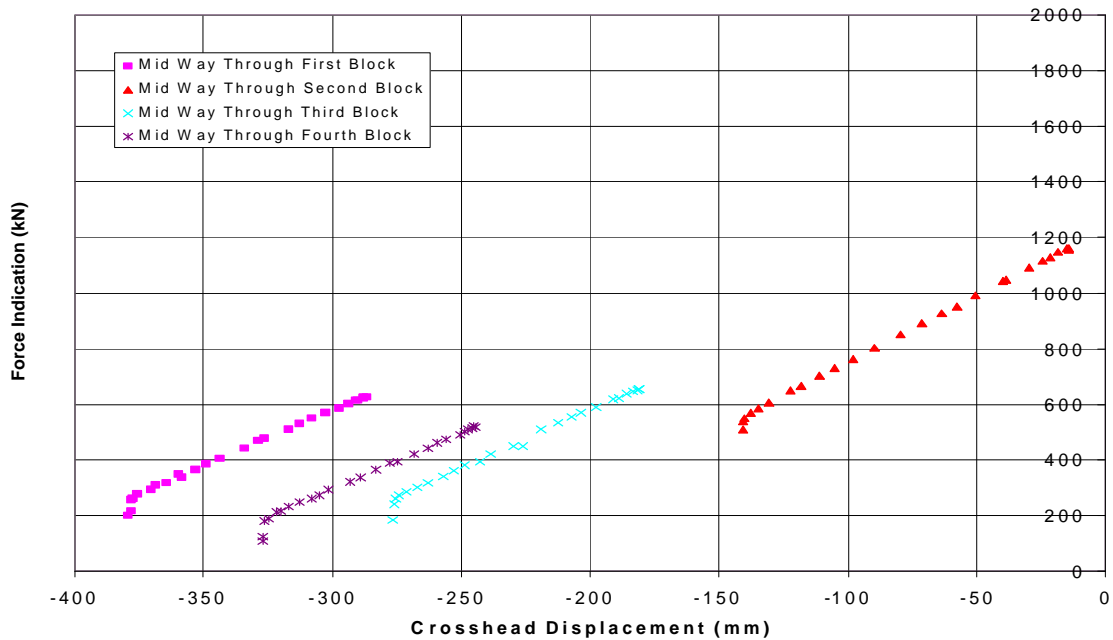
Figure 8.7a Example Load-Displacement Plots During First Sequence: MQIQ 3

The handling test (MQIQ 3) – Table 8.8) displays slightly different elongation characteristics to the other tests in that a fair proportion of the total elongation occurred during runs 5 and 6 of the second sequence. Also the total elongation was 5.6% which was almost the same as the induced damage test (MQIQ 4). The reasons listed previously when discussing Figure 8.7a apply to Table 8.8. That is;

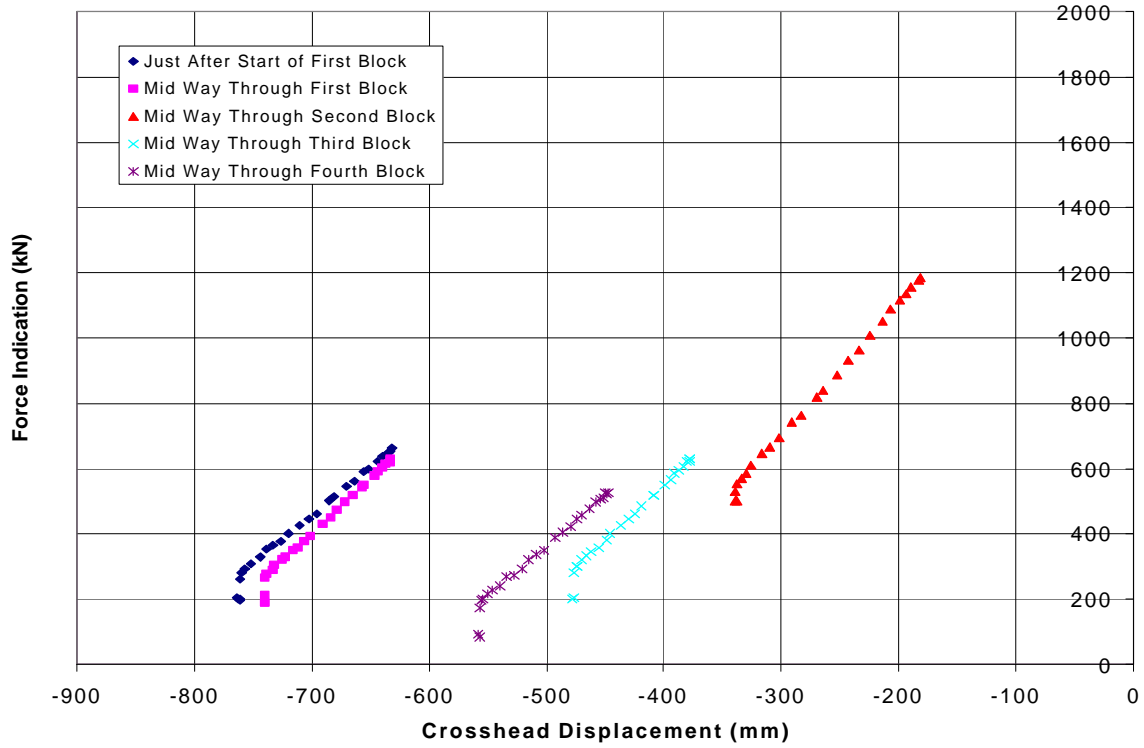
Figure 8.7b Example Load-Displacement Plots During Second Sequence: MQIQ 3

➤ The possible exception to the above comment is the handling test (MQIQ 3), where although some of the runs in the first sequence were not logged) the relatively large elongation values (whether increases or reductions) between test runs during the second sequence (Figure 8.7b) suggest the following;

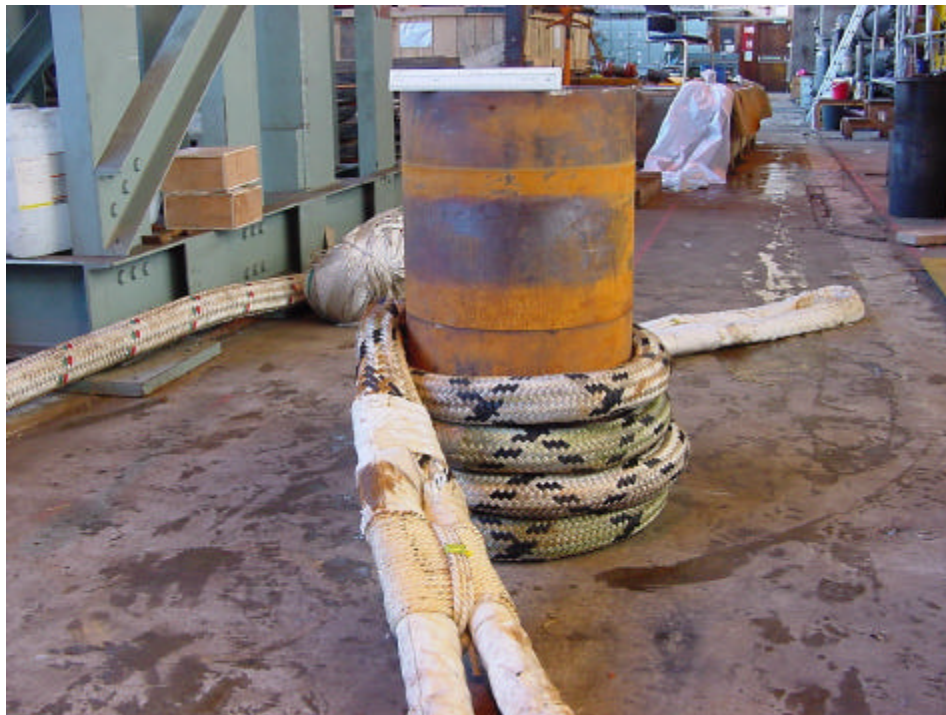
Figure 8.12 MQIQ 3 – Wrapping of Rope Round Drum

Figure 8.12 shows the wrapping of the rope around the drum during the handling test (MQIQ 3). Figure 8.15 shows the rope laid out after the break test. It cannot be said with confidence whether the wavy appearance is due to recoil from the break test or was induced when winding the rope on and off the drum.

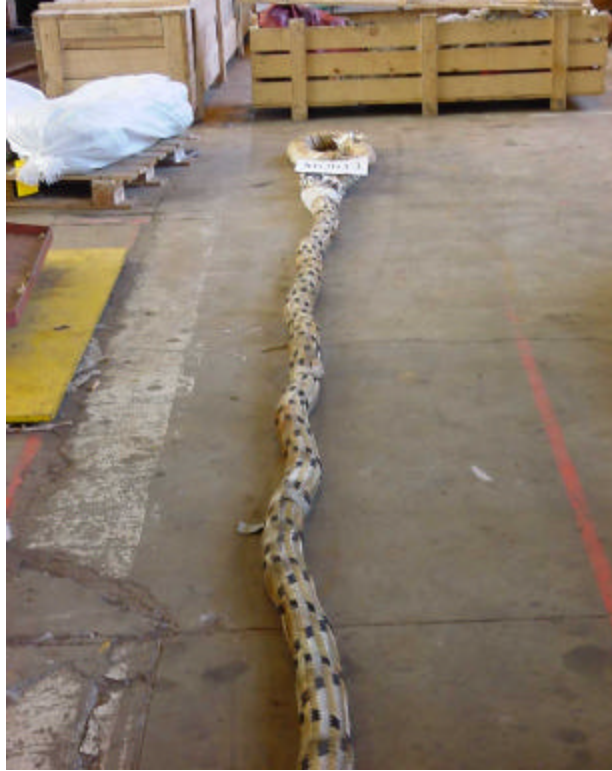
The main failure site for the handling test (MQIQ 3) is shown in Figure 8.13. There are effectively two failure sites, the first being the splice region and the second at the tangent point of the eye/spool of the same splice. Figure 8.14 shows a close up of the tangent point failure. It cannot be said with any certainty which failure occurred first. There are no indications from the load-extension plot (Figure 8.3) of any partial failures prior to the main failure to suggest that subrope failures might have occurred at the tangent point. The best that can be said is that both failures must have occurred essentially at the same time. Shown in Figure 8.16 is a close up of the eye at the opposite of the rope where it can be seen that the outer cover is worn away together with an inner cover protecting a group of subropes. However, the subropes don't appear to be damaged. Recall that this splice was ad hoc, a cross between the old design and the new one.

Figure 8.14 MQIQ 3 – Close-up of Tangent Point Failure
