# Surveys of Abandoned Vessels: Guam and CNMI

**SURVEYS OF ABANDONED VESSELS:  
GUAM AND THE COMMONWEALTH OF THE NORTHERN MARIANA ISLANDS**

Christine Lord and Colin Plank  
Research Planning, Inc.  
Columbia, South Carolina 29202

October 2003

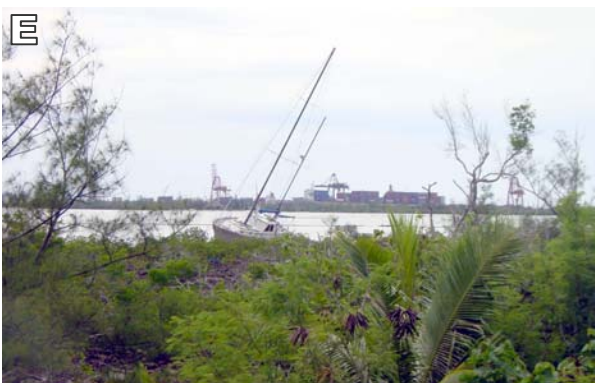
**Comparison to Other Vessels/Removal Considerations:** The *Seagull* is in good condition and may be usable if salvaged, as opposed to the majority of recreational vessels surveyed, which were more severely damaged. Of the vessels surveyed, this boat has the highest potential to impact mangroves. Most other vessels in mangrove habitats were WWII era steel barges that are unlikely to move or be removed.

**Photographs of *Seagull* (3 June 03):**

- A. View of vessel hard aground on mud-draped cobble and pebble tidal flat.
- B. View of vessel condition.
- C. View of stern.
- D. View of vessel aground in mangrove and tidal flat habitats.
- E. View of vessel from point of access at road.

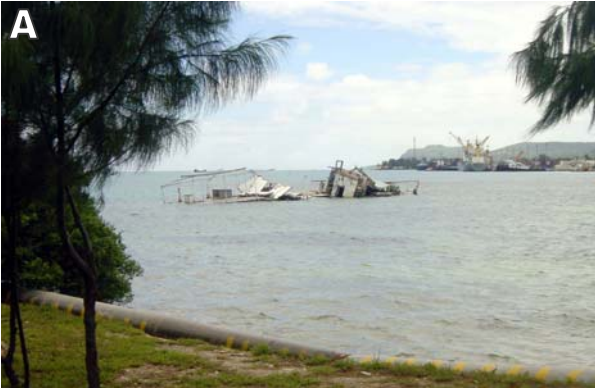
**Comparison to Other Vessels/Removal Considerations:** This was the only vessel surveyed that was constructed largely of wood and is deteriorating at a great rate. Of the vessels characterized as “high priority for removal”, the *Samala* appears to be having the most noticeable impact on surrounding coral reef habitats.

**Photographs of *Samala* (5 June 03):**

- A. View from access point at Outer Cove Marina.
- B. View of wooden cabin deterioration.
- C. View of debris on *Porites* coral head immediately adjacent to vessel.
- D. Compressed gas tanks observed in debris.
- E. View of *Acropora* and damselfish near vessel.

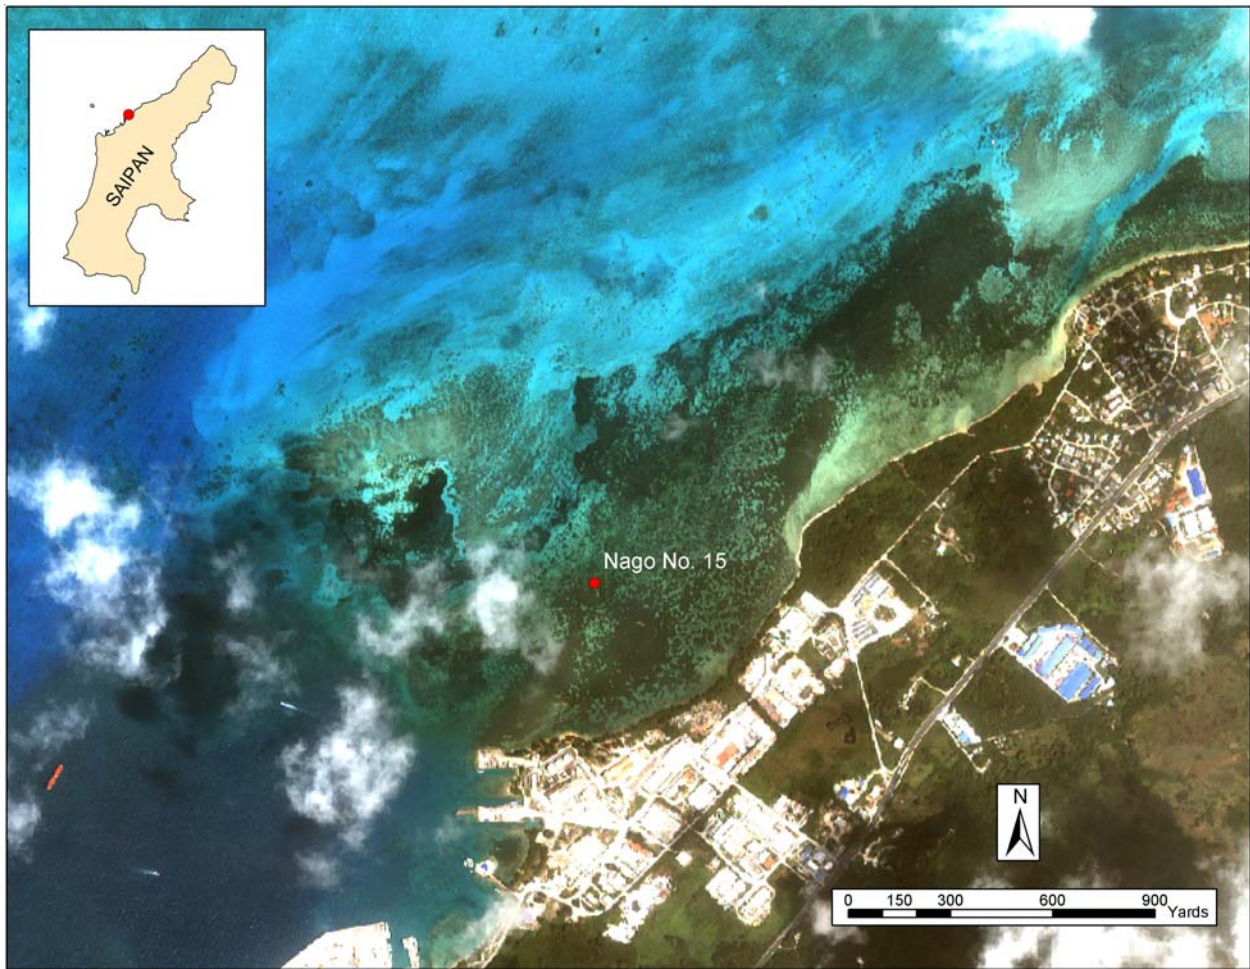
**PLATE 4.** *Nago No. 15*, Saipan Lagoon, Saipan.

**Removal Scenario:** High priority for removal.

**Environmental Characterization:** Dense seagrass, (>70% cover, 90-100% cover in some areas) and a sandy substrate. Scouring has occurred off of the port side (8 ft swath) and bow (20 ft swath).

**Comparison to Other Vessels/Removal Considerations:** Seagrass coverage surrounding the vessel was denser and covered a more extensive area than in all other areas surveyed in Guam and CNMI. Previous attempts to remove the vessel failed, but our survey assessment indicated that removal would probably be feasible if performed by experienced personnel.

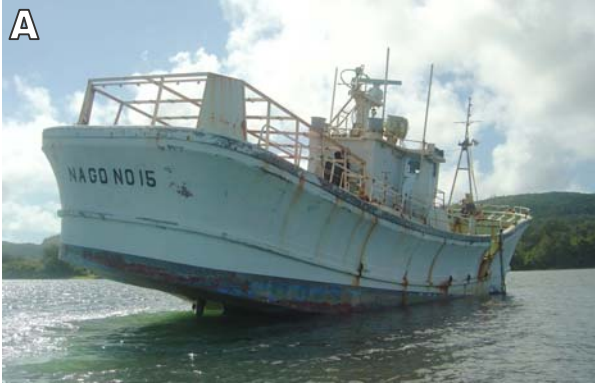
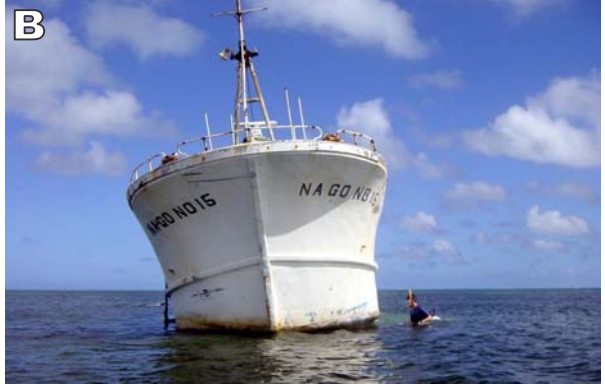
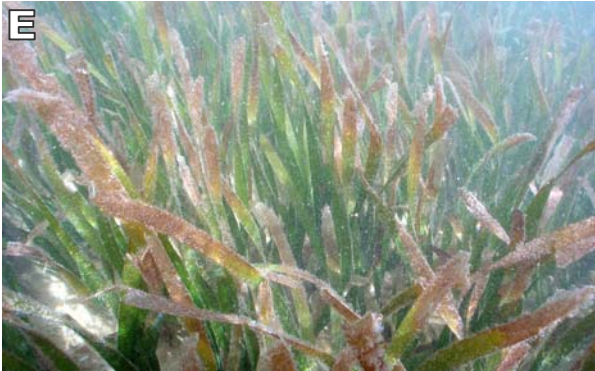
**Photographs of *Nago No. 15* (6 June 03):**

- A. View of stern.
- B. View of bow.
- C. Unvegetated scour area that extends 8-20 ft off of port side and bow.
- D. Engine compartment in vessel.
- E. Dense seagrass habitat adjacent to the vessel.

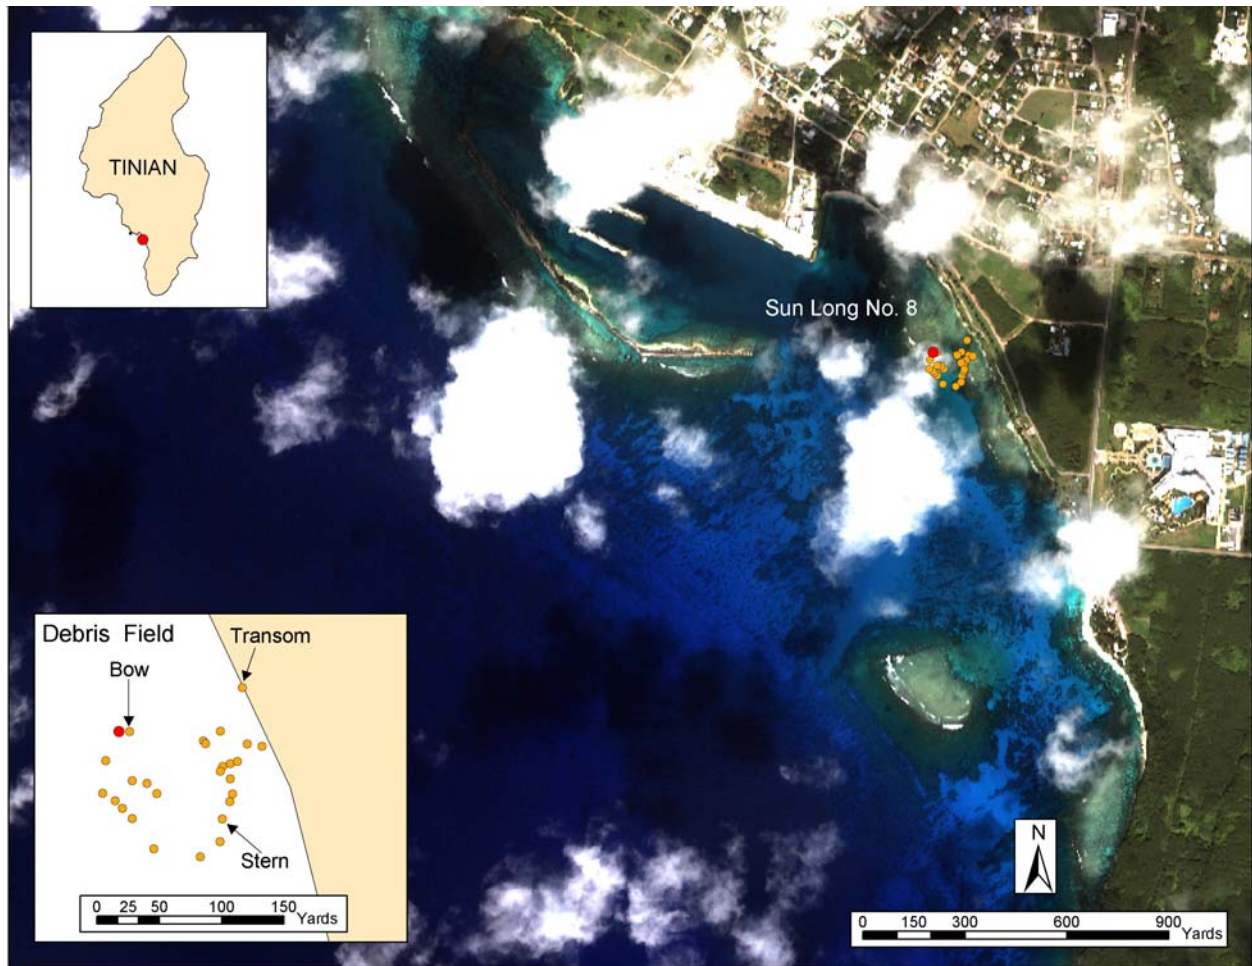
**PLATE 5.** *Sun Long No. 8*, Tinian Harbor, Tinian.

**Removal Scenario:** Logistically complex due to extensive debris field.

**Environmental Characterization:** The primary habitat type is coral reef/hardbottom. There is some rubble surrounding the vessel with live coral ranging from <10% to ~10-30% cover. The reef is very close to the bow (~20% live cover) but is ~45 ft off of the port and starboard sides.

**Comparison to Other Vessels/Removal Considerations:** This is one of two sites that had extensive debris fields over a range of depths. *Sun Long No. 8* is one of the largest vessels surveyed at 325 ft.

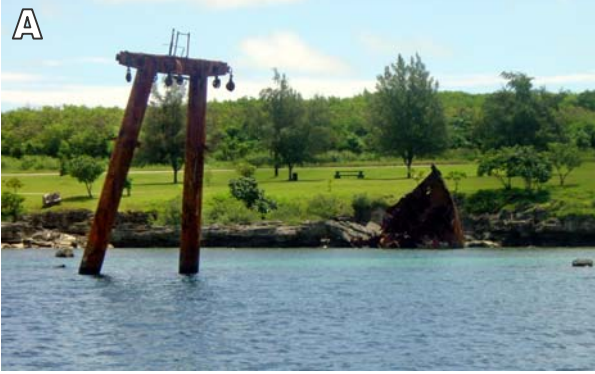
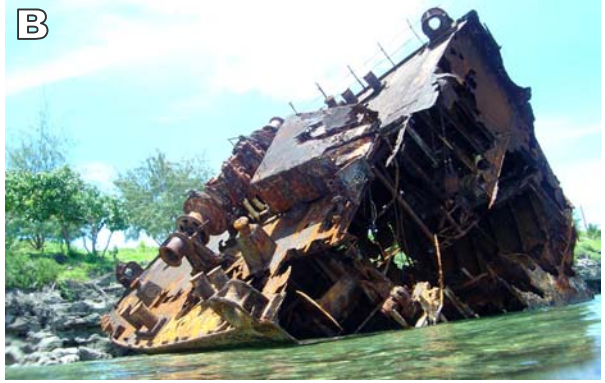
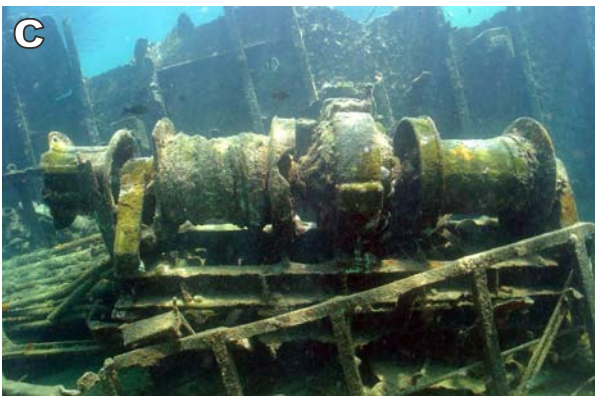
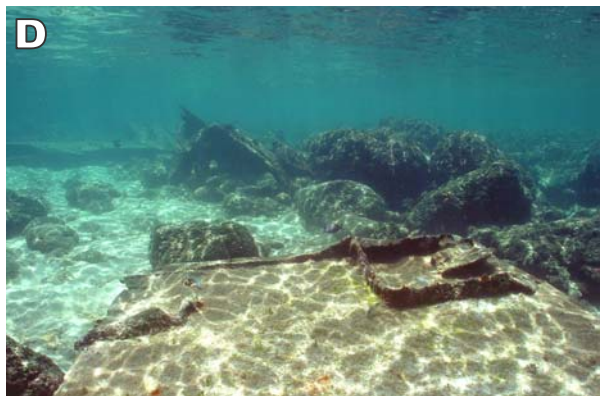
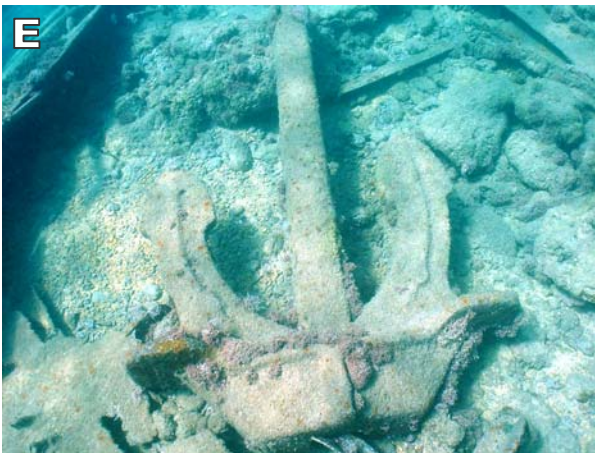
**Photographs of *Sun Long No. 8* (9 June 03):**

- A. Kingpost and large piece of debris on shore.
- B. View of large piece of debris on riprap shoreline.
- C. View of dense debris.
- D. Small portion of debris field and sand and gravel substrate with coral rubble.
- E. Anchor among the debris atop sand and gravel.

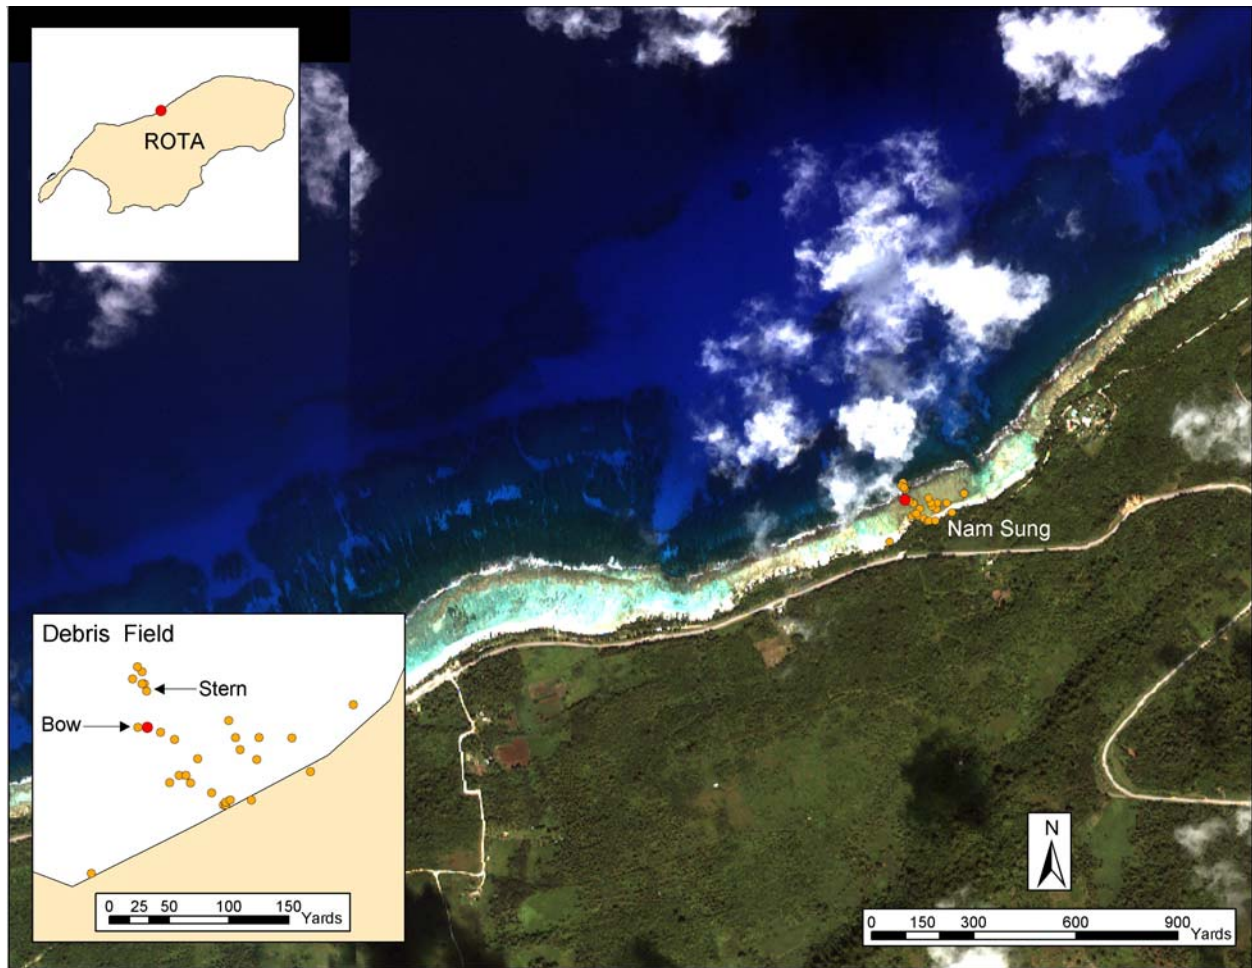
**PLATE 6.** #62 *Nam Sung*, Sasanlago-Tatqua beach, Rota.

**Removal Scenario:** Logistically complex due to extensive debris field.

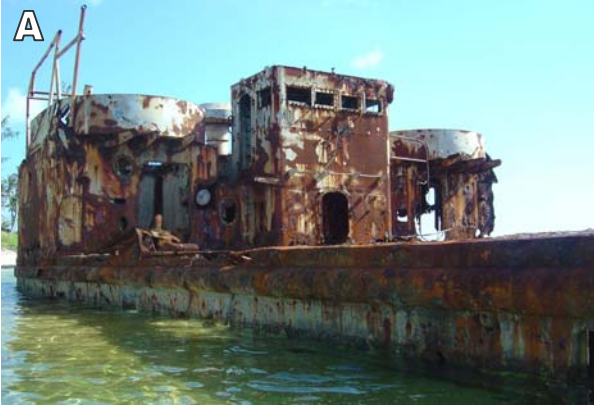
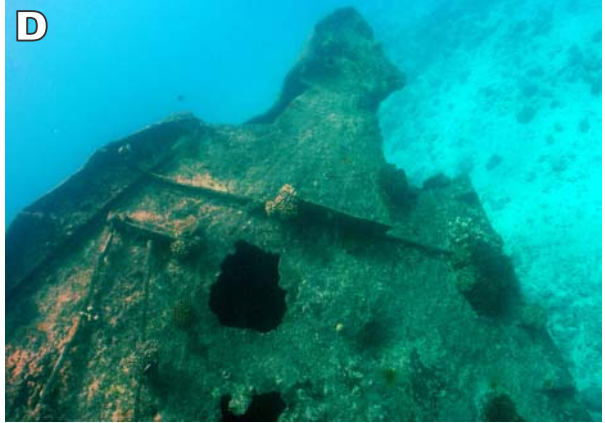
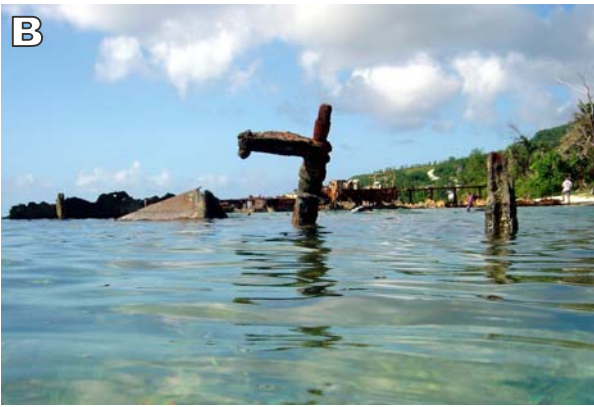
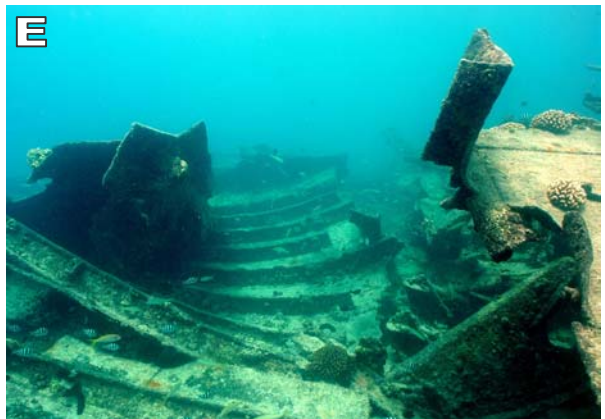
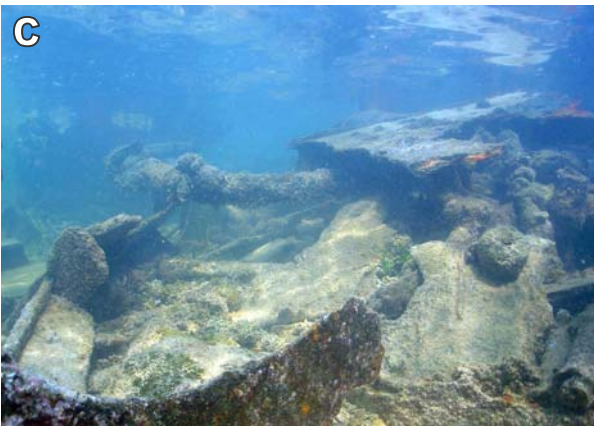
**Photographs of M-boats and *Shaoan Maru* (6-10 June 03):**

**Comparison to Other Vessels/Removal Considerations:** The M-Boats and Japanese vessel are much larger than the majority of WWII barges surveyed (See Plate 7). There is relatively little debris associated with the M-Boats, which are deeply entrenched like many of the WWII era barges that were surveyed. Unk2545 has deteriorated to an extensive debris field with a few pieces that closely approach the surface.

- A. View of starboard side of *T.T. Gov't 1* (Incident ID: 1830).
- B. Wreckage from *T.T. Gov't 2* (Incident ID: 1831).
- C. Debris and coral rubble at *T.T. Gov't 2* site (Incident ID: 1831).
- D. A small portion of Unk2545.
- E. The bow of the Unk2545 on sand and gravel bottom.

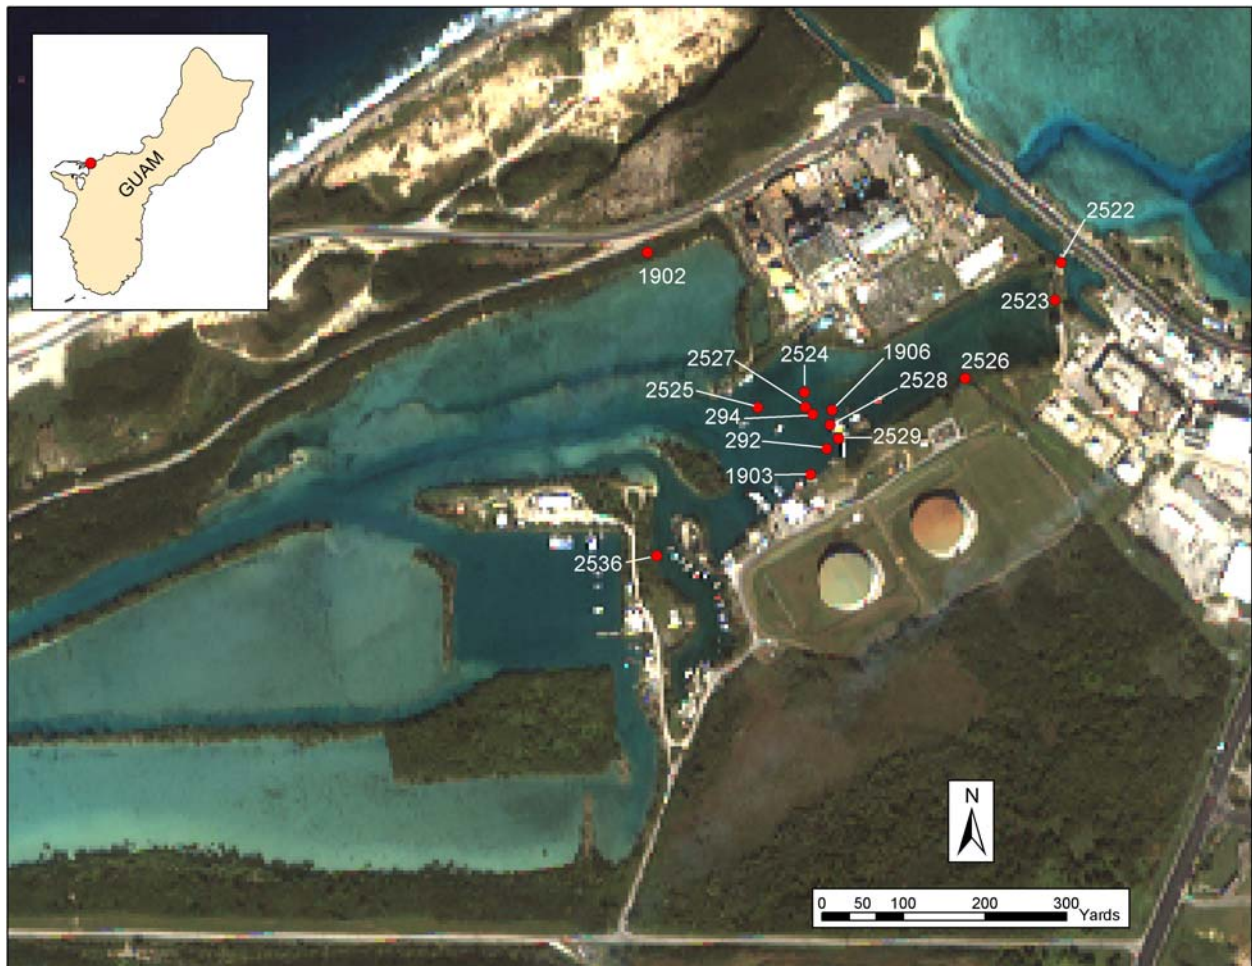
**PLATE 9.** Piti Channel, Guam.

**Comparison to Other Vessels/Removal Considerations:** These vessels are in one of the tighter “clusters” found in the survey. These types of areas often become dumps for abandoned vessels, and several similar areas were surveyed in the U.S. Caribbean. None of these vessels are a pollution threat but all are threats to navigation.

- A. View to the SE from within the Piti Channel towards Unk1906 (forefront) and *Gauhan-2* (back).
- B. Photo taken just west of image A, showing *Chamorro-1* (right) and its proximity to *Gauhan-2* (left).
- C. Unk2527 (forefront) lying against the starboard side of *Gauhan-2*.
- D. *Merlin* aground just southwest of *Chamorro-1*; note the seawall and storage tank in both image B and D.
- E. *Dolphin Dancer*, photo taken just north of other vessels.

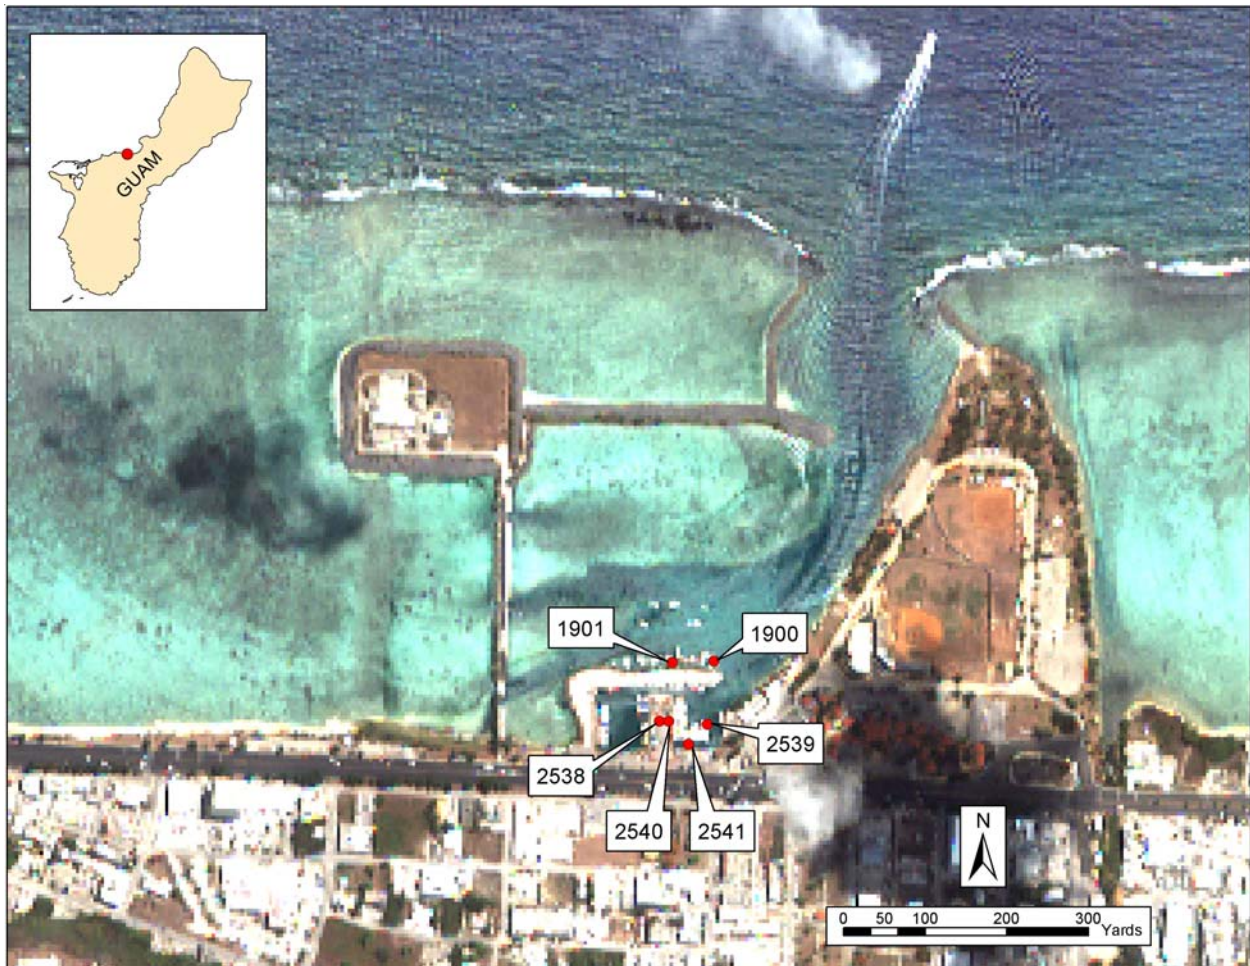
**PLATE 10.** Agana Boat Basin, Guam.

**Environmental Characterization:** Five vessels in this cluster rest on sand and gravel substrate. One is aground on a gravel beach. There were minor amounts of live coral and macroalgae observed at the site.

**Comparison to Other Vessels:** These vessels are in one of the tighter “clusters” found in the survey. One of these vessels (*Lion’s Den*, Incident ID: 1901) is a pollution threat and one (Unk1900) is a threat to navigation. These vessels could also threaten other vessels moored in the area if they were to move in a storm. Vessels clustered in mooring areas following hurricanes were also common in the U.S. Caribbean.

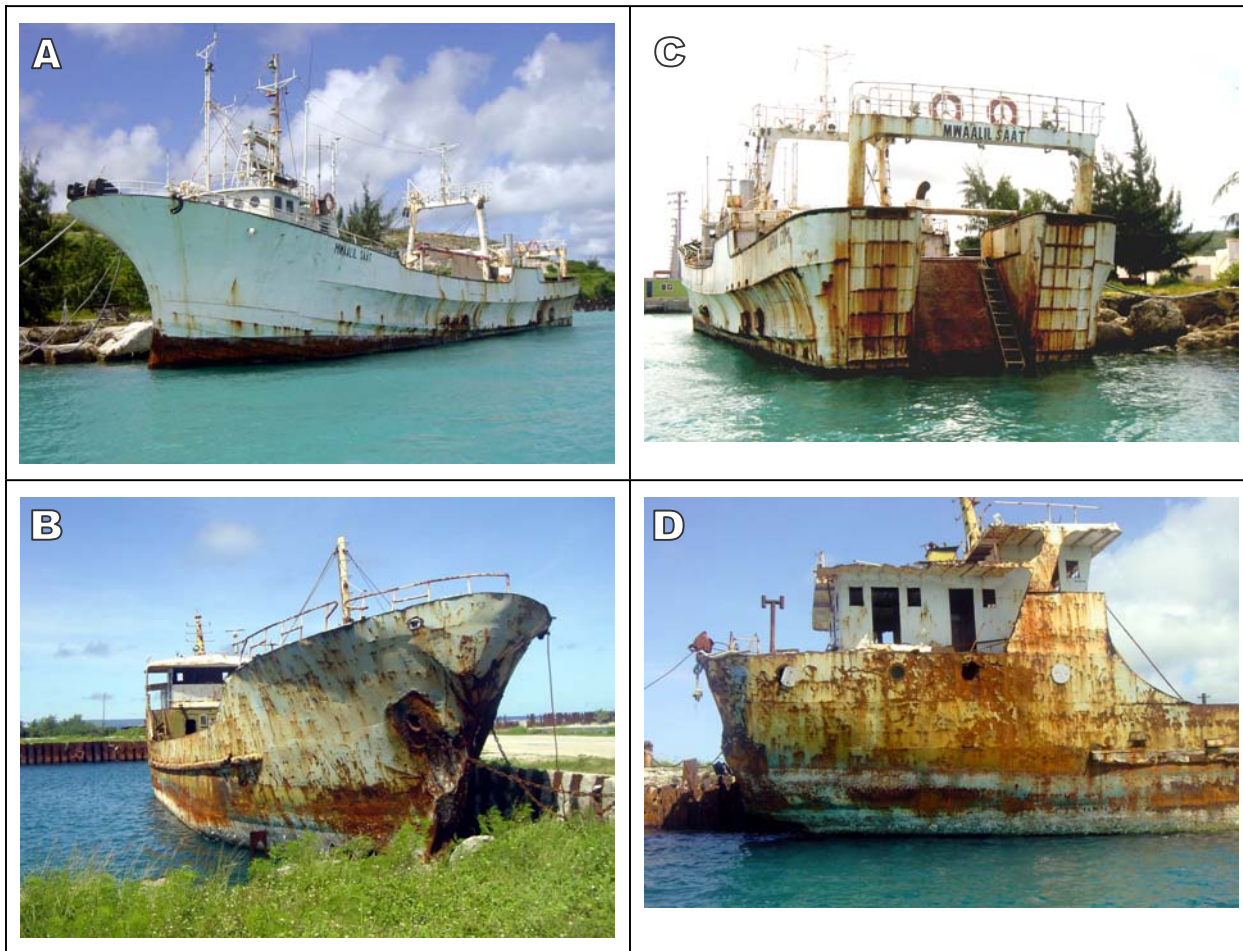
**Photographs of currently (2003) derelict vessels still afloat:**

**Comparison to Other Vessels/Removal Considerations:** Each of these vessels is of note because they are pollution and health risks that can be eliminated prior to grounding or sinking. Vessels such as these are in their last relatively easily manageable stage before becoming a much more logistically complex salvage and recovery project.

- A. *Mwaalil Saat*, moored in Saipan, 2003.
- B. *Mwaalil Saat* viewed from the stern.
- C. *Lian Gi*, docked in Tinian Harbor, 2003.
- D. *Lian Gi* as viewed from the port side.

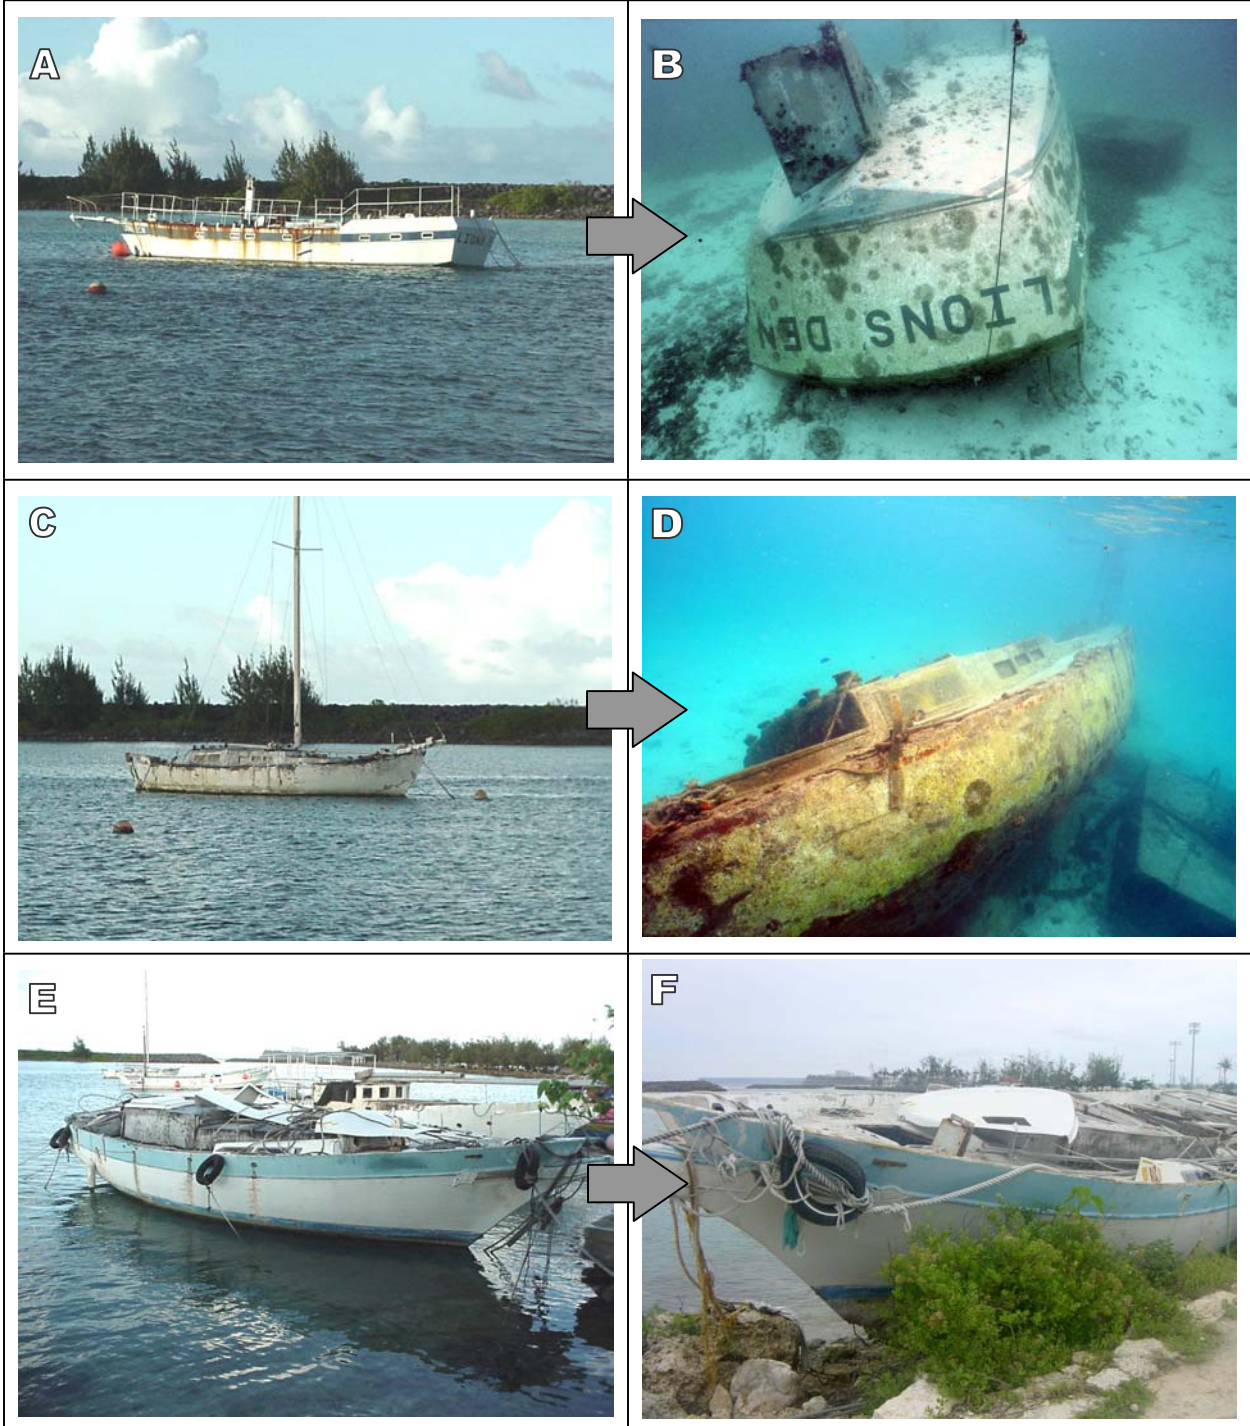
**PLATE 12. (See Below)** Formerly derelict, now grounded/sunken vessels in Agana Boat Basin, Guam.

**Vessel Information:** The vessels pictured below were described in Plate 10 as a cluster of sunken/grounded vessels observed during the 2003 surveys. Photos A, C, and E were taken prior to Supertyphoon Pongsona in 2002. The vessels were derelict and identified as risks for grounding/sinking at that time. Photos B, D, and F were taken following the storm during the 2003 surveys.

A& B. *Lion's Den*, Incident ID: 1901.

E&F. *Ciao*, Incident ID: 2541 (foreground) and Unk2539 (background). See Plate 10, photo D for present condition of Unk2539.

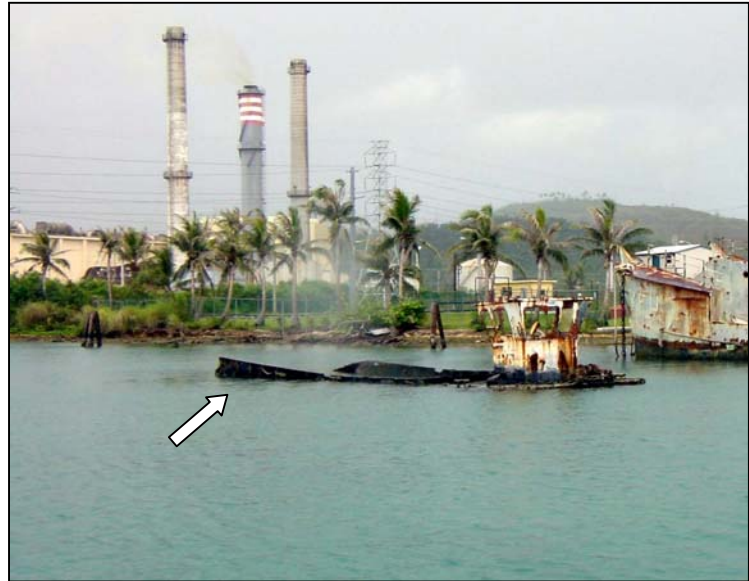
- 3) Vessel Information:** 55 ft. x 13 ft. steel landing craft in ~8 ft of water, large portion exposed. Gov. Guam Reg. # (?): E6CMVB752.

Abandoned at mooring in 1980's.

Hull is rusted out, but unlikely to be many swimmers in channel.

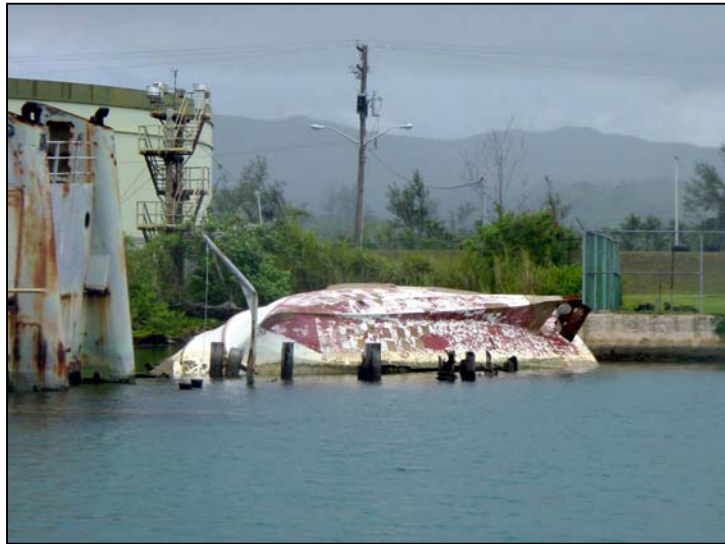
**3) Vessel Information:** 49 ft. x 10.5 ft. fiberglass commercial longliner, upside down and partially submerged, Gov. Guam Reg. #: GU26464. Hull is intact, but submerged deck is rotting.

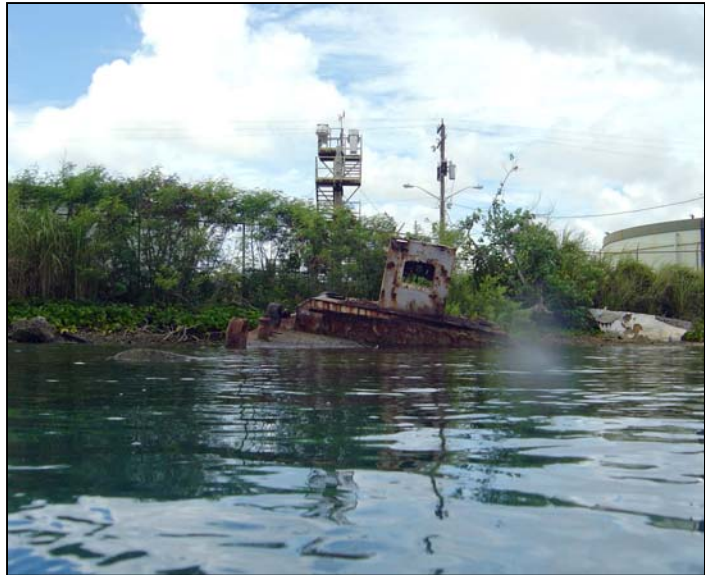
**3) Vessel Information:** 50 ft. x 14 ft. steel landing craft. Submerged on stern/starboard sides, rusted out.

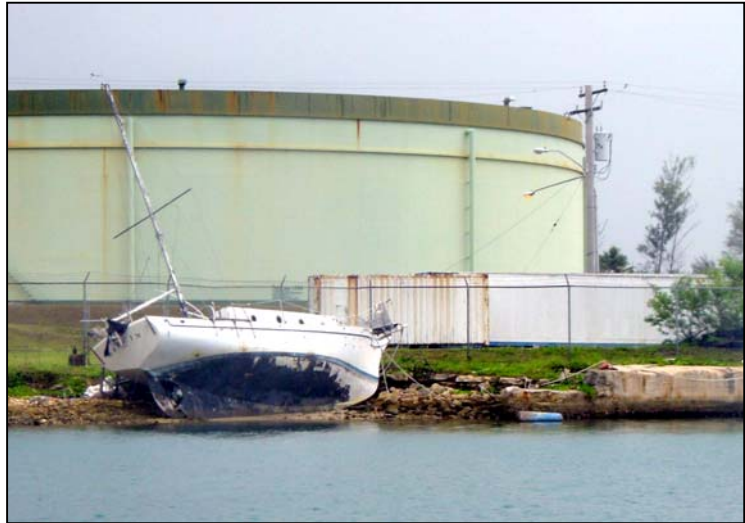
**3) Vessel Information:** 41 ft. x 9 ft. fiberglass ketch. Onshore.

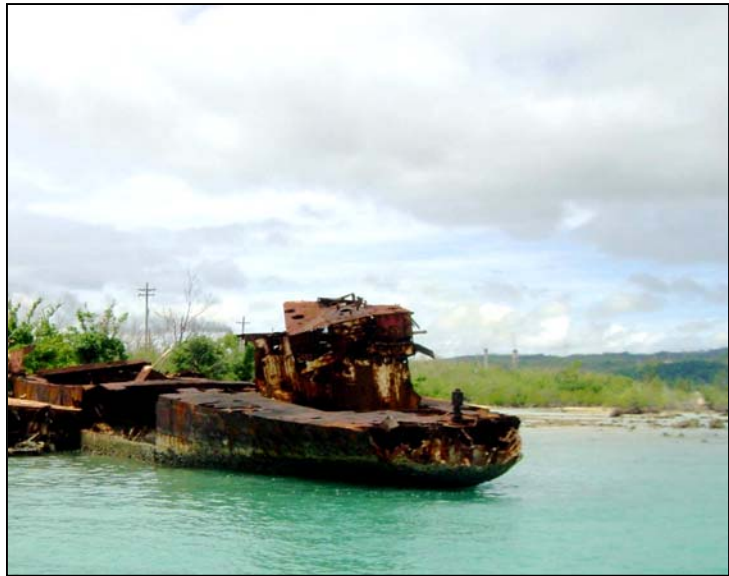
**3) Vessel Information:** 26 ft. x 120 ft. commercial steel freighter. Somewhat intact, rusty. Almost ashore at bow, in ~9-15 ft. of water at stern.

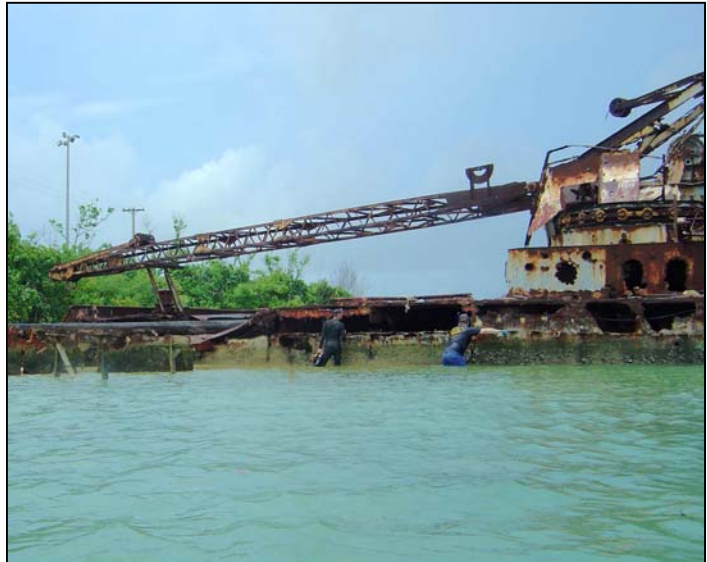
**3) Vessel Information:** 30 ft. x 100 ft. steel commercial crane barge. Rusted out.

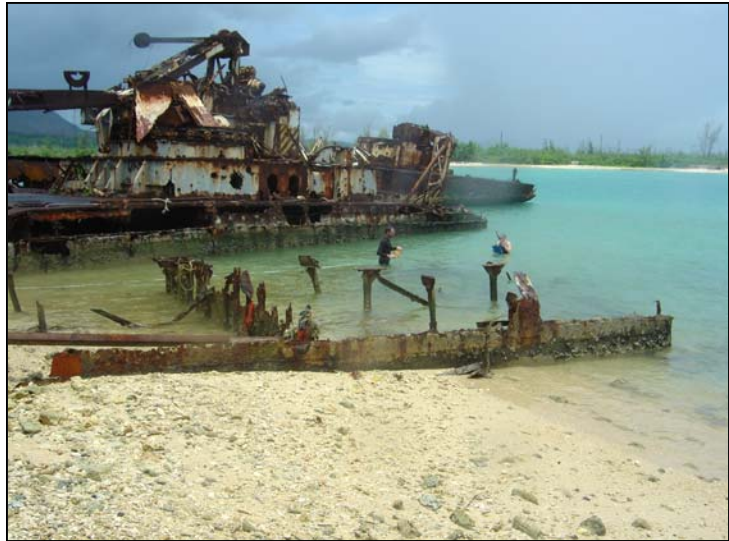
**3) Vessel Information:** 27 ft. x 67 ft. rusted, broken down partial vessel. Type unknown, but in cluster with other barges.

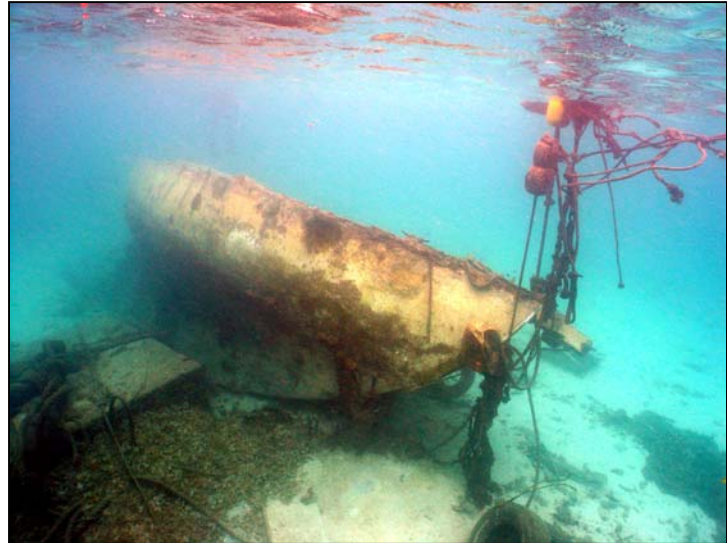
**3) Vessel Information:** 41 ft. x 10 ft. ferro-cement sloop, ~10 ft. debris field present on port and starboard sides. No mast, stripped, rotting, right below the water surface.

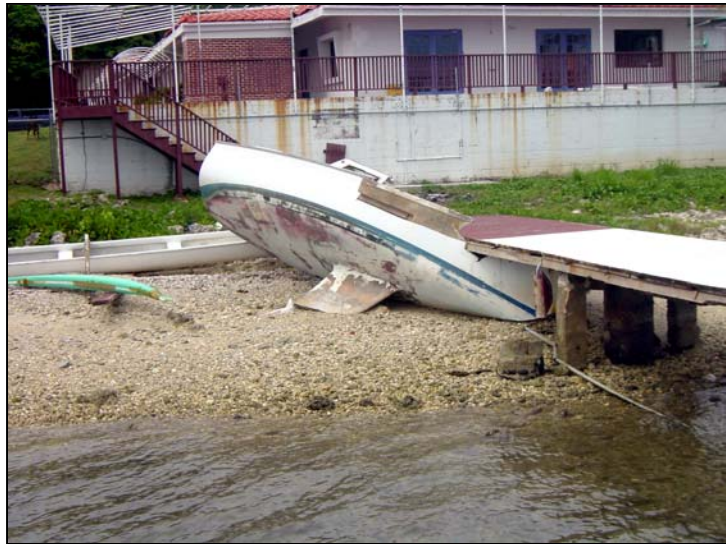
Slip/fall hazard.

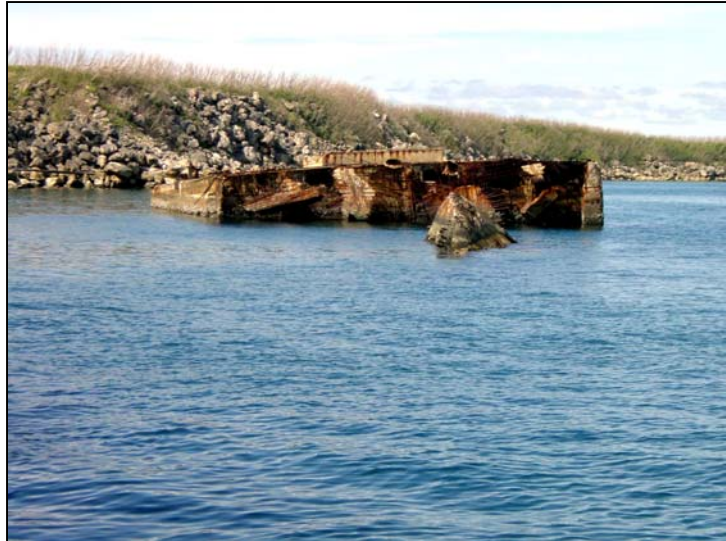
Potential slip/fall hazard.

- 8) Habitat Types/Potential Environmental Impacts:** Habitat is similar for 4-vessel cluster. Bottom is sand and gravel with patchy coral cover (~10% live cover), mainly on boulders or attached to vessels. Maximum ~30% live cover in some areas. Coral species observed included: *Porites rus*, *Pocillopora damicornis*, *Porites lutea*, *Sacrophyta sp.*, fire coral. Sea cucumbers and reef fish observed. Green/red algae and sponges were observed around vessel and debris.

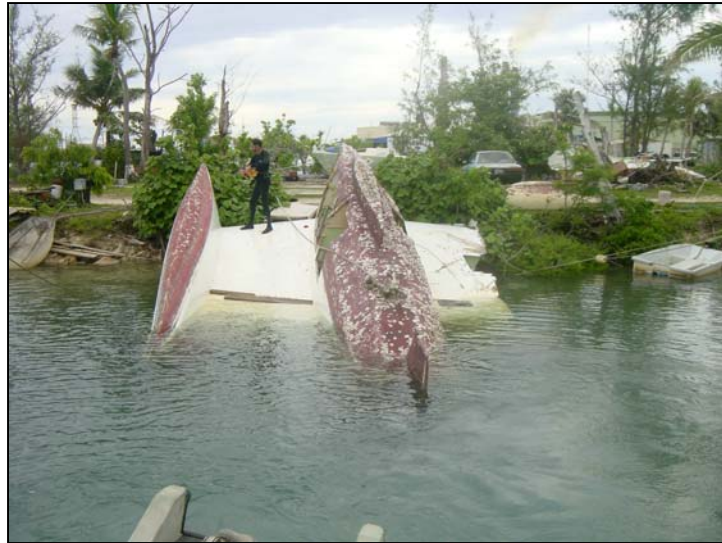
41 ft. x 23 ft., fiberglass trimaran. Vessel is upside down and missing left pontoon, some panels cut from hull.

Slip/fall hazard.

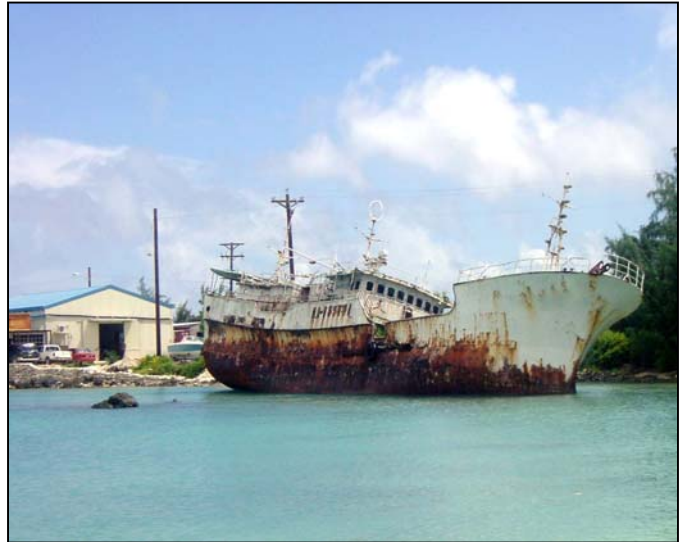
- c) **Date of grounding/length of time the vessel has been “abandoned”:** August 12, 1997
- d) **General description of vessel damage:** Mostly intact, but rusting.
- e) **Vessel Cargo:** None.

- a) **Is there fuel or hazmat onboard? Estimated quantities:** Reported to be empty.
- b) **Evidence of releases? Sheens? No.**
- c) **Evidence of illegal dumping? No.**
- d) **Condition of fuel tanks:** Not inspected. Vessel was not boarded.
- e) **Other equipment and supplies that may pose their own threats:** Possibly batteries.
- f) **What new or continuing harm to natural resources might result by removing oil/hazardous substances but leaving the vessel? N/A.**

- a) **Public uses in the area:** High use recreational fishing, boating, and birding area. A small boat launch and anchorage is located 500 ft from vessel.
- b) **Evidence of people boarding the vessel? No.**
- c) **Entrapment or slip/fall hazards? Yes, potential entrapment hazard.**

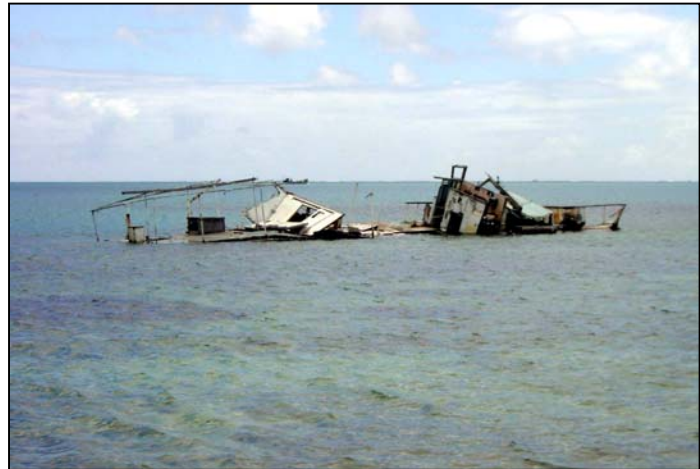
- d) **General description of vessel damage:** Hull has broken into multiple sections and there is an extensive field of debris
  - e) **Vessel cargo:** None.
-

- a) **Is there fuel or hazmat onboard? Estimated quantities?** Potential for fuel onboard.
  - b) **Evidence of releases? Sheens?** No.
  - c) **Evidence of illegal dumping?** No.
  - d) **Condition of fuel tanks:** Fuel tanks intact, also compressed fuel tanks observed in debris.
  - e) **Other equipment and supplies that may pose their own threats:** No.
  - f) **What new or continuing harm to natural resources might result by removing oil/hazardous substances but leaving the vessel?** Continuing expansion of debris field and continued break down in vessel condition may lead to damage of coral habitat.
-

- a) **Public uses in the area:** Recreational fishing, boating, and swimming.
  - b) **Evidence of people boarding the vessel?** Children reported frequently diving off of wreck.
  - c) **Entrapment or slip/fall hazards?** Yes, slip/fall and entrapment hazard.
-

- f) **Damage observations:** Scouring and destruction of coral heads due to large debris observed and photographed, nets and other floating debris present. Additional damage to seagrass beds or corals likely as debris field increases.

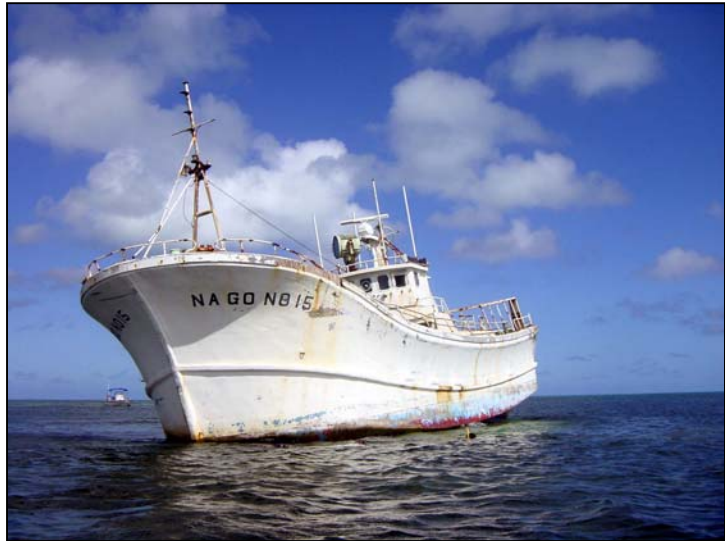
- c) **Date of grounding/length of time the vessel has been “abandoned”:** Unknown
  - d) **General description of vessel damage:** Steel portions of deck are rusting
  - e) **Vessel cargo:** Engine, generator still on board and intact.
-

- a) **Is there fuel or hazmat onboard? Estimated quantities:** Fuel and oil have been removed. Hydraulic hoses associated with engine likely still have fluid. Refrigerant possibly onboard.
  - b) **Evidence of releases? Sheens?** No.
  - c) **Evidence of illegal dumping?** No.
  - d) **Condition of fuel tanks:** Unknown.
  - e) **Other equipment and supplies that may pose their own threats:** Batteries probably still onboard.
  - f) **What new or continuing harm to natural resources might result by removing oil/hazardous substances but leaving the vessel?** Vessel may move in storm and impact seagrass.
-

- a) **Public uses in the area:** Fishing.
  - b) **Evidence of people boarding the vessel?** No.
  - c) **Entrapment or slip/fall hazards?** Yes, slip/fall hazard.
-

- a) **Dimensions of vessel grounding footprint:** 8ft wide on port side, 20 ft wide off bow.
- b) **Dimensions of debris field:** Limited amount of debris primarily within area described above.
- c) **Primary habitat(s):** Seagrass, >70% cover, 90-100% cover in some areas. Dominant species is *Enhalus macroroides*.
- d) **Secondary habitat(s):** None.
- e) **Substrate:** Sand
- f) **Damage observations:** Scouring of seagrass in 8ft. wide swath on portside and 20 ft. swath off of bow.

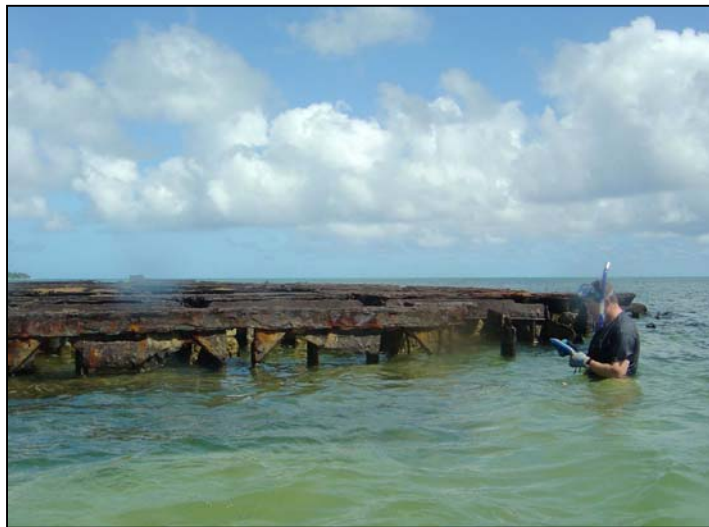
71 ft. x 86 ft. steel barge, highly decayed, deck missing, very rusty.

Possibly damaged during WWII or abandoned following WWII.

Slip/fall hazard, rusting.

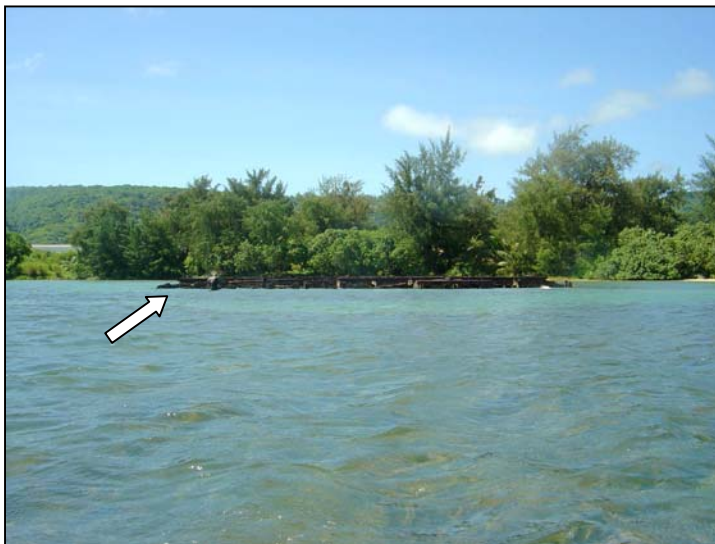
74 ft. x 88 ft. steel barge, highly decayed, deck missing, very rusty.

Possibly damaged during WWII or abandoned following WWII.

Slip/fall hazard, rusting.

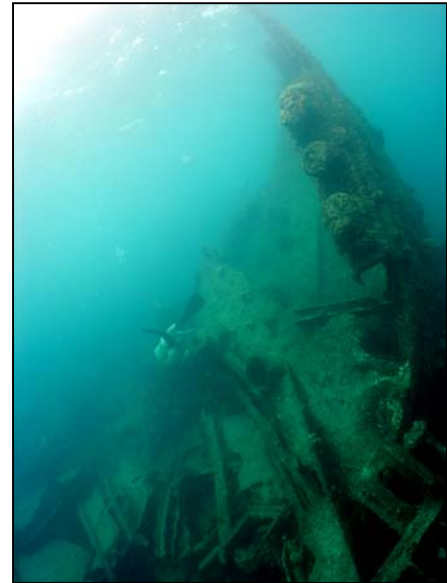
- a) **General status of vessel:** Submerged, partially awash.
- b) **Nature of casualty:** Sunk during or before WWII.
- c) **Date of grounding/length of time the vessel has been "abandoned":** Unknown
- d) **General description of vessel damage:** Mostly debris left, vessel may be identified by remaining kingposts as the *Shoan Maru*.
- e) **Vessel cargo:** None.

- a) **Dimensions of vessel grounding footprint:** Same as debris field.
- b) **Dimensions of debris field:** >367 ft. x 100 ft. Vessel is so broken down and large that it was difficult to measure in rough/deep water.
- c) **Primary habitat(s):** Sand and gravel.
- d) **Secondary habitat(s):** A variety of hard corals (branching and other forms) growing on and around debris, 0-10% live cover.
- e) **Substrate:** Sand and gravel.
- f) **Damage Observations:** Vessel has deteriorated to an extensive debris field.
