# Surveys of Abandoned Vessels: Guam and CNMI

**SURVEYS OF ABANDONED VESSELS:  
GUAM AND THE COMMONWEALTH OF THE NORTHERN MARIANA ISLANDS**

Christine Lord and Colin Plank  
Research Planning, Inc.  
Columbia, South Carolina 29202

October 2003

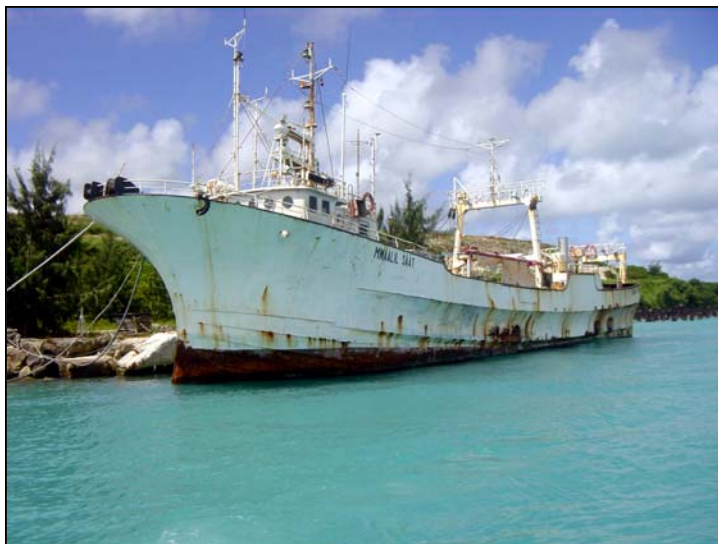
Commercial fishing vessel, stern trawler, steel. Homeport: Saipan, CNMI. Originally was the Mariana Lady. Vessel is tied up and rusting.

People seen on ship from time to time, possibly the owner. Potential slip/fall hazard.

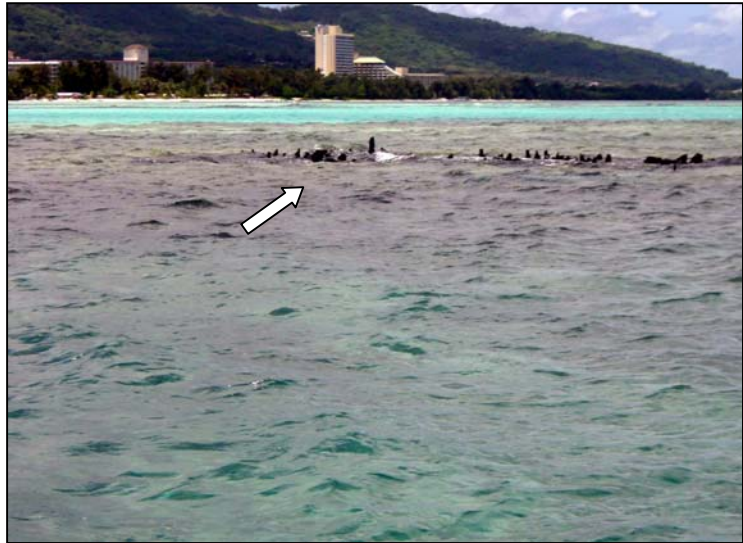
Steel barge, rusting, conditions too dangerous to measure vessel (surf, shallow coral).

Possibly damaged during WWII or abandoned following WWII.

Slip/fall hazard, but limited access.

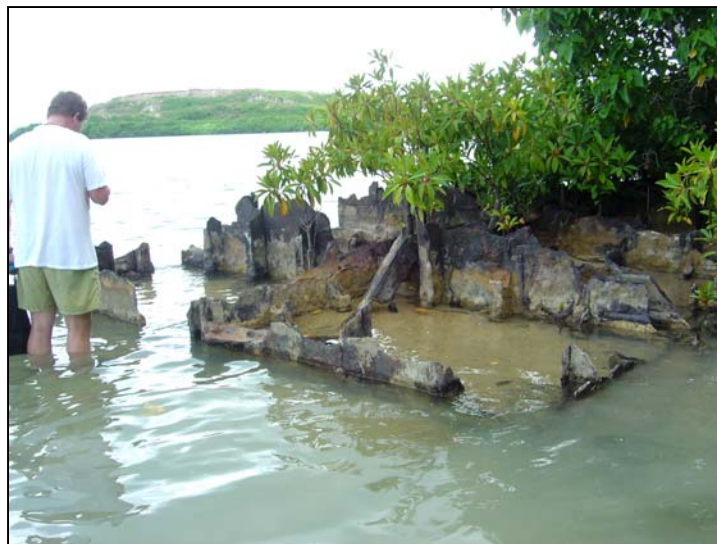
Possibly damaged during WWII or abandoned following WWII.

Rusty and onshore. Slip/fall hazard.

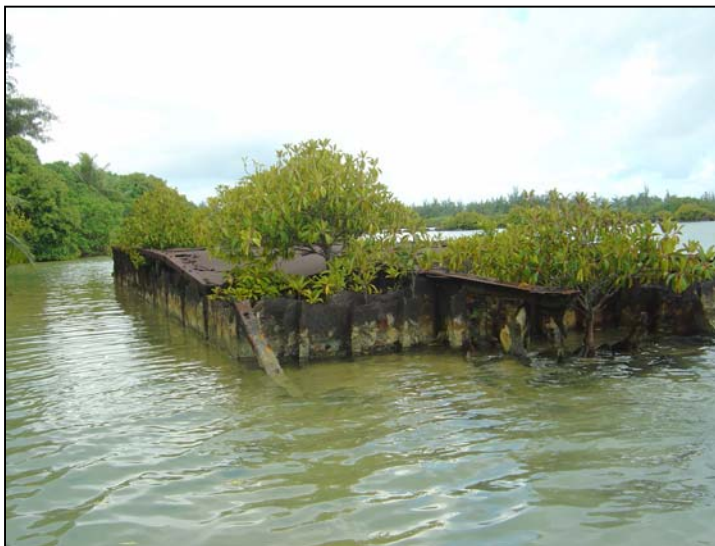
Possibly damaged during WWII or abandoned following WWII.

Rusty, slip/fall hazard.

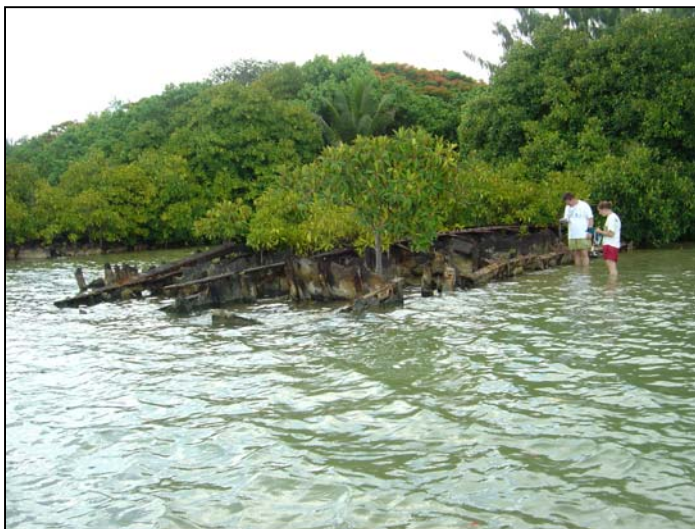
Possibly damaged during WWII or abandoned following WWII.

Slip/trip, rusting onshore.

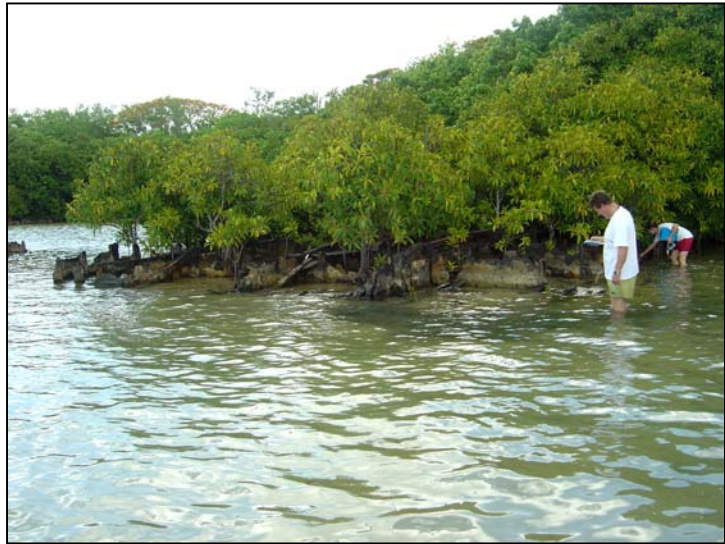
Possibly damaged during WWII or abandoned following WWII.

Slip/trip, rusting onshore.

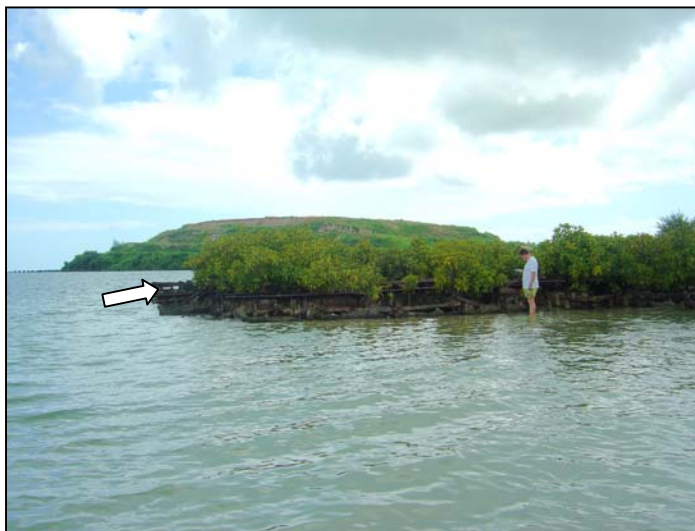
Rusty, possible slip/trip hazard.

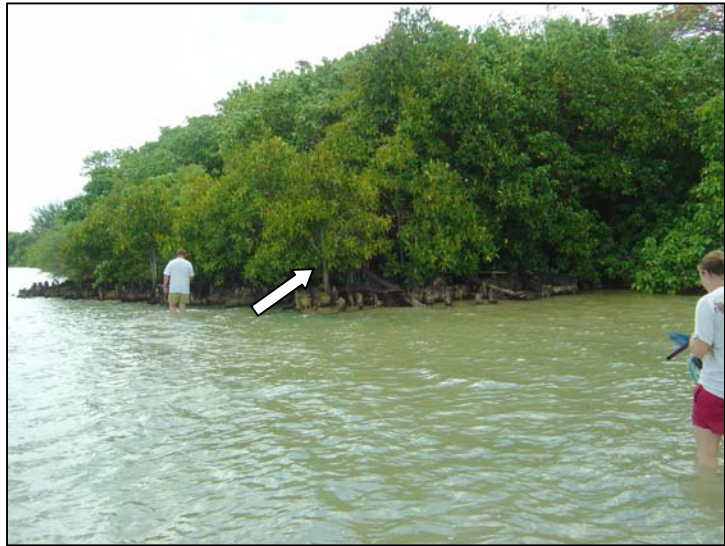
Possibly damaged during WWII or following WWII.

Rusty, possible slip/trip hazard.

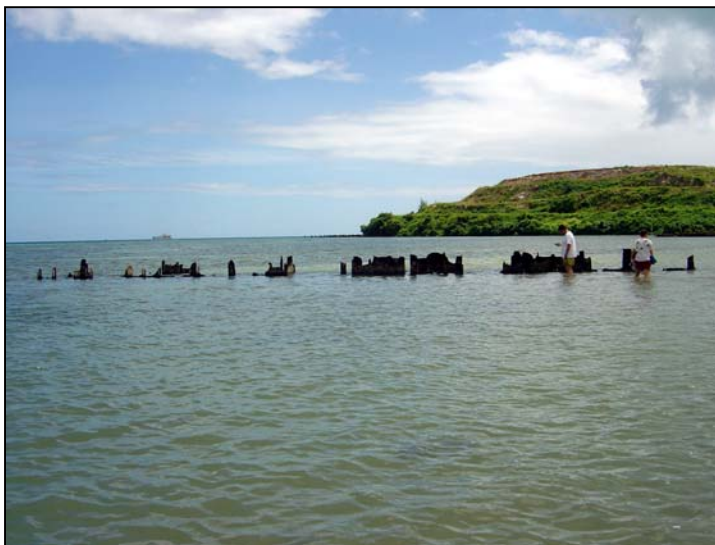
Possibly damaged during WWII or abandoned following WWII.

Rusty, possible slip/trip hazard.

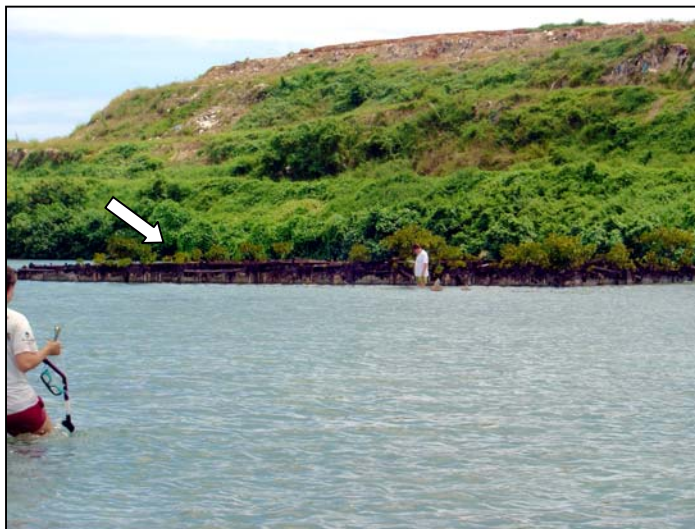
Possibly damaged during WWII or abandoned following WWII.

Rusty, possible slip/trip hazard.

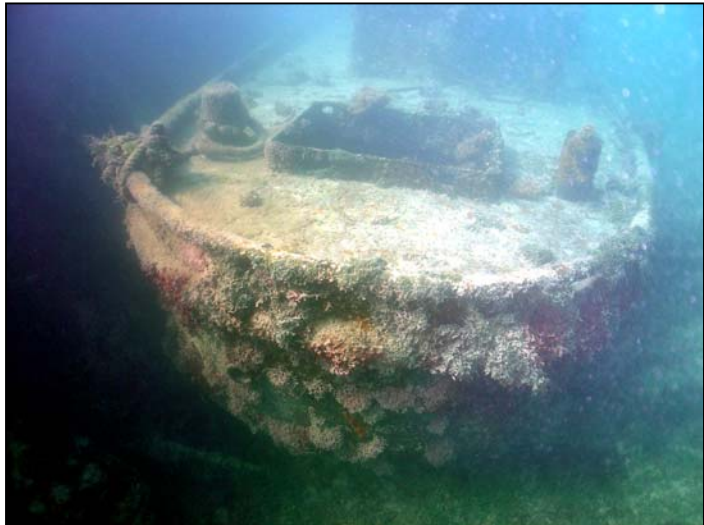
- d) **General description of vessel damage:** Rusting, cabin broken,
- e) **Vessel cargo:** All cargo is gone.

- a) **Dimensions of vessel grounding footprint:** Approximately that of the vessel.
- b) **Dimensions of debris field:** Minor amounts of debris.
- c) **Primary habitat(s):** Sandy bottom, highly engineered area surrounded by seawall.
- d) **Secondary habitat(s):** Some coral present (small *Acropora*) and low algal cover.
- e) **Substrate:** Sand.
- f) **Damage Observations:** Minor amounts of debris, Unk2578 actually sits partially atop Unk2579.

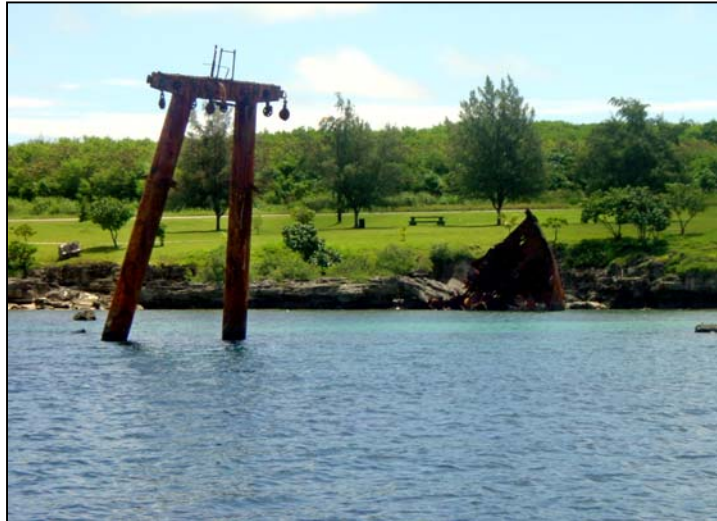
- c) **Date of grounding/length of time the vessel has been “abandoned”:** Since 1986.
- d) **General description of vessel damage:** Vessel is largely broken down and strewn about reef.
- e) **Vessel cargo:** At the time of casualty vessel was loaded with frozen tuna. All cargo is gone.

- a) **Dimensions of vessel grounding footprint:**
- b) **Dimensions of debris field:** Extensive debris field mapped with GPS, roughly 502 ft. wide.
- c) **Primary habitat(s):** Coral reef. There is some rubble surrounding the vessel with live coral ranging from <10% to ~ 10-30% cover. Reef is very close to bow with areas of ~20% live cover. Reef lies ~ 15 yards off of port and starboard sides, and is similar to reef off of bow. Reef ~5 yards off of stern has very low live cover. Dominant genuses include *Porites*, *Acropora*, and possibly others. Encrusting and fleshy algae was also observed on the reefs.
- d) **Secondary habitat(s):** Sand and gravel.
- e) **Substrate:** Sand and gravel.
- f) **Damage Observations:** Extensive amounts of debris spread through out coral reef. Areas where debris occurs appear to have lower % live coral cover than adjacent areas.

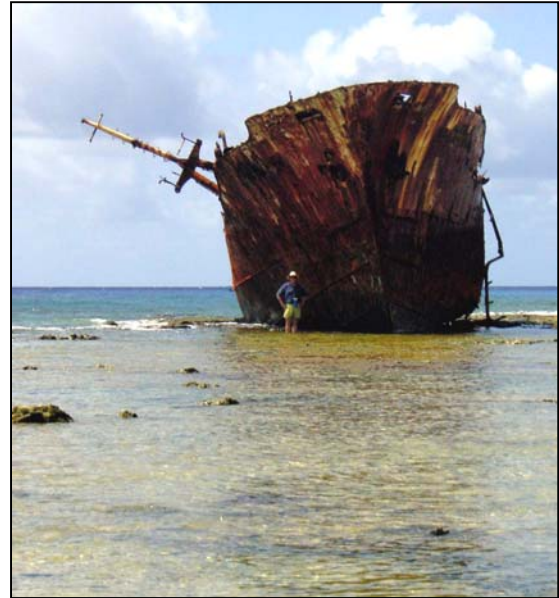
- a) **Adjacent land ownership / land-use:** Privately owned land, public beach below high tide line. Area used recreationally for swimming and fishing.
- b) **Points of access:** Road.
- c) **Sea conditions and exposure to wave energy at site:** Exposed, waves breaking on reef and vessel.
- d) **Depth and nearby bathymetry:** Vessel is exposed atop reef in 1 ft. of water. Seaward the depth increases to 10-15 ft.

- d) **Secondary habitat(s):** None.
- e) **Substrate:** Sand and gravel.
- f) **Damage Observations:** Extensive amounts of debris spread through out coral reef. Further break-up of the vessel may cause additional damage.

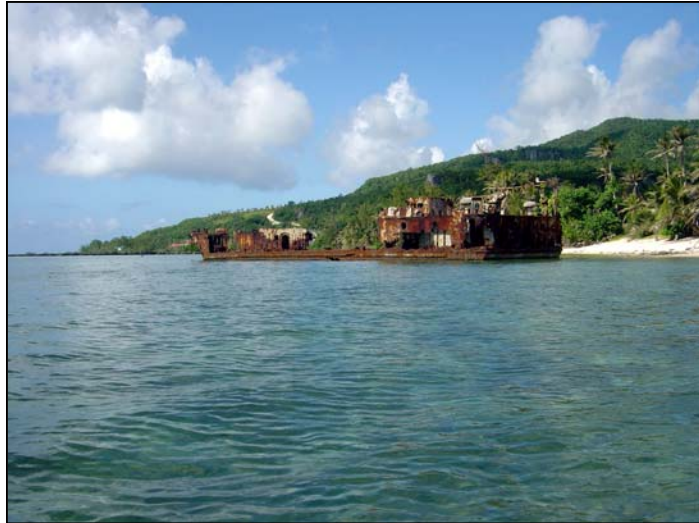
- c) **Date of grounding/length of time the vessel has been "abandoned":** Post WWII.
- d) **General description of vessel damage:** Relatively intact.
- e) **Vessel cargo:** Cargo appears to be gone.

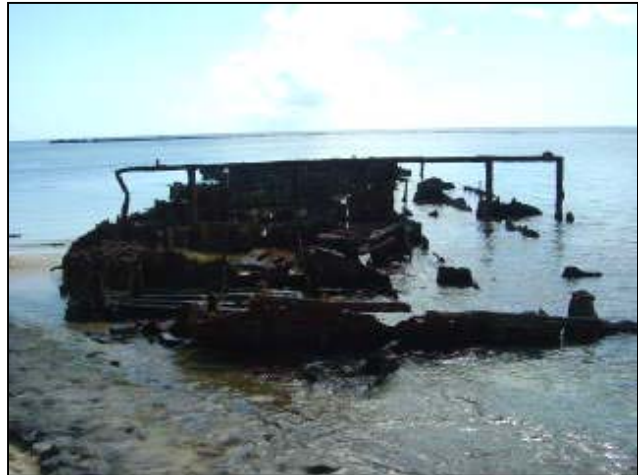
- a) **General status of vessel:** Aground.
- b) **Nature of casualty:** Unknown.
- c) **Date of grounding/length of time the vessel has been "abandoned":** Post WWII.
- d) **General description of vessel damage:** Only a portion of the hull remains.

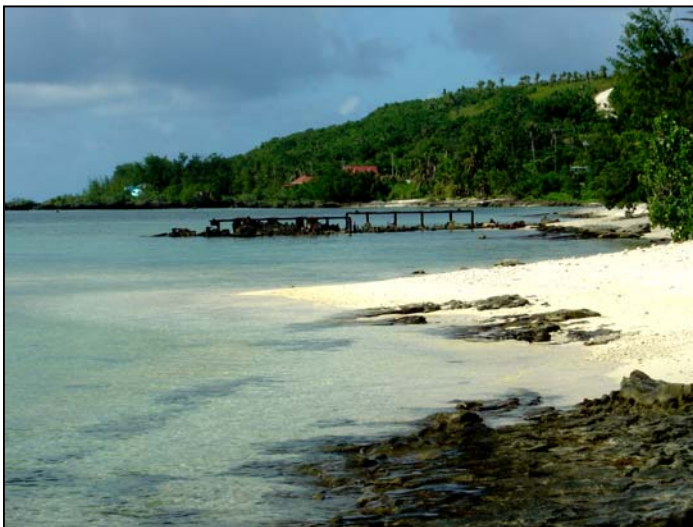
- d) **General description of vessel damage:** Partial hull remains, dilapidated.
- e) **Vessel cargo:** None.
