INVESTIGATION REPORT

COMBUSTIBLE DUST FIRE AND EXPLOSIONS

CTA ACOUSTICS, INC.

REPORT NO. 2003-09-I-KY

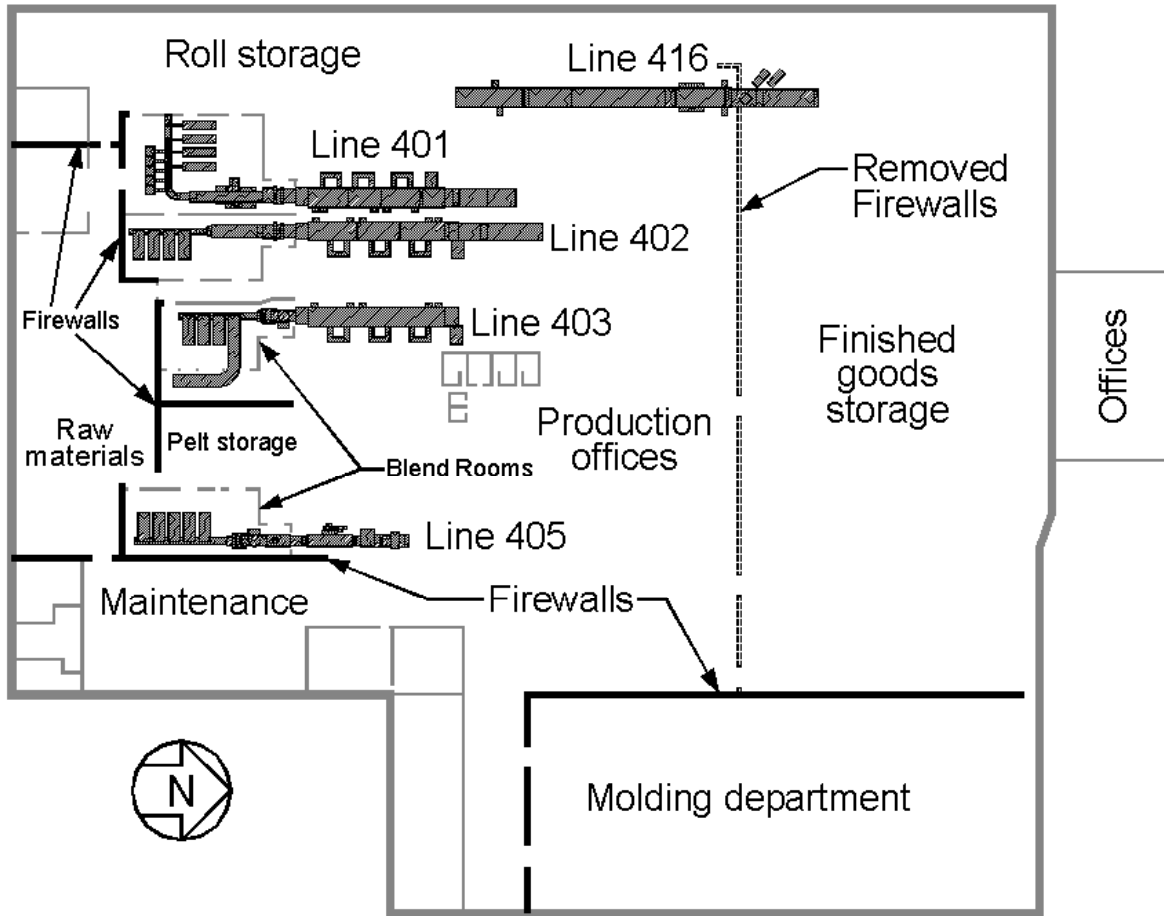
Figure 1. Simplified layout of CTA facility.

Four production lines—401, 402, 403, and 405—were located in the center portion of the southern half of the plant. Production line 416 was located near the west wall (Figure 1). The production lines included material feeders, separating and mixing machines, curing ovens, and trimming equipment connected by conveyors. Lines 401, 402, and 403 were adjacent to each other; line 405 was approximately 80 feet east of line 403. The open area between lines 403 and 405 was used to store racks of semi-cured acoustical insulation, referred to as “pelts.” The molding department, where hydraulic molding presses and water jet cutters were used to shape and size the automotive insulation products, was located in the northeast quadrant of the plant.

Firewalls to the south segregated the production lines from raw materials storage. A firewall also segregated the southeast portion of line 405 from the maintenance shop. This configuration created a 5- to 8-foot-wide aisle between the firewall and the east side of line 405. Another firewall, which ran from south to north in the open area between lines 403 and 405, partially segregated these lines. There was no firewall on the west side of the production area. In late 2002, CTA removed firewalls on the north side of the production area that segregated that area from the finished goods storage area. The Kentucky Department of Housing, Buildings, and Construction (which became the Kentucky Office of Housing, Buildings, and Construction in 2004) approved removal of these firewalls.

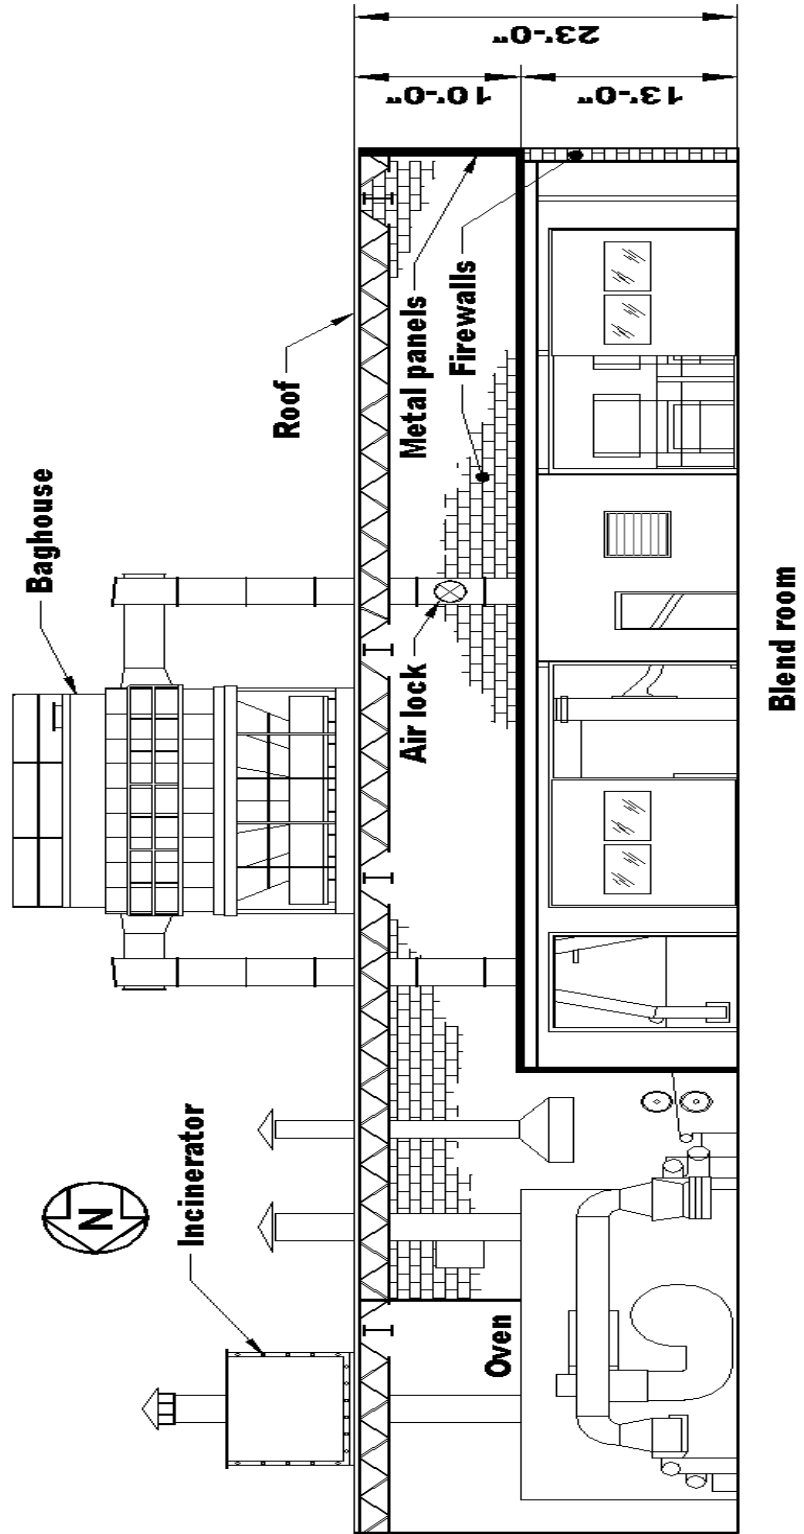
Figure 2. Side view showing location of line 405 blend room.

Thirteen-foot-high freestanding enclosures, called “blend rooms,” covered processing equipment on the south end of four production lines. Figure 2 shows the location of the blend room in a side view of line 405. Blend room ceilings were constructed of metal panels with recessed fluorescent light fixtures. The areas between the roofs of the blend rooms and the plant roof were generally open on two or three sides.

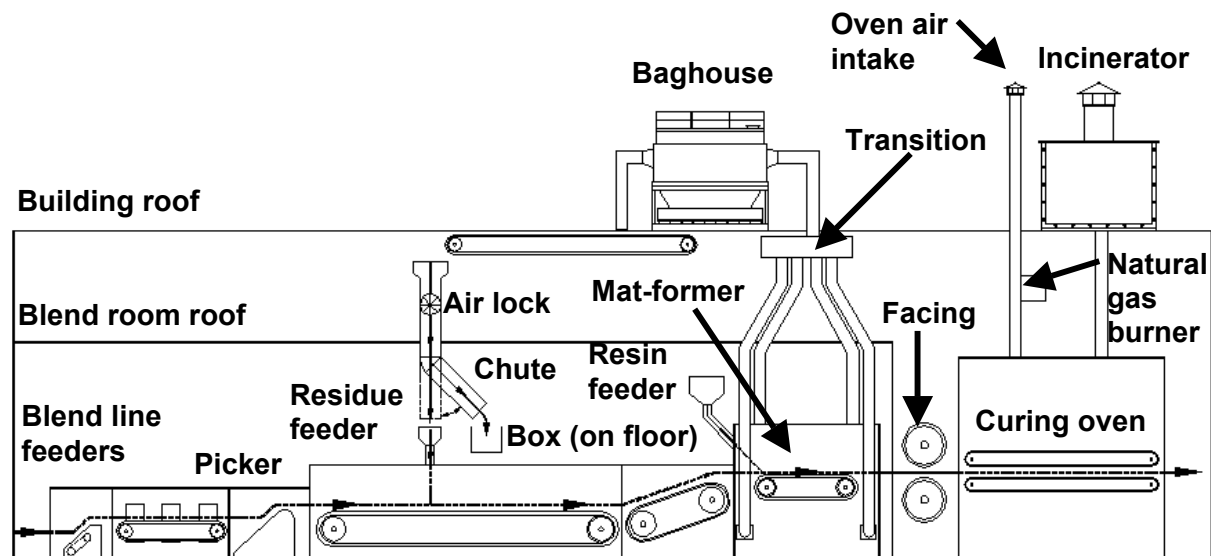
Figure 3. Line 405 process flow.

Lines 401, 402, and 403 generally operated in a manner similar to 405 (Figure 3). However, the process at line 405 is significant because CSB determined that it most likely was the origin of the initial ignition and explosion (Section 7.1.1.1). Line 416 only applied additional coatings to the industrial insulation products produced in Lines 401 and 402 and used no powdered phenolic resins.

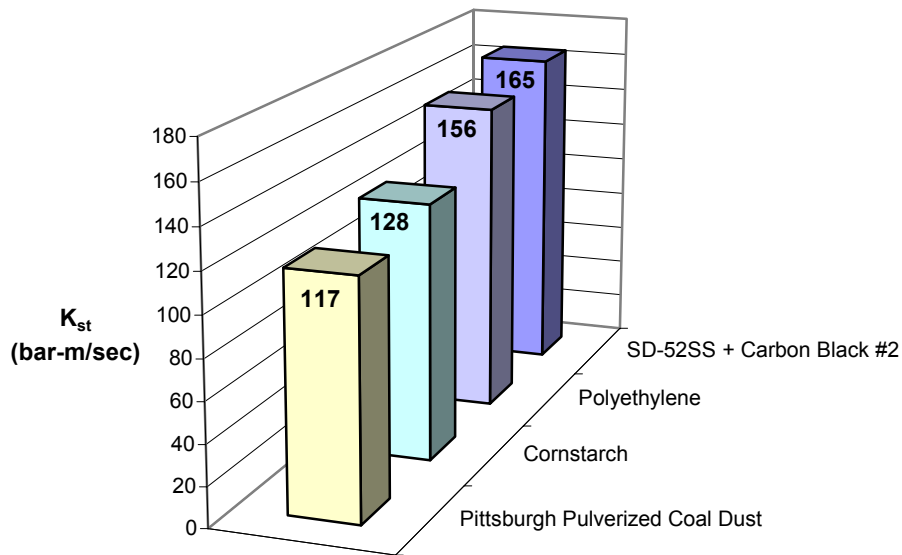
Figure 14. Explosion severity of Durite SD-52SS compared with other common combustible dusts.

Test data from the resin samples were also compared to the explosion characteristics of other common combustible dusts—namely, Pittsburgh coal dust, polyethylene dust, and cornstarch. Figure 14 shows that the Borden Chemical black phenolic resin used at CTA has a higher K_{st} value than the other dusts.

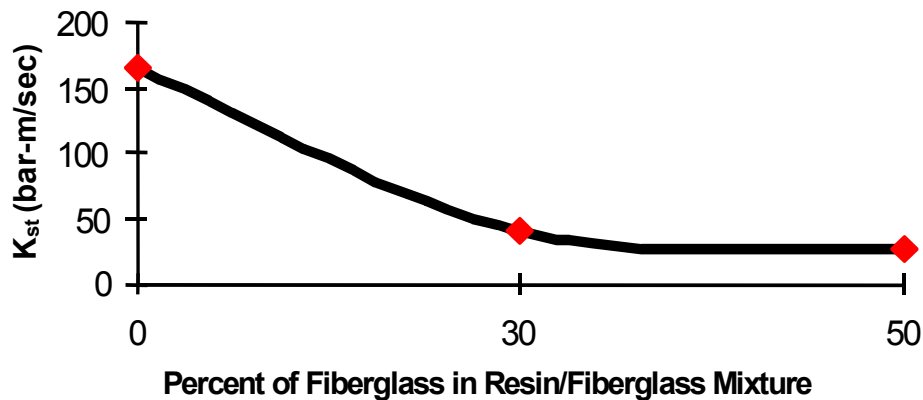
Figure 15. Explosivity testing results for resin/fiberglass mixtures.

Dust that settled in the CTA production area was typically a mixture of phenolic resin and small fiberglass fibers. Samples of ground fiberglass and phenolic resin were mixed in varying percentages in the CSB contractor's laboratory and tested. The test results show that as the fiberglass content increased, the mixtures remain explosible, but explosion severity decreased (Figure 15).

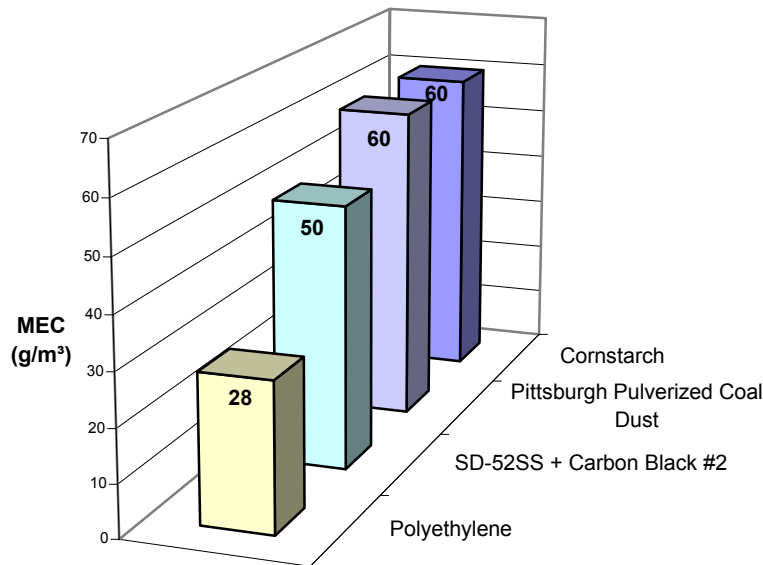
Figure B-3. Minimum explosive concentration of Durite SD-52SS compared with other common combustible dusts.

Figure B-3 compares MECs for the Borden Chemical SD-52SS phenolic resin, Pittsburgh coal dust, polyethylene dust, and cornstarch.

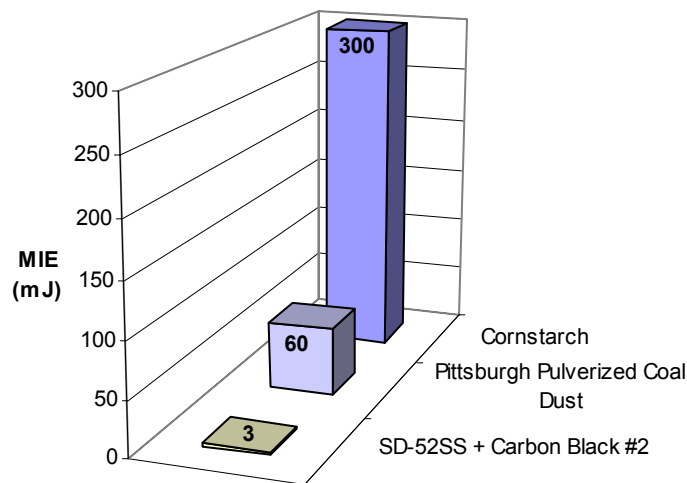
Figure B-4. Minimum ignition energy of Durite SD-52SS compared with other common combustible dusts.

Figure B-4 shows MIE test results for a Durite SD-52SS dust cloud in air. Results indicate that the phenolic resin is very easy to ignite, requiring only 3 millijoules (mJ) of energy to initiate an explosion.

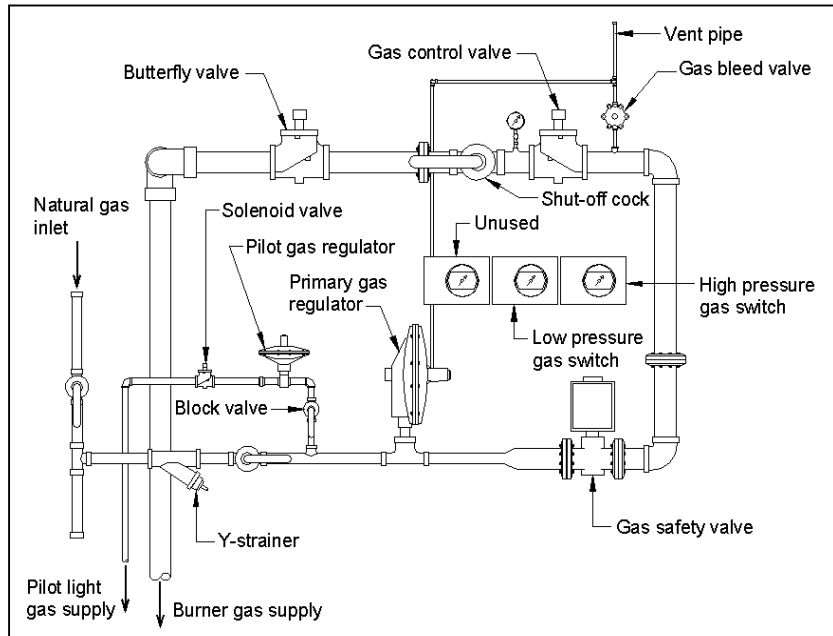
Figure C-1. Oven natural gas piping manifold.

No significant external gas leaks into the building were found. All internal gas leaks (i.e., gas control valve, gas bleed valve) would have been directed to the externally piped gas vent line.

CSB reviewed these findings and conclusions and determined that equipment testing results identified no single component failure as the cause of the incident.
