OCS Report
MMS 86-0100

**Investigation of the December 1985 Blowout and Fire,
Lease OCS-G 4268,
West Cameron Block 648,
Gulf of Mexico,
Off the Louisiana Coast**

October 1986

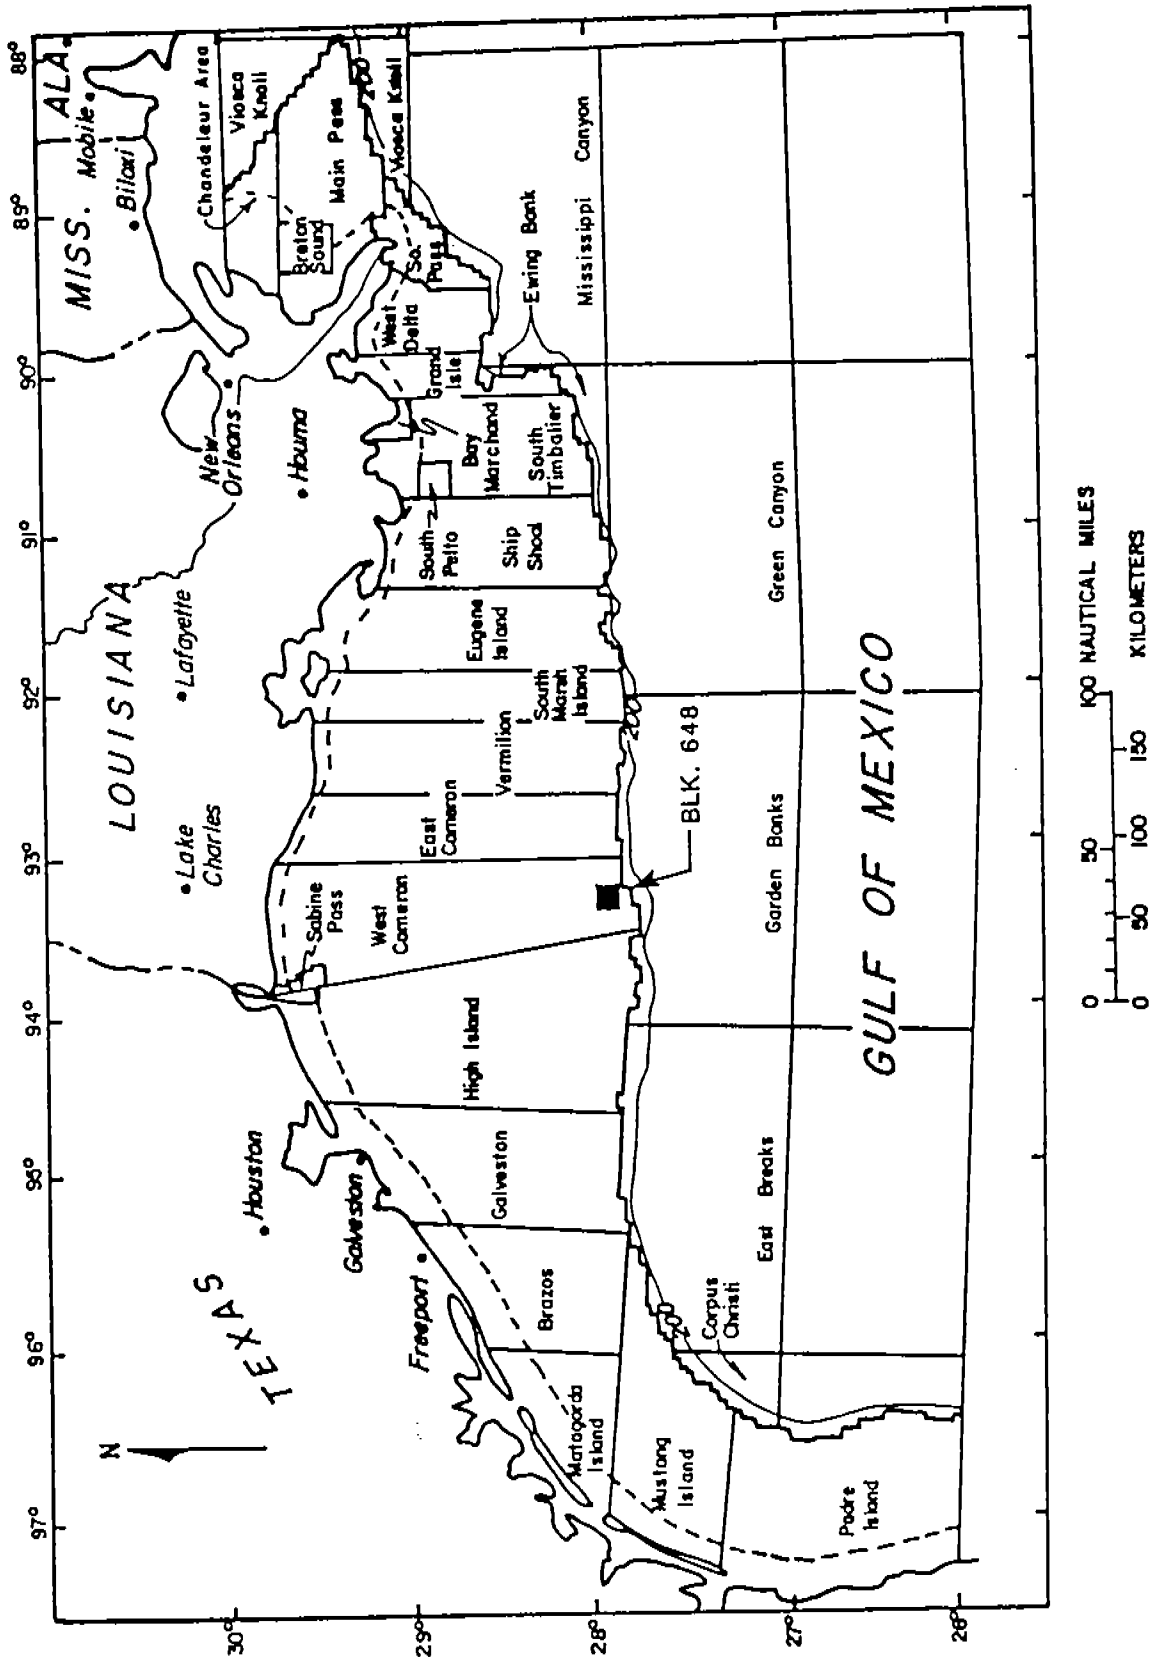
Photographs of Fire

The wellbay area of the West Cameron Block 648 Platform A was completely destroyed. All wellheads and flowlines in the area were replaced. The firewall separating the wellbay area from the rest of the platform prevented the fire from spreading to and destroying the production equipment, living quarters, and heliport. (For photograph of production side of platform, see appendix, attachment 6.) The platform was restored to production on August 20, 1986. The S.E.E. Rig No. 14 was completely destroyed.
