**Investigation of Rig Accident and Fatality
Grand Isle Block 19
Gulf of Mexico
Off the Louisiana Coast
September 24, 1996**

Frank Pausina
Mike Conner
Thomas Machado

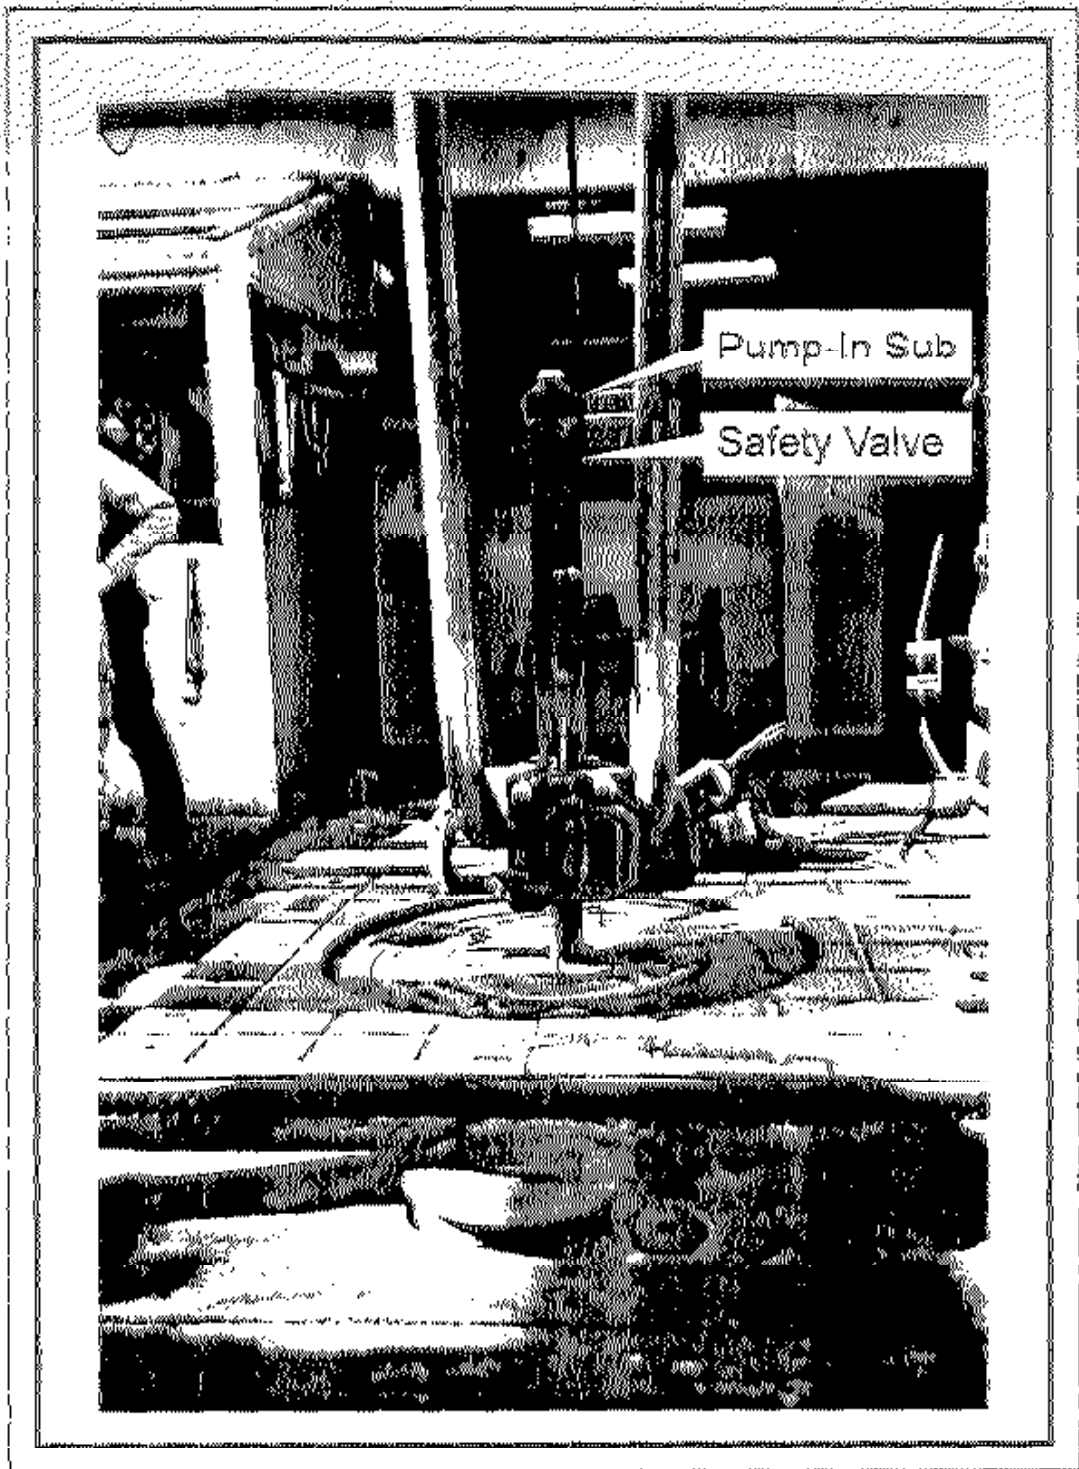
Photograph of pump-in sub and safety valve

An examination of the threads of the male end of the pump-in sub revealed that it had been made up to a depth of approximately five threads to the female end of the pump-in sub connection with approximately that many threads left unused. This was determined by an inspection of the thread's Teflon coating. For a photograph of the male end of the pump-in sub, see Attachment 7. A visual inspection of the male and female threads of the connection did not reveal any significant damage to the threads. One interviewed crew member stated that more threads should have been used.

4. The unused threads of the male end of the pump-in sub at the very least did not add to the integrity of the connection and at worst compromised that integrity. The degree to which the connection would have held had all threads been used is not known. However, when considered in conjunction with the possible interference of the swivel by the safety chain, not using all the threads available can be considered a possible cause of the accident.
