**Investigation of Fatal Accident
V-Door Guide Post Failure
Chandeleur Block 31, Well No. 1
OCS-G 27214
18 July 2006**

**Gulf of Mexico
Off the Louisiana Coast**

Jack Williams – Chair
Tom Perry
David Emilien
Kevin Langlinais

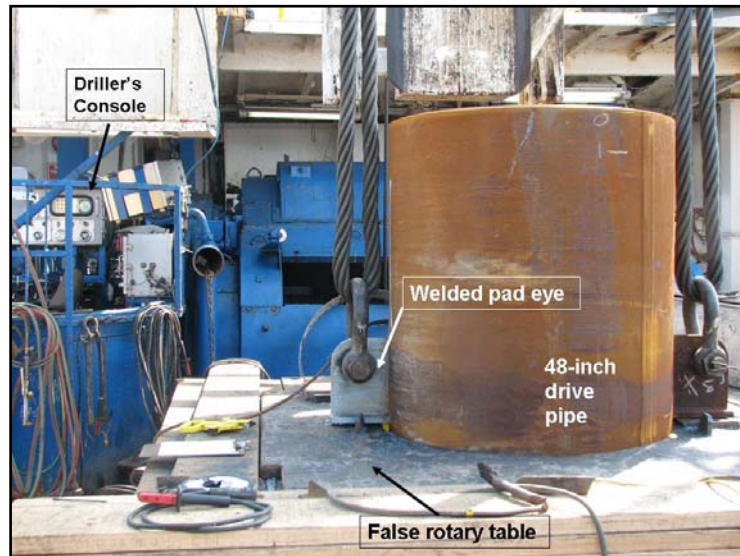
Figure 2: Drive pipe assembly and false rotary table.

On 18 July 2005, operations preparing to spud the subject Well were continuing on the jack-up drilling Rig, Nabors D-110. Three joints of 48-in drive pipe with two pup joints had been welded together and the pipe was suspended extending below the false rotary but not to the mud line. During the night shift, an additional joint of 48-in had been welded up and the entire string had been lowered until the drive pipe pad eyes contacted the top of the rotary table (*see figure 2*).

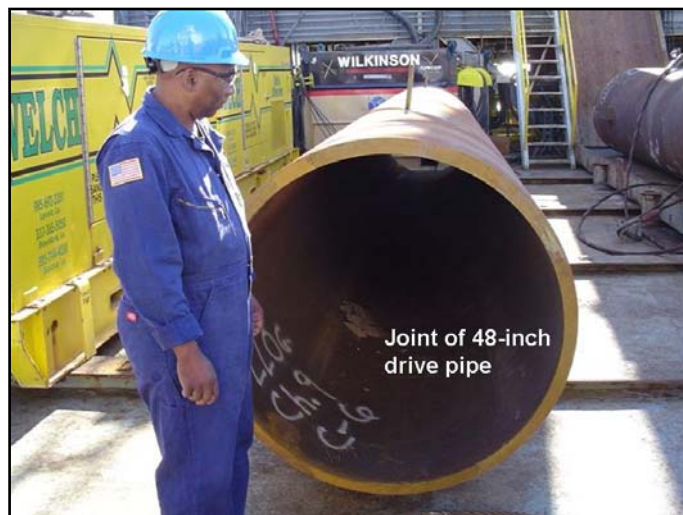
Figure 5: Example, 48-in drive pipe

15-16 Jul 2007, 1100 hrs - The Rig moved onto location, jacked-up to approximately a 55-ft air gap, skidded out, and commenced operations preparatory to drilling the Well. The 48-in drive pipe and welding equipment were taken onboard the Rig (*see figure 5*).

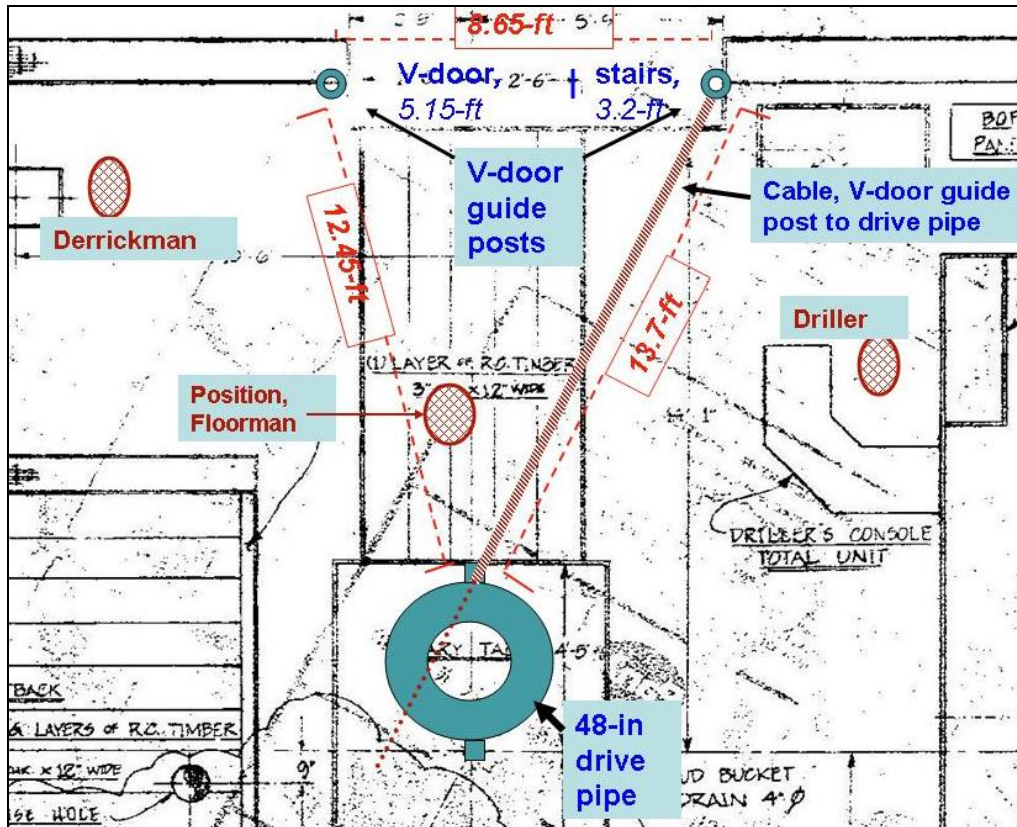
Figure 11: Schematic, drill floor layout

According to testimony, the cable from the air hoist to the drive pipe pad eye was not looped around the drive pipe to assist in applying rotation force (torque). With the rig up method employed in this case, once the drive pipe had been rotated near its intended final position, the angle of the cable applying the force to the drive post was so reduced that the perpendicular distance from the center of the drive pipe to the plane of the rotating force, the “lever,” became nearly non-existent.

Without a “lever” element, no torque (turning force) can be applied to turn an object. Instead, additional applied force will simply act to pull that object in the direction of the applied force rather than turn it. From examination of the diagram (*see figure 11, p.16, below*) it is evident when the pad eye of the drive pipe was oriented into the position at the time of the Accident, little or no effective torque was being applied to the drive pipe despite any increase in applied force.

However, increasing “torque” was being applied elsewhere. An equal but opposite force to that being applied to the drive pipe was being applied to the top of the right V-door guide post. This force was being applied there because the cable had been routed through a shackle attached to a pad eye at that location. The force at the top of the V-door guide post was converted to a rotational “moment” on the bottom of the post, magnified by the approximate 7-ft distance from the shackle to the weld at the base of the post. This rotational force on the base of the post can be approximated by multiplying the force on the cable by the length of the post (lever distance). The torque on the base of the post was many times greater than that which would have been applied if the rotational assembly had been directly attached to the bottom of the V-door guide post.

2. Rigging up the rotating mechanism to the top of the V-door guide post rather than the bottom multiplied the force applied to the welds at the base of the post several times over. This probably contributed to the failure of the welds and/or pipe.
