# Highway Concrete Pavement Technology Development and Testing: Volume V— Field Evaluation of Strategic Highway Research Program (SHRP) C-206 Test Sites (Bridge Deck Overlays)

PUBLICATION NO. FHWA-RD-02-086

AUGUST 2006

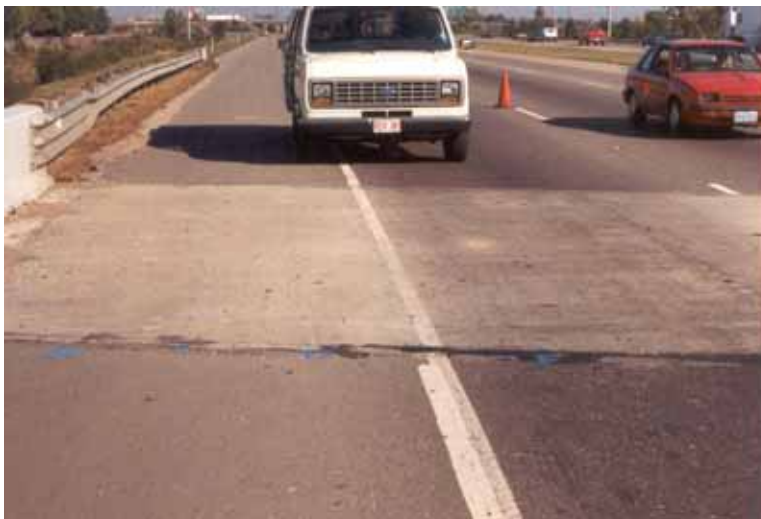
**Figure 3. Photograph showing test section on I-270 southbound (1995).**

The test sections studied on both spans include the shoulder and travel (outside) lanes. Examination of the deck overlay surface indicated several narrow longitudinal cracks in the shoulder lanes of both bridges. Cracks were more frequent in the travel lanes. The travel lane of the northbound SFC bridge had mostly single nonconnected cracks running in both the longitudinal and transverse directions with very little branching. The travel lane of the southbound LMC bridge had more and longer longitudinal cracks and also more branching of cracks.

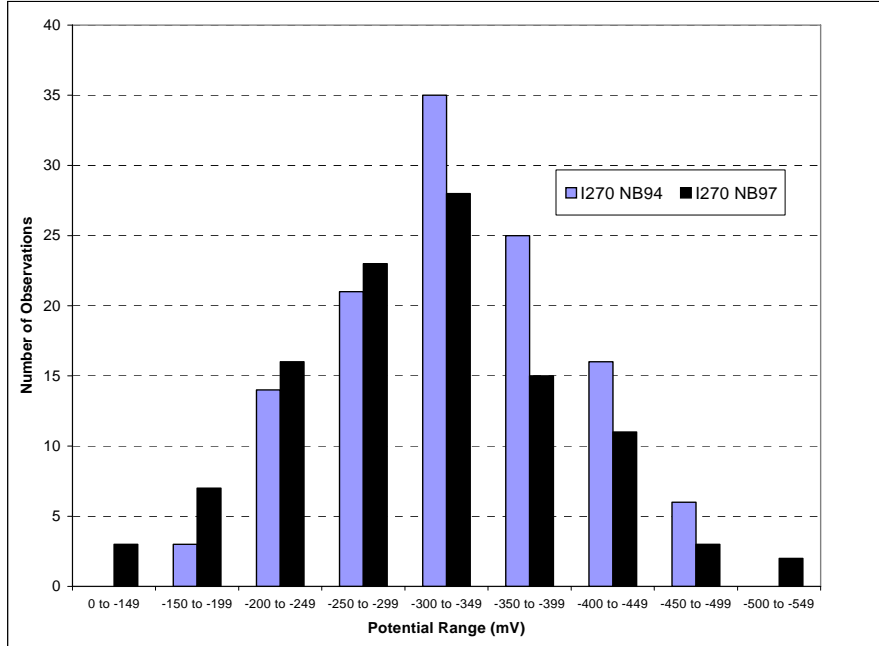
**Figure 4. Histogram of half-cell potentials for I-270 NB SFC test section for 1994 and 1997.**

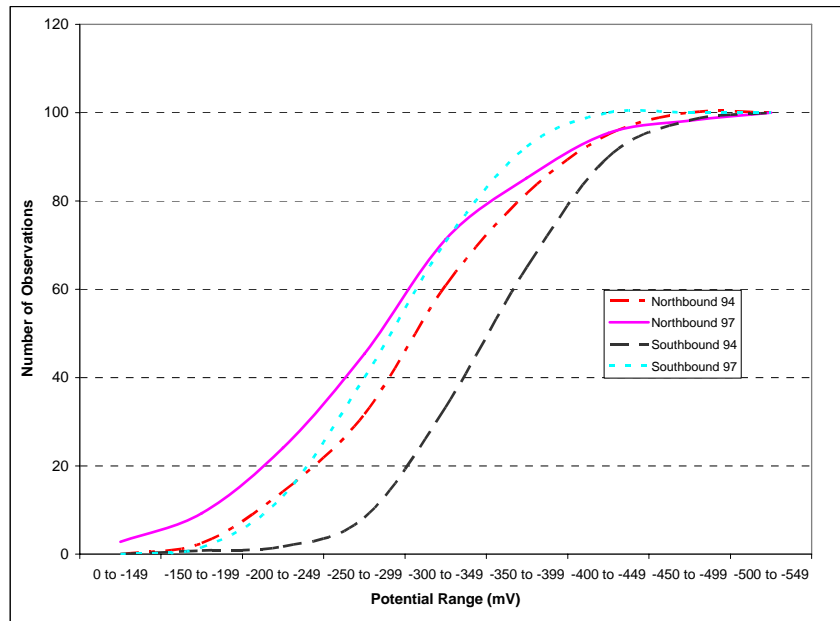
Past experience with research performed at the contractor site and published in FHWA report FHWA-RD-86-193, *Protective Systems for New Prestressed and Substructure Concrete*, indicates that corrosion potentials more negative than approximately  $-230$  mV indicate that corrosion is taking place in bridge deck type structures. According to the  $-230$  mV criteria, the majority of the locations surveyed had potentials indicating that corrosion was taking place. Both structures appear to be undergoing corrosion over the majority of their deck area. The ends of the bridges and the areas under cracked delaminations appear to be especially vulnerable. A cumulative frequency diagram of the potentials is shown in figure 8. The curve for both bridge decks is shifted to the left from 1994 to 1997. This indicates a decrease in the overall half-cell potentials. The shift is larger for the southbound lanes which have the latex-modified overlay.

**Figure 8. Cumulative frequency diagram for I-270 (NB and SB) for years 1994 and 1997.**

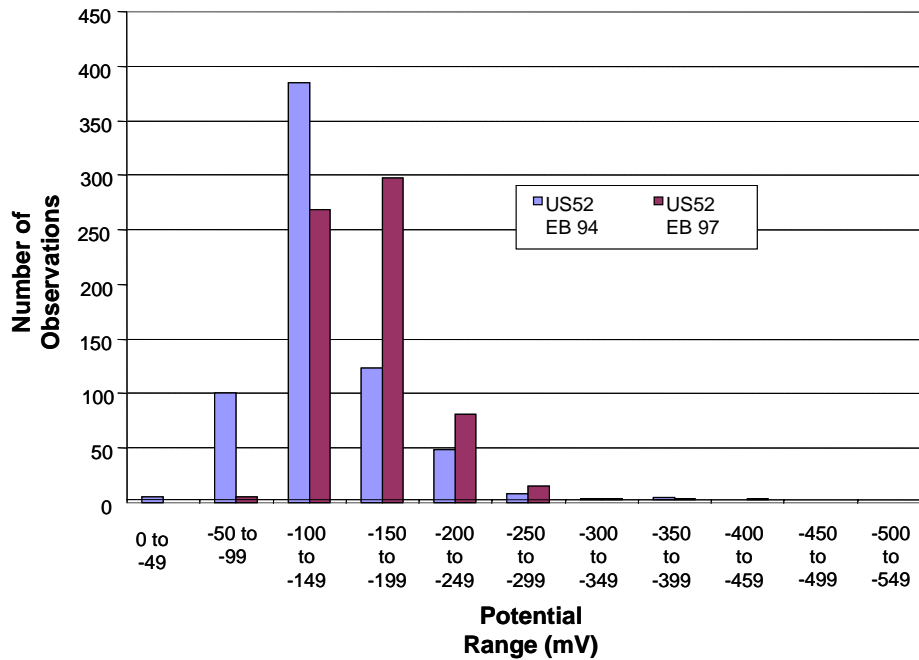
The readings for the eastbound travel lane in 1997, shown in table 21, range from  $-0.089$  V to  $-0.412$  V. Over 97 percent of the readings are below  $-0.250$  V. A histogram for the eastbound travel lane in 1994 and 1997 is shown in figure 12. The half-cell readings for the westbound travel

**Figure 12. Histogram of half-cell potential readings for U.S. 52 eastbound travel lane LMC in 1994 and 1997.**

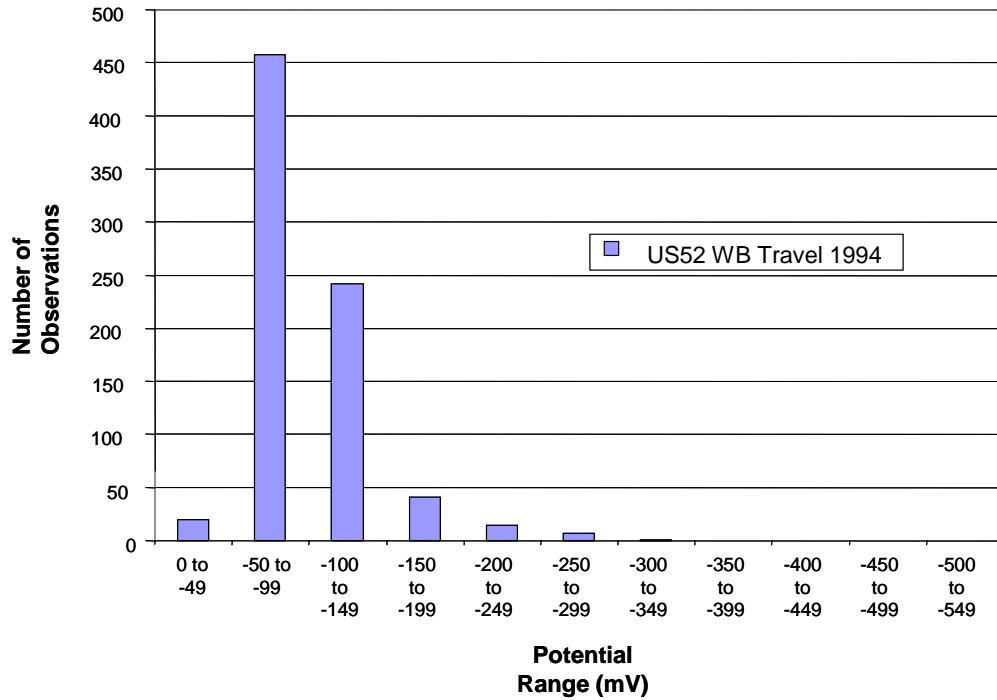
**Figure 13. Histogram of half-cell potentials for U.S. 52 westbound travel lane LMC in 1994.**

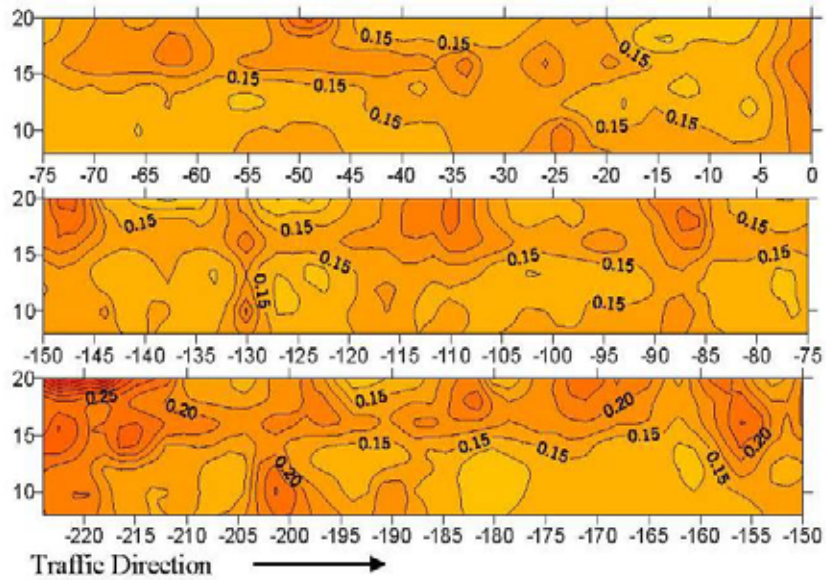
**Figure 155. Equipotential map of half-cell potentials for eastbound travel lane U.S. 52 in 1997 (latex-modified concrete).**

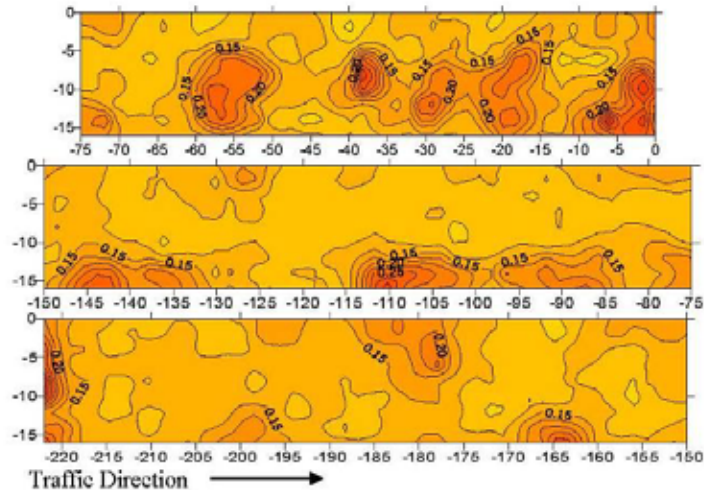
**Figure 16. Equipotential map of half-cell potentials for westbound passing lane of U.S. 52 in 1997 (silica fume concrete).**

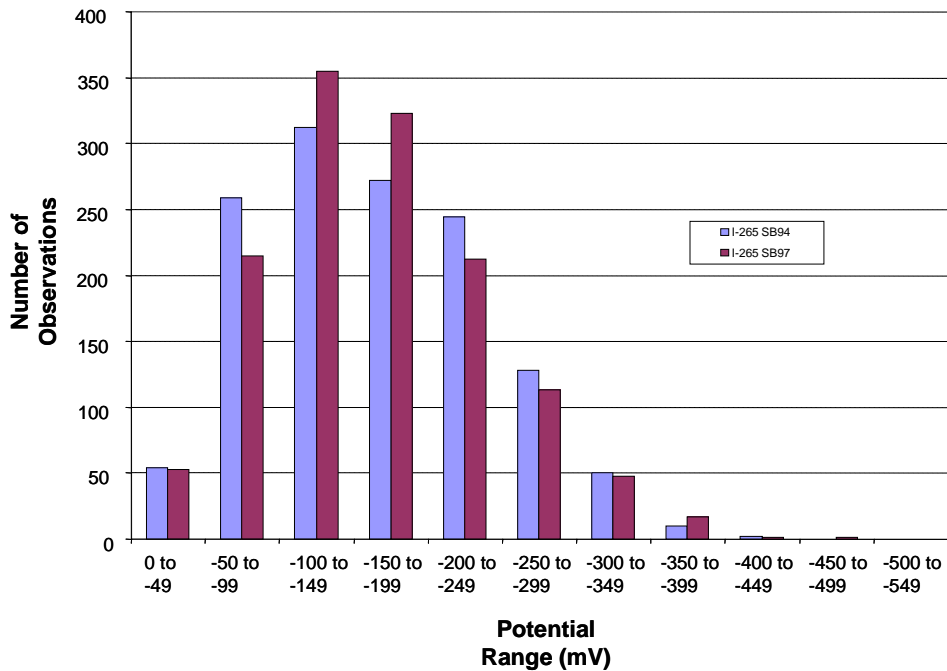
In 1997, the half-cell potentials ranged from +265 mV to -600 mV. Span 1 again had the highest average potential reading of -207 mV. Span 2 again had the highest potential reading at -600 mV and the lowest average reading at -149 mV. Span 3 had an average potential reading of -160 mV. Tables 35 and 36 give the cumulative frequencies of the half-cell potentials for the southbound test section of I-265 for 1994 and 1997, respectively. In 1994, over 85 percent of the readings were less negative than -250 mV. In 1997, over 86 percent of the readings were less negative than -250 mV. A histogram of the half-cell potential readings for the southbound test section in 1994 and 1997 is shown in figure 19.

**Figure 19. Histogram of half-cell potential readings for I-265 southbound SFC test section.**

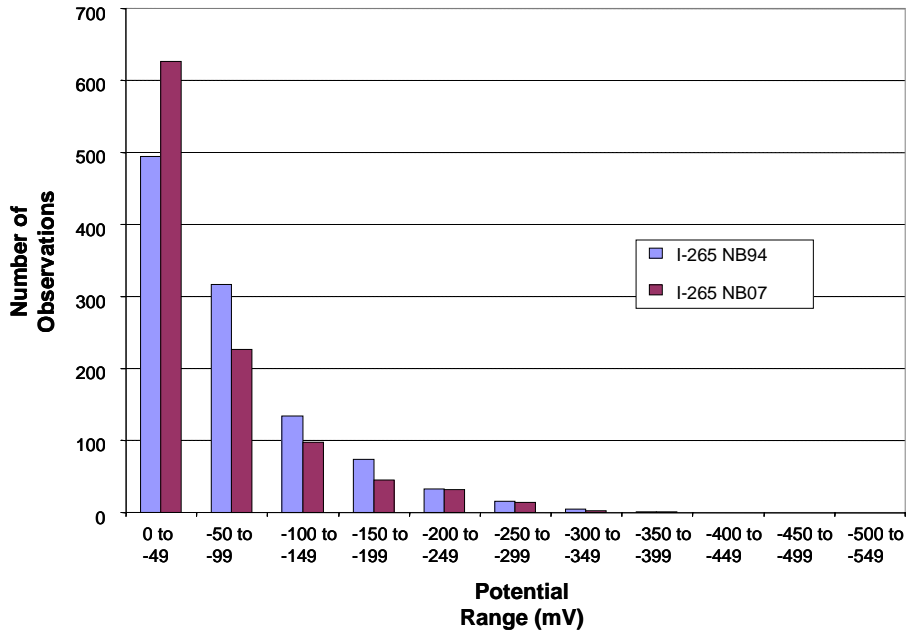
Span 2 had the highest individual reading at -356 mV but had an average reading of only -65 mV. Span 1 had an average potential reading of -55 mV. In 1997, span 3 again had the highest average potential reading at -86 mV but also had the highest individual reading at -352 mV. Span 2 had an average potential reading of -61 mV and span 1 had an average of -27 mV. Tables 37 and 38 show the cumulative frequency of the half-cell readings for the northbound spans in 1994 and 1997. A histogram of the half-cell potential readings for the northbound test section for 1994 and 1997 is shown in figure 20. In 1994 and 1997, approximately 98 percent of the readings were less negative than -250 mV. In areas away from the joints, the potentials were generally less negative than -100 mV, indicating that very little corrosion is taking place in the bridge.

**Figure 20. Histogram of half-cell potential readings for the I-265 northbound LMC test section.**

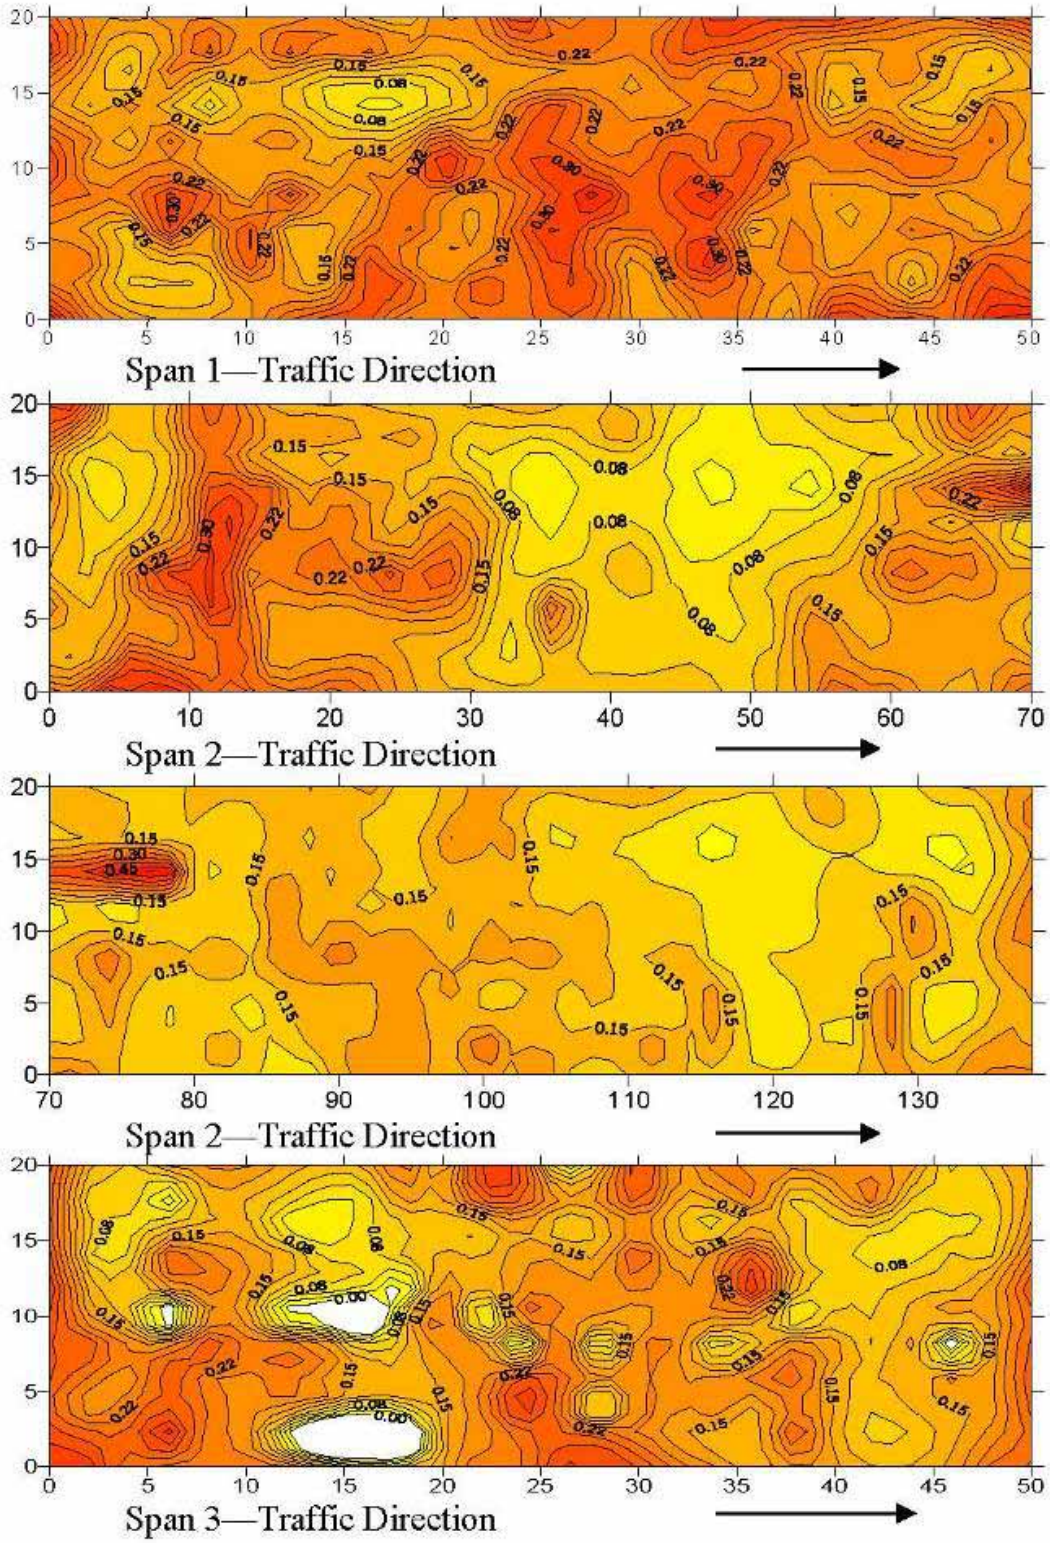
Figure 21 shows an equipotential map of the half-cell readings for the southbound SFC test section for 1997. Spans 1 and 3 appear to have more isolated spots of corrosion (anodic) activity than the main span. An equipotential map of the half-cell potential readings for the northbound LMC test section for 1997 is shown in figure 22. The magnitude of the half-cell readings is much lower in the northbound LMC test section than in the southbound SFC test section. However, some anodic areas are present, mainly near the joints and in the main span.

**Figure 21. Equipotential maps of half-cell potentials of the three southbound spans SFC of the I-265 test section in 1997.**

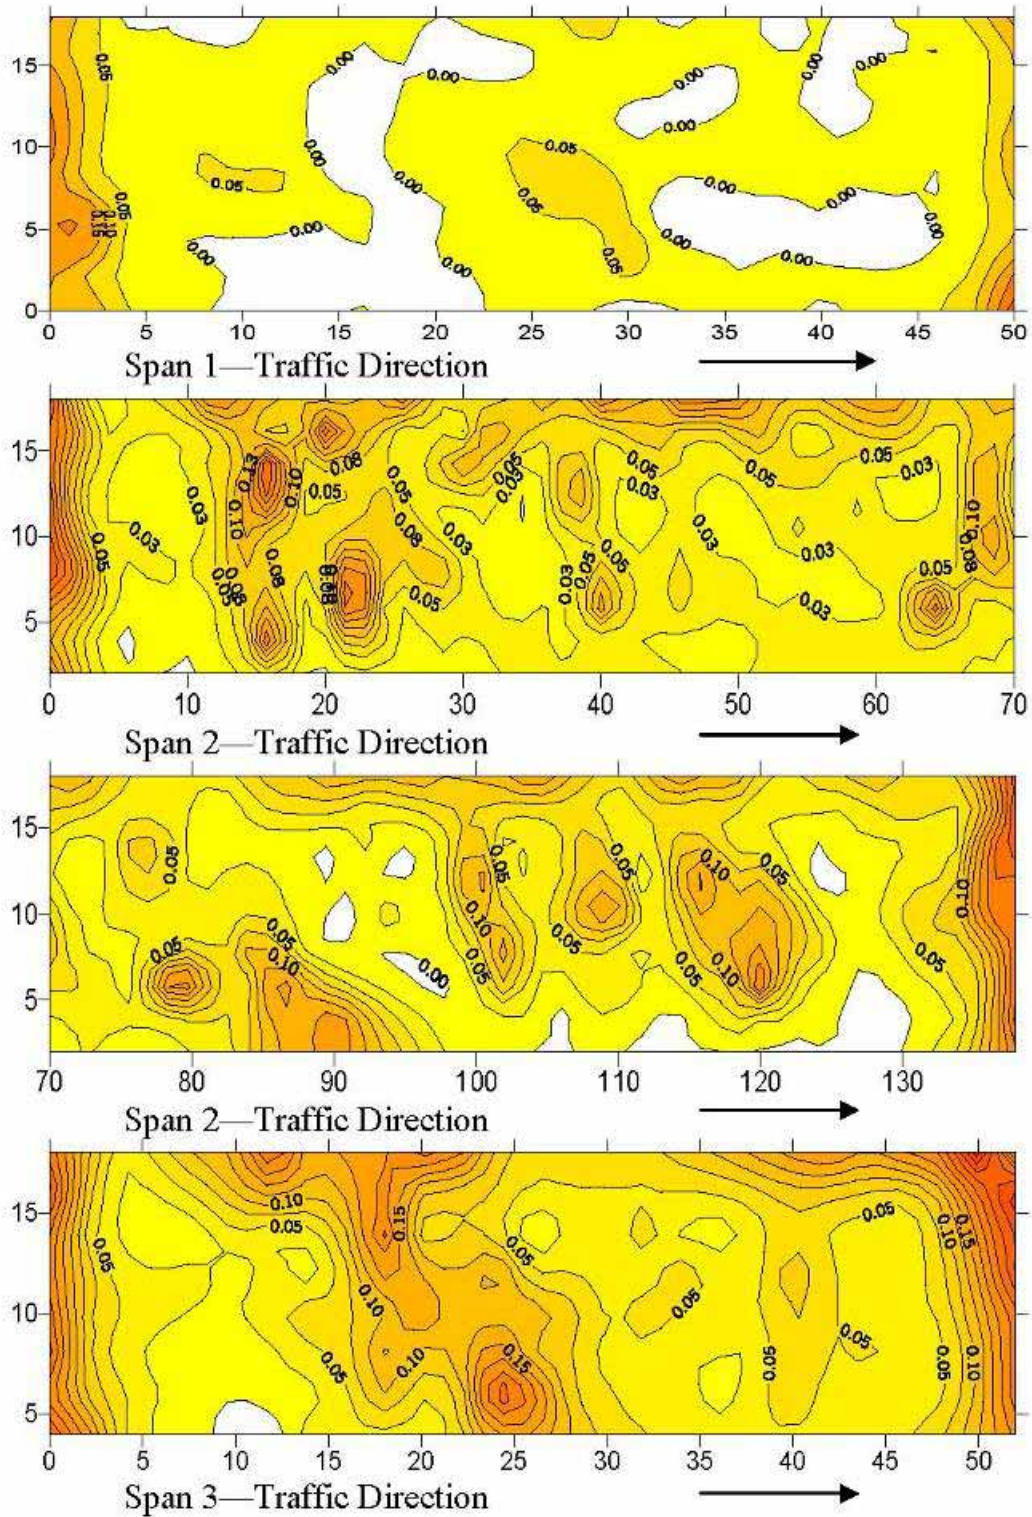
**Figure 22. Equipotential maps of half-cell potentials of the three northbound spans LMC of the I-265 test section in 1997.**

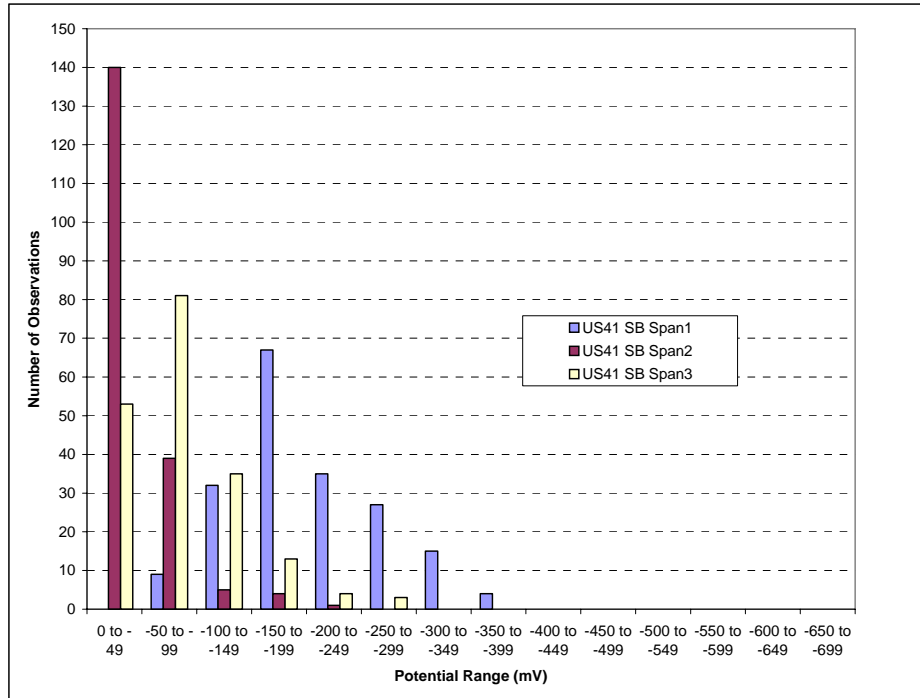
**Figure 27. Histogram of half-cell potential readings for U.S. 41 southbound in 1994 SFC.**

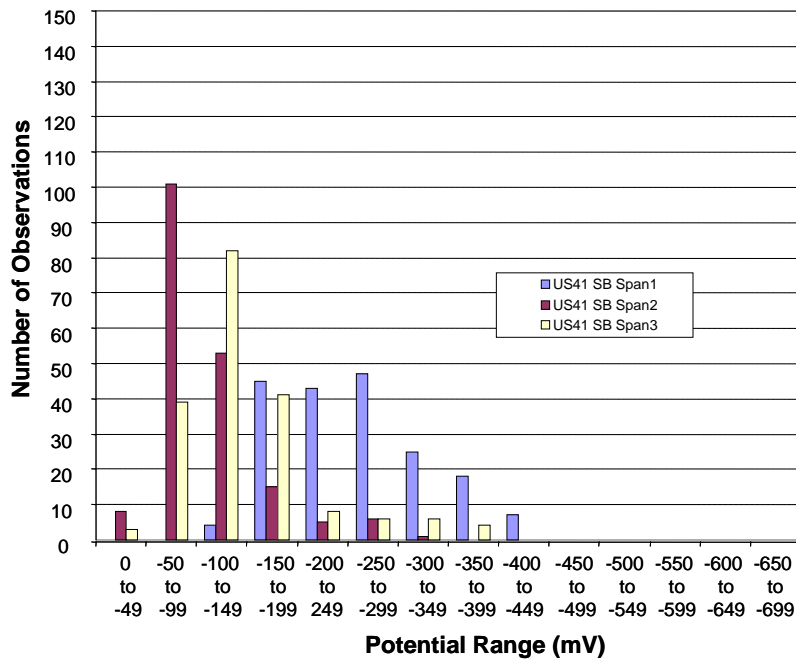
A summary of the half-cell measurements for the southbound structure in 1997 is shown in table 50. The half-cell measurements were more negative for all three spans in 1997 than in 1994. Span 1 had an average reading of 258 mV with a maximum negative reading of -435 mV and a minimum negative reading of -134 mV. Span 2 had an average of -108 mV with a maximum of -305 mV and a minimum of -19 mV. Span 3 had an average reading of -142 mV with a maximum of -383 mV and a minimum of -16 mV. The average half-cell reading for Span 1 was above the 250 mV threshold for corrosion to occur. A histogram comparing the distribution of half-cell readings for the southbound section in 1997 is shown in figure 28. A histogram comparing the distribution of half-cell measurements for the entire southbound test section in 1994 and 1997 is shown in figure 29. The curve for 1997 is shifted significantly to the right which indicates a probability of increased corrosion activity, especially in Span 1.

**Figure 28. Histogram of half-cell potential readings for U.S. 41 southbound in 1997 SFC.**

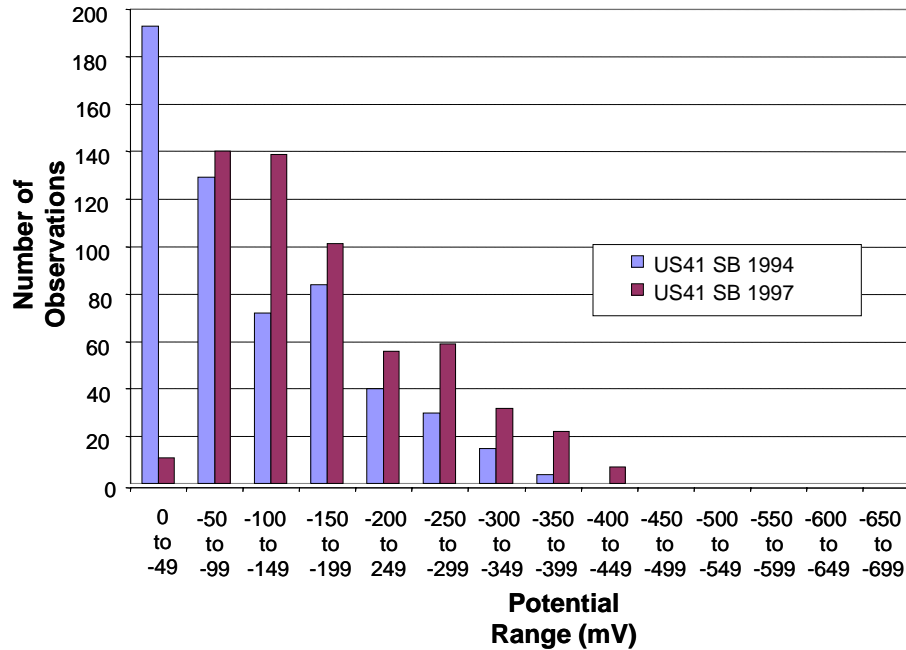
**Figure 29. Histogram of half-cell potential readings for U.S. 41 southbound SFC in 1994 and 1997.**

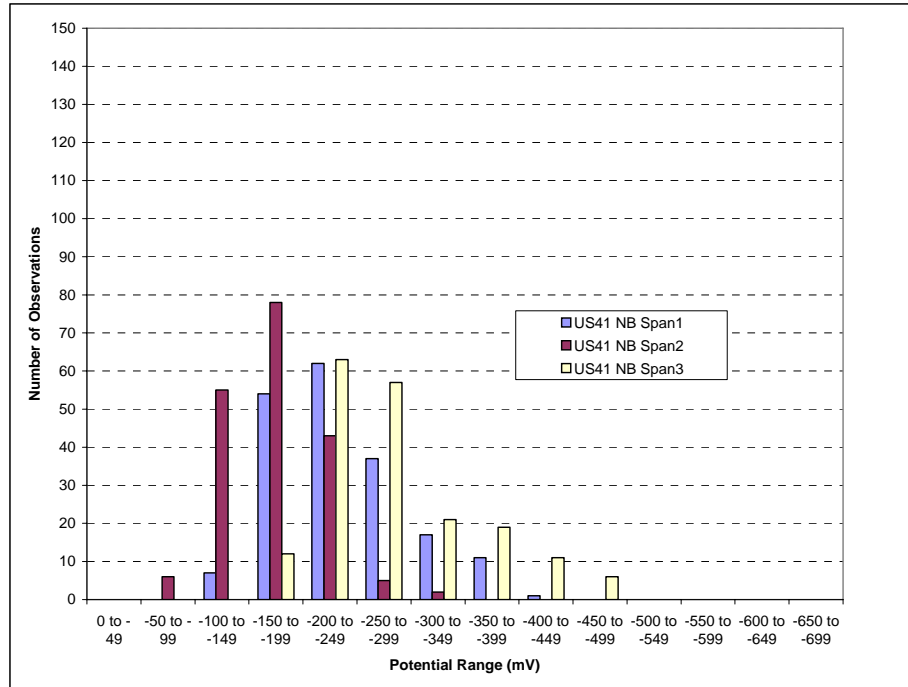
A summary of the half-cell potential readings for the northbound LMC spans in 1994 is shown in table 51. Span 3 has higher magnitude half-cell readings than the other two spans. The average half-cell potential reading for Span 3 was -281 mV, compared to -235 mV for Span 1, and -171 mV for Span 2. The average for Span 3 was over the threshold limit of 250 mV needed for corrosion. The maximum half-cell potential for Span 3 is -499 mV, for Span 1 is -425 mV, and for Span 2 is -320 mV. All three spans had half-cell potentials indicative of corrosion occurring in the deck. A histogram of the distribution of half-cell potentials for the northbound LMC spans in 1994 is shown in figure 30. Span 3 had the most negative potentials (most corrosive).

**Figure 30. Histogram of half-cell potential readings for U.S. 41 northbound LMC in 1994.**

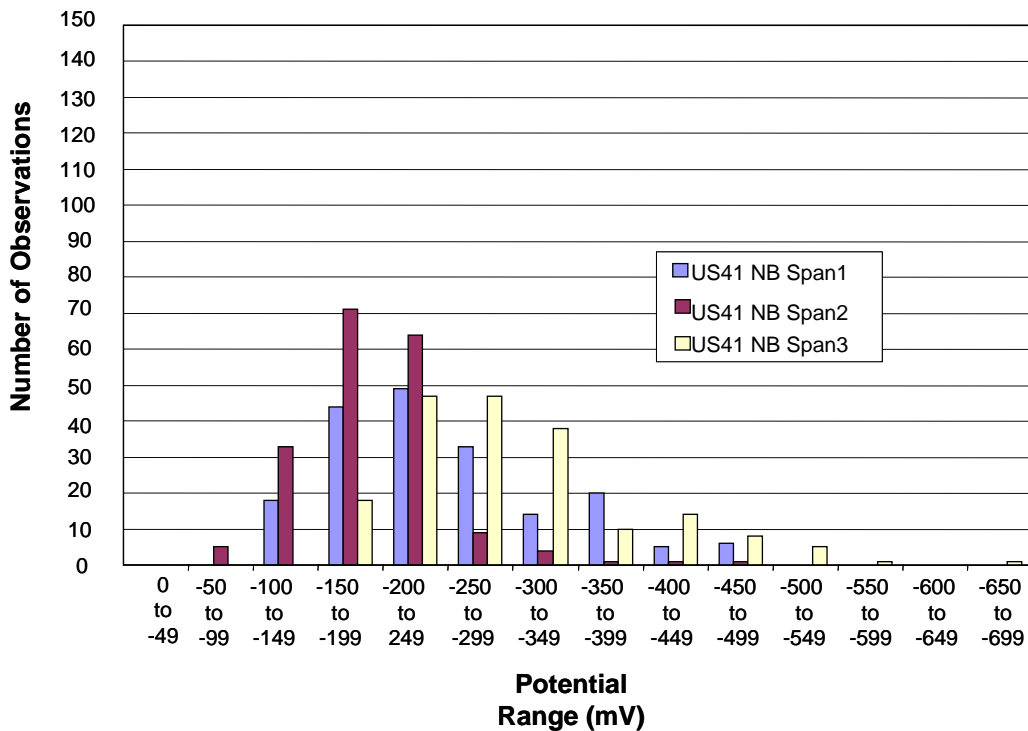
shown in figure 31. A histogram of the half-cell potential readings for the entire northbound structure in 1994 and 1997 is shown in figure 32. The distribution appears similar but the curve for 1997 is shifted to the right, indicating a probability of increased corrosion.

**Figure 31. Histogram of half-cell potential readings for U.S. 41 northbound LMC in 1997.**

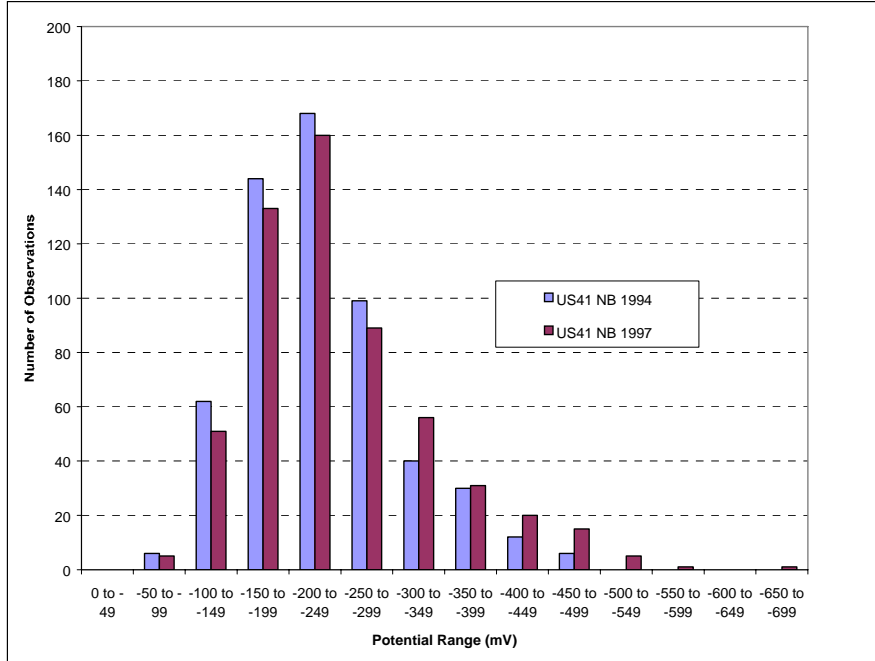
**Figure 32. Histogram of half-cell potential readings for U.S. 41 northbound spans in 1994 and 1997.**

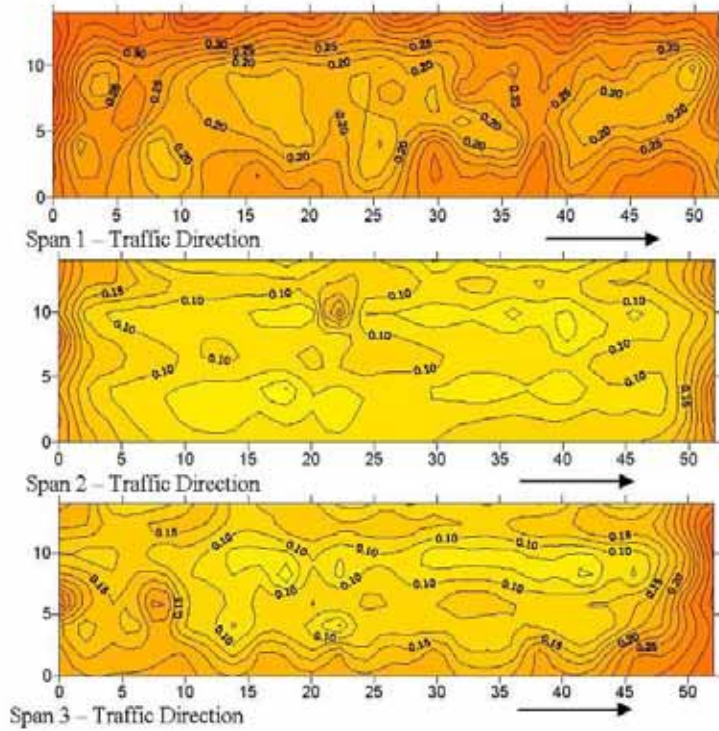
A cumulative frequency diagram for both test sections of U.S. 41 is shown in figure 33. The figure shows the shift to the right for both test sections. The shift in the curve for the southbound SFC spans is much greater than that for the northbound spans LMC. However, the northbound spans LMC had more negative values both initially and at the end of the study than the southbound SFC spans. An equipotential map of the half-cell readings for the southbound spans SFC of U.S. 41 is shown in figure 34. The figure for Span 1 indicates there is corrosion occurring along the edge between the travel and passing lane and at the two ends of the span. The figures for Span 2 and Span 3 indicate corrosion is occurring in isolated areas and also at the ends of the spans. An equipotential map for the half-cell readings for the northbound spans LMC is shown in figure 35. The maps for Span 1 and Span 3 indicate corrosion occurring over much of both spans and especially along the edge between the travel and passing lanes. The map for Span 2 indicates isolated areas of corrosion but most areas are at the ends of the span.

**Figure 34. Equipotential maps of half-cell potentials for the three spans of the southbound test section of U.S. 41 in 1997 SFC.**

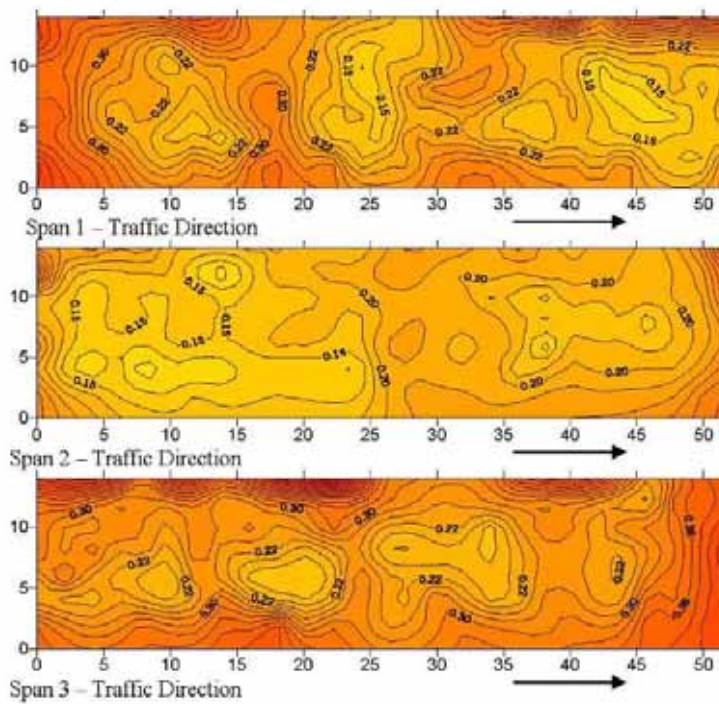
**Figure 35. Equipotential maps of half-cell potentials for the three spans of the northbound test section of U.S. 41 in 1997 LMC.**
