The October 17, 1989, Loma Prieta, California, Earthquake—Selected Photographs

by By J.K. Nakata, C.E. Meyer, H.G. Wilshire, J.C. Tinsley, W.S. Updegrove,
D.M. Peterson, S.D. Ellen, R.A. Haugerud, R.J. McLaughlin, G.R. Fisher, *and*
M.F. Diggles

Photographs and descriptions to accompany
Digital Data Series DDS-29
Version 1.2
1999

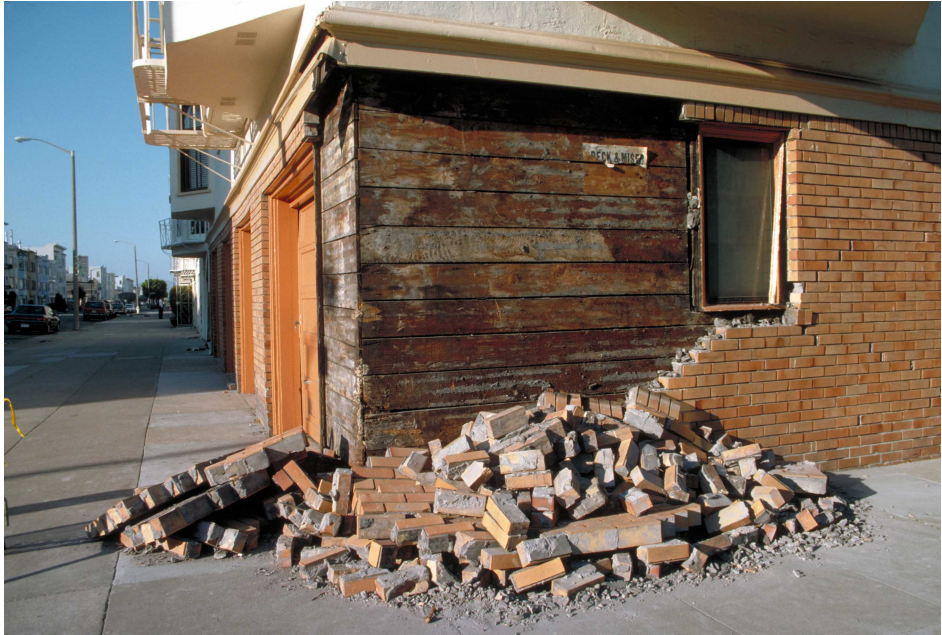
10. Collapsed brickwork from a corner apartment building, *Marina District*. [C.E. Meyer, U.S. Geological Survey]

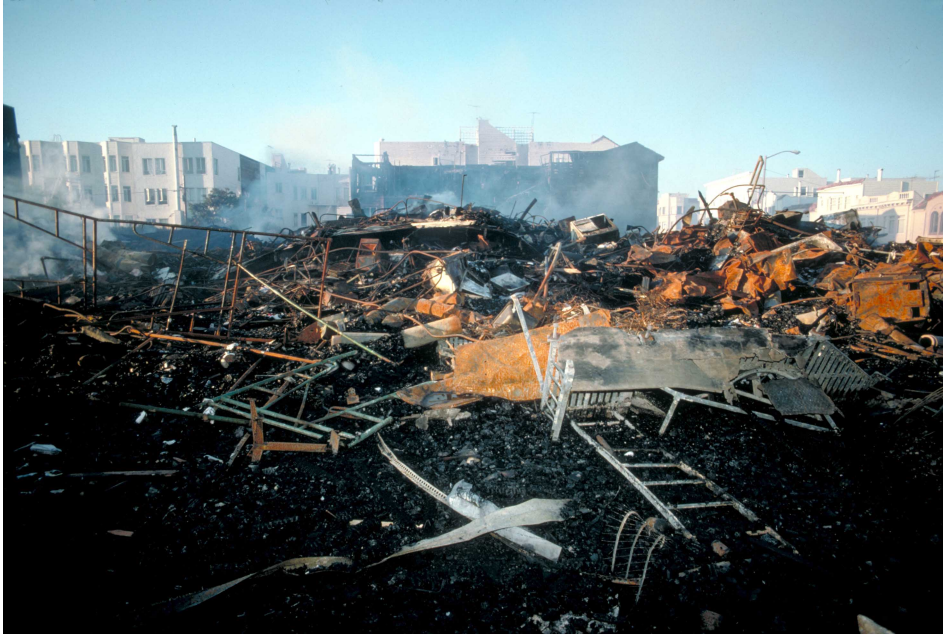
11. Smoldering remains of the apartment complex at the corner of Beach and Divisadero Streets, the *Marina District*. [J.K. Nakata, U.S. Geological Survey]

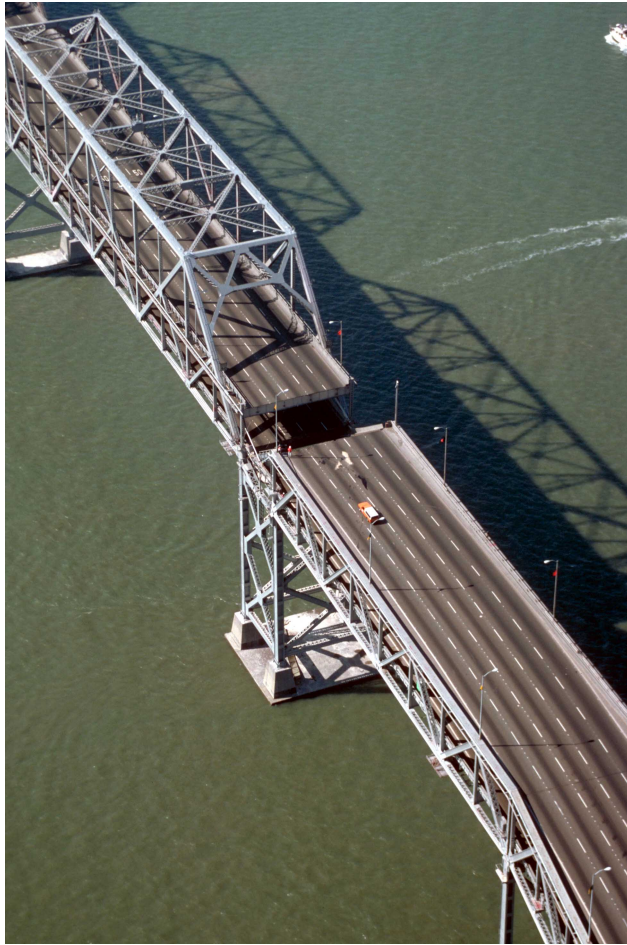
16. **Aerial view** of the collapsed section of the San Francisco-Oakland Bay Bridge. View westward. [C.E. Meyer, U.S. Geological Survey]

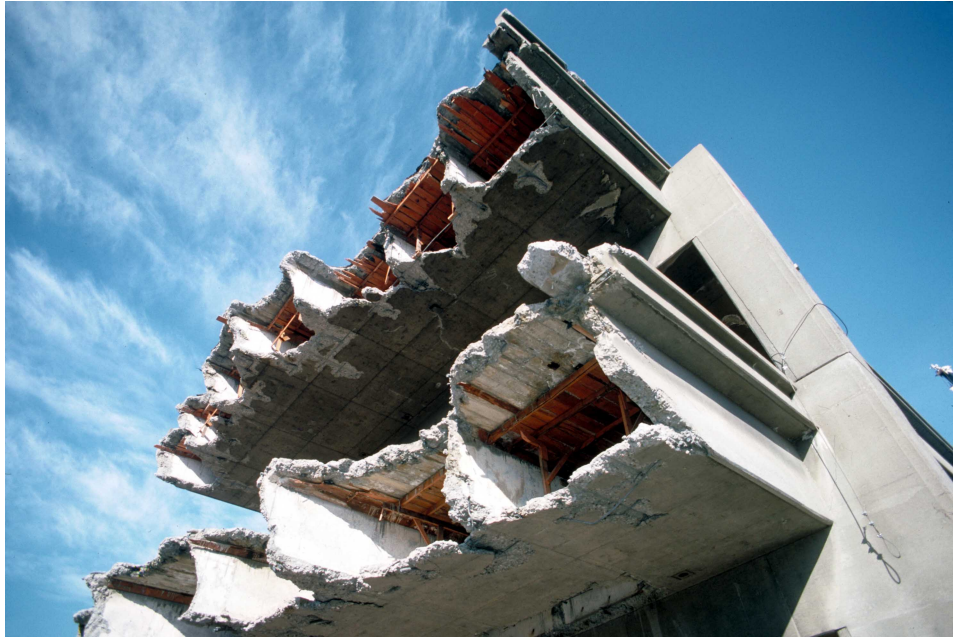
21. Remnant portion of the north- and south-bound Cypress viaduct exposing box girders near 14th Street. [J.K. Nakata, U.S. Geological Survey]

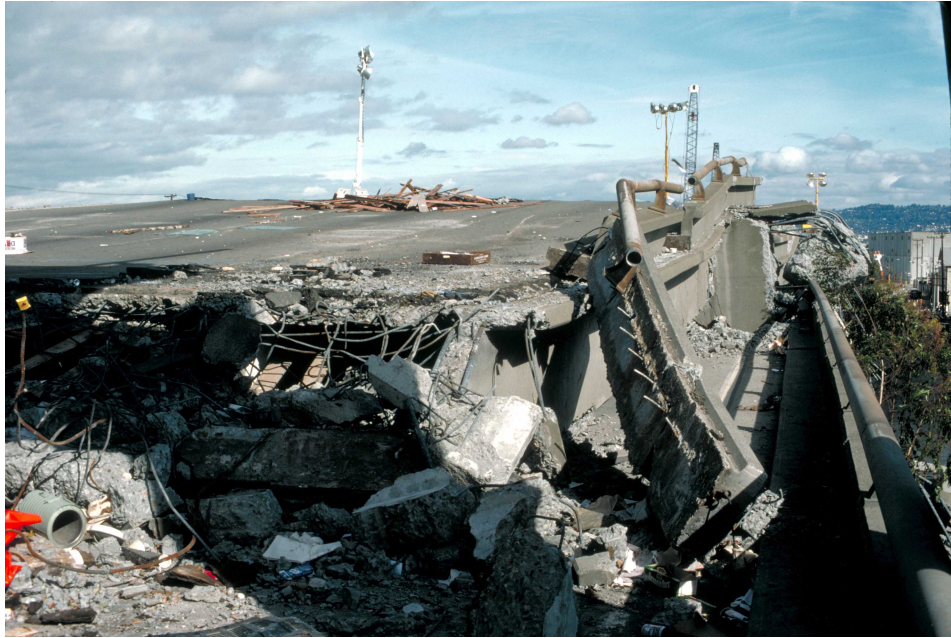
26. Pancaked upper deck, Cypress viaduct. Guard rail at right is on lower deck. [H.G. Wilshire, U.S. Geological Survey]

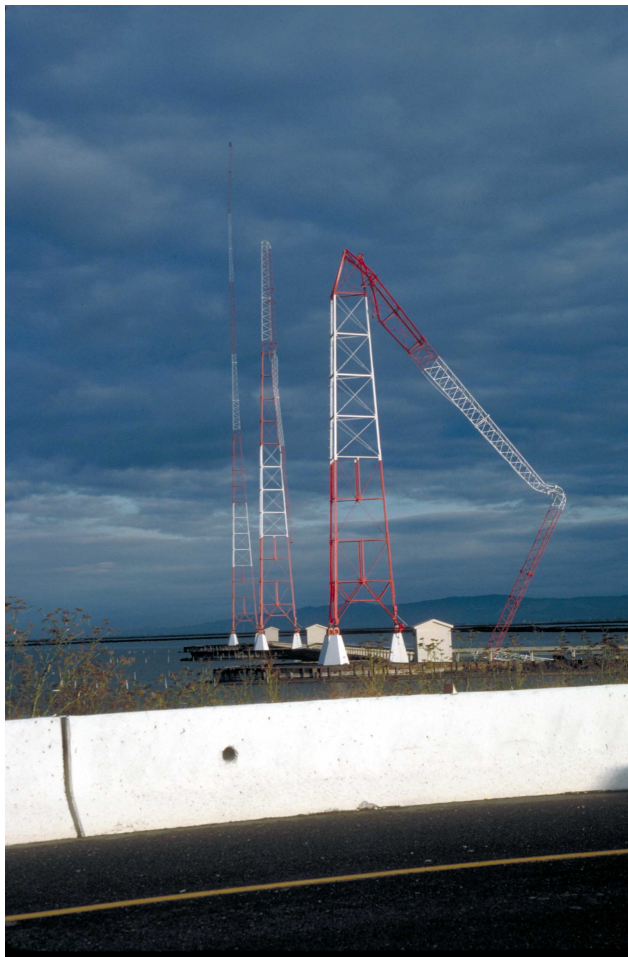
37. KGO radio transmission towers, built on *bay mud* in a salt-evaporation pond used by the Leslie Salt Company. Note progressively less damage to towers away from viewer. [H.G. Wilshire, U.S. Geological Survey]

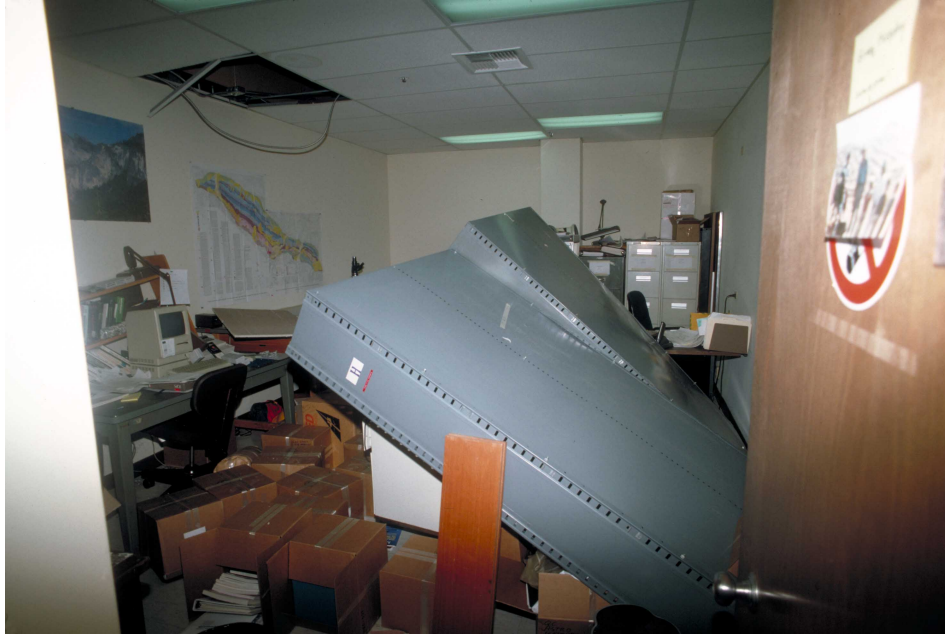
39. Unfastened bookcases in an office building fell during the primary shock. [J.K. Nakata, U.S. Geological Survey]

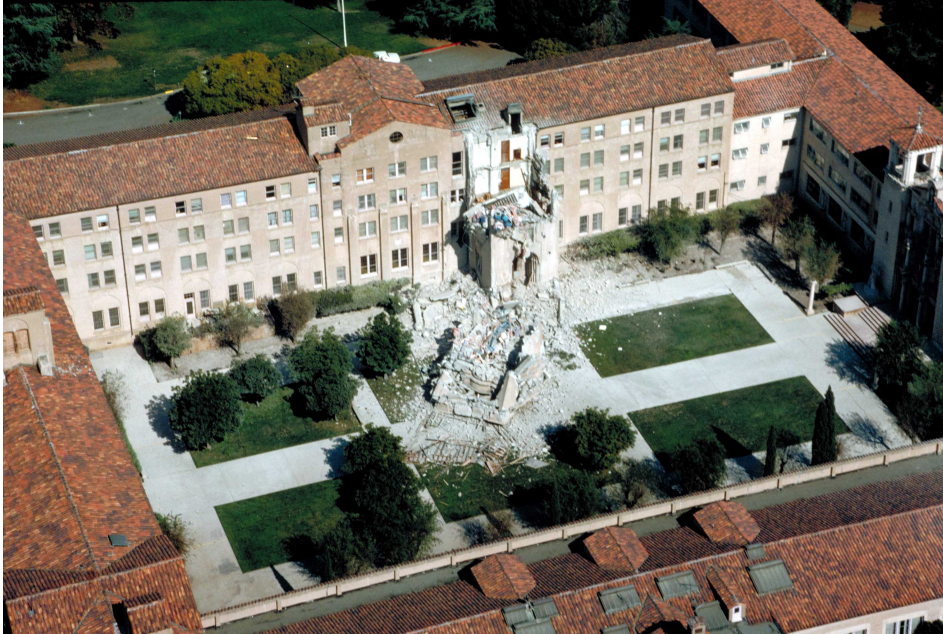
42. **Aerial view** of collapsed five-story tower, St. Joseph's Seminary. One person working in tower was killed. [H.G. Wilshire, U.S. Geological Survey]

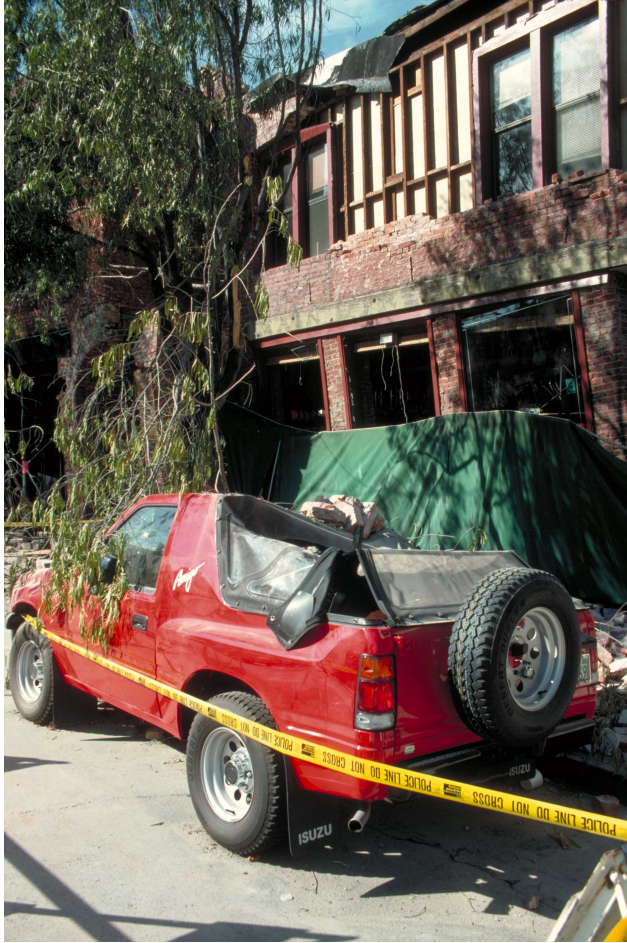
51. Vehicle crushed by collapse of unreinforced-brick masonry. [C.E. Meyer, U.S. Geological Survey]

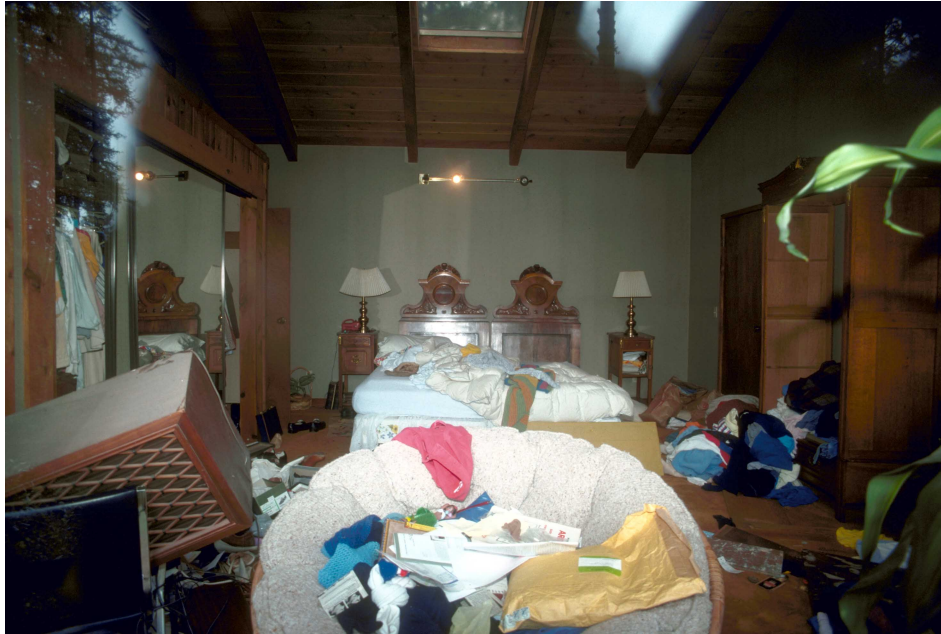
61. Bedroom showing effects of the earthquake. [J.K. Nakata, U.S. Geological Survey]

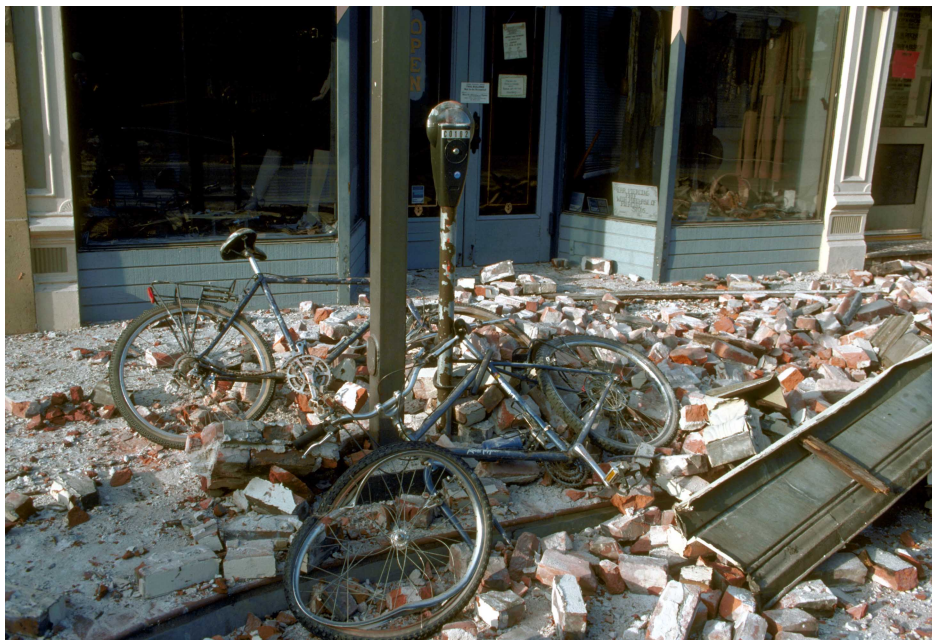
73. Bicycles crushed by falling unreinforced brick facade, Pacific Garden Mall. [C.E. Meyer, U.S. Geological Survey]

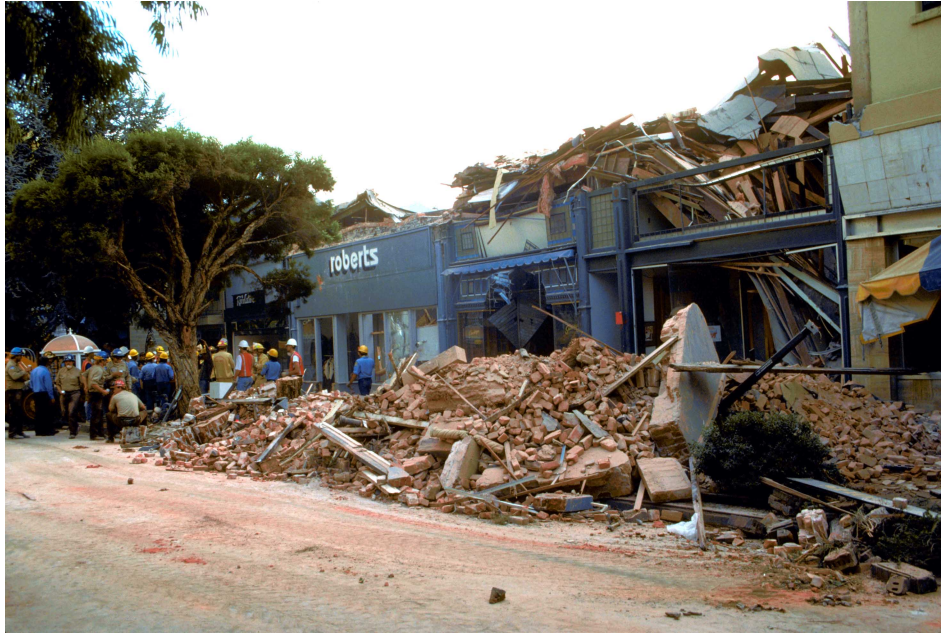
75. Rescue efforts, Pacific Garden Mall. [C.E. Meyer, U.S. Geological Survey]

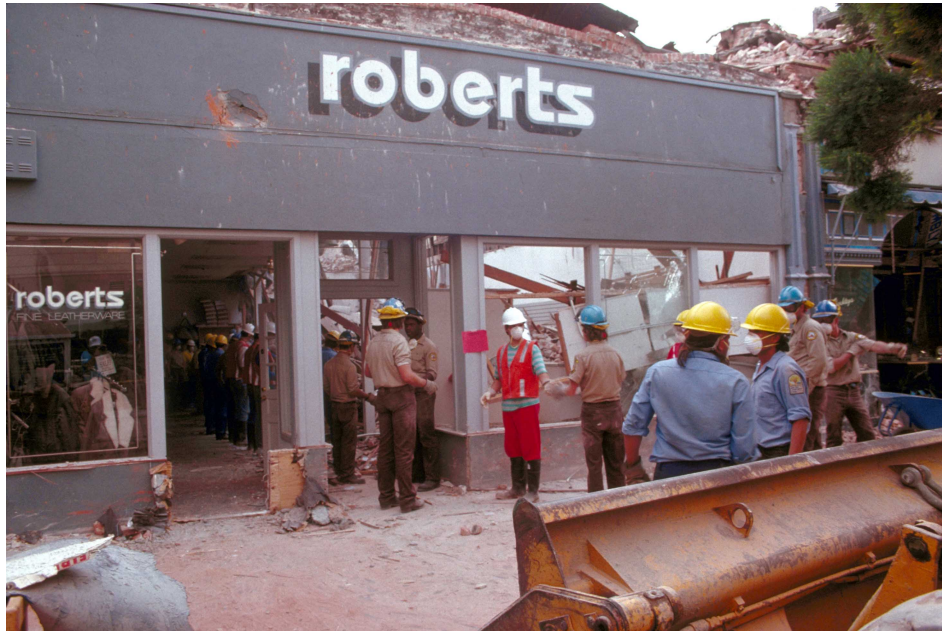
76. Removal of debris while searching for victims, Pacific Garden Mall. [C.E. Meyer, U.S. Geological Survey]
