Fire at Watts Bar Hydroelectric Plant

Rhea County, Tennessee

USFA-TR-147/September 2002

Authored by: Jennifer L. Roberson
Hollis Stambaugh

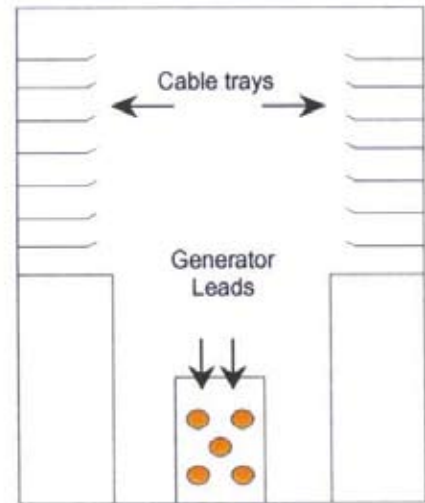
runs horizontally west from the generators for approximately 200', then runs vertically from the powerhouse to the control building and cable switchyard through a 120' shaft. The tunnels are constructed of concrete, with cable trays lining the walls on both sides of the horizontal shaft. The five generator leads are carried through a concrete conduit located on the floor in the middle of the horizontal shaft. The diagram to the right shows a cross-section of the horizontal shaft.

Cross-section of the horizontal cable shaft

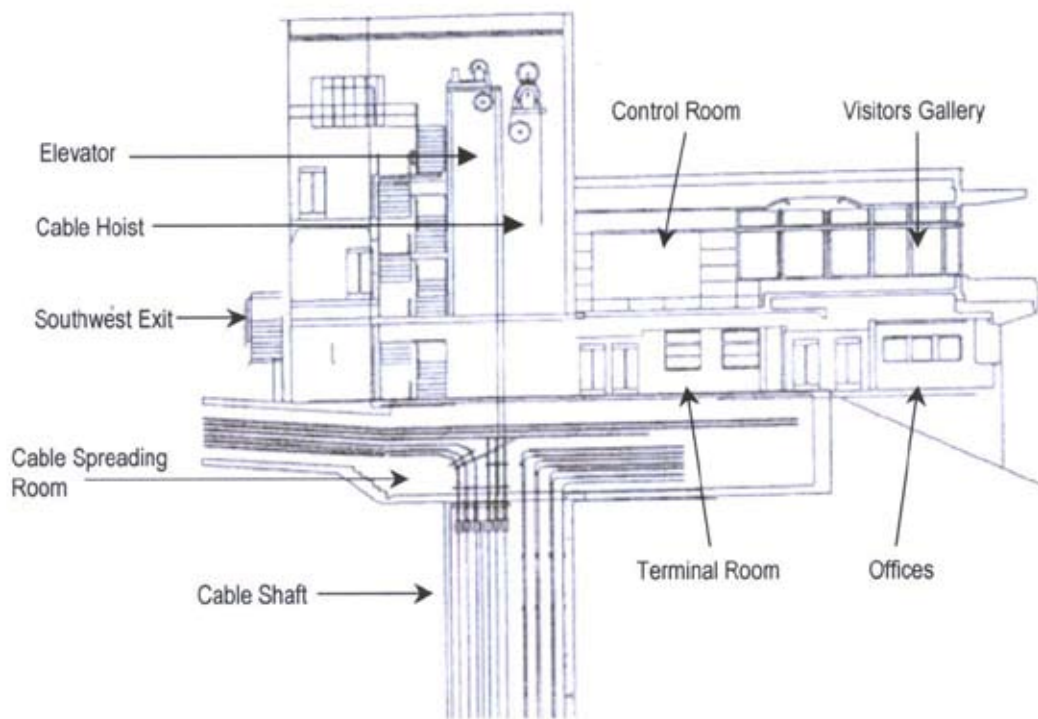
Watts Bar Hydroelectric Plant Control Building

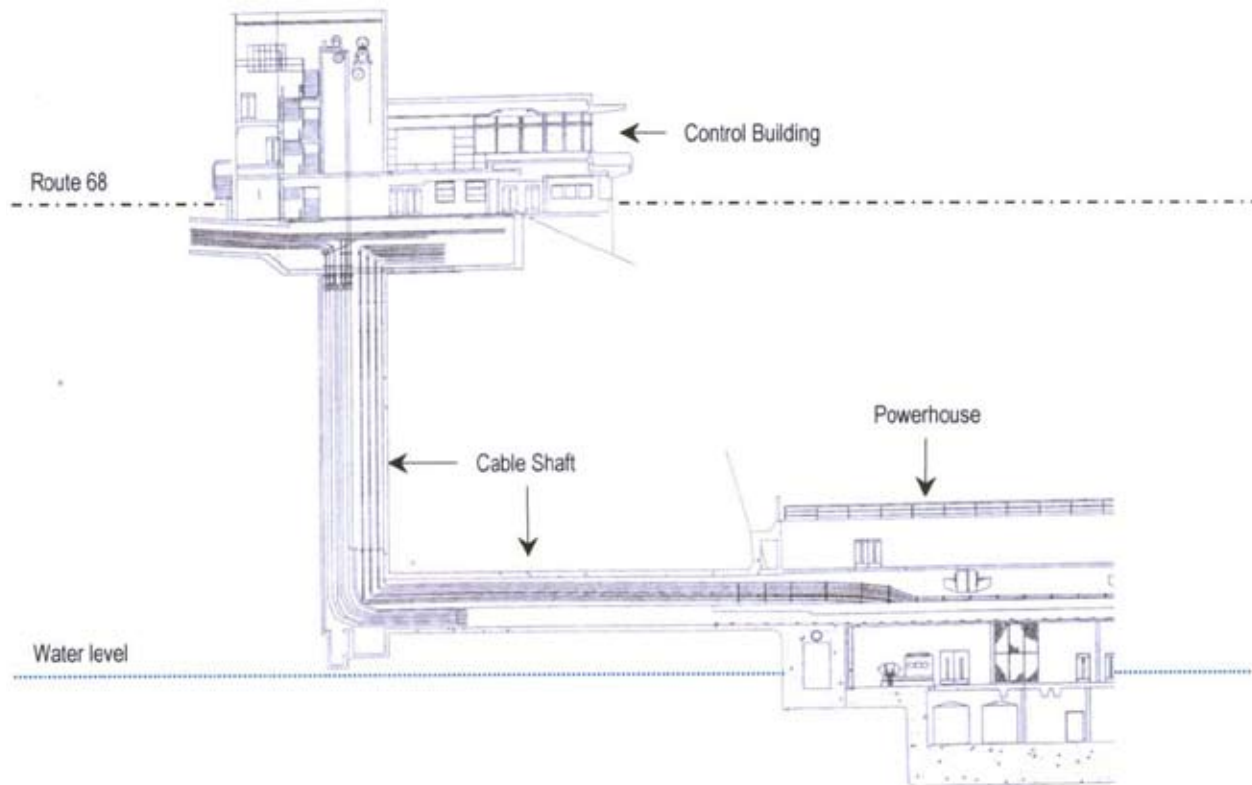
Due to the hydraulic properties of the site, a constant breeze flows from the powerhouse floor, through the cable and elevator shafts, to the control building. At a minimum, this breeze is 1/8 miles per hour—any fluctuation in wind speed outside the structure increases the velocity of the breeze. The chimney effect resulting from this natural phenomenon contributed significantly to the fire development and spread. On the day of the fire, the wind speed outside the plant was 16 mph.

Side view of the Watts Bar Hydroelectric Plant

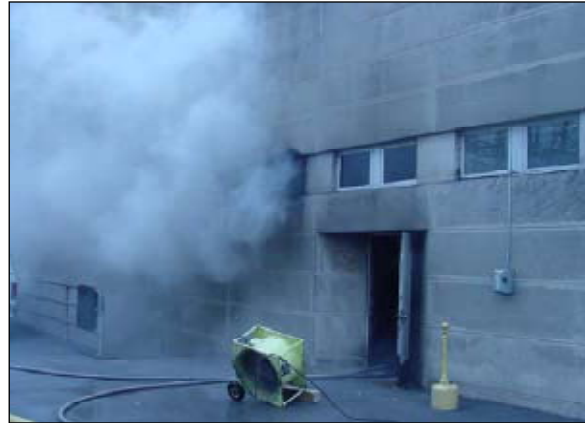
Ventilation attempt on the southwest side of the building
