Entrapment in Garage Kills One Firefighter

San Francisco, California

USFA-TR-084/March 1995

**75 Everson Street
San Francisco, California**

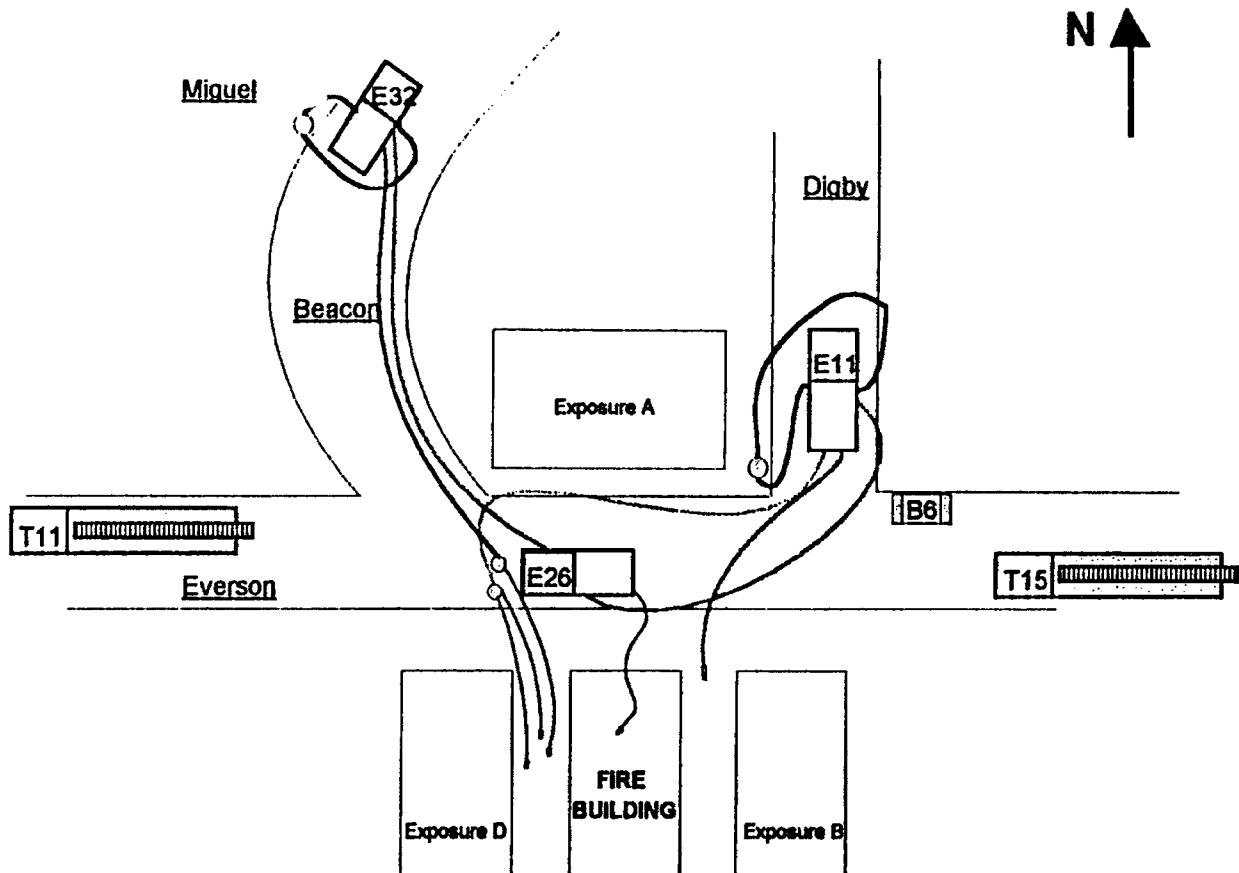
Figure 6

SFFD Engine 26 arrived on the scene at 12:59:10 and reported a “working fire.” The pump operator pulled slightly past the fire building in an effort to give his officer a look at three sides of the scene (Figure 6). A few blocks away Truck 11 had just gone back in service from another call and heard the Engine 26 report. Truck 11 told the Communications Center that they would respond to 75 Everson Street.
