Appendix 2. Pre- and post-test documentation

Turtle #1 – Pre-test documentation
 MXH20060301-01

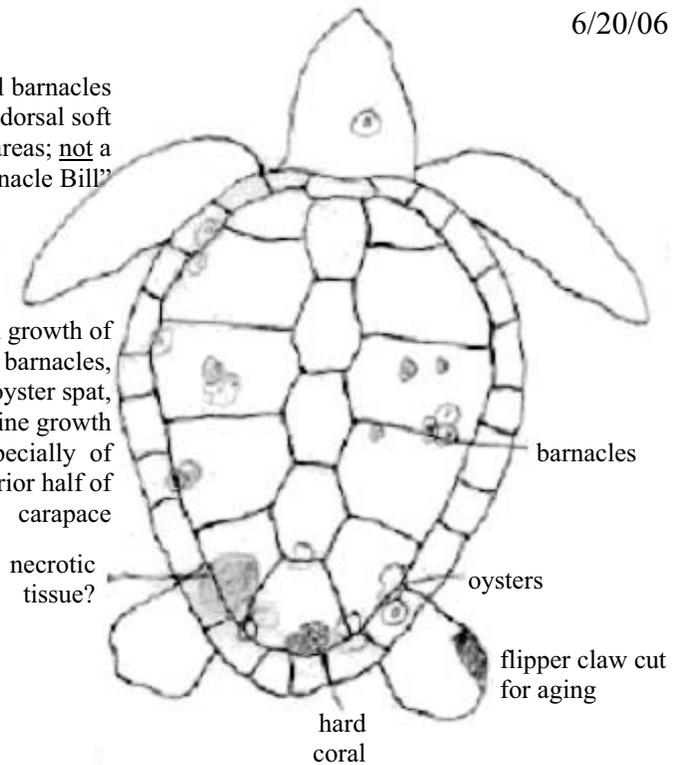
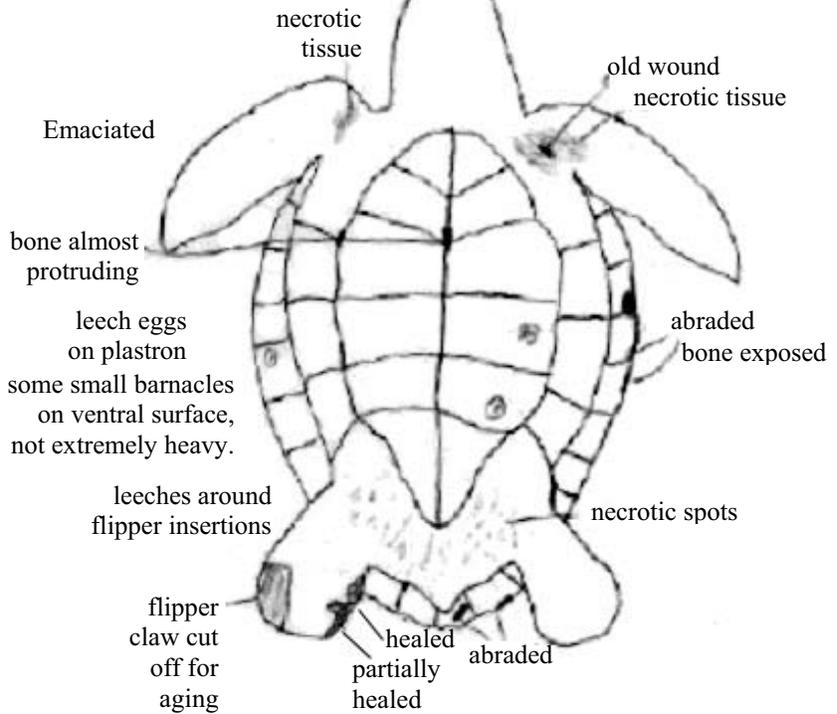
Much growth of
 small barnacles,
 algae, oyster spat,
 other marine growth
 – especially of
 posterior half of
 carapace

Tow #6 (see diagrams):
Abrasions on L & R side marginals,
both dorsal and ventral. Crack in
bone in left side marginals, only
visible ventral. Abraded to bone
on RC #4.

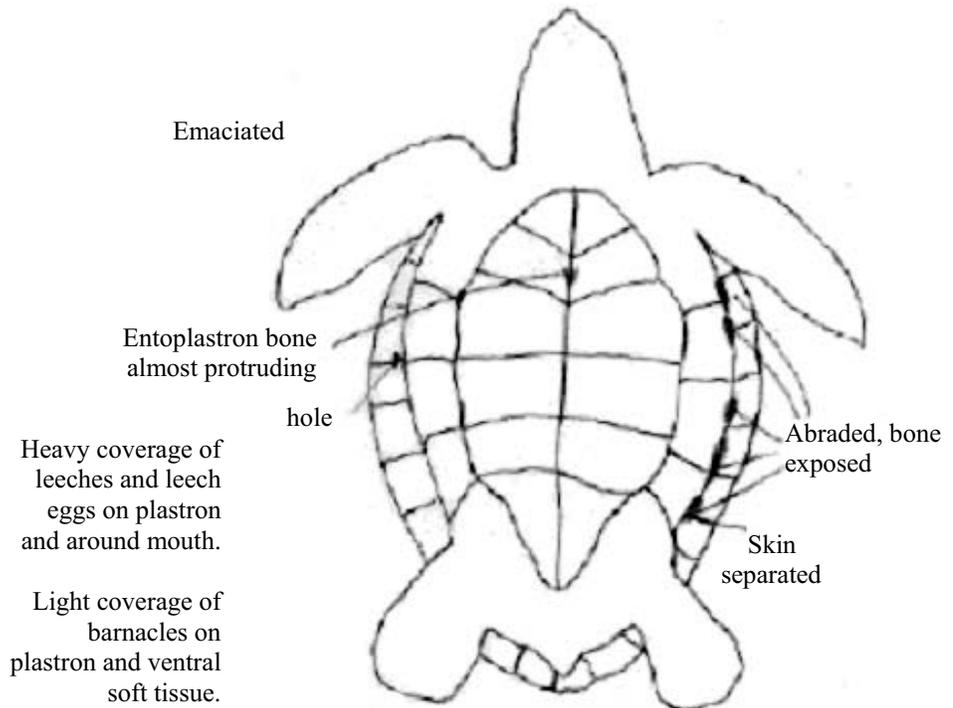
Tow #10

Scutes abraded from dorsal surfaces of both front flippers and R rear flipper.

Separation/hole larger between L marginals and LC #2. Hole between R marginals. RC #2 scute gone/abraded on R posterior marginal and minor on R side marginals. Bone exposed (skin abraded) on posterior carapace where scute was missing previously.
