Report No. FHWA-RD-78-162

COUNTERMEASURES FOR HYDRAULIC PROBLEMS AT BRIDGES

Vol. I Analysis and Assessment

September 1978
Final Report

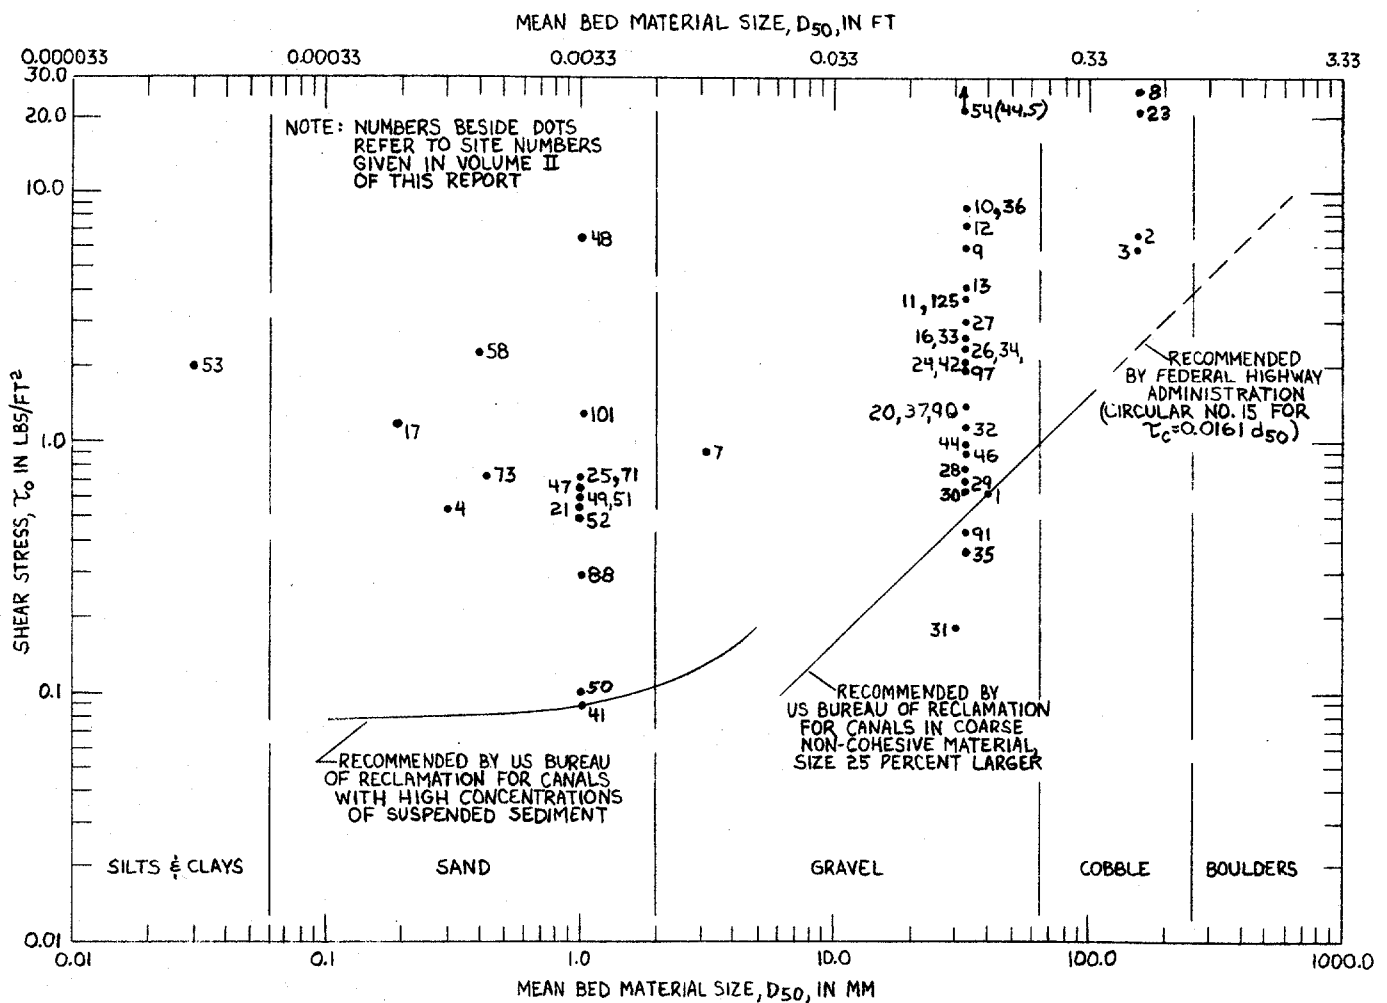
Figure 42. Relation of shear stress to bed material at selected bridge sites.

The relation of shear stress to bed material size in natural channels at selected bridge sites is shown in figure 42. Numbers on the plot refer to the case history site number (table 31). At several sites, the median particle size (D_{50}) has been determined. For most sites, the median diameter of the bed material is unknown, and plotting positions were placed at the midpoint of the size (sand, gravel, or other) classification. The shear stress (τ_o) was obtained from table 31, and in instances where shear stresses were determined for several floods, only the maximum value was used in figure 42.

Analysis of figure 42 indicates that the bed shear stress at almost all sites exceeds the critical shear stress (τ_c) criteria developed by the U.S. Bureau of Reclamation (1962) and the Federal Highway Administration (1974) for stable channel conditions. This situation is the result of several factors such as:

1. Most bridge sites included in the study had a history of hydraulic problems representative of unstable channel boundaries.

2. In many cases, shear stresses were computed for channel conditions and large flood events with high recurrence intervals.
3. The shear stresses were calculated assuming uniform flow instead of varied or unsteady flow conditions.
4. The size of bed material observed at a site may represent material deposited during low flow conditions. With higher flows, the smaller material generally moves into suspension, leaving coarser bed material which is more resistant to erosion and higher shear stresses. This condition is known as armoring.
5. The criteria in use for estimating stable channel conditions are based on average conditions and may not consider adequately such flow factors as high velocities that occur near the channel bed during floods.

One of the difficulties in applying the critical shear stress relations (fig. 42) to the design of stable channels is the lack of definition of these relations for higher values of shear stress that apparently occur in natural stream channels.

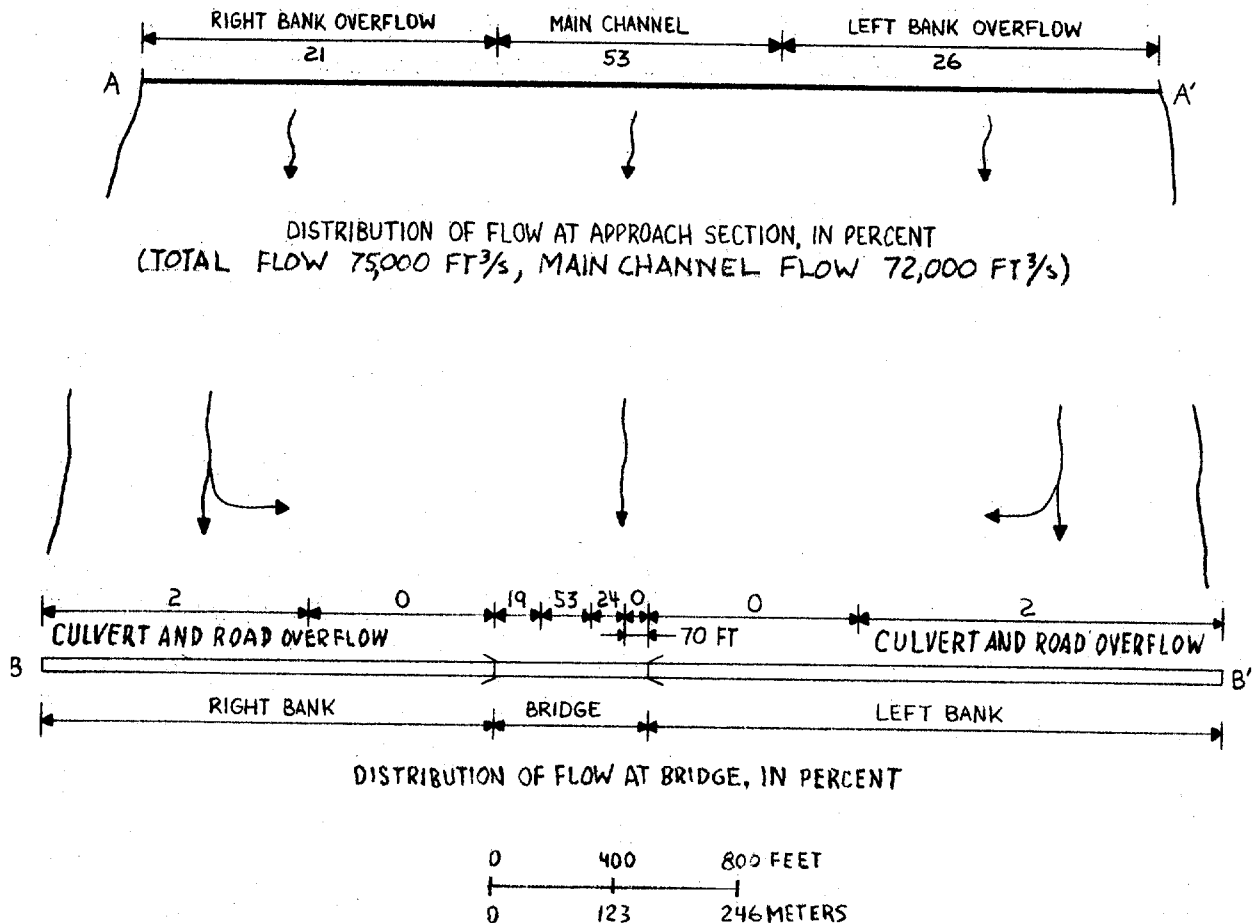
Figure 43. Distribution of flow, Fourche La Fave River at SR-28 crossing near Bluffton, Ark. (Site 46) during flood of December 10, 1971.

The case history for Fourche La Fave River at SR-28 near Bluffton, Ark., (site 46) provides data illustrating the effects of a bridge constriction on overbank flow. Flooding in December 1971 inundated the flood plain on both banks of the main channel (J. N. Sullivan, written commun., 1972). During this flood (discharge $75,000 \text{ ft}^3/\text{s}$), serious bank scour occurred on the left bank about 35 ft (11 m) upstream from the bridge. This scour is attributed partly to return flow from the left bank flood plain and partly to main channel flow deflected toward the left bank by a bend in the river upstream from the bridge. The distribution of flow through the bridge during the December 1971 flood indicates that flow from the left-bank flood plain occupied 150 ft (49 m) of the 504-ft (154-m) long bridge opening. Also, because of poor flow alignment at the junction of the left-bank overflow and main channel flow near the left-bank abutment, about 70 ft (21 m) of the bridge opening on the left bank (not part of the 150 ft) was not used to transfer flows downstream (fig. 43).

Bank erosion also occurred downstream from the bridge constriction. Approximately 43 percent of the total flow was forced to leave the flood plain and pass through the bridge constriction. As a result, flows formerly on the flood plain and temporarily constricted at the bridge could not be contained in the main channel and subsequently re-entered the flood plain downstream from the bridge on both banks of the stream. Local areas of bank erosion at the points of re-entry then occurred.

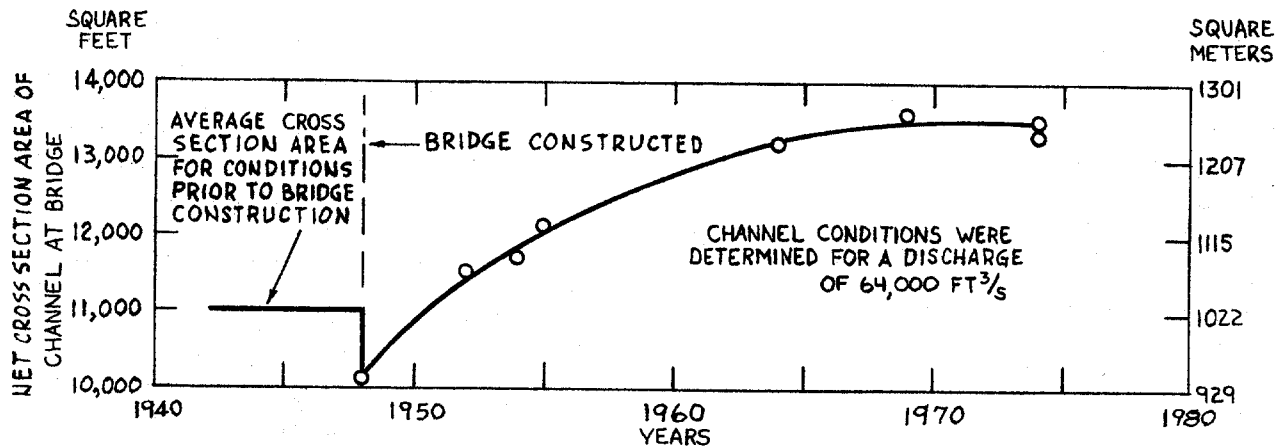
Figure 44. Variation in net channel area before and after bridge construction, Sacramento River at SR-162 at Butte City, Calif.

The limit of channel scour may not have been reached (table 33) by 1974. The cross-sectional area showed signs of stabilizing (fig. 44), but the maximum depth of scour below the 1946 channel bed (which is greater than the average depth of scour in table 32) was still increasing in 1974. Coarse bed material may have acted as an armor and restricted the amount of scour. Also, several floods occurred after construction of the bridge. Annual floods exceeding 64,000 ft³/s (1,812 m³/s) occurred five times during the 7-year period after construction of the bridge.

A countermeasure that may be used to stabilize a channel subject to extensive scour caused by large piers in the waterway is the placement of rock riprap on the streambed (sites 17 and 124).

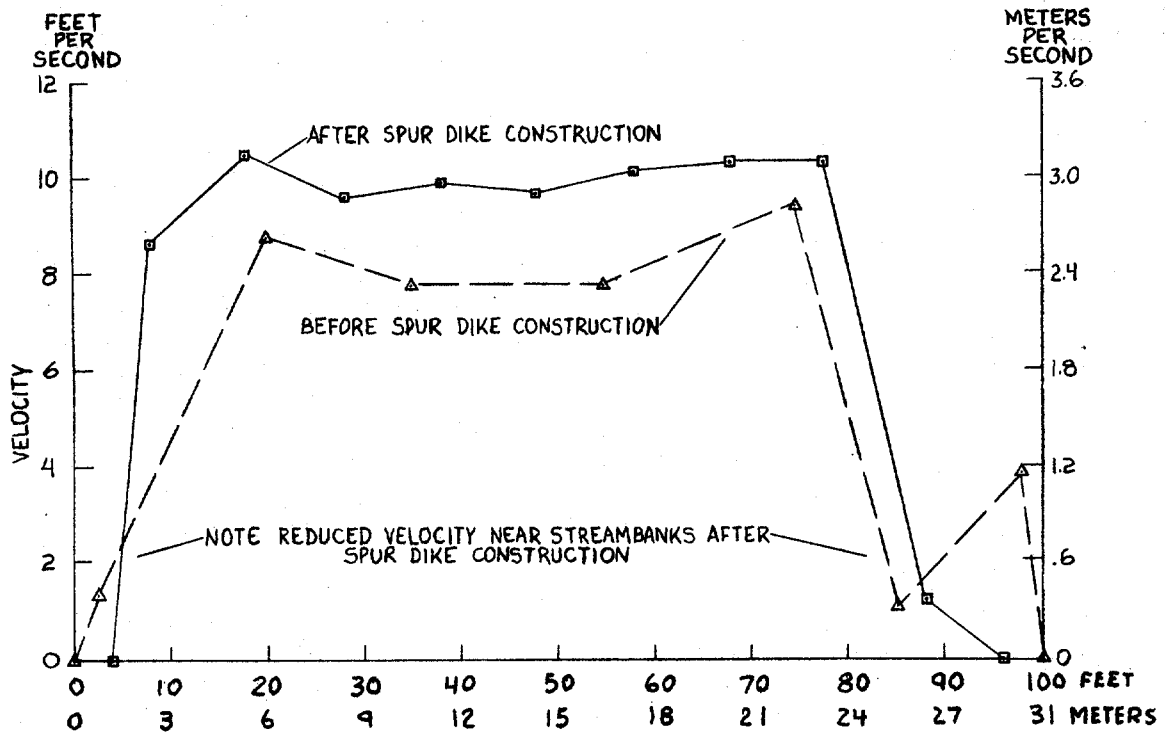
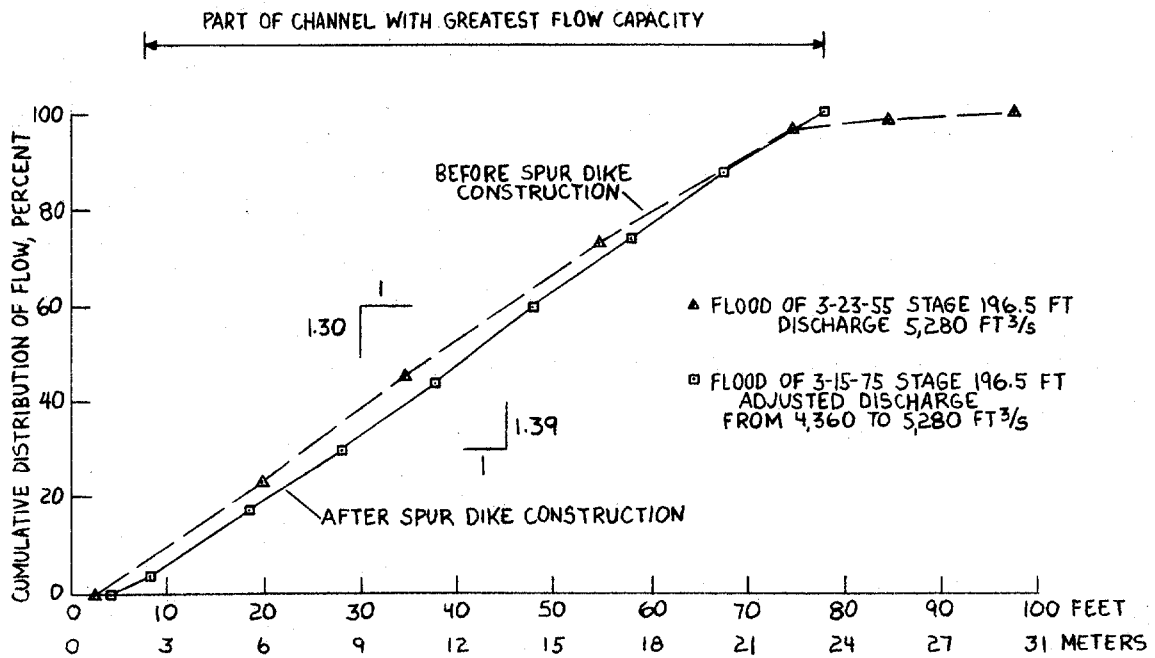
Figure 46. Improvement in flow distribution and velocity in bridge waterway after construction of spur dikes, Tombigbee River relief bridge 2 near Aberdeen, Miss. (Site 41).

Data obtained at the site during floods in 1955 and 1975 illustrate the effectiveness of spur dikes in improving flow conditions at a bridge waterway (fig. 46). Discharge measurements of floods on March 23, 1955 (discharge, 5,280 ft³/s or 147 m³/s), and March 15, 1975 (discharge, 4,360 ft³/s or 122 m³/s), were used to compare flow patterns before and after construction of spur dikes. For the comparison, measured velocities of the March 1975 measurement, which had the same water-surface elevation as the March 1955 measurement, were adjusted by increasing the incremental flow velocities in proportion to the difference in discharge of the two measurements.

Prior to construction of spur dikes at both abutments, the discharge per unit of width in the center part of the bridge waterway was 68.8 ft³/ft (6.4 m³/m). After spur dike construction late in 1973, data obtained during the March 1975 flood showed the discharge per unit of width in the center part of the waterway increased to 73.4 ft³/ft (6.8 m³/m), indicating improved hydraulic efficiency of the bridge opening. Associated with the improved conditions, flow velocities within about 5 ft (1.5 m) of the bridge abutments were about 2 ft/s (0.6 m/s) (fig. 46). To summarize, the spur dikes increased the flow capacity of the bridge and decreased the potential for scour at the abutment.

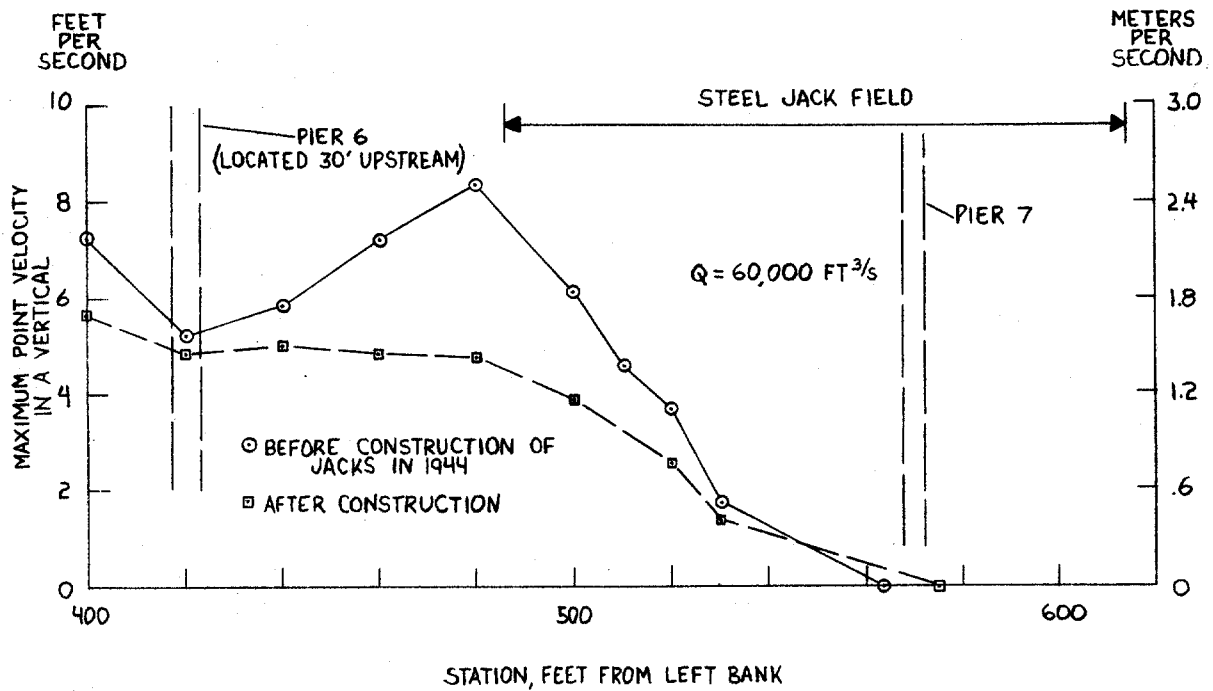
Figure 47. Effect of steel jacks on velocity of flow near the right bank, Colorado River, US-90 at Columbus, Tex. (Site 133).

In 1944, 250 steel jacks were placed on the right bank of the Colorado River at the US-90 crossing at Columbus, Texas (site 133) to prevent further lateral erosion and eventual damage to the bridge abutment. The effect of the jack field is illustrated by the significant reduction in maximum flow velocities near the right bank (fig. 47). For a discharge of 60,000 ft³/s (1,699 m³/s), the maximum flow velocity between piers 6 and 7 was reduced from

8.4 ft/s (2.6 m/s) to 5 ft/s (1.5 m/s). Field surveys at the site between 1944 and the mid-1970's indicate the jack field has been effective in preventing further bank erosion, and suspended material is depositing in the jack field causing restoration of the bank.
