**Federal Building and Fire Safety Investigation of the  
World Trade Center Disaster**

**Final Report of the  
National Construction Safety Team  
on the Collapses of the  
World Trade Center Towers (Draft)**

September 2005

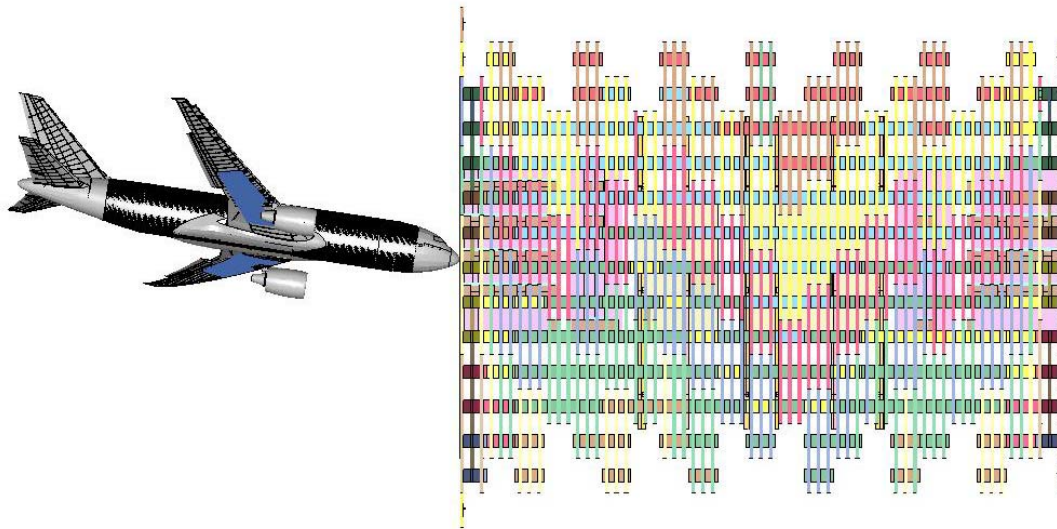
At 8:46:30 a.m. EDT, five hijackers flew American Airlines Flight 11 (AA 11) with 11 crew and 76 passengers into the north face of WTC 1 (Figure 2–1).

**Figure 2–1. Simulated impact of American Airlines Flight 11 with WTC 1.**

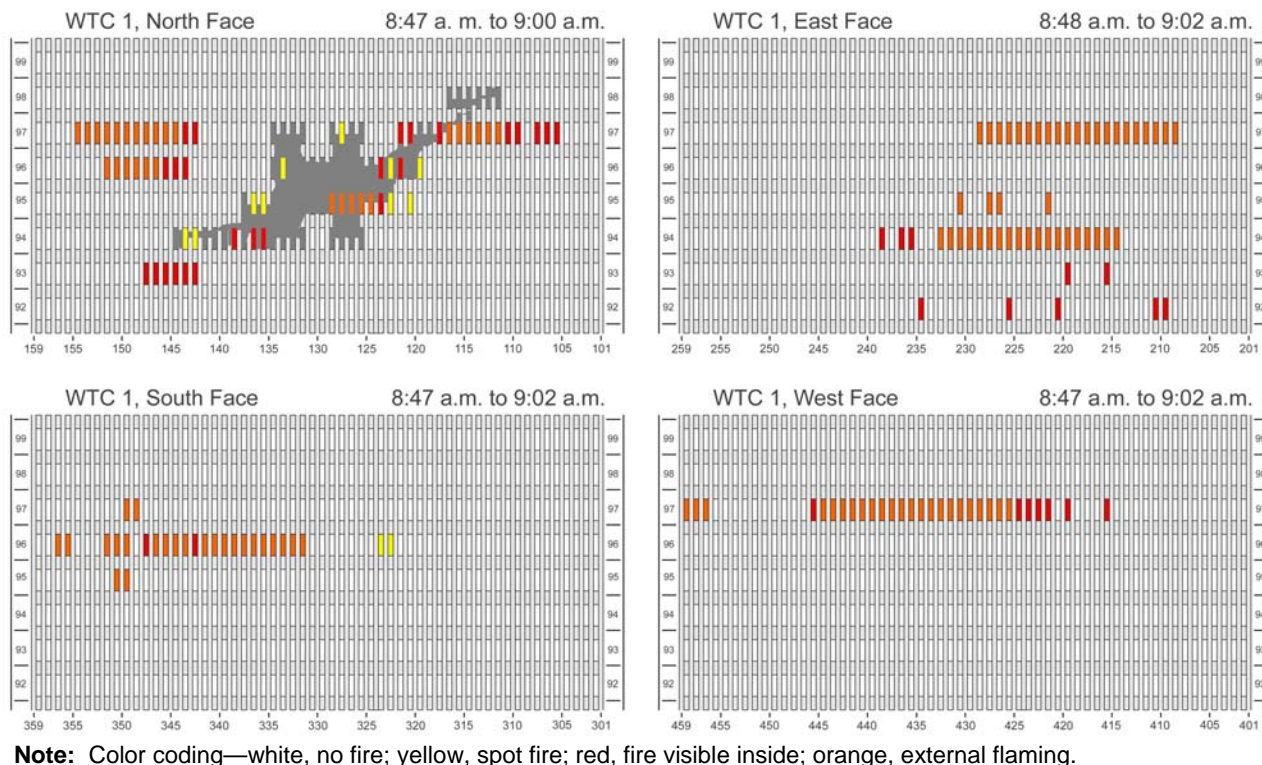
The burning of the jet fuel cloud had consumed much of the oxygen within the 94<sup>th</sup> and 96<sup>th</sup> floors, although photographs showing survivors indicated there were some zones with breathable air. The oxygen-starved fires died down, but didn't quite go out. Within the first 2 min after the impact, fires could be seen in the north side windows on the 93<sup>rd</sup> through 97<sup>th</sup> floors, the 96<sup>th</sup> floor of the south face, and the 94<sup>th</sup> floor of the east face. As fresh air entered the perforated facades, there began the steady burning of the office furnishings and the 13 tons of combustibles from the aircraft that would eventually overwhelm the already damaged building. By 9:00 a.m., these fires had grown and spread to the extent shown in Figure 2-5. In addition to burning around the aircraft entrance hole, there was intense burning on the north, east, and west faces of the 97<sup>th</sup> floor. Large fires burned on the south side of the 96<sup>th</sup> floor and the east side of the 94<sup>th</sup> floor. At 8:52 a.m., a stream of smoke emerged from the south side of the 104<sup>th</sup> floor, although there was no evidence of a significant fire there yet.

There was no way to fight the fires. The piping providing the water supply to the automatic sprinklers had been broken, and water was flowing down the stairwells. Even had this not happened, the system was designed to supply water to about 8 sprinkler heads at one time, enough to control the flames from as much as 1,500 ft<sup>2</sup> of burning material. The water supply was likely sufficient to control fires up to triple that size. The fires, however, had already grown far larger than that.

**Figure 2-5. Representation of exterior views of the fires on the four faces of WTC 1 from 8:47 a.m. to about 9:02 a.m.**

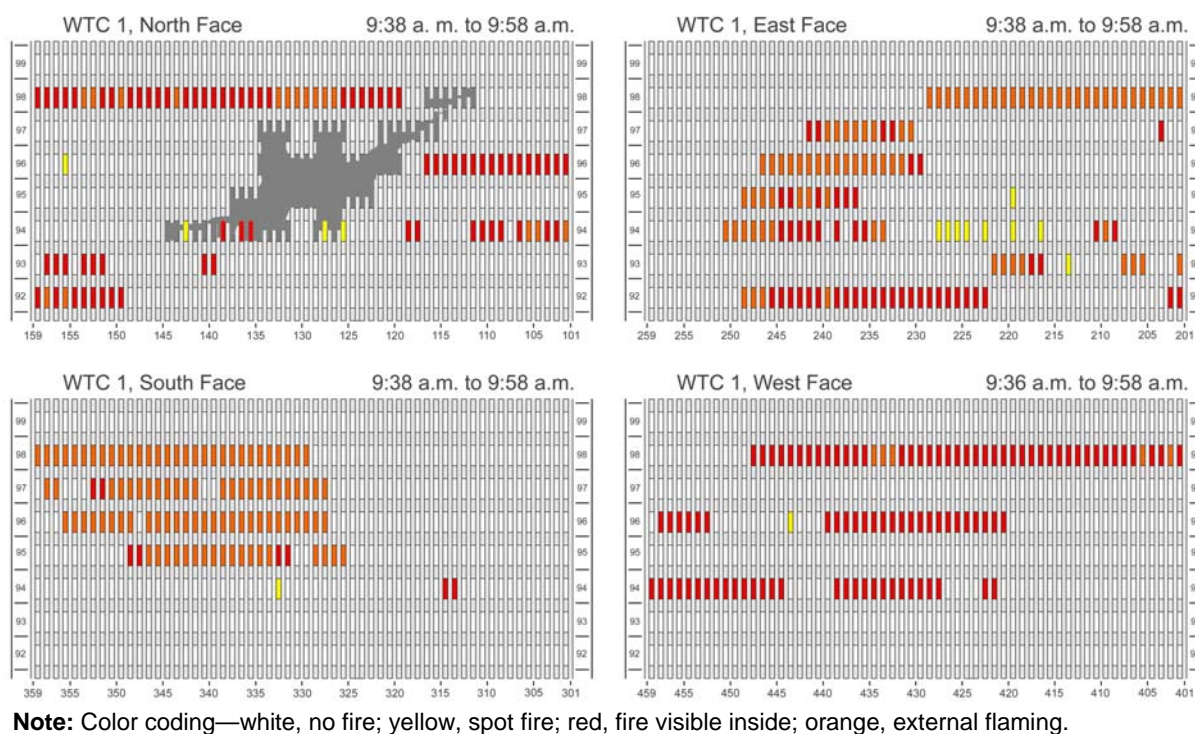
Seventy-five minutes after the impact, approaching 10:00 a.m., the fire on the 97<sup>th</sup> floor had begun to burn itself out, but the fire on the 94<sup>th</sup> floor had intensified and filled much of the north half of the floor (Figure 2–7). Starting about 9:30 a.m., there were vigorous fires on nearly the full perimeter of the 98<sup>th</sup> floor. There was still almost no burning on the 99<sup>th</sup> floor or above.

**Figure 2–7. Representation of exterior views of the fires on the four faces of WTC 1 from about 9:38 a.m. to 9:58 a.m.**

The hot smoke from the fires now filled nearly all the upper part of the tenant space on the impact floors. Aside from isolated areas, perhaps protected by surviving gypsum walls, the cooler parts of this upper layer were at about 500 °C, and in the vicinity of the active fires, the upper layer air temperatures reached 1,000 °C. The aircraft fragments had broken through the core walls on the 94<sup>th</sup> through the 97<sup>th</sup> floors, and temperatures in the upper layers there were similar to those in the tenant spaces.

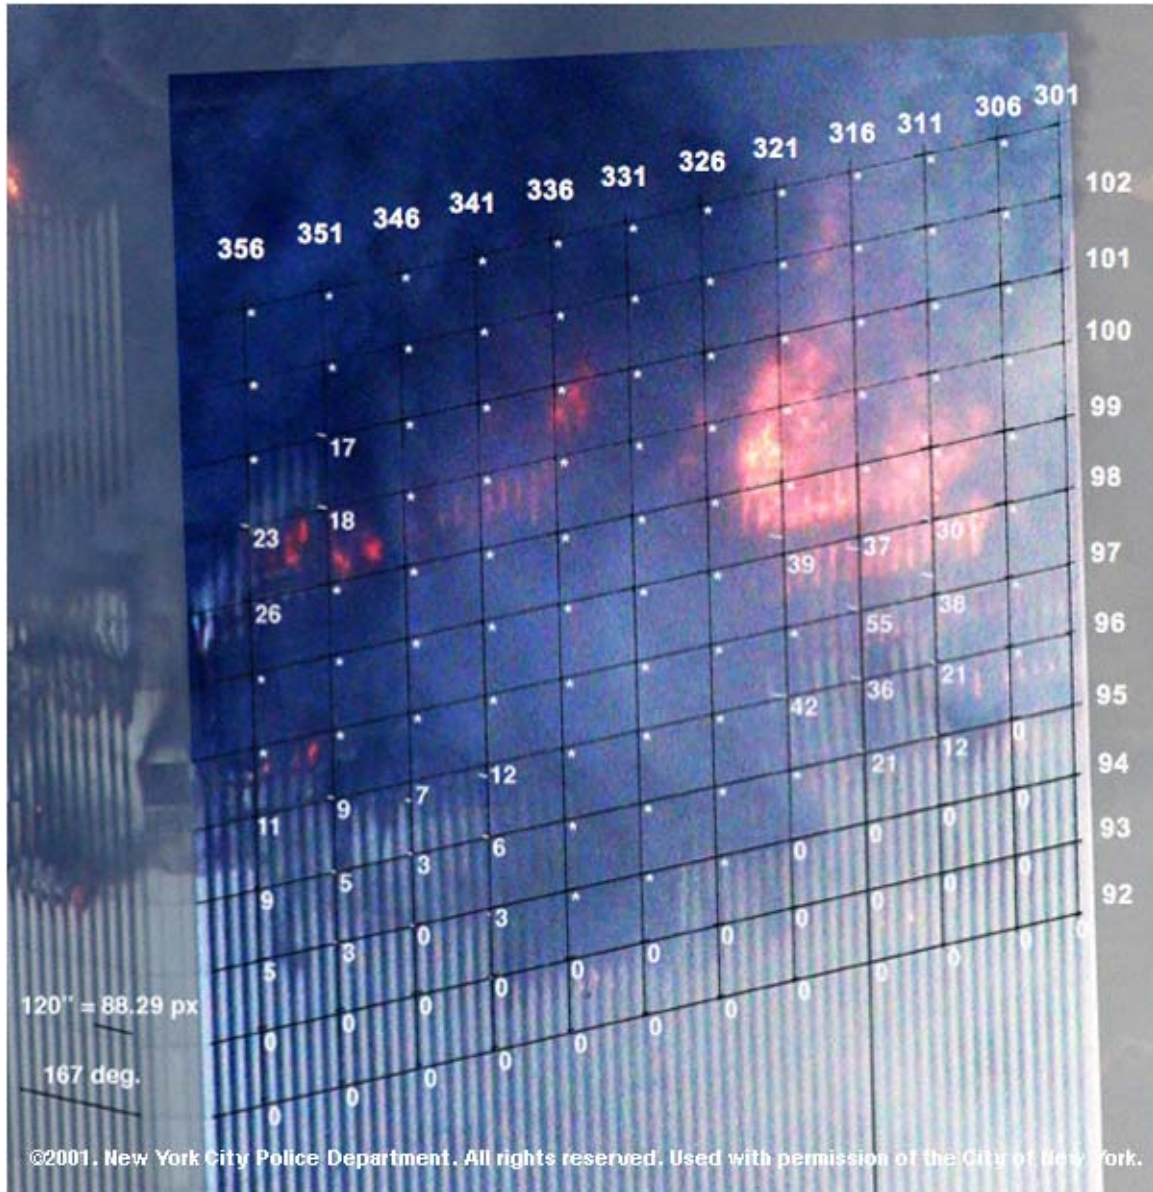
The tower was being overwhelmed. Three of the four major structural systems—the core, the floors, and the perimeter walls—were weakening. The south wall became unstable and tried to transfer its remaining load to the weakened core via the hat truss and to adjacent perimeter columns via the spandrels. The entire section of the building above the impact zone began tilting as a rigid block toward the south. The upper section of the building then collapsed onto the floors below. Within 12 s, the collapse of WTC 1 had left nothing but rubble.

Figure 2-12. South face of WTC 1 at 10:23 a.m., showing inward buckling (in inches) of perimeter columns.

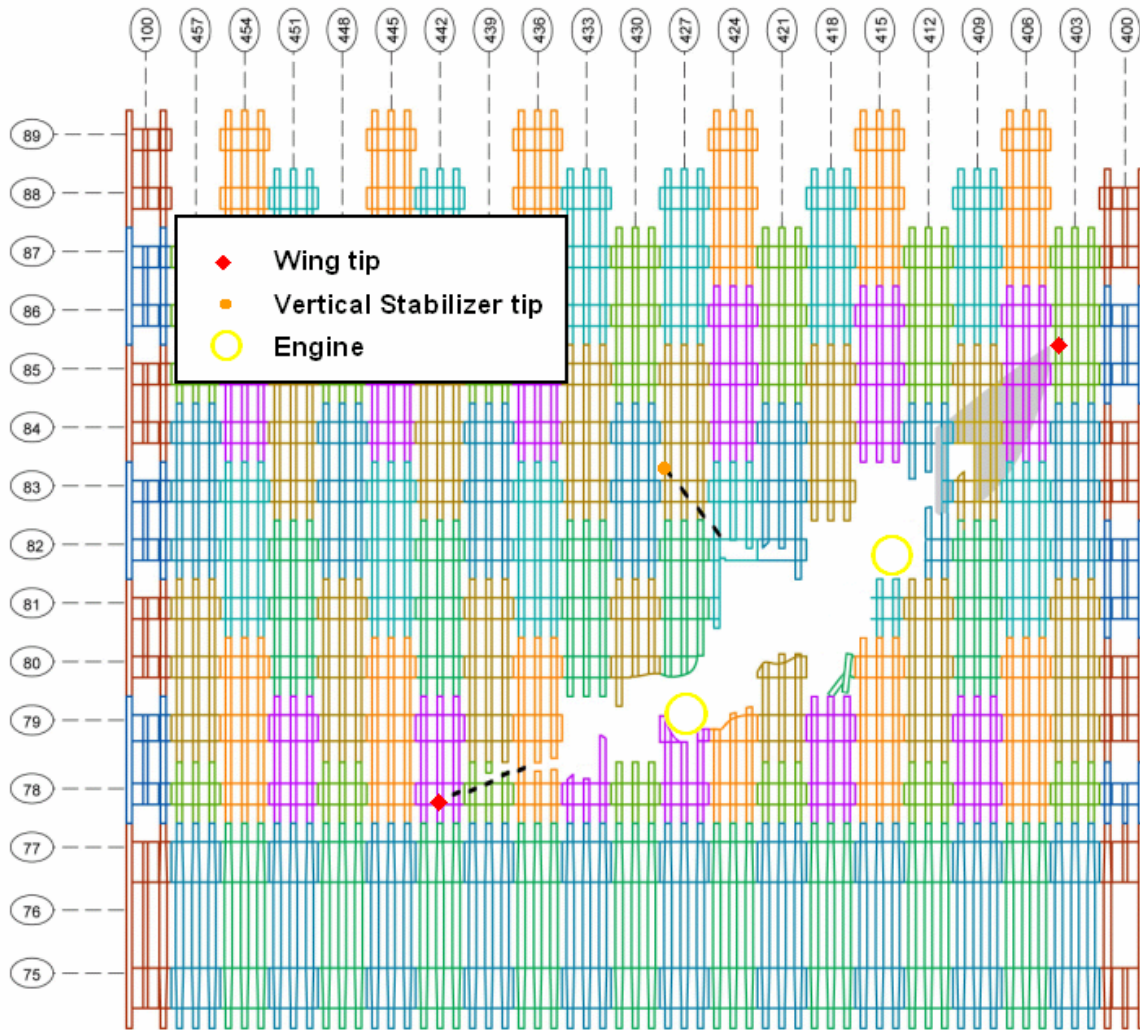
The center of the nose of the plane struck at the 81<sup>st</sup> floor slab. The plane was banked 38 degrees to the left (right wing upward) and was heading slightly (6 degrees) downward from the horizontal. Since the bank angle was steeper than that of AA Flight 11, this entry wound stretched over nine floors, from 77 to 85, rather than eight in WTC 1 (Figure 3–2). The occupancy of those floors is shown in Table 3–1.

Damage in shaded area cannot be accurately determined.

**Figure 3–2. South face damage of WTC 2 with key aircraft component locations marked.**

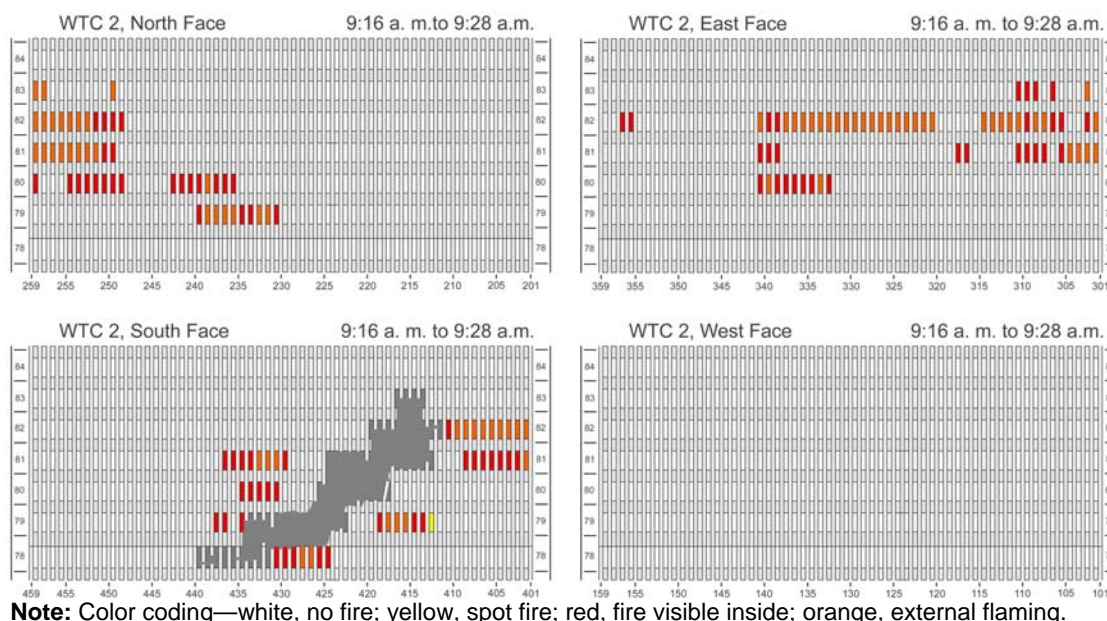
For the next half hour, small fires were burning in and near the aircraft impact cavity on the south side of the building. There were vigorous fires on the east side of the 80<sup>th</sup> through 83<sup>rd</sup> floors (Figure 3–4), especially on the northeast end of the 81<sup>st</sup> and 82<sup>nd</sup> floors, where the aircraft had bulldozed the office desks and chairs and added its own combustibles. In addition to the ample supply of fuel, these fires had access to plenty of air, as numerous windows on the east face had been blown out by the impact or fireball. They would continue to burn as long as the building stood.

**Figure 3–4. Representation of exterior views of the fires on the four faces of WTC 2 at about 9:20 a.m.**

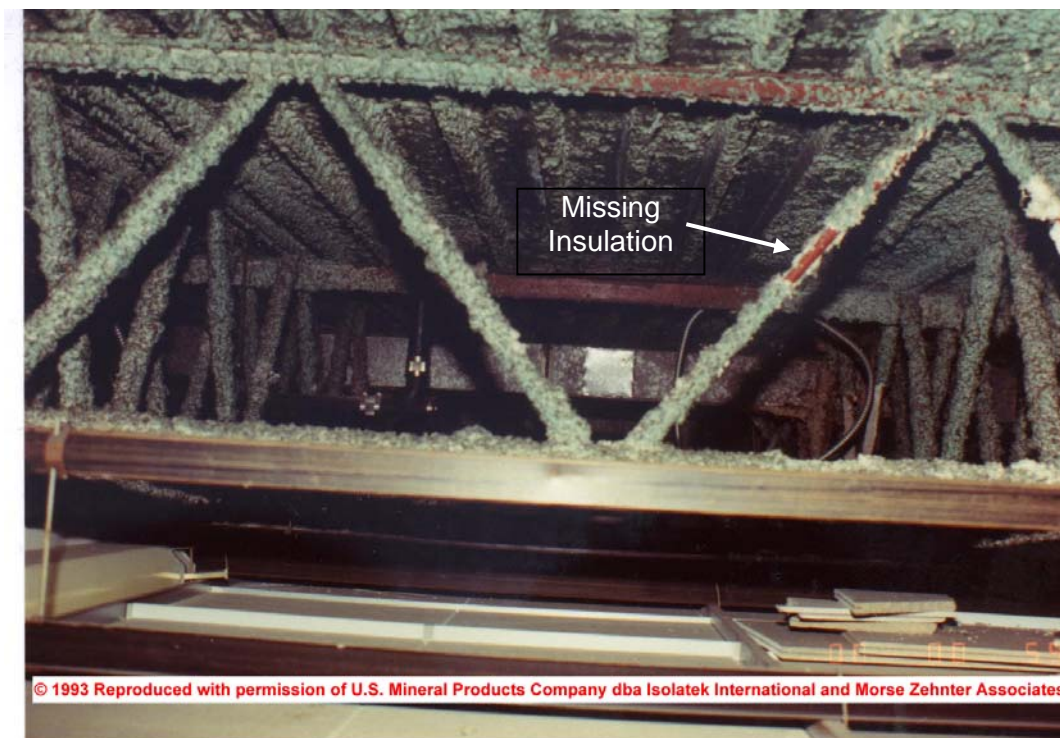
In 1994, The Port Authority measured the SFRM thickness on trusses on floors 23 and 24 of WTC 1. In all, average thicknesses were reported for 32 locations, and the overall average thickness was found to be 0.74 in. NIST performed a further evaluation of the SFRM thickness using photographs taken in the 1990s of floor trusses on (non-upgraded) floors 22, 23, and 27 of WTC 1 (Figure 5–5). By measuring dimensions on the photographs, NIST estimated the insulation thicknesses on the diagonal web members of trusses. (The thickness of chord member insulation could not be measured.) The average thickness and standard deviation of web members was 0.6 in. ± 0.3 in. on the main trusses, 0.4 in. ± 0.25 in. on the bridging trusses, and 0.4 in. ± 0.2 in. on the diagonal struts. These numbers indicated that there were areas where the coating thickness was less than the specified 0.5 in.

**Figure 5-5. Irregularity of coating thickness and gaps in coverage on SFRM-coated bridging trusses.**

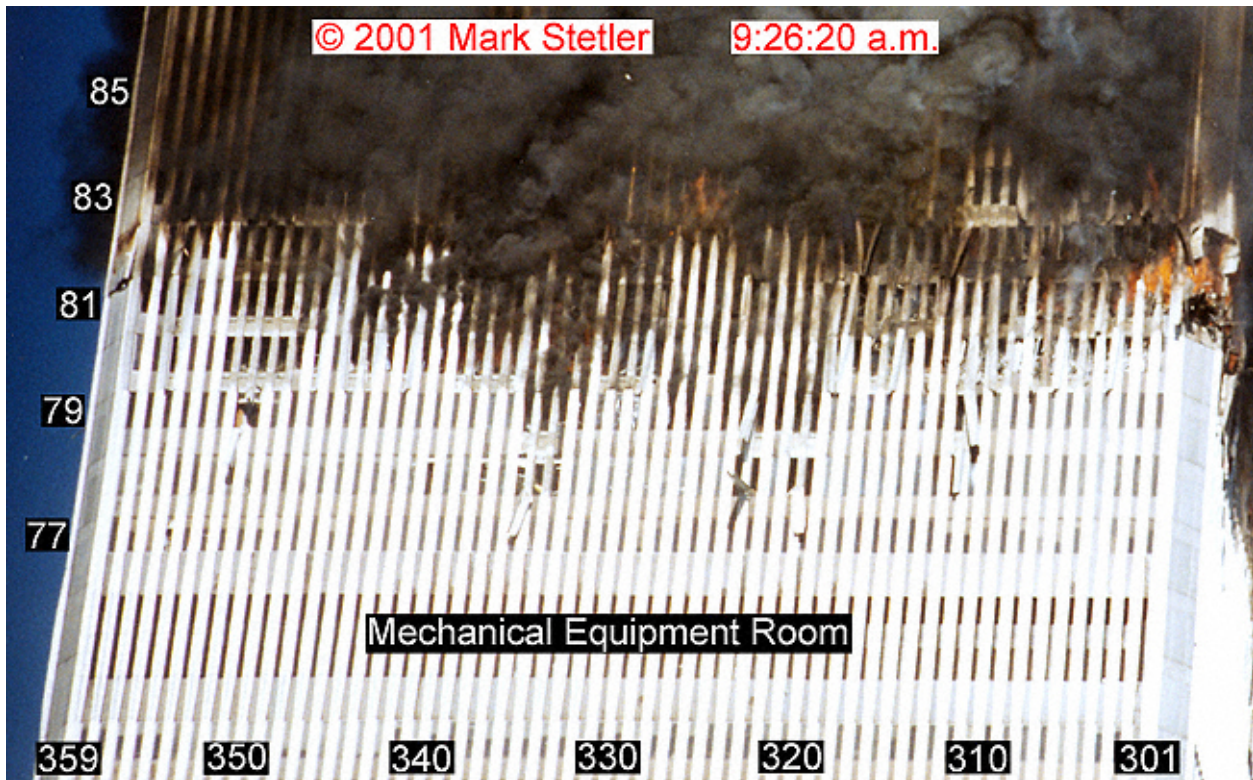
As an example of information that was extracted, Figure 6–1 shows an enhanced image of the east face of WTC 2. Figure 6–2 expands a section of interest. The amount of detail available is evident. For instance, large piles of debris are present on the north side of the tower on the 80<sup>th</sup> and 81<sup>st</sup> floors, and locations where fires are visible or where missing windows are easily identified. Many details of each frame were important in tracking the evolution of the fires and the damage to the buildings.

**Figure 6–1. 9:26:20 a.m. showing the east face of WTC 2.**

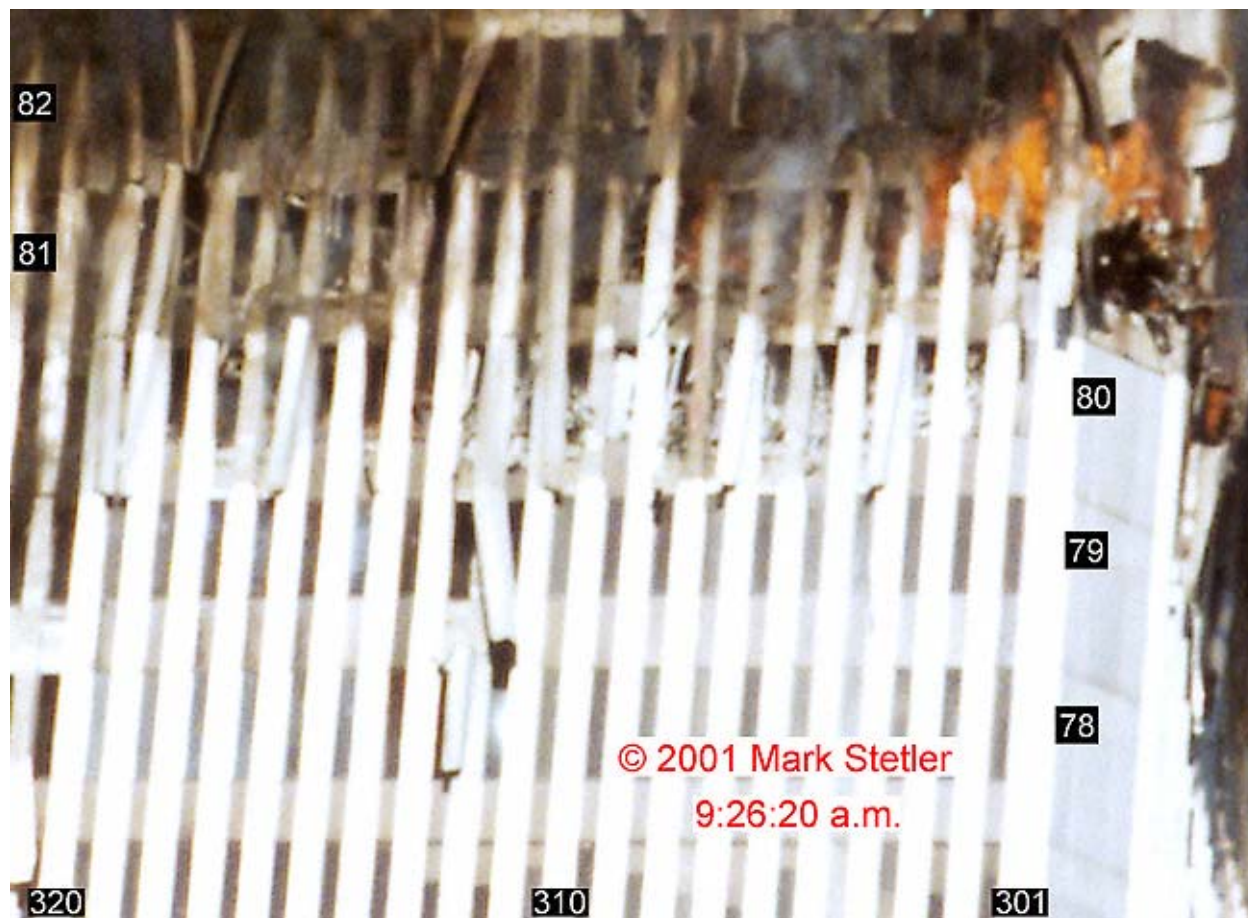
Figure 6–2. Close-up of section of Figure 6–1.

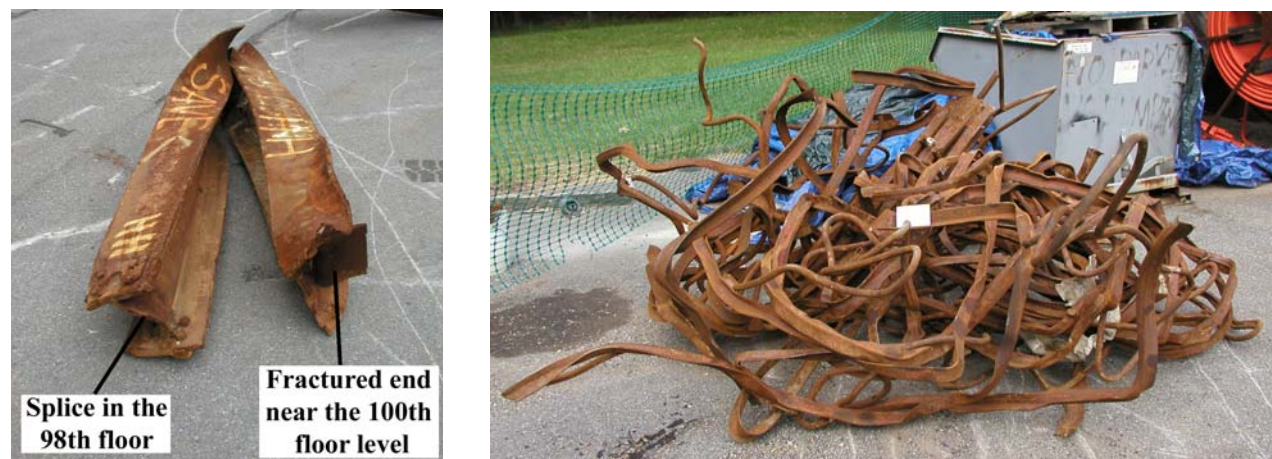
**Figure 6–3. Examples of a WTC 1 core column (left) and truss material (right).**

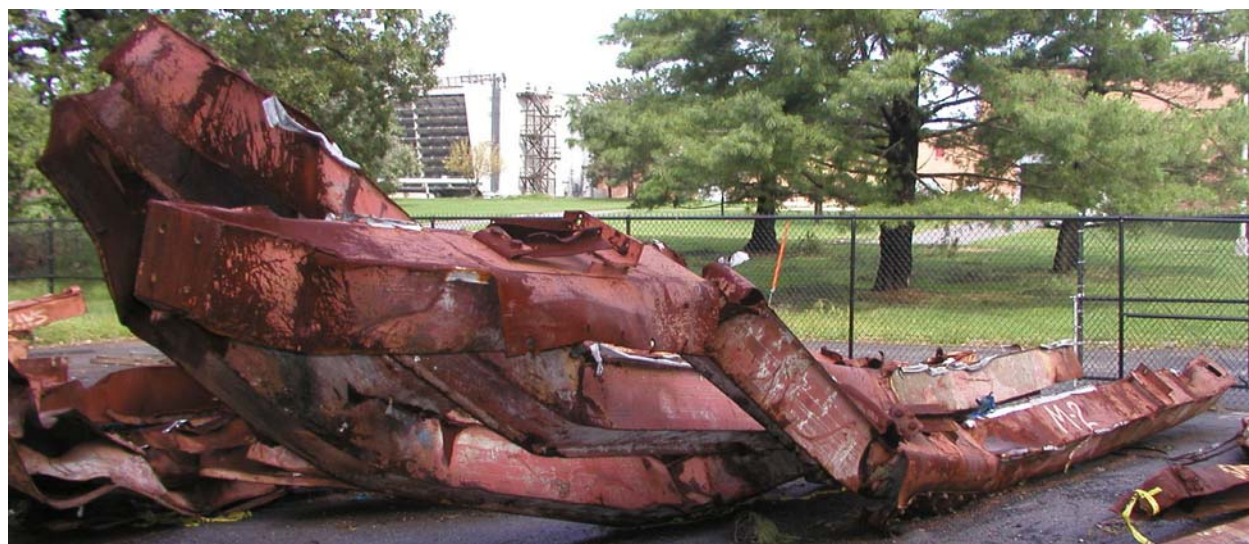
**Figure 6–4. WTC 1 exterior panel hit by the fuselage of the aircraft.**

For two of the five exterior panels from the impact zone of WTC 1, the general shape and appearance of the recovered pieces matched photographs taken just before the building collapse. Thus, NIST was able to attribute the observed damage to the aircraft impact. NIST also made determinations regarding the connections between structural steel elements:

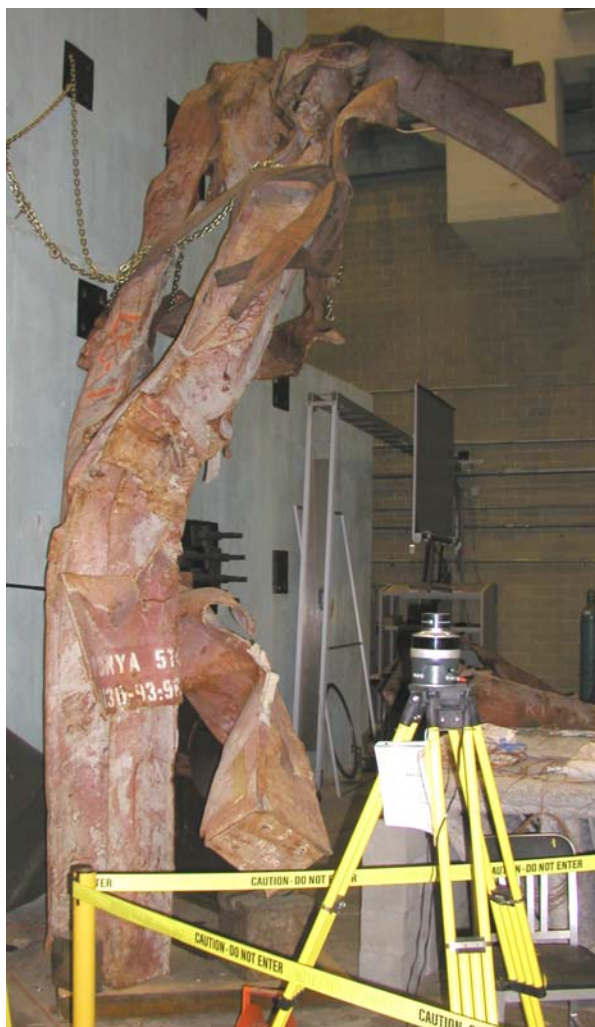
**Figure 6–5. WTC 1 exterior panel hit by the nose of the aircraft.**

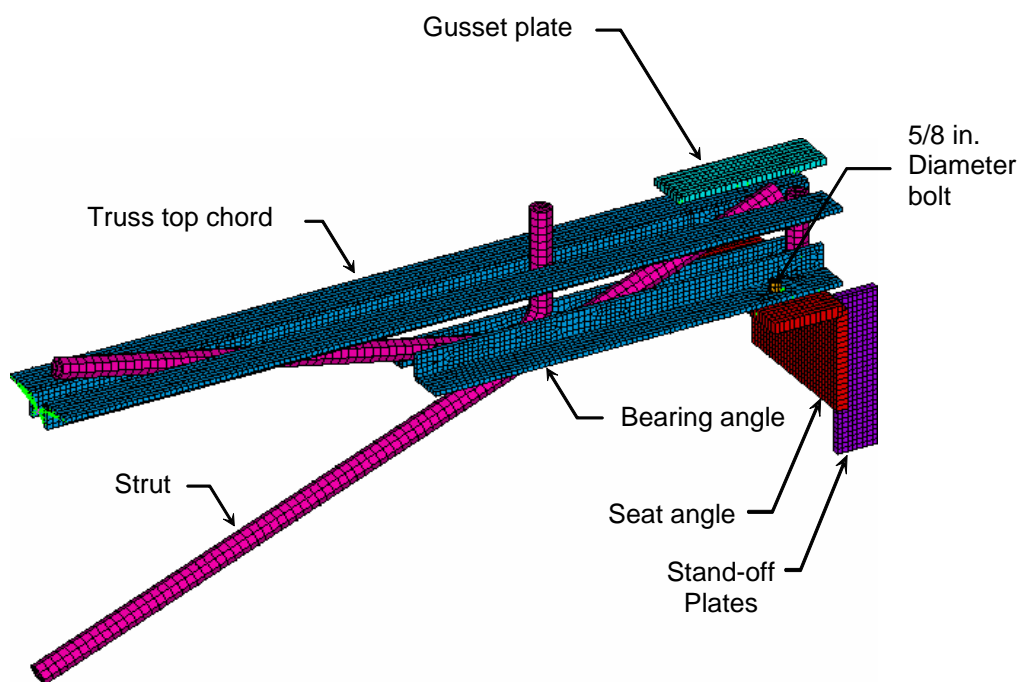
- **Truss seats.** Figure 6–10 shows how an exterior seat connection was represented in the finite element structural model. The component analysis determined that failure could occur at the bolted connection between the bearing angle and the seat angle, and the truss could slip off the seat. Truss seat connection failure from vertical loads was found to be unlikely, since the needed increase in vertical load was unreasonable for temperatures near 600 °C to 700 °C.
- **Knuckles.** The “knuckle” was formed by the extension of the truss diagonals into the concrete slab and provided for composite action of the steel truss and concrete slab. A model was developed to predict the knuckle performance when the truss and concrete slab acted compositely.

**Figure 6–10. Finite element model of an exterior truss seat.**

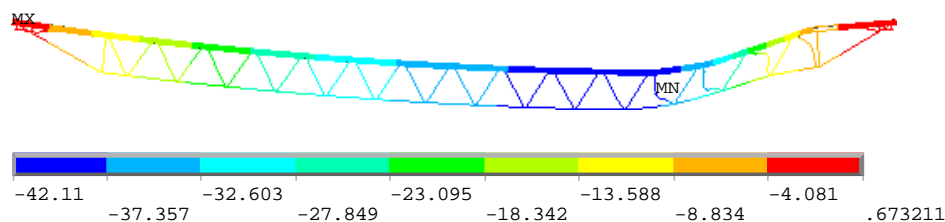
- Single composite truss and concrete slab section. A floor section was modeled to investigate failure modes and sequences of failures under combined gravity and thermal loads. The floor section was heated to 700 °C (300 °C at the top surface of the slab) over a period of 30 min. Initially the thermal expansion of the floor pushed the columns outward, but with increased temperatures, the floor sagged and the columns were pulled inward. Knuckle failure was found to occur mainly at the ends of the trusses and had little effect on the deflection of the floor system. Figure 6–11 shows that the diagonals at the core (right) end of the truss buckled and caused an increase in the floor system deflection, ultimately reaching approximately 42 in. Two possible failure modes were identified for the floor-truss section: sagging of the floor and loss of truss seat support.

**Figure 6–11. Vertical displacement at 700 °C.**

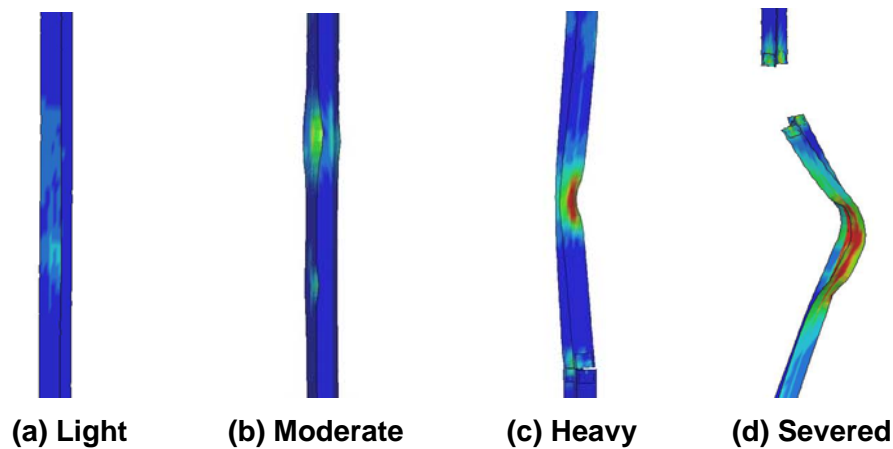
Each of the four global simulations generated information about the state of the structural components following the impact of the aircraft. The four degrees of column damage are defined as follows and shown graphically in Figure 6–19. The unstrained areas are blue and the highly strained areas are red.

- Lightly damaged column: column impacted, but without significant structural deformation;
- Moderately damaged column: visible local distortion, but no deformation of the column centerline;
- Heavily damaged column: Permanent deflection of the column centerline; and
- Failed column: Column severed.

**Figure 6–19. Column damage levels.**

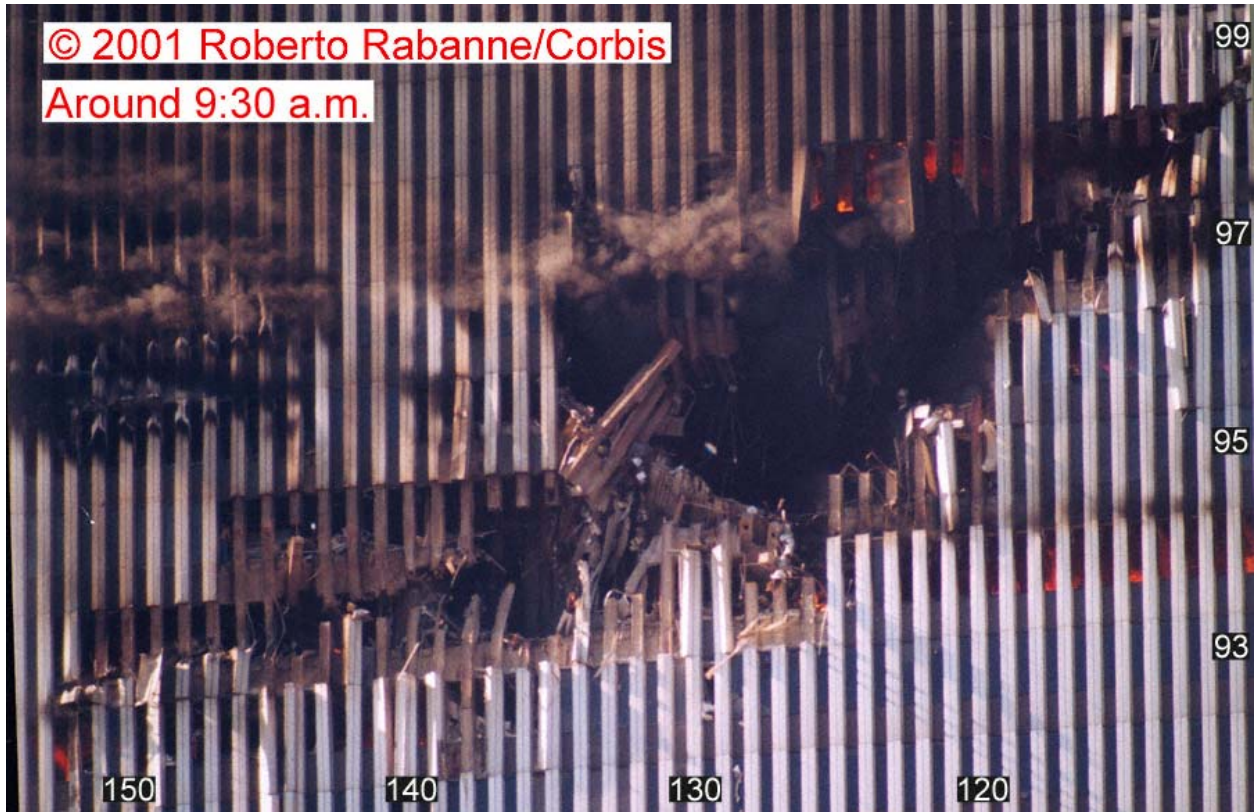
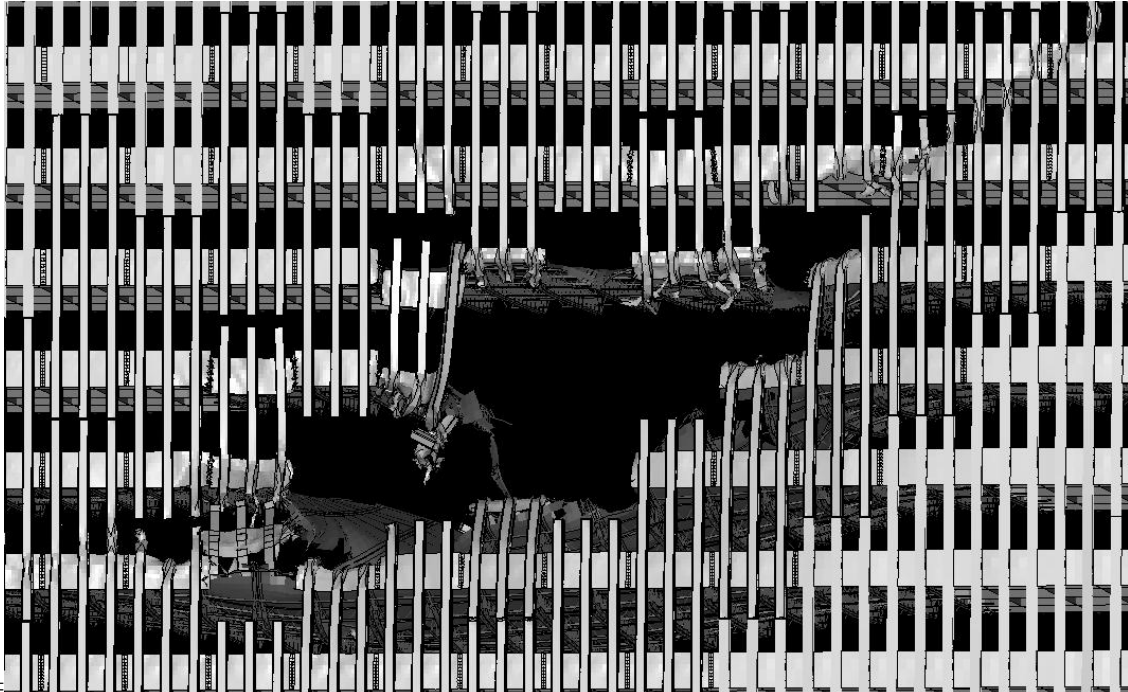
Figure 6–26. Observed and Case A calculated damage to the north face of WTC 1.

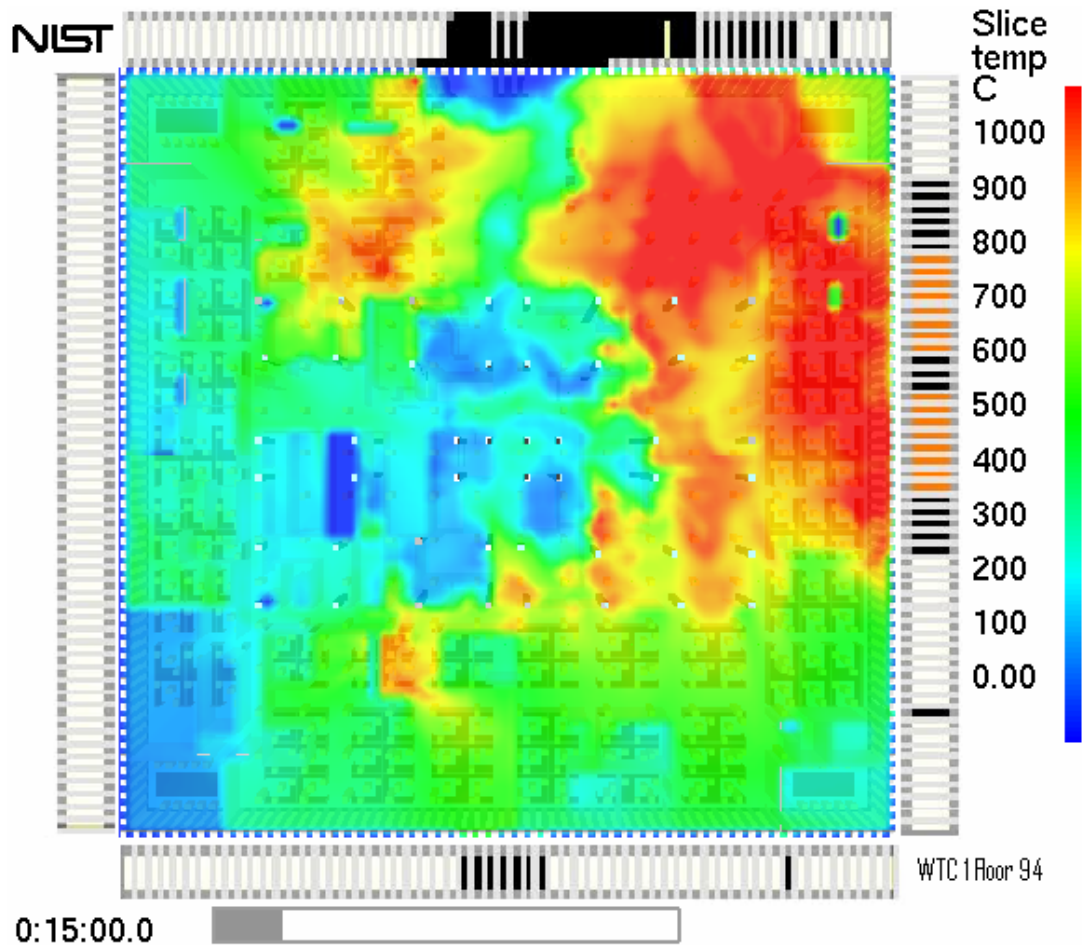
**Figure 6–36. Upper layer temperatures on the 94<sup>th</sup> floor of WTC 1, 15 min after impact.**

Given the uncertainties in some of the floor plans, the damage to the internal walls, and movement of the office furnishings, the intent of the simulations was to capture the magnitudes of the fires and the broad features of their locations and movement; and they did so.

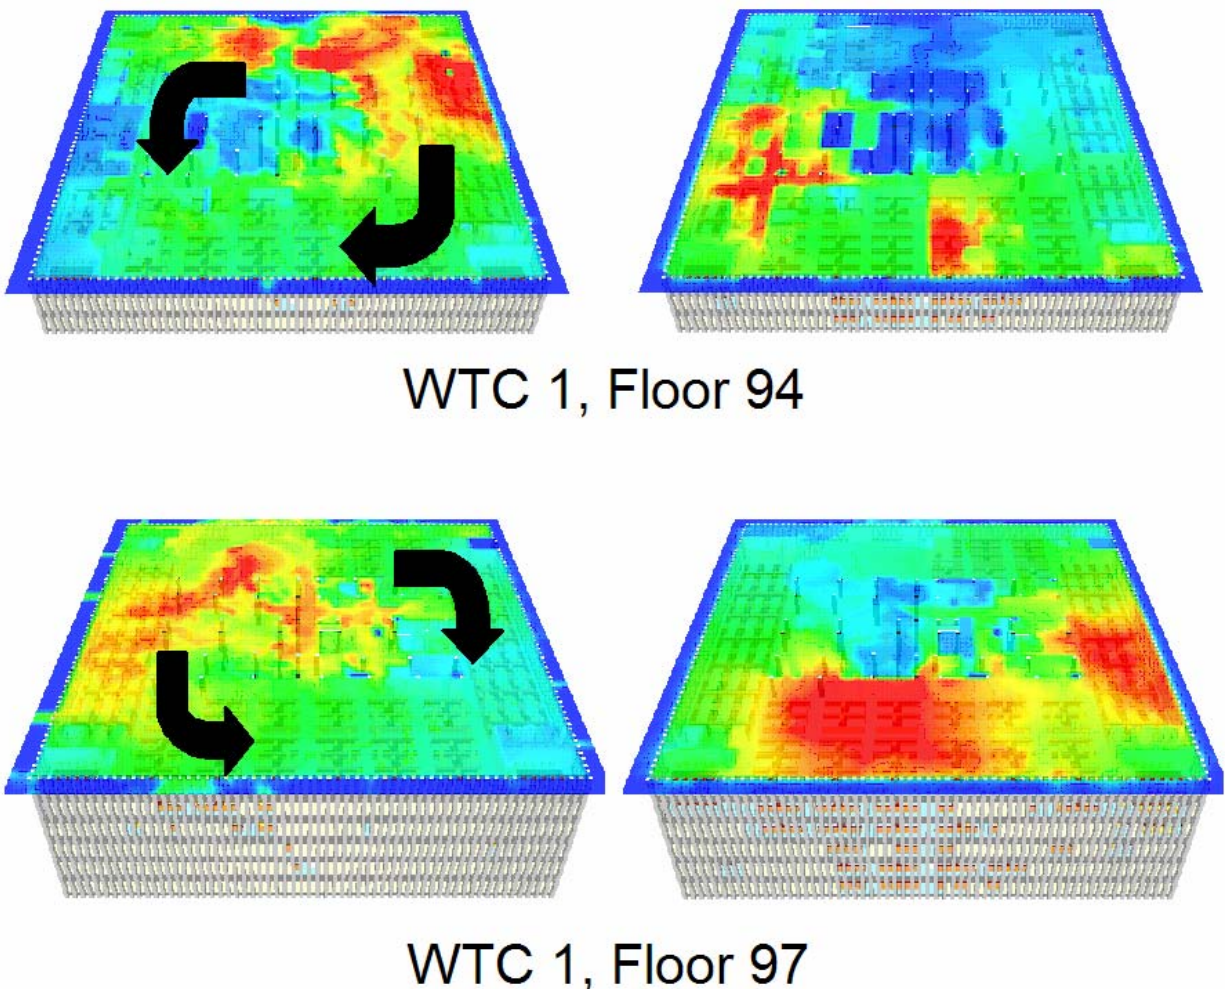
Much of the fire activity was initially in the vicinity of the impact area in the north part of the building. As a result of the orientation of the impacting aircraft and its fuel tanks, the early fires on the 92<sup>nd</sup> through 94<sup>th</sup> floors tended toward the east side of the north face, while the early fires on the 97<sup>th</sup> through 99<sup>th</sup> floors tended toward the west side of the north face. The fires on all the floors spread along the east and west sides and were concentrated in the south part of the building at the time of collapse, as depicted in Figure 6–37.

**Figure 6–37. Direction of simulated fire movement on floors 94 and 97 of WTC 1.**

The fire simulation results for Case A and Case B were similar, indicating only a modest sensitivity to the fuel load and the degree of aircraft-generated damage. This was because, in general, the size and movement of the fires in WTC 1 were limited by the supply of air from the exterior windows. Since the window breakage pattern was not changed in Case B, the additional and re-distributed combustibles within the building did not contribute to a *larger* fire. The added fuel did slow the spread slightly because the fires were sustained longer in any given location.

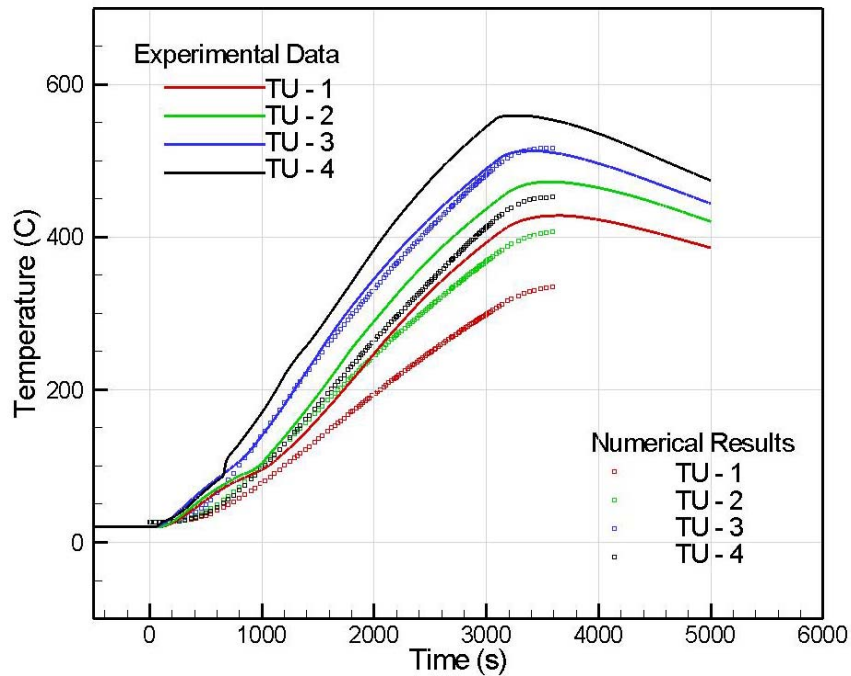
Figure 6-44 compares the measured and predicted temperatures on the steel surface of the top chord of a bare truss. Figure 6-45 is the analogous plot of the measured and predicted temperatures on the steel surface of the top chord of a truss insulated with 19 mm (3/4 in.) of BLAZE-SHIELD DC/F. Similar curves were generated for each of the steel pieces, bare and insulated.

Figure 6-45. Comparison of numerical simulations with measurements for the temperature of the steel surface at four locations on the top chord of an insulated truss.

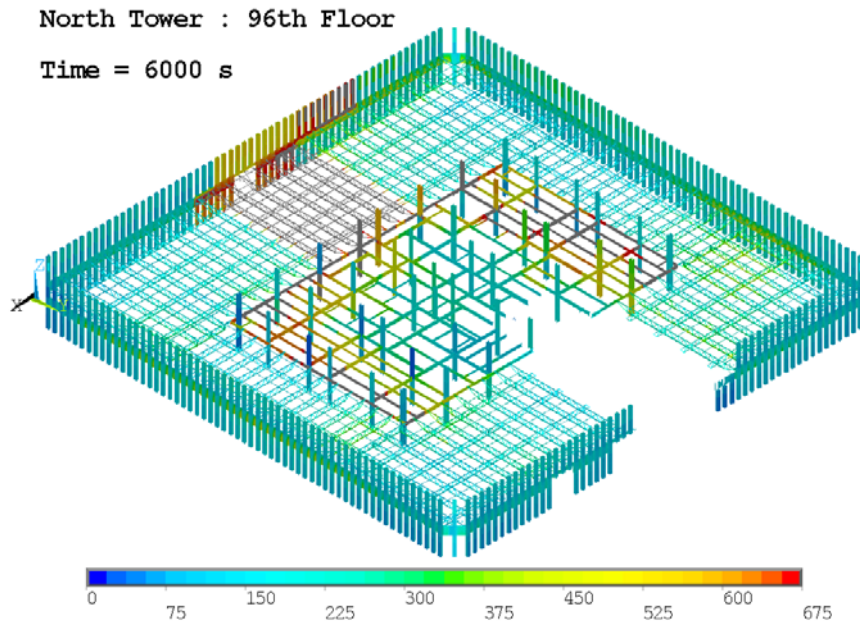
For ease of visualization, two graphic representations were developed. Figure 6–46 shows an example of the temperature map for the 96<sup>th</sup> floor of WTC 1. Severed columns and broken floor segments are not shown. Figure 6–47 shows a similar map for the 81<sup>st</sup> floor of WTC 2.

**Figure 6–46. Temperatures (°C) on the columns and trusses of the 96<sup>th</sup> floor of WTC 1 at 6,000 s after aircraft impact, Case B.**

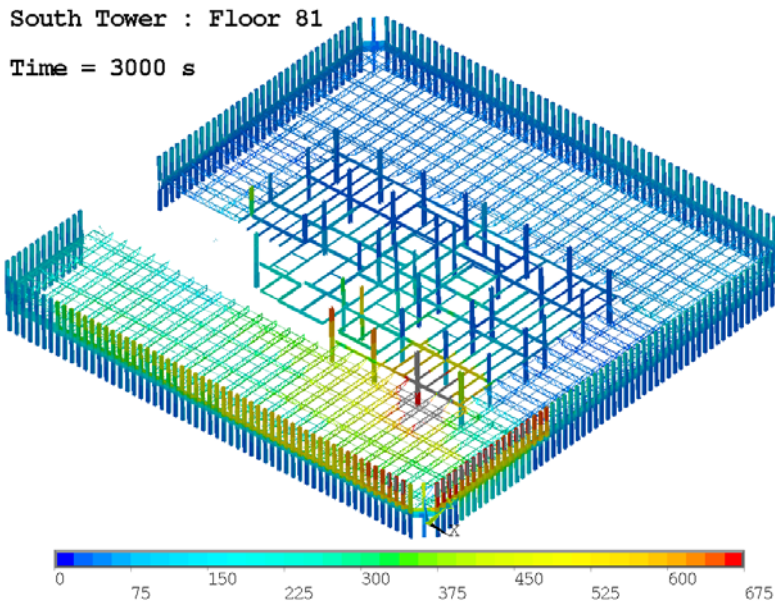
**Figure 6-47. Temperatures (°C) on the columns and trusses of the 81<sup>st</sup> floor of WTC 2 at 3,000 s after aircraft impact, Case D.**

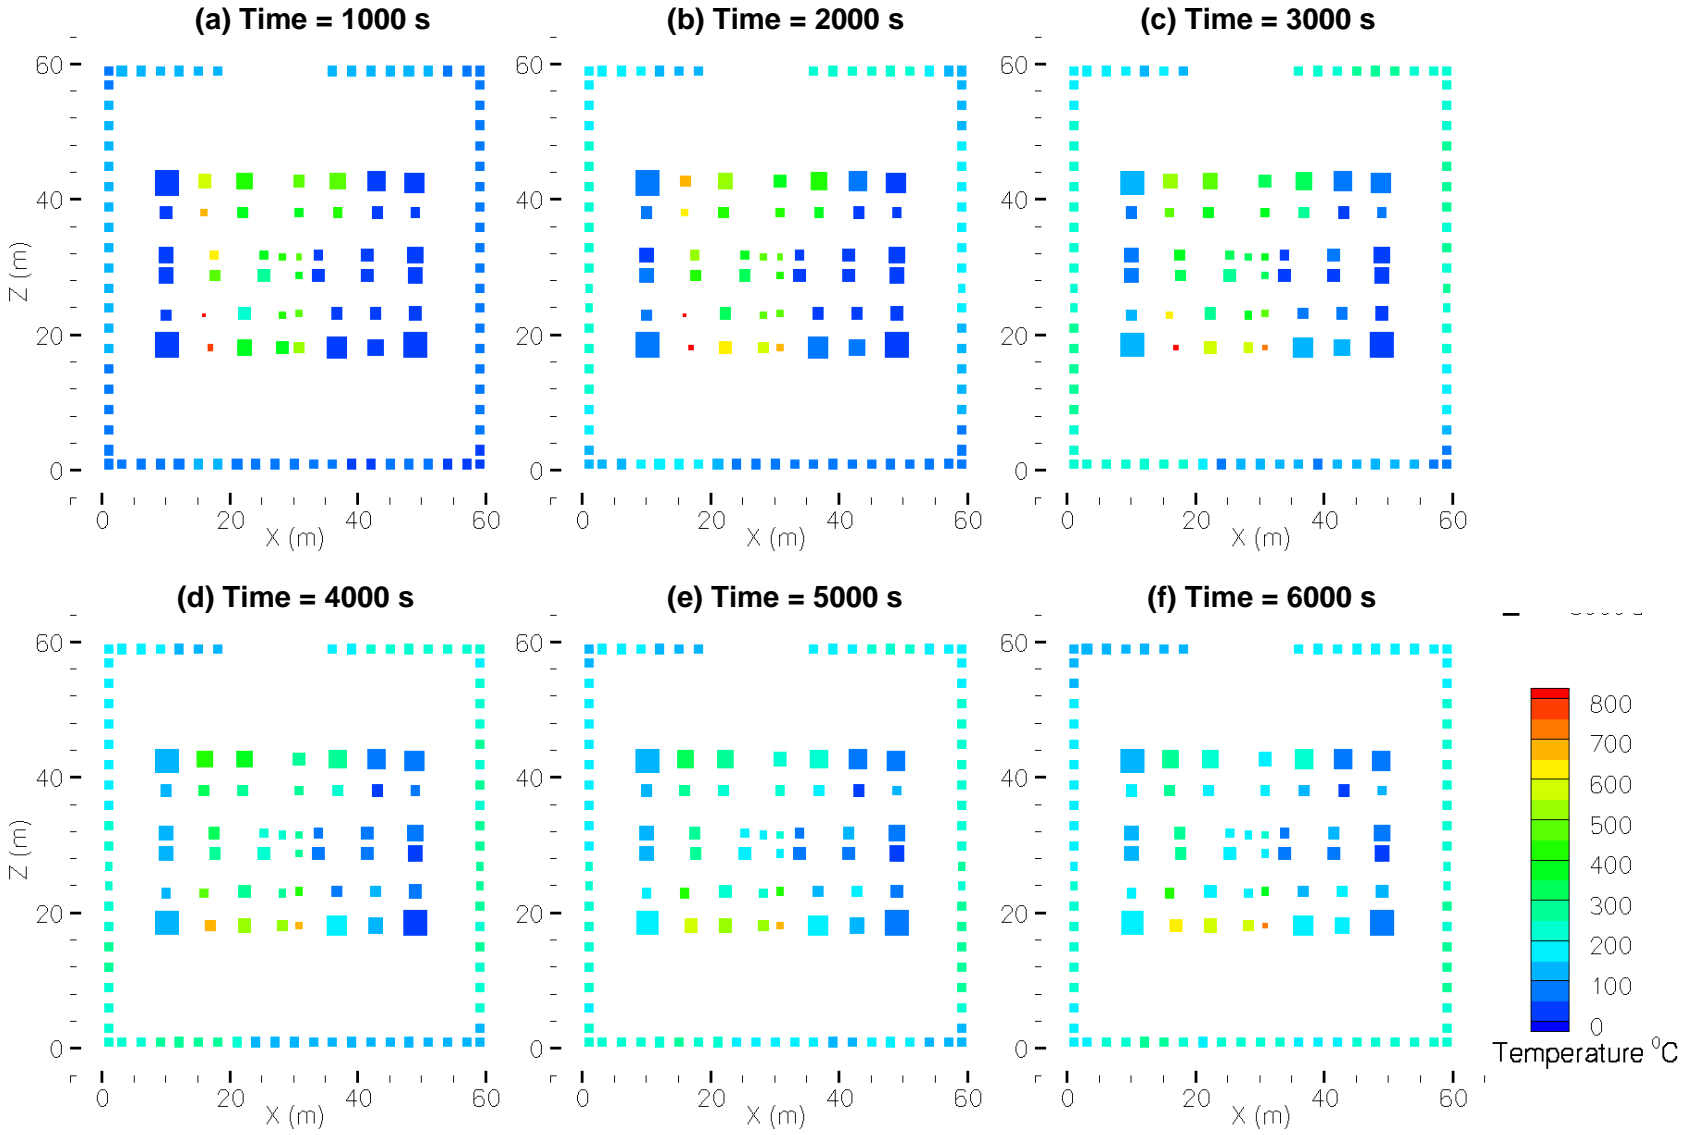
A third visualization tool was animation of the evolving temperatures of the columns. Frames from an example, again of the 96<sup>th</sup> floor of WTC 1, Case A, are shown in Figure 6-48. The size of the square representing a column represents its yield strength. Columns may have been heated when the fire was nearby and then cooled after the local combustibles were consumed.

Figure 6-48. Frames from animation of the thermal response of columns on the 96<sup>th</sup> floor of WTC 1, Case A.
