**Federal Building and Fire Safety Investigation of the  
World Trade Center Disaster**

**Final Report of the  
National Construction Safety Team  
on the Collapses of the  
World Trade Center Towers (Draft)**

September 2005

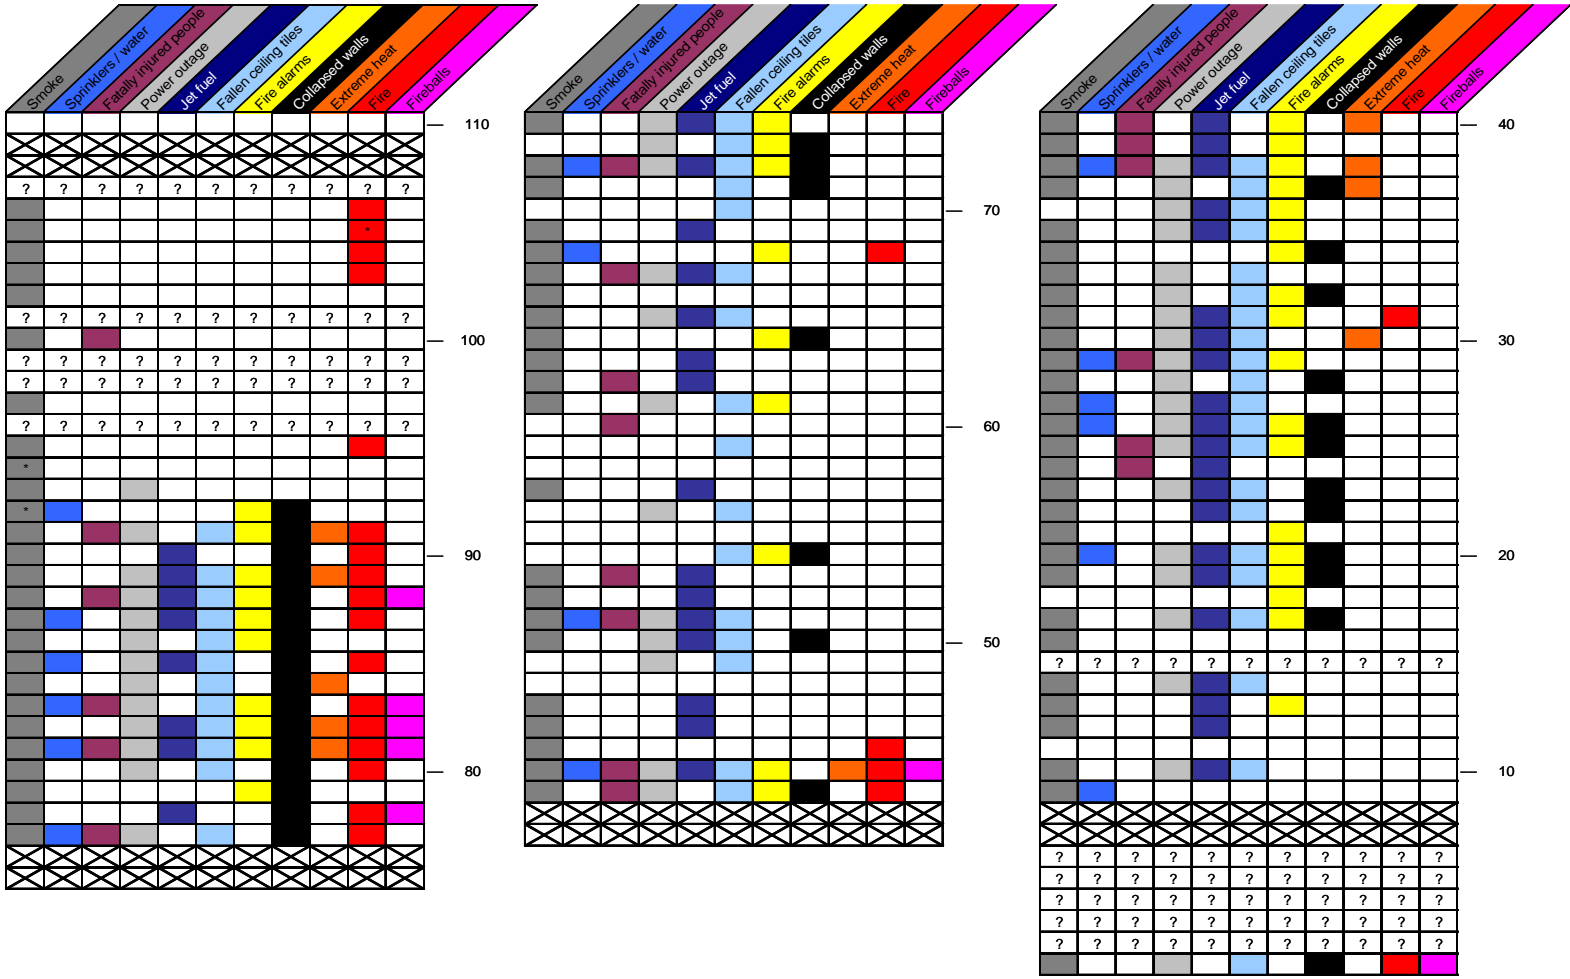
- Occupants throughout the building observed various types of impact indicators throughout the building, including wall, partition, and ceiling damage and fire and smoke conditions. The filled-in squares in Figure 7–3 indicate the floors on which the different observations were reported.

Figure 7-3. Observations of building damage after initial awareness but before beginning evacuation in WTC 1

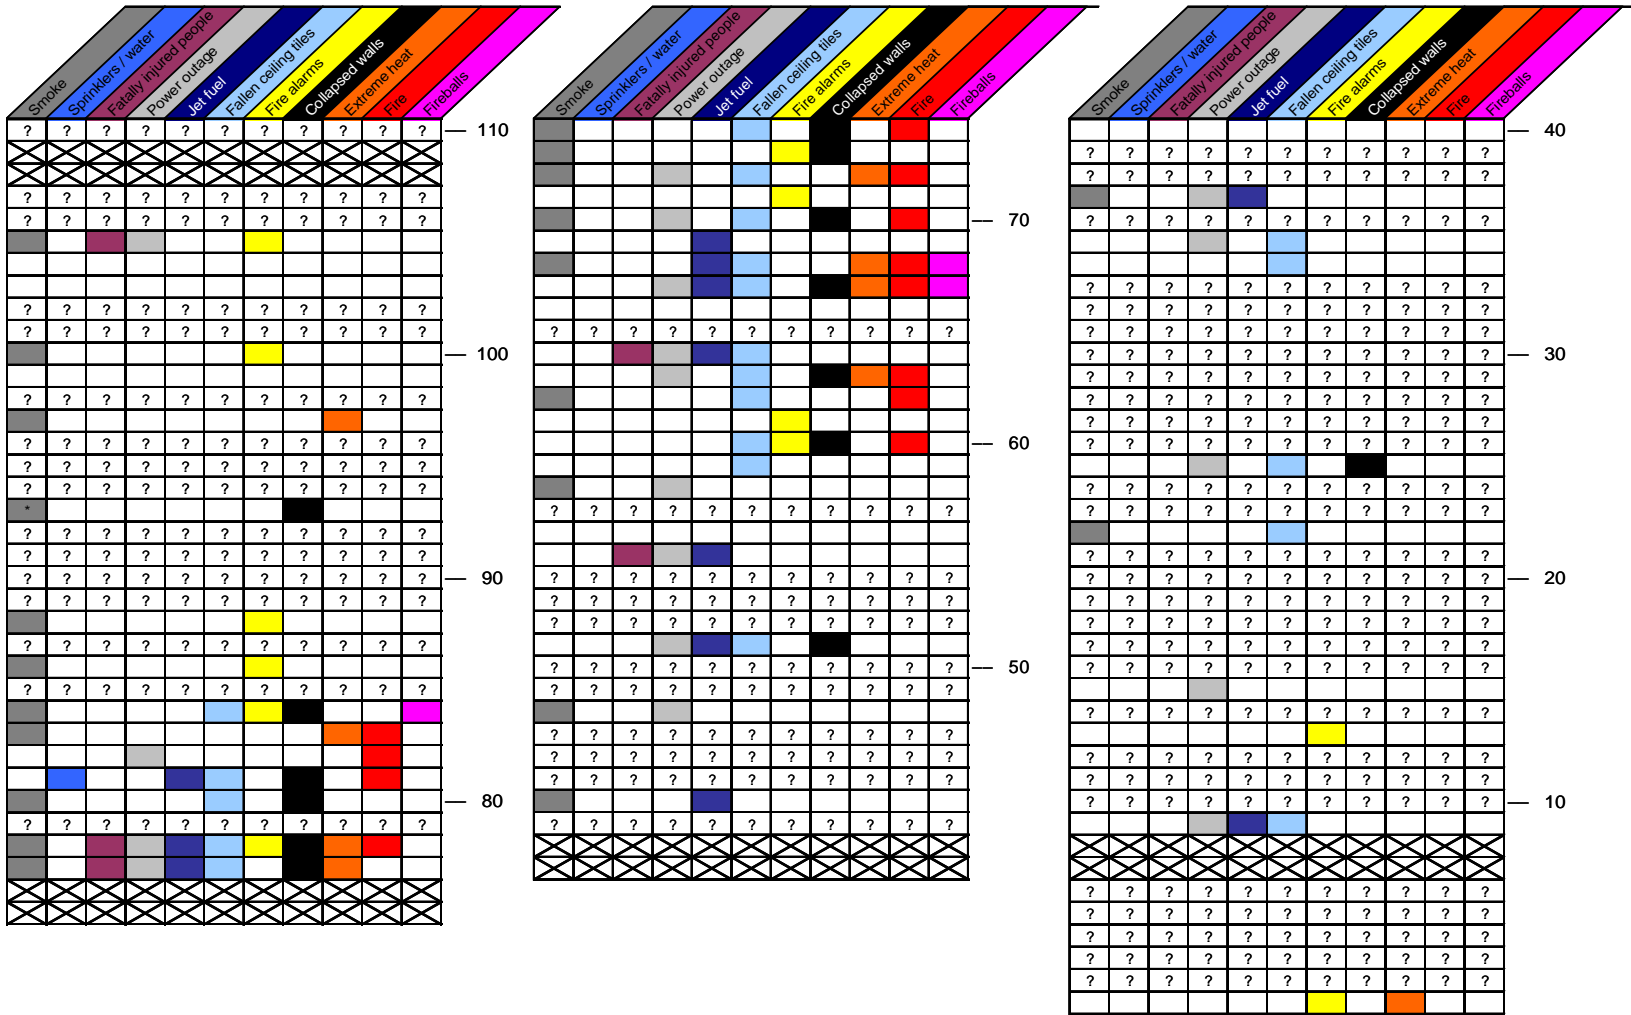
- The median time to initiate evacuation was 6 min, somewhat longer than in WTC 1.
- As in WTC 1, occupants observed various types of impact indicators throughout the building, including wall, partition, and ceiling damage and fire and smoke conditions (Figure 7–4).

Figure 7-4. Observations of building damage from tenant spaces in WTC 2.
