**Ohio Route 50 Joint Sealant Experiment**

*State Job No.: 14668(0)*

**FINAL REPORT**

*April 2002*

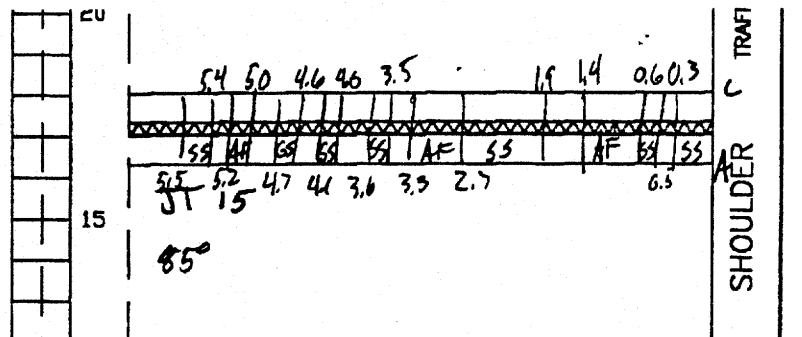
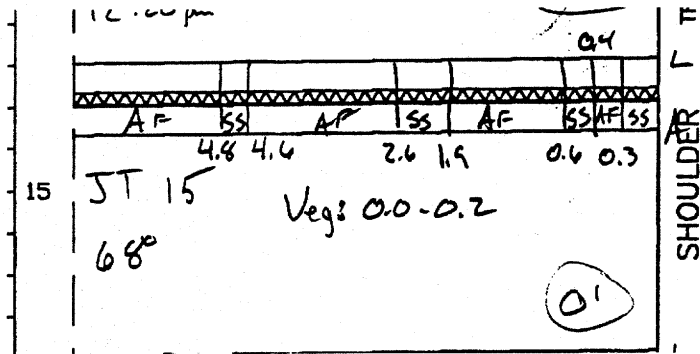
**Figure 5.9** Comparison between field logs from EBOC00 and EBJN01 for Joint 15 in the Crafc0 903-SL (4) section.

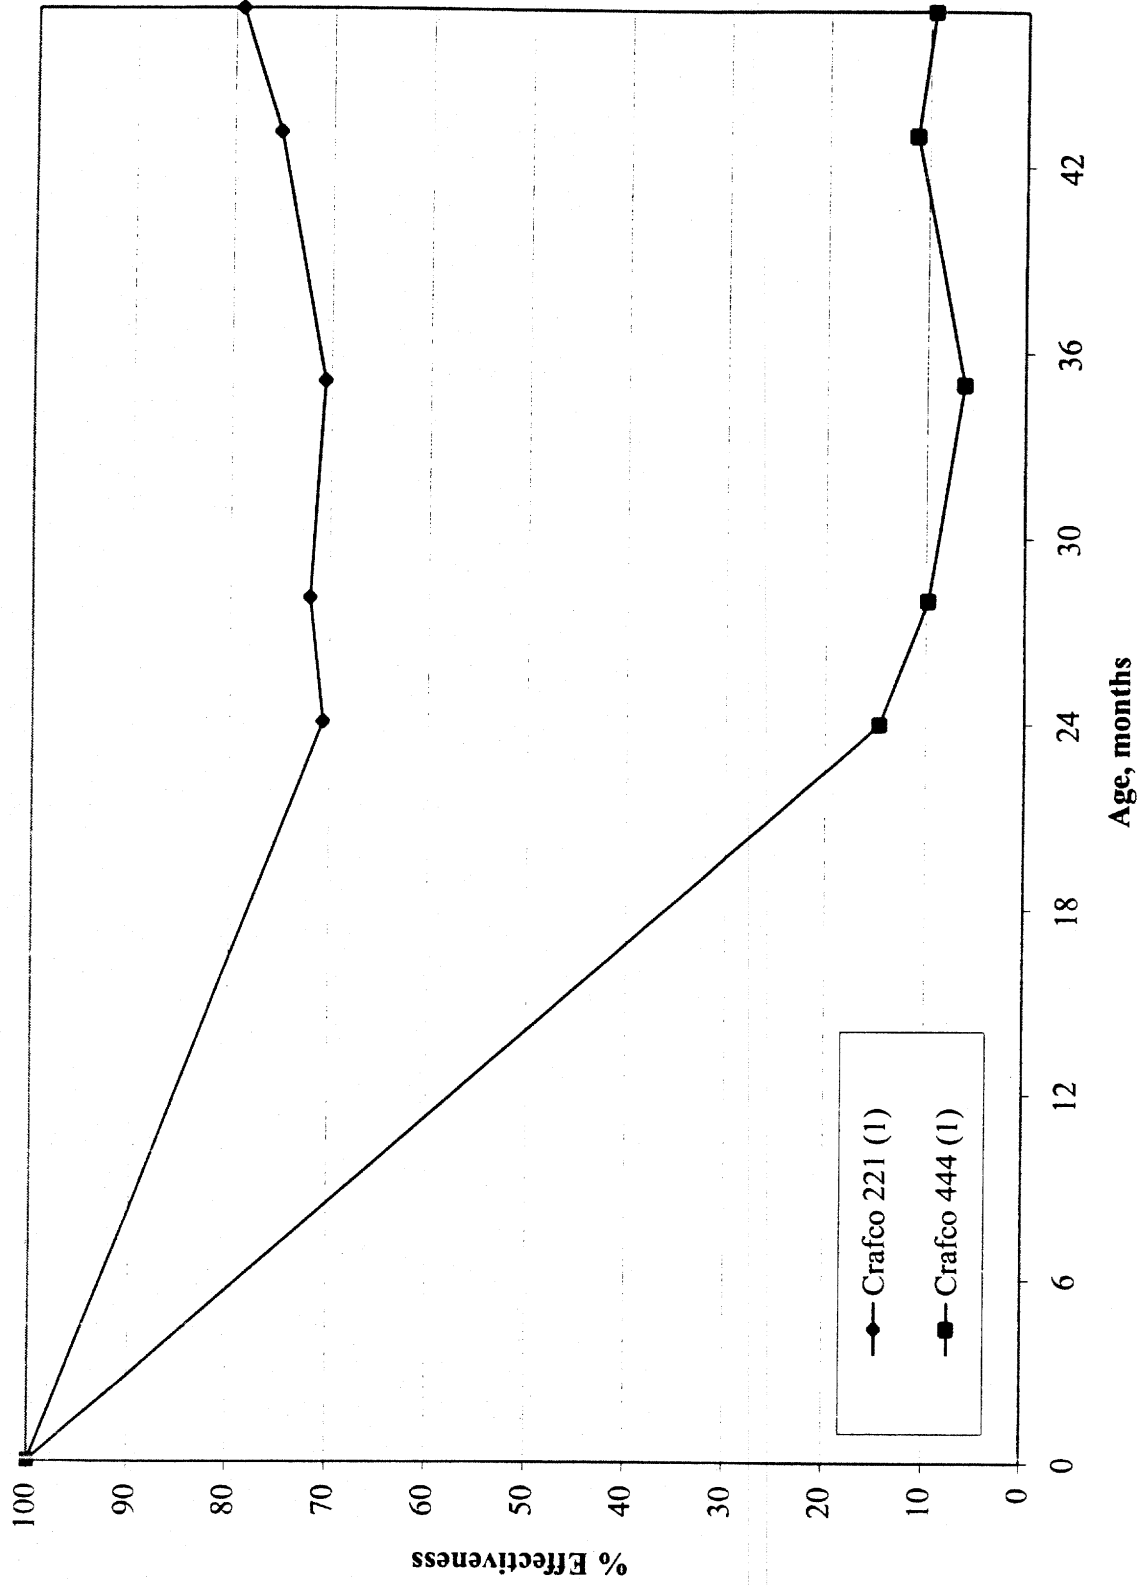
**Figure 5.18** Deterioration of hot-applied sealants in the eastbound lanes as of EBOC01

The performance to date of the hot-applied sealant sections is shown in Figure 5.18. It is apparent that Crafc0 444 (1) began deteriorating at a faster rate than the other hot-applied sealant, Crafc0 221 (1). The former appears to be at a terminal effectiveness level since it does not have much more effectiveness to lose. The latter is maintaining an effectiveness between 70 and 80%.

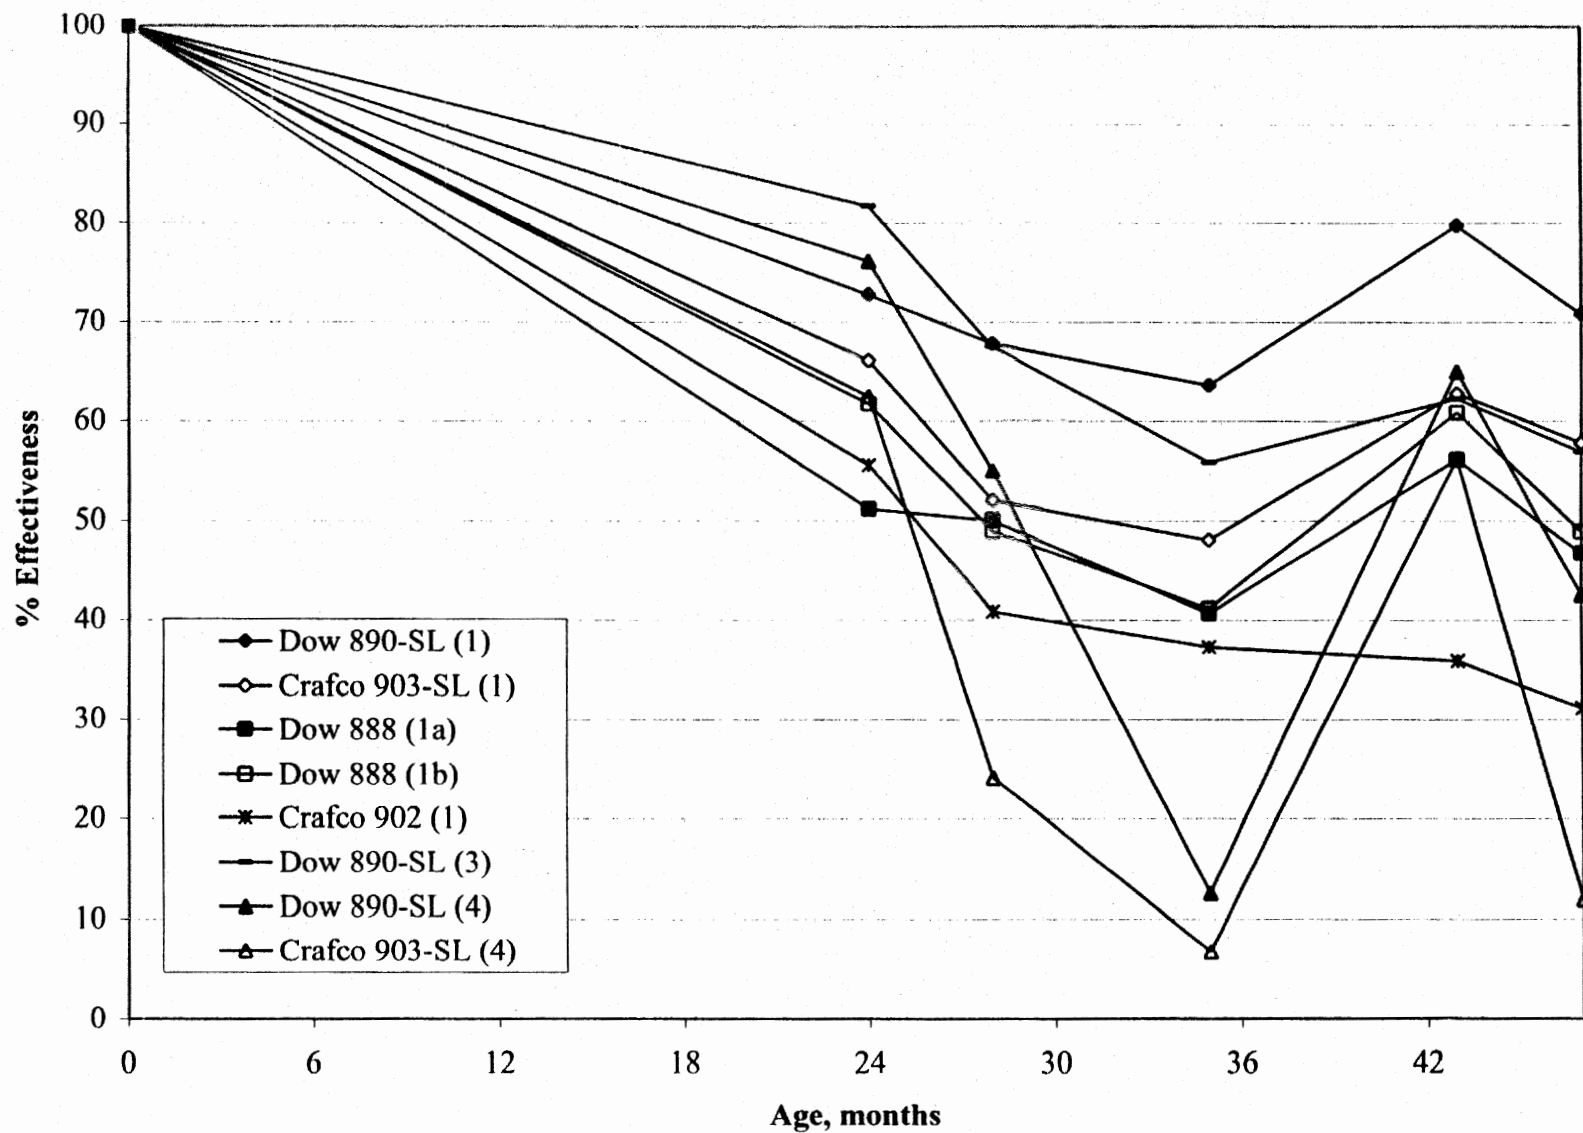
Figure 5.19 Deterioration of silicone sealants in the eastbound lanes as of EBOC01

Figure 5.19 displays the effectiveness values of the silicone sealants over their life-span to date. The effectiveness increases observed during EBJN01 make the graph difficult to decipher. The majority of the effectiveness apparently gained during the last survey (EBJN01) appears to have been lost during the current survey (EBOC01) and throws into doubt the results of the former survey. Only Crafc0 902 (1) exhibits no effectiveness increases at all during its lifetime. The current effectiveness values for almost all sections are still above those from a year ago (EBOC00). Most of the sections, however, are only a few percentage points above their October 2000 value.

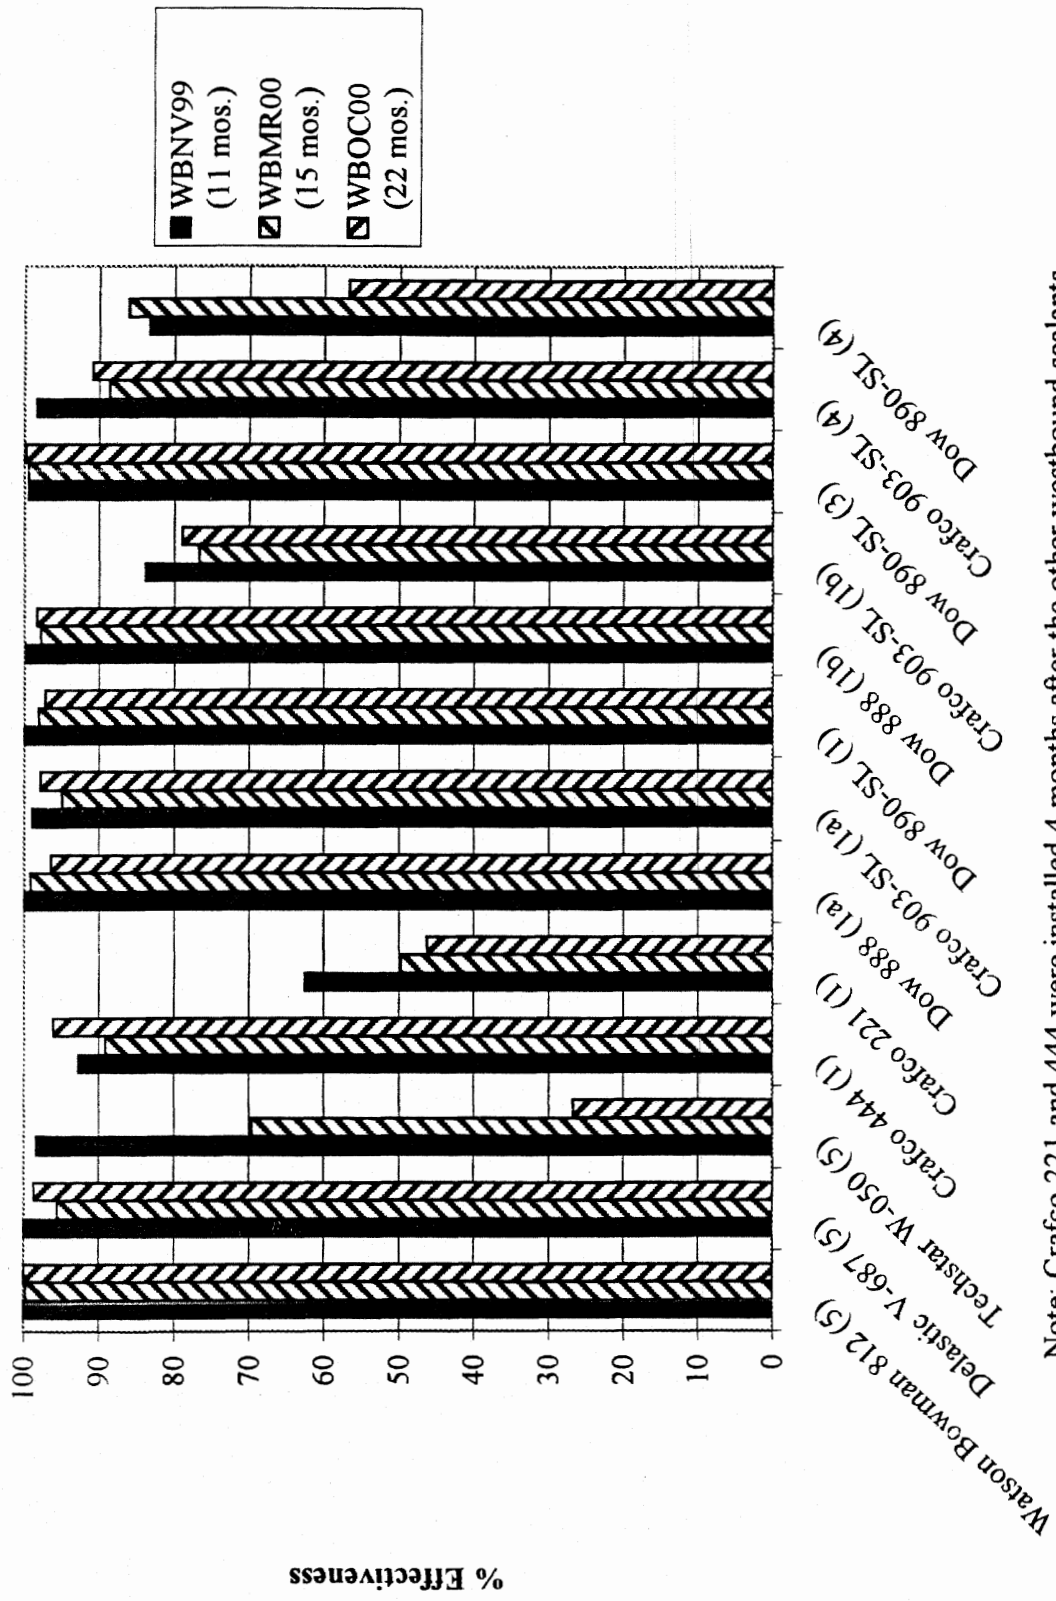
Figure 5.22 Deterioration of sealants from WBNV99 to WBOC00

Figure 5.22 shows the effectiveness trend for each sealant since the first survey conducted in Fall 1999. With few exceptions, all sections have experienced little or no loss in effectiveness.

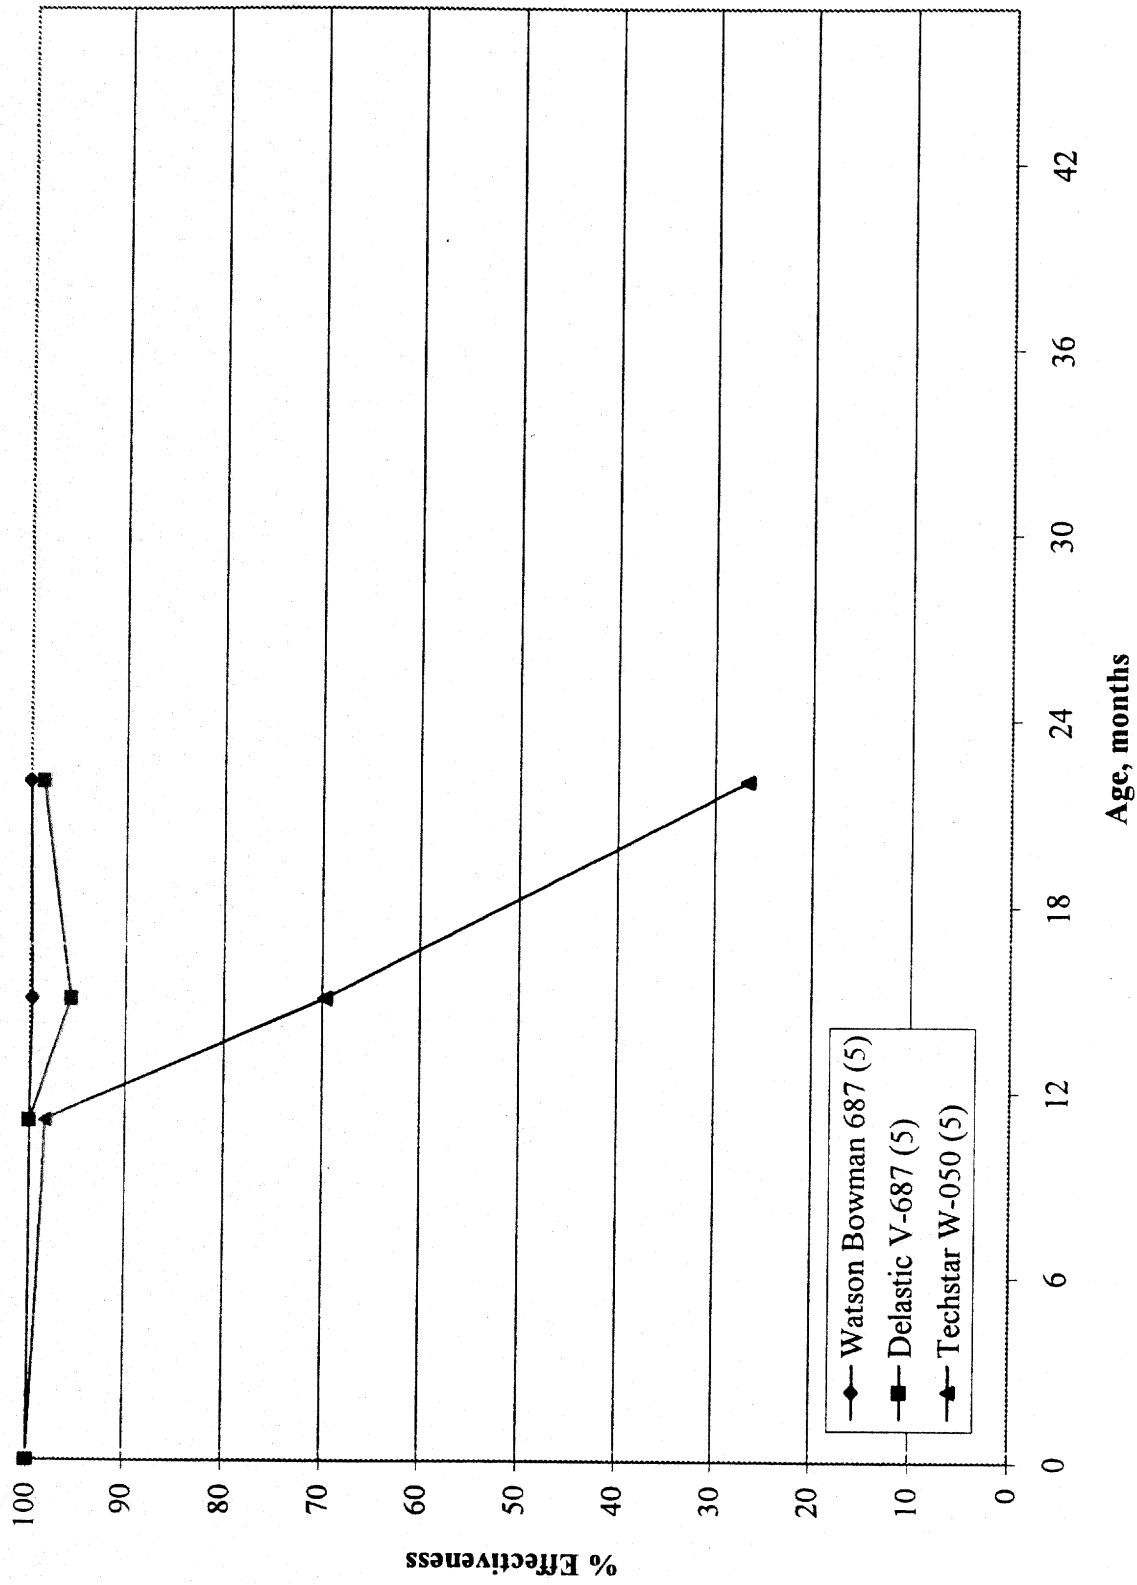
Figure 5.23 Deterioration of compression seals in the westbound lanes as of WBOC00

The deterioration of the compression seals is displayed in Figure 5.23. The Watson Bowman 812 (5) and Delastic V-687 (5) compressive seals continue to exhibit superior effectiveness values, with very little or no deterioration. The former shows no loss of effectiveness in any of the inspected joints. The Techstar W-050 (5) section, on the other hand, is again the exception among the compression seals, losing 43% since Spring 2000 and 72% since Fall 1999.

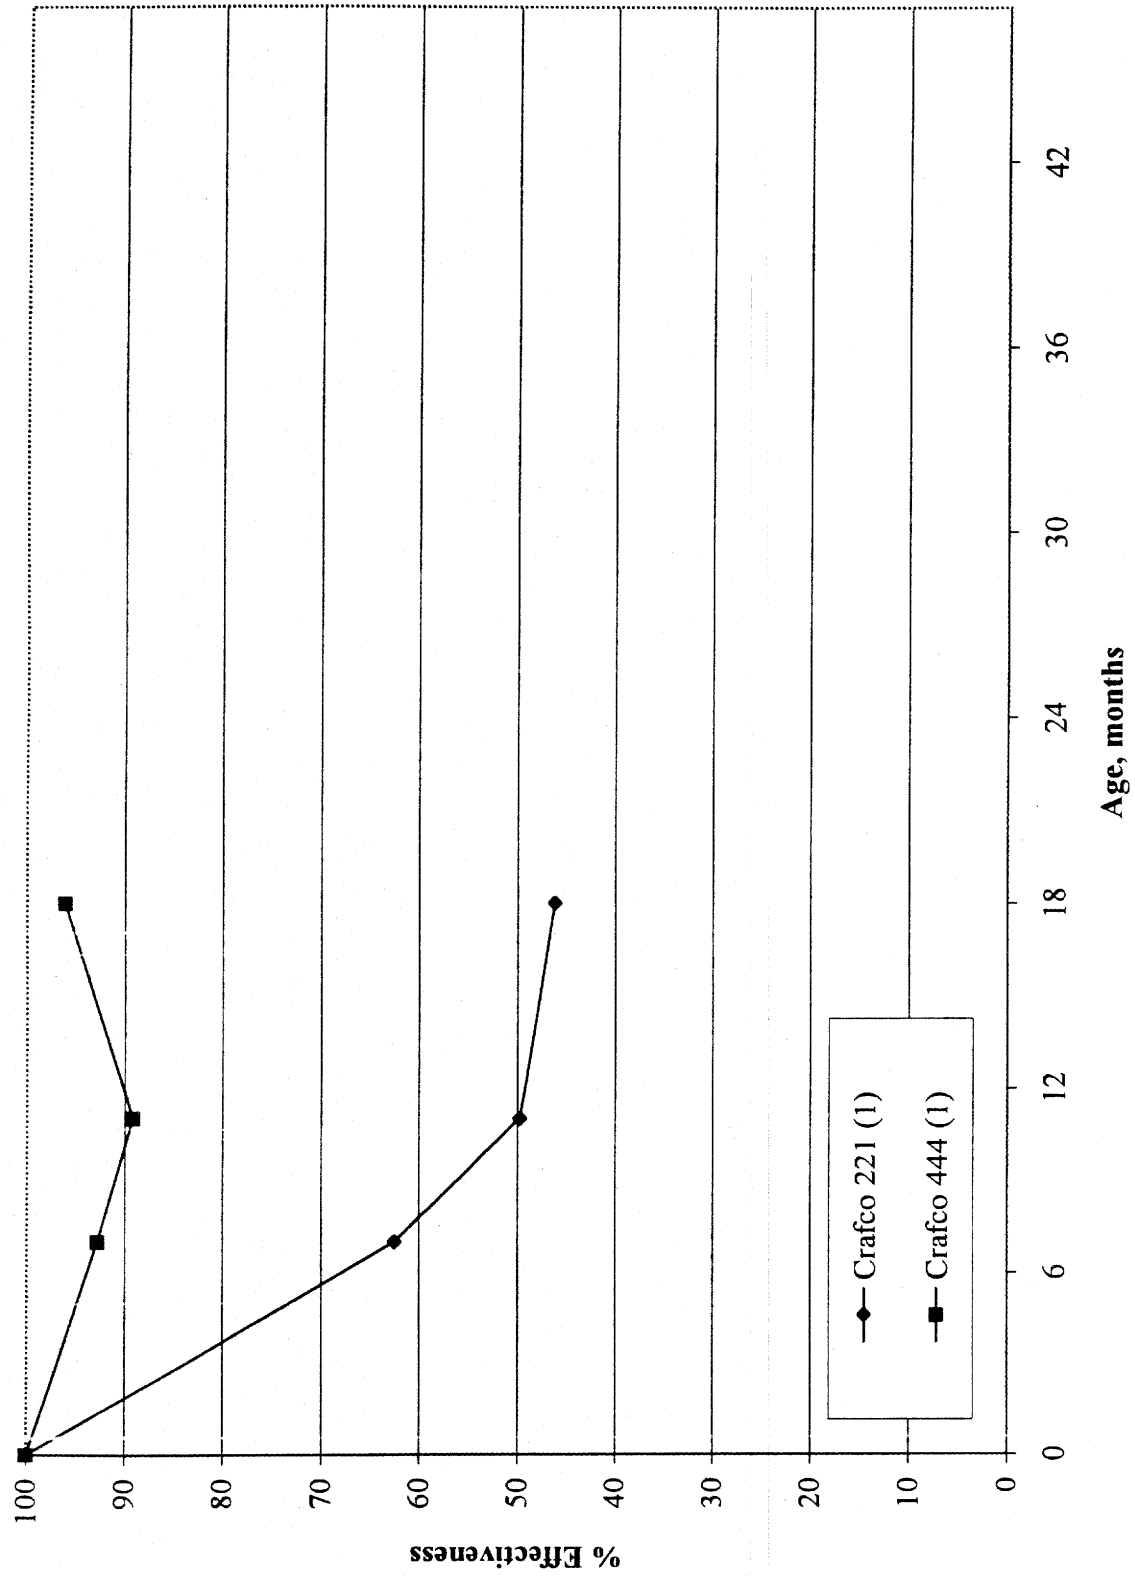
Figure 5.24 Deterioration of hot-applied sealants in the westbound lanes as of WBOC00

The two hot-applied sealants have very different deterioration rates again, as shown in Figure 5.24. The Crafcoc 444 (1) section has experienced no loss of sealant effectiveness since the original survey, whereas the Crafcoc 221 (1) section has lost nearly 20%. Incidentally, these two sealants are the youngest ones: they were installed four months after the rest in the westbound lanes.

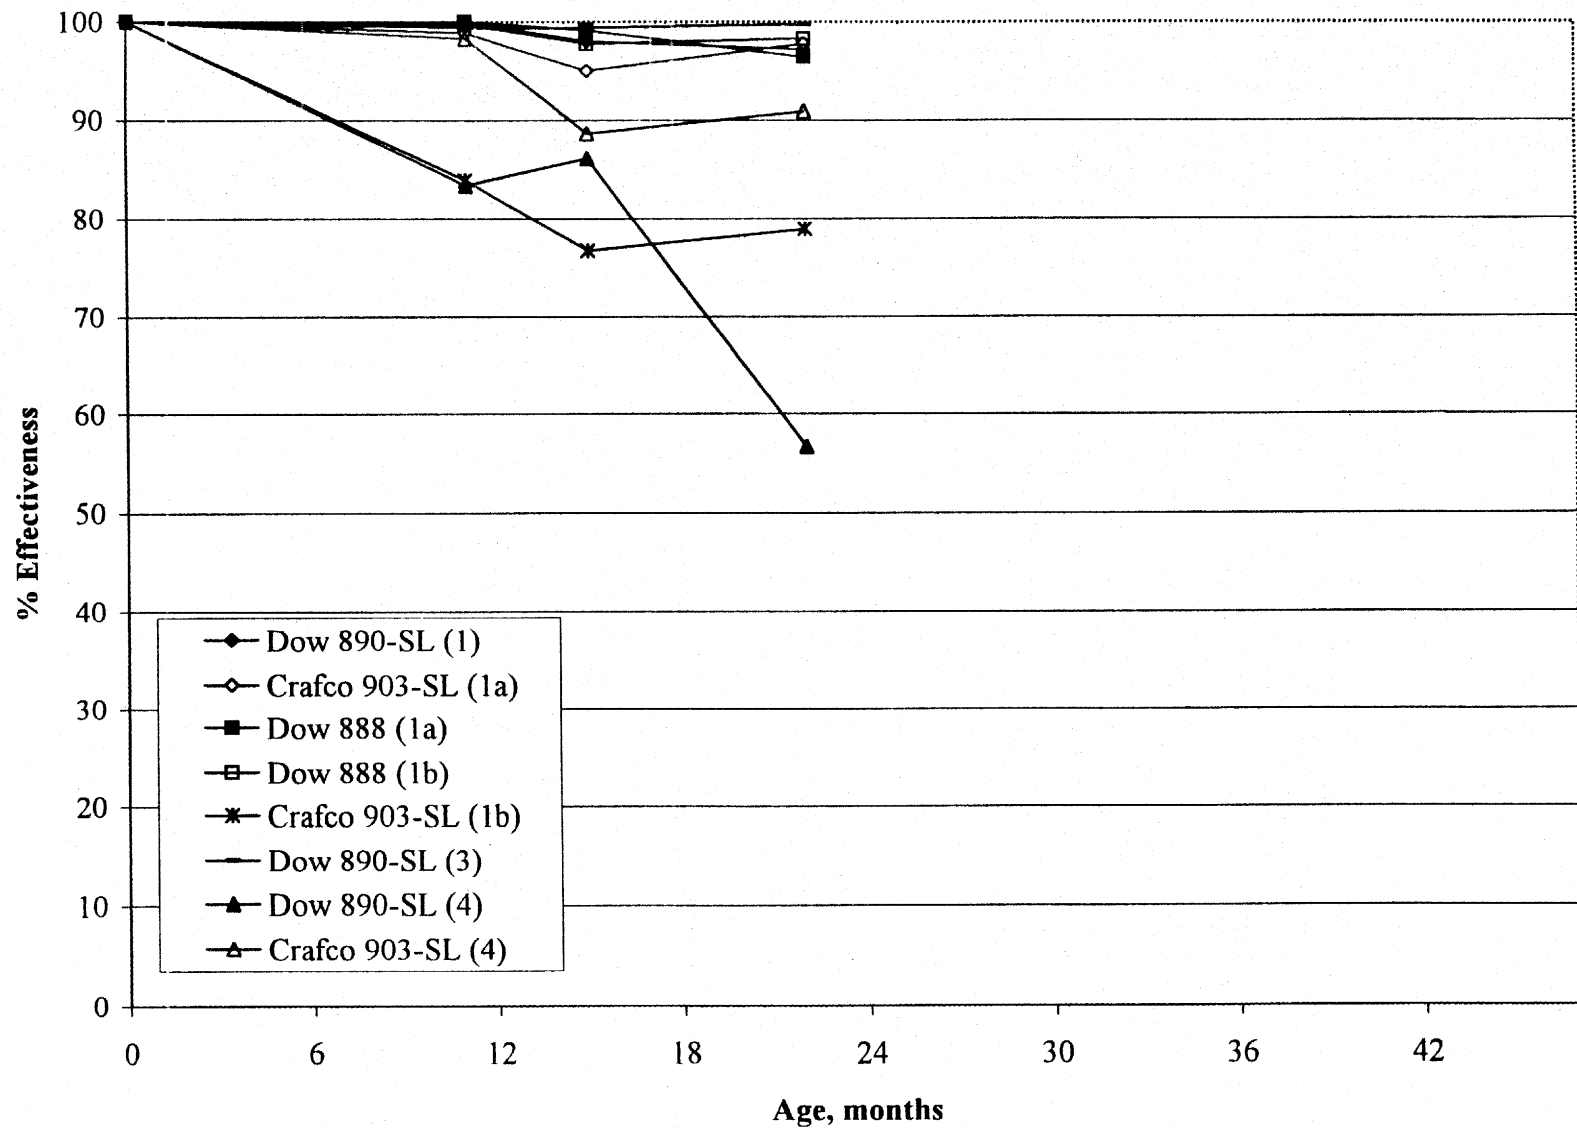
Figure 5.25 Deterioration of silicone sealants in the westbound lanes as of WBOC00

observed to have high initial effectiveness values and experience little or no loss of effectiveness in later surveys (Figure 5.25). In view of the lack of deterioration in the westbound lanes, it is likely that it is poor installation led to the loss of effectiveness in the silicone sealants in the eastbound lanes.

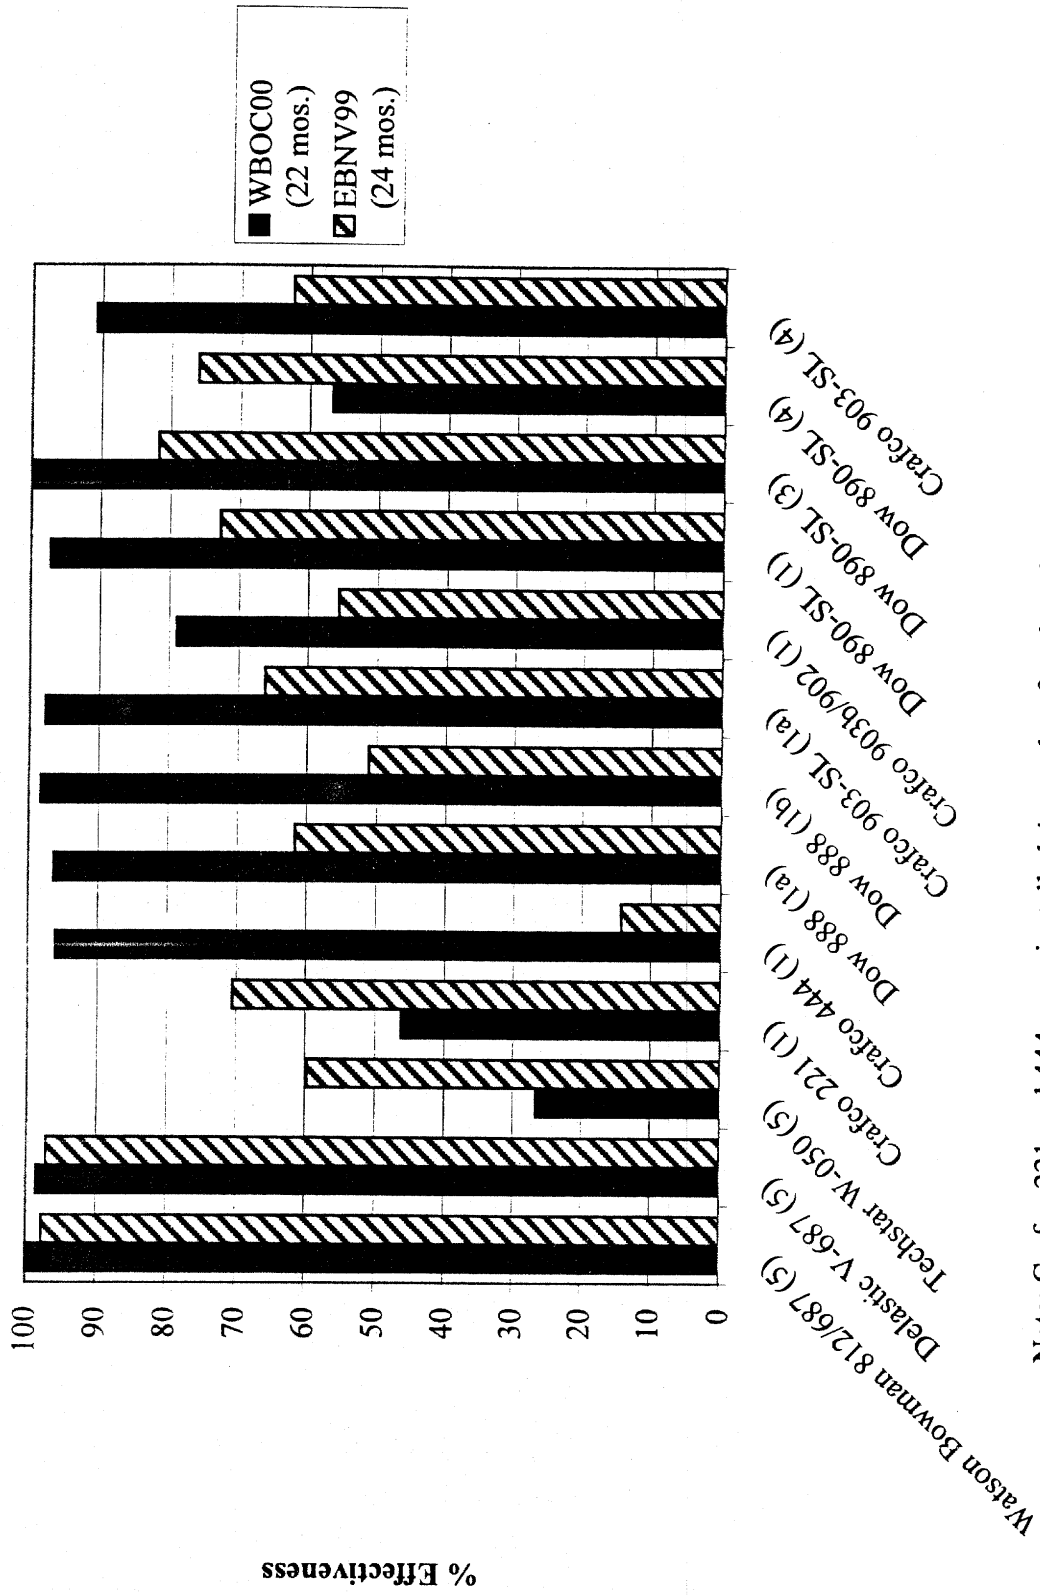
Figure 5.26 Comparison of eastbound and westbound lane sealants after 2 years in service

The performance of the westbound compressive seals manufactured by Watson Bowman and Delastic is very similar to their counterparts in the opposite lane direction since none has experienced an effectiveness loss. The Techstar W-050 (5) seals offer one of the few exceptions found in Figure 5.26. The eastbound Techstar seals performed much better than those in the westbound lanes. The former maintained 60% effectiveness

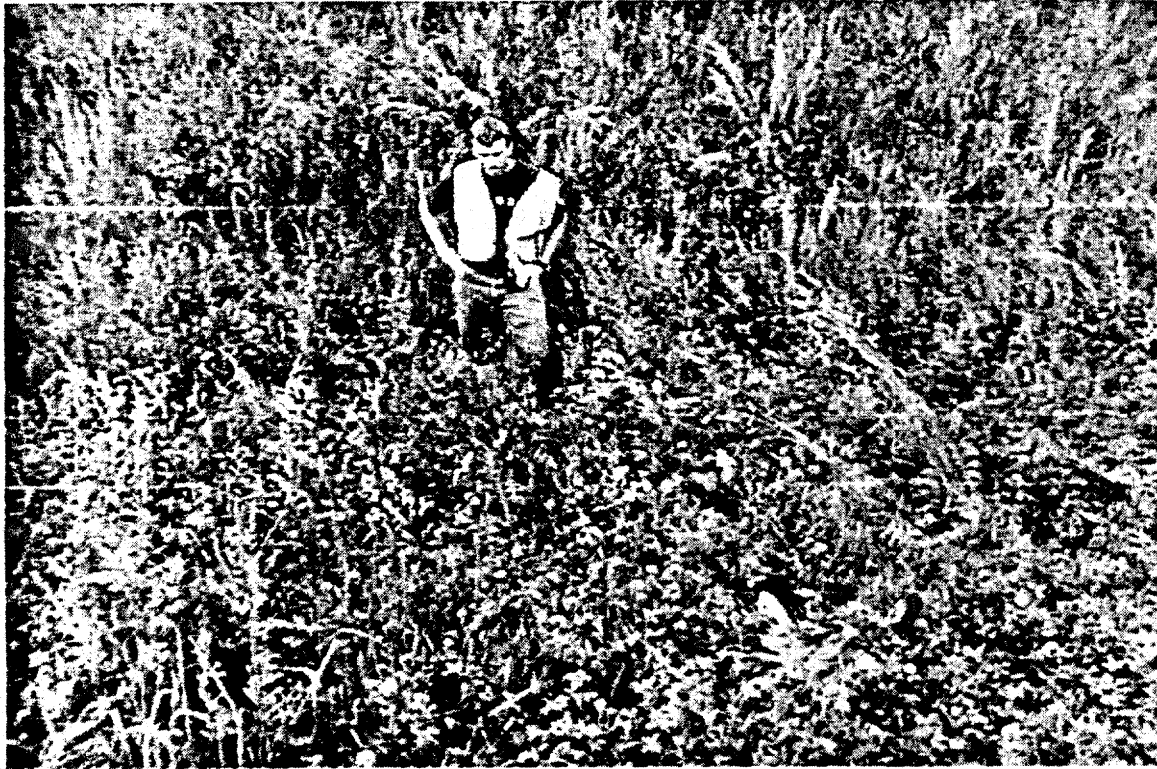
Some of the outlets that listed on the Ohio Department of Transportation (ODOT) specifications and plans (ODOT, 1995) were not found. Of the 26 outlets listed in the project span, 19 were found (73%). Many of the outlets were engulfed by tall vegetation growth (Figure 6.3), which had to be cleared before they could be examined (Figure 6.4). The area adjacent to the shoulder had been mowed, but the region further back, where the outlets are located, had not been (Figure 6.5). Such regions are intentionally left unmowed for environmental conservation reasons (Bob McQuiston, 2001: personal communication). It is believed that some of the outlets were not found because of the thick vegetation, even after the area had been thoroughly searched. Other locations, however, did not have large amounts of vegetation, yet some outlets were not found there either. These outlets were probably never constructed in accordance with the ODOT (1995) plans. The experience of the UC research team is not untypical. Baldwin and Long (1987) conducted a similar evaluation in the mid-1980s, inspecting drain outlets once a year for three years. During their inspections, they never found more than 60% of the total 533 possible outlets. Compared to their efforts, the number of outlets discovered at the Athens project site may be considered remarkable.

Figure 6.3 Tall vegetation made finding the outlets difficult

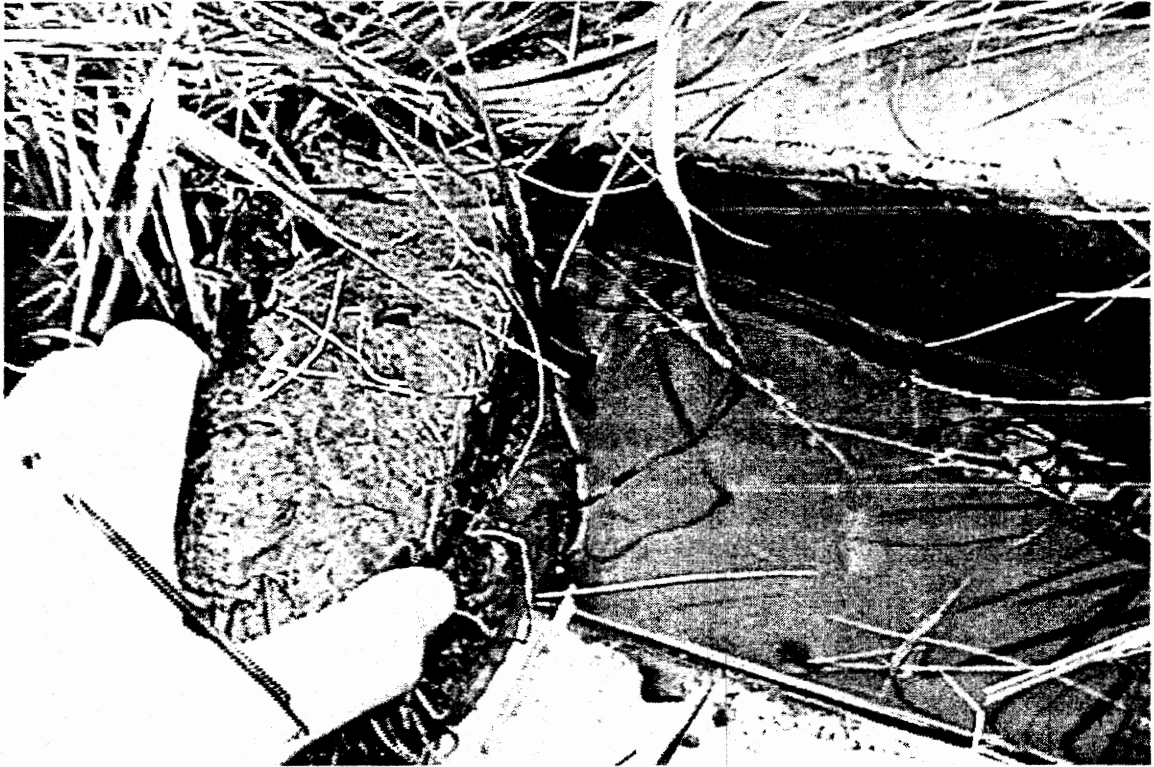
Most of the outlets that were found had large amounts of silt, moss, and weeds in them, and at times this combination was several inches thick (Figure 6.6). One outlet even had a large weed growing out of its rodent screen (Figure 6.7). All outlets were checked for standing or flowing water, which is a telltale sign as to whether the collector pipes are functioning properly. If water is found flowing out of the outlet, the drain is obviously

Figure 6.6 Combination of silt, moss and weeds that has collected in the outlet

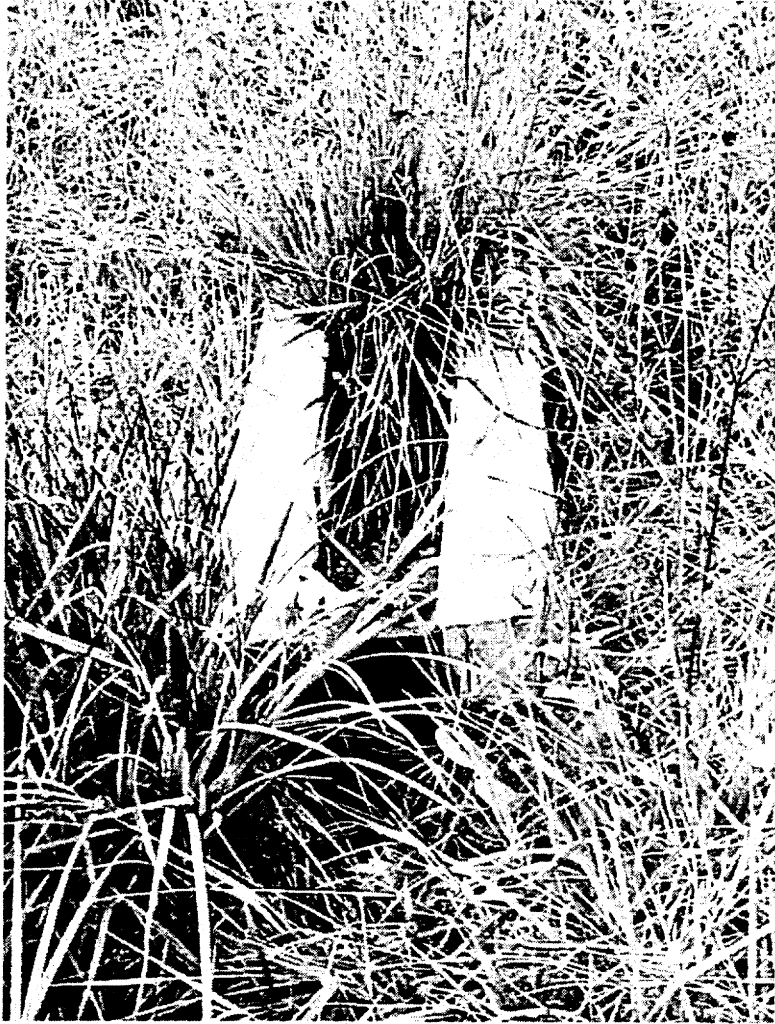
**Figure 6.7** A large weed growing out of one of the outlets

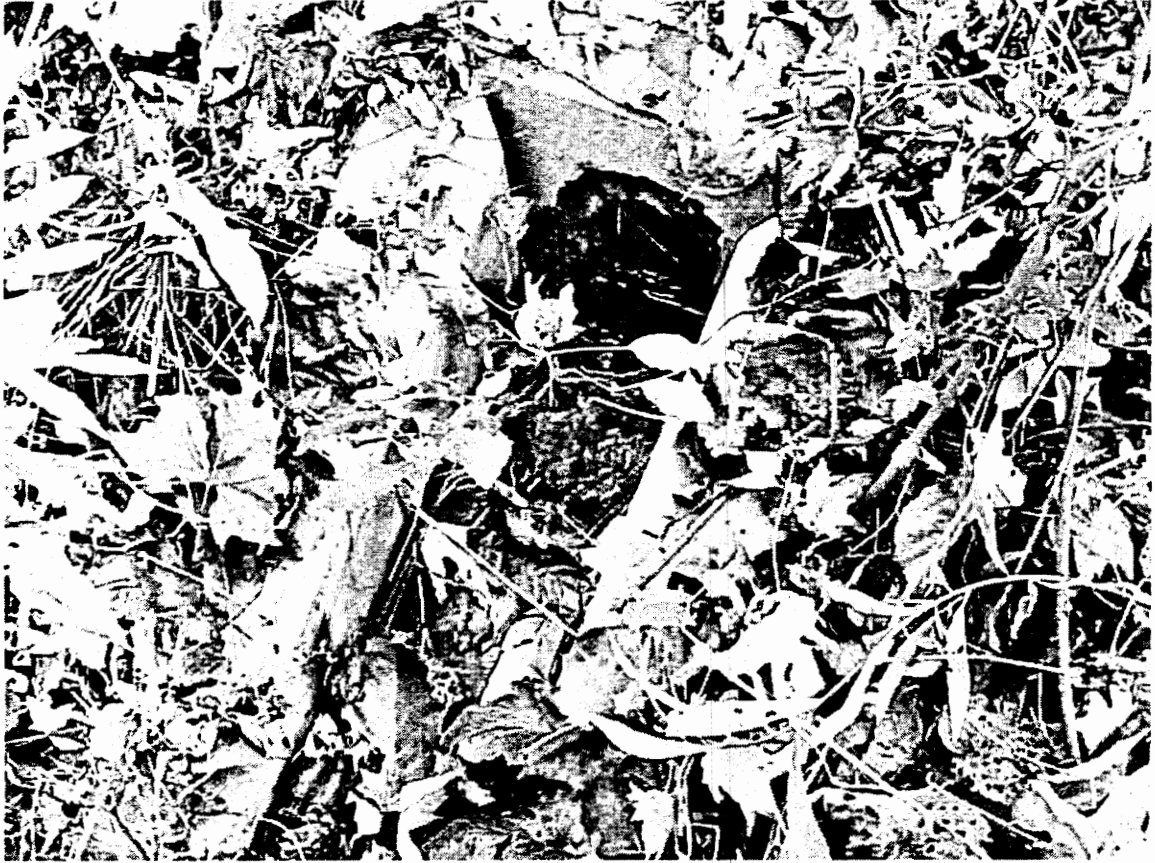
**Figure 6.8** Water flowing out of the outlet
