Highway Concrete Pavement Technology Development and Testing: Volume I— Field Evaluation of Strategic Highway Research Program (SHRP) C-202 Test Sites (Alkali-Silica Reaction (ASR))

PUBLICATION NO. FHWA-RD-02-082

AUGUST 2006

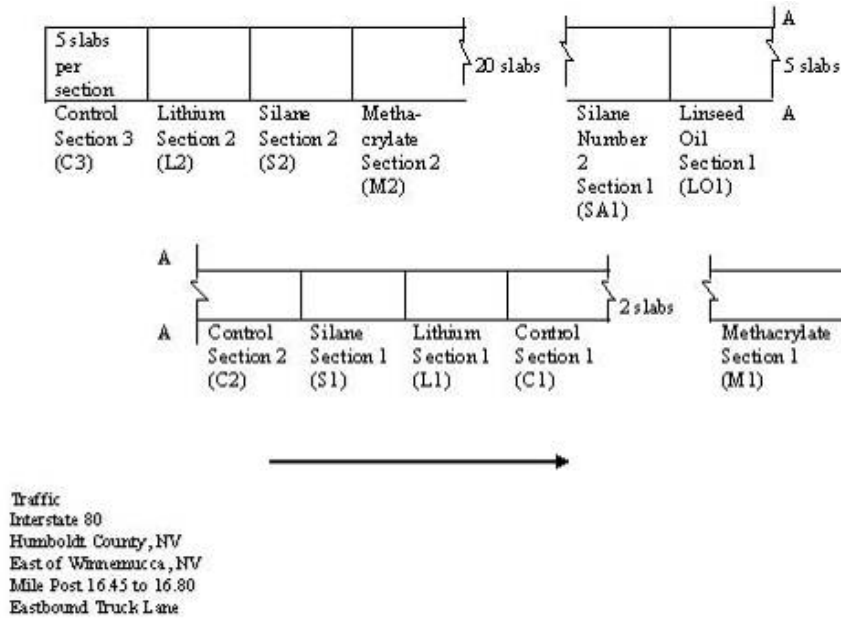
Figure 2. Winnemucca, NV test section layout.

A third surface treatment was Sikagard 70. It was a blend of polysiloxane resins that was a colorless, nonfilm-forming, nonvapor barrier formulation to seal absorbent cementitious surfaces. The intent was to minimize penetration of atmospheric moisture into the concrete pavement, thereby reducing additional cracking from swelling of ASR gel reaction products. Figure 2 shows the location of the individual test sections.

On October 7, 1992, one year after the initial testing, three additional surface treatments were applied on the same region of Eastbound I-80 near Winnemucca. One application of linseed oil and one of SilAct silane each were applied to test sections as shown in figure 2. Also, two applications of the 10 percent LiOH solution were applied to the same test sections, at the same locations as before. These were applied at the rate of 1.7 m²/3.8 L (18 ft²/gal).

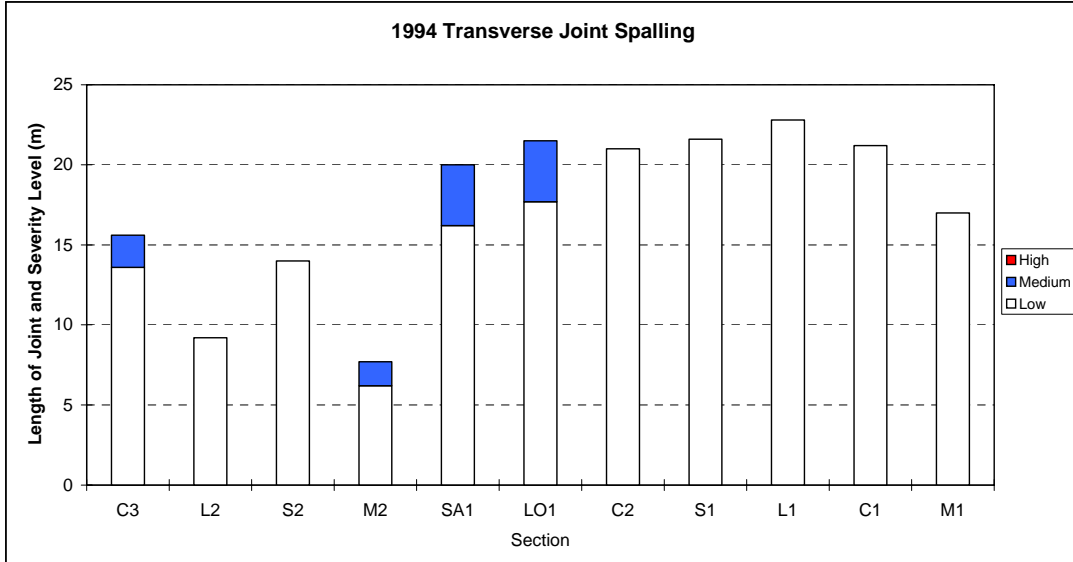
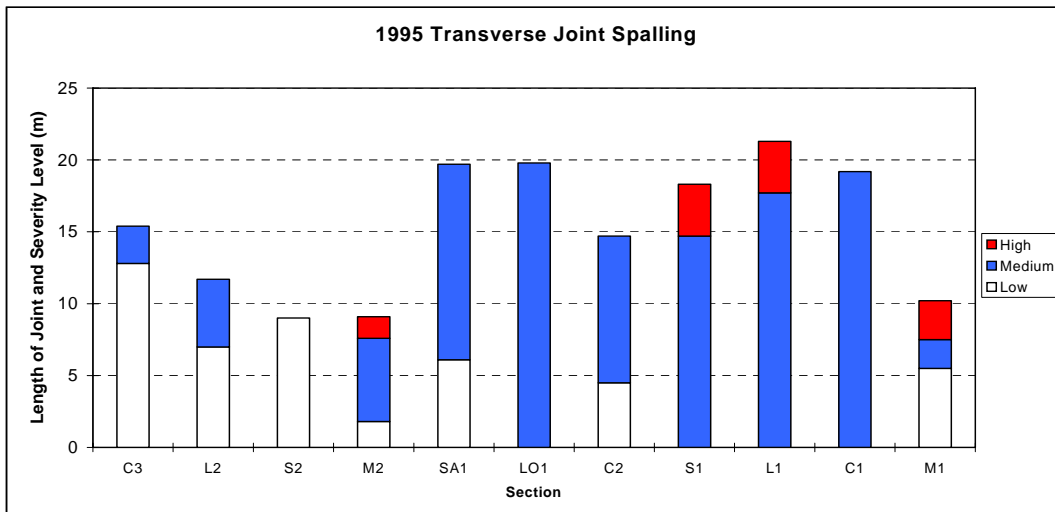
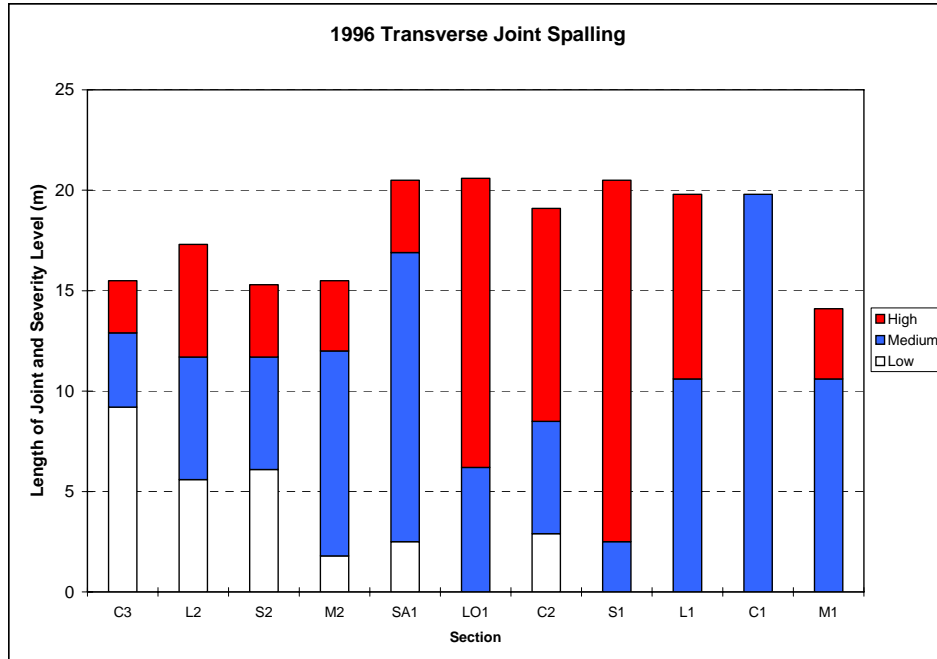
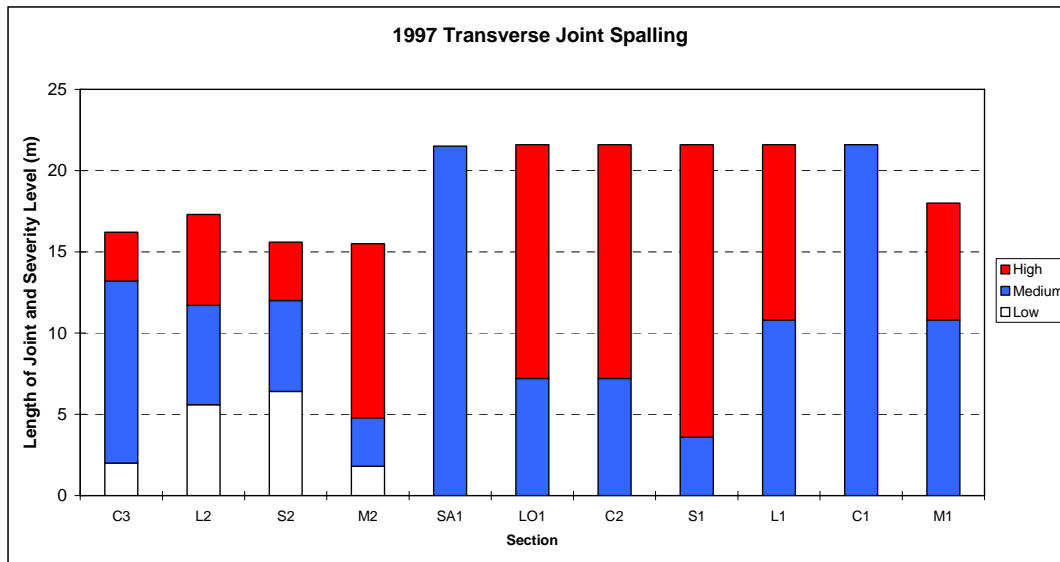
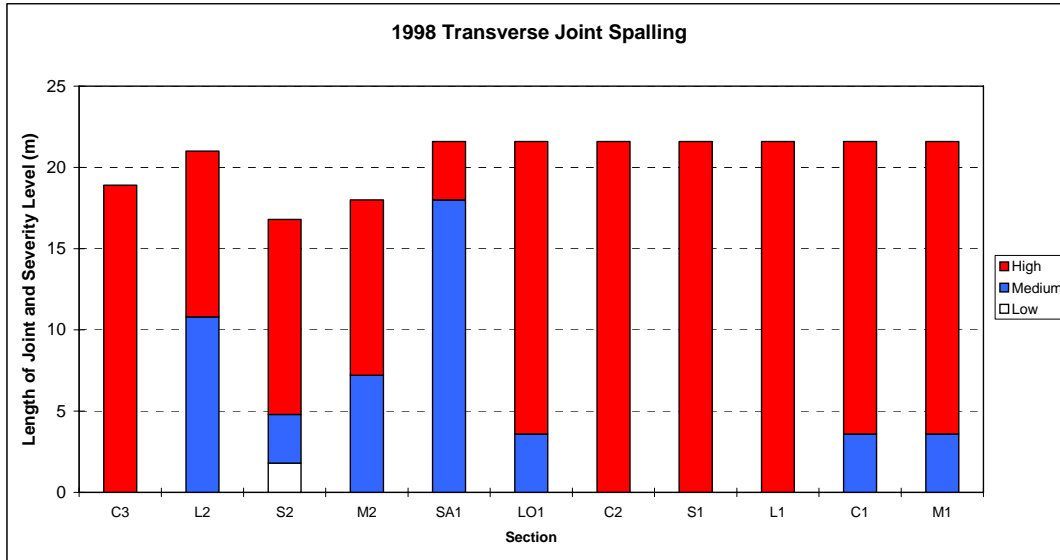
Figures 5 through 9 show the amount and severity of joint distress for each section over the 4 years of the study. The figures are based on the 10 percent rule defined in the LTPP rating system. The amount and severity of joint distress has increased considerably during the study period. In 1994, all the joint distress was rated low except for small areas in sections SA1, C3, LO1, and M2 where the rating was medium. At that time, there were a large number of joints that had lengths without cracking or spalling. The deterioration increased to a point in 1998 where almost the entire length of all transverse joints in each test section is distressed. The only section with any joint length rated low was section S2 (figure 9). The joints in several sections (C2, L1, C3, and S1) are rated high using the 10 percent rule.

Figure 5. Joint distress for all sections of Winnemucca test site (1994).

Figure 6. Joint distress for all sections of Winnemucca test site (1995).

Figure 7. Joint distress for all sections of Winnemucca test site (1996).

Figure 8. Joint distress for all sections of Winnemucca test site (1997).

Figure 9. Joint distress for all sections of Winnemucca test site (1998).

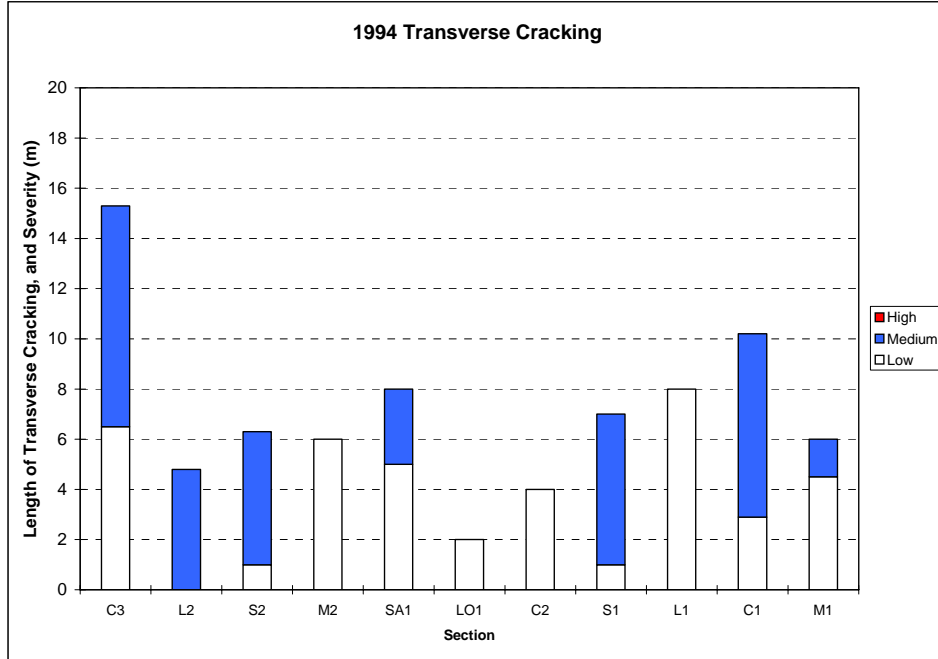
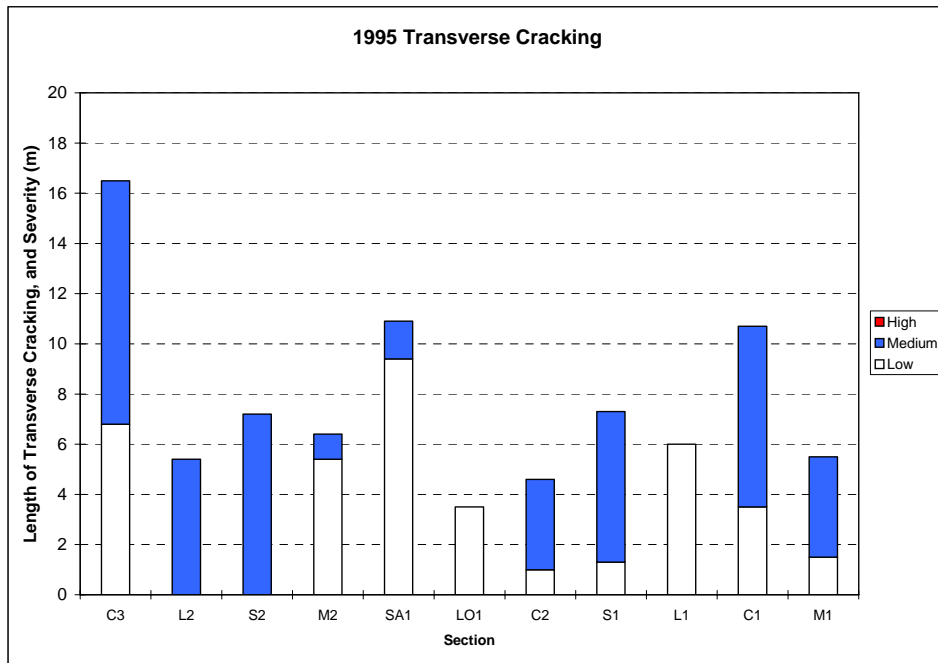
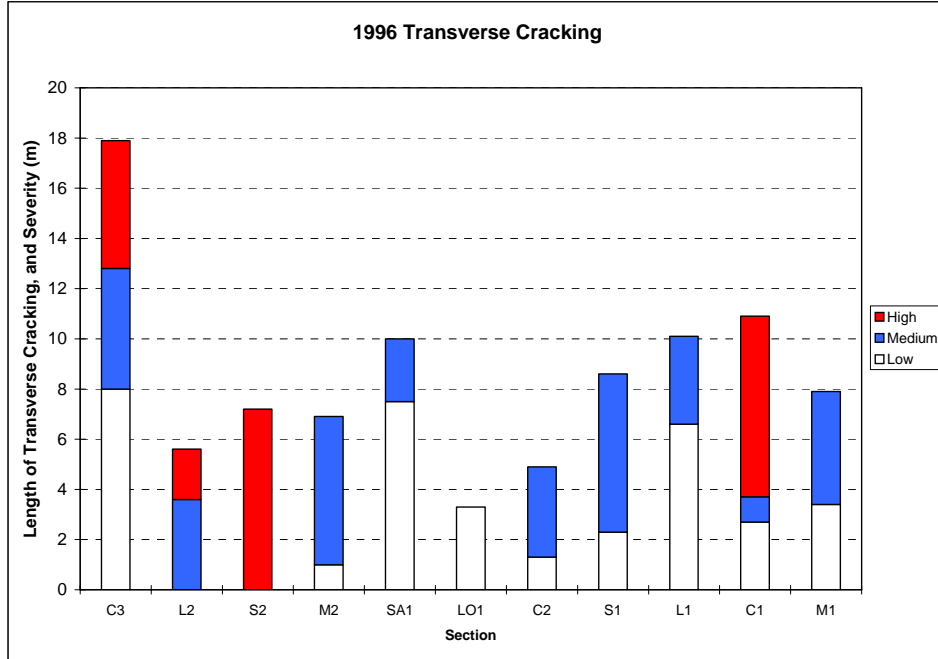
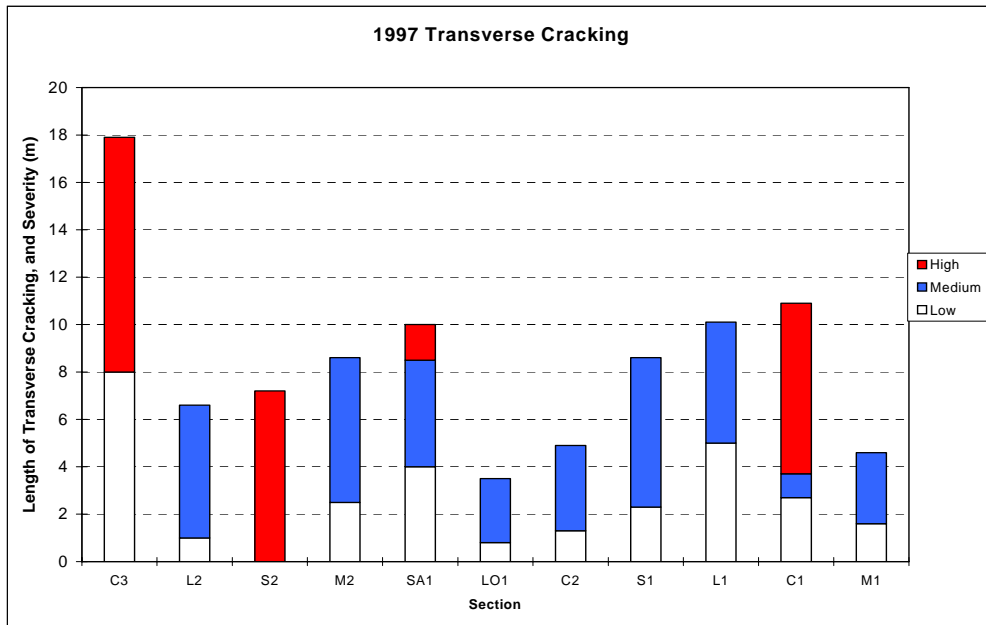
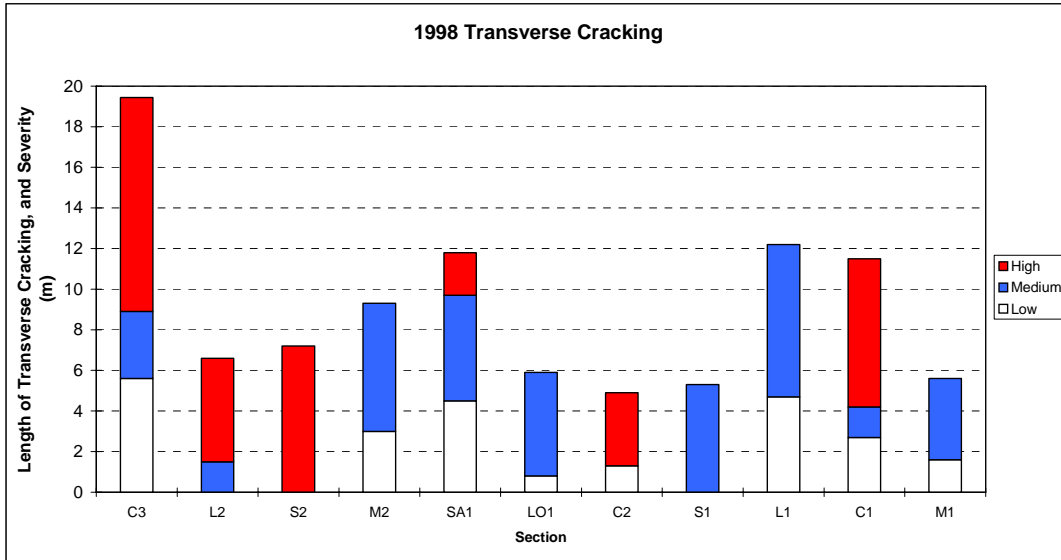
All of the test sections have several transverse cracks, such as that shown in figure 15. Some extend full width while others only reach partway across the lane. Some other transverse cracks, such as the one in figure 16, intersect with longitudinal cracks. A comparison of the transverse cracking for each year is shown in figures 17 through 21. Table 3 indicates the number of transverse cracks in each section for all years of the study. A transverse crack consists of a single distinct crack or a single crack with only a few branches. The number of transverse cracks in a section can decrease if the crack becomes part of an area of severe map cracking.

Figure 17. Amount and severity of transverse cracking for all sections (Winnemucca, NV, 1994).

Figure 18. Amount and severity of transverse cracking for all sections (Winnemucca, NV, 1995).

Figure 19. Amount and severity of transverse cracking for all sections (Winnemucca, NV, 1996).

Figure 20. Amount and severity of transverse cracking for all sections (Winnemucca, NV, 1997).

Figure 21. Amount and severity of transverse cracking for all sections (Winnemucca, NV, 1998).

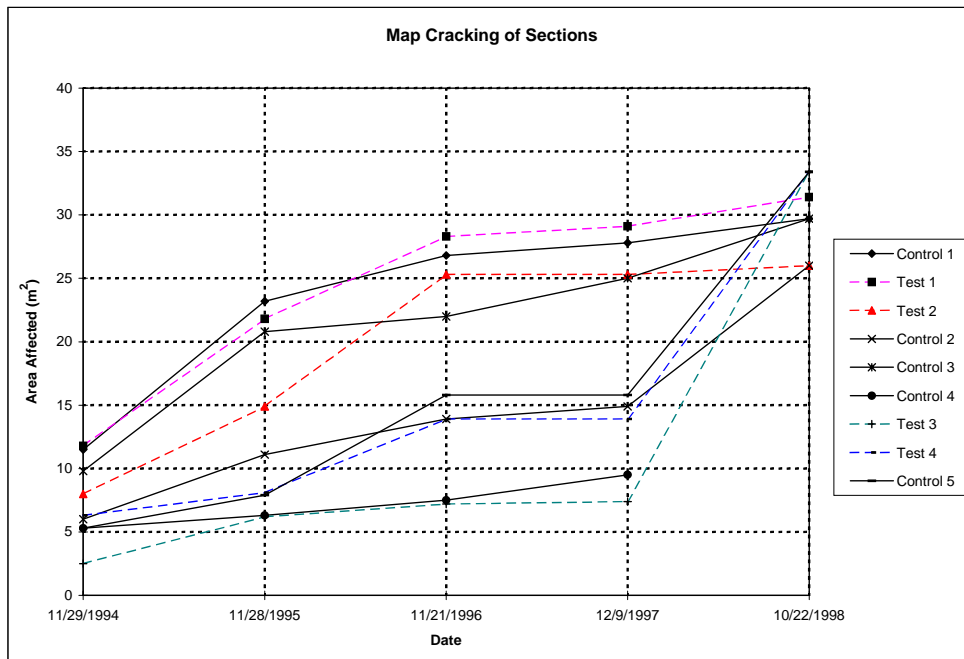
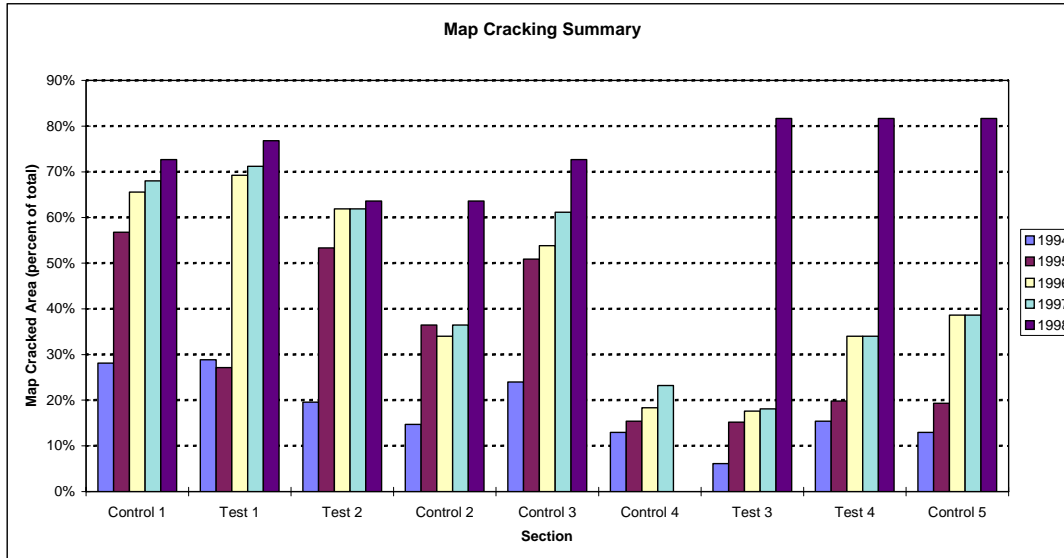
The area of each slab affected by map cracking has increased over the 4 years of the study. Figure 25 shows a graph of the area affected in each section over the 4 years of the study. Two levels of distress are apparent. One group, which consists of control 1, test section 1, test section 2, and control 3, has approximately the same area affected by map cracking. The area has gradually been increasing over the 5 years. The other group consists of control 2, test section 3, test section 4, control 4, and control 5. The area of these sections affected increased gradually over the first 4 years but at a lower level than the other group. However, the area affected increased sharply in the last year of the study and was at the same level as the other group. This can also be seen in figure 26, which shows the area affected by map cracking as a percentage of the total section area. All sections had more than 60 percent of their area affected by map cracking in 1998. There is no value for control 4 in 1998. Test section 3, test section 4, and control 5 have the most area affected, at over 80 percent, but these areas had the smallest affected areas the year before. All the map cracking was of low severity.

Figure 25. Area of each slab affected by map cracking over the 5 years of the study (Newark, DE).

Figure 26. Area of each slab affected by map cracking expressed as a percentage of the total section area (Newark, DE).

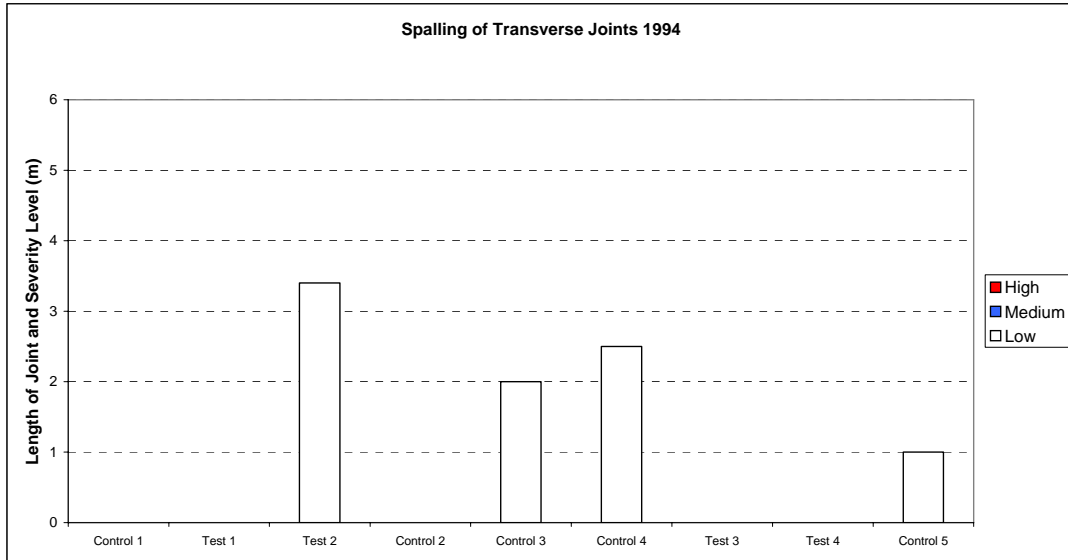
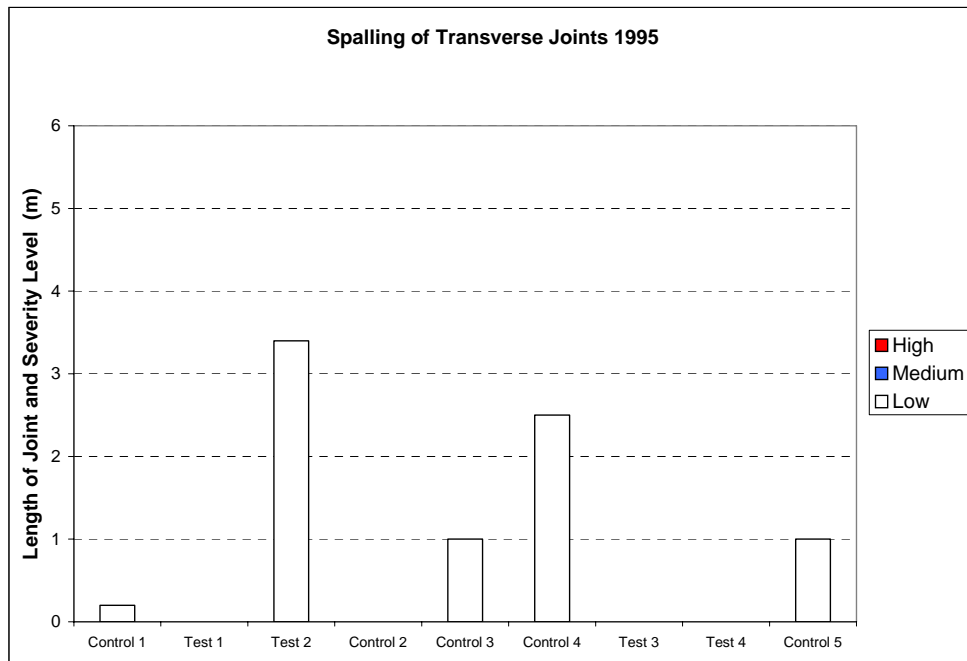
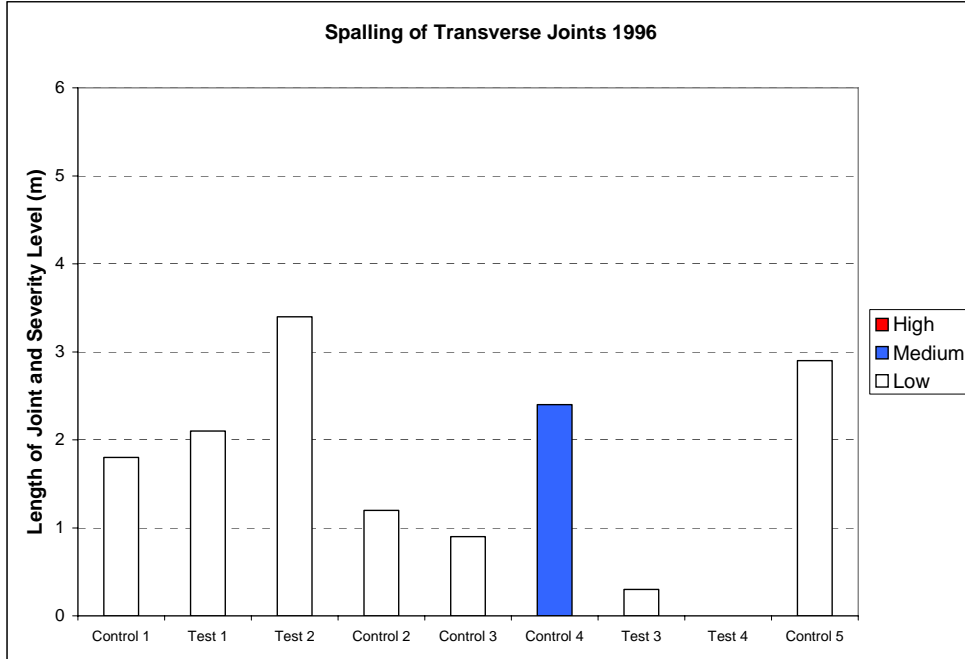
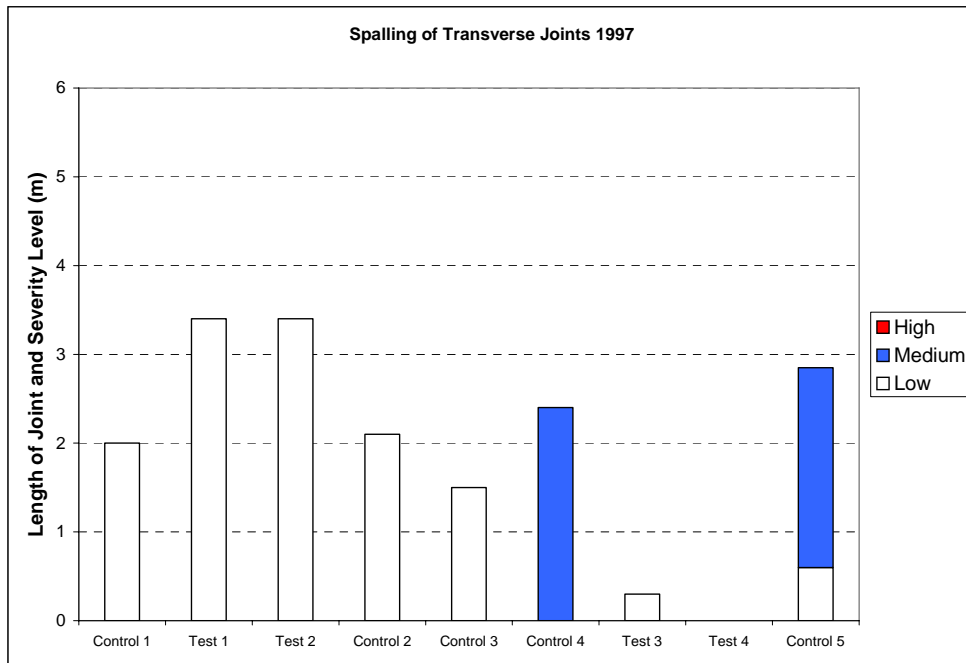
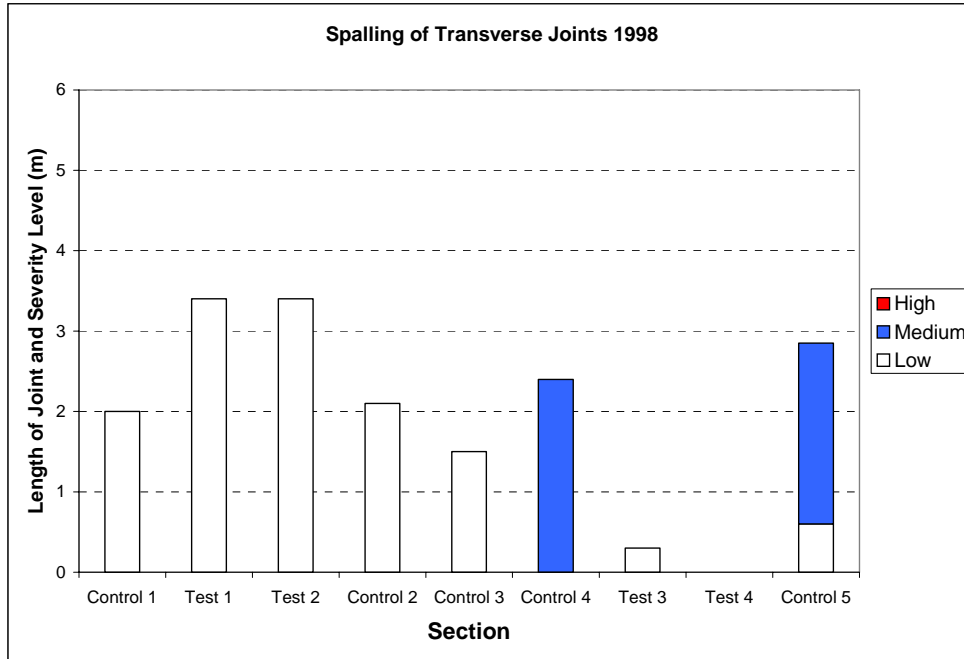
Figures 29 through 33 show the amount and severity of joint spalling over the 5 years of the study. In 1994, the control 3, control 4, control 5, and test section 2 had joint spalling. At this time the spalling was all low severity. In 1998, all sections except test section 4 have transverse joint spalling. All sections have low-severity spalling except control 4 and control 5, which have spalling of medium severity. Test sections 3 and 4 are performing much better than test sections 1 and 2 with respect to transverse joint spalling. This likely is due to the different exposure conditions previously discussed.

Figure 29. Length and severity of joint distress for all test sections (Newark, DE, 1994).

Figure 30. Length and severity of joint distress for all test sections (Newark, DE, 1995).

Figure 31. Length and severity of joint distress for all test sections (Newark, DE, 1996).

Figure 32. Length and severity of joint distress for all test sections (Newark, DE, 1997).

Figure 33. Length and severity of joint distress for all test sections (Newark, DE, 1998).

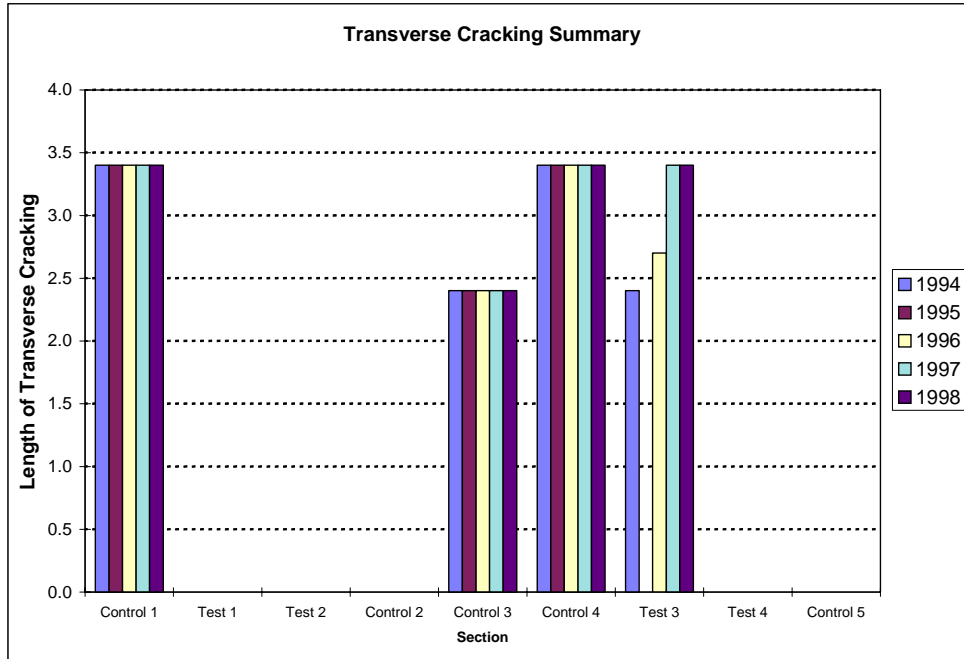
A summary of the transverse cracking in each section over the 5 years is shown in figure 34. The only sections with transverse cracking are control 1, control 3, control 4, and test section 3. The cracking in the three control sections had occurred before the first year of the study and did not increase in length or severity during the next 4 years of the study. The cracking in test section 3 had also occurred before the first year of the study but increased in length over the 4 years. There was no increase in severity, and all severity ratings are low. Generally, the transverse cracking of the Delaware test sections were there before the study began and do not appear to be getting more severe.

Figure 34. Summary of transverse cracking in each section for the five inspections (Newark, DE).

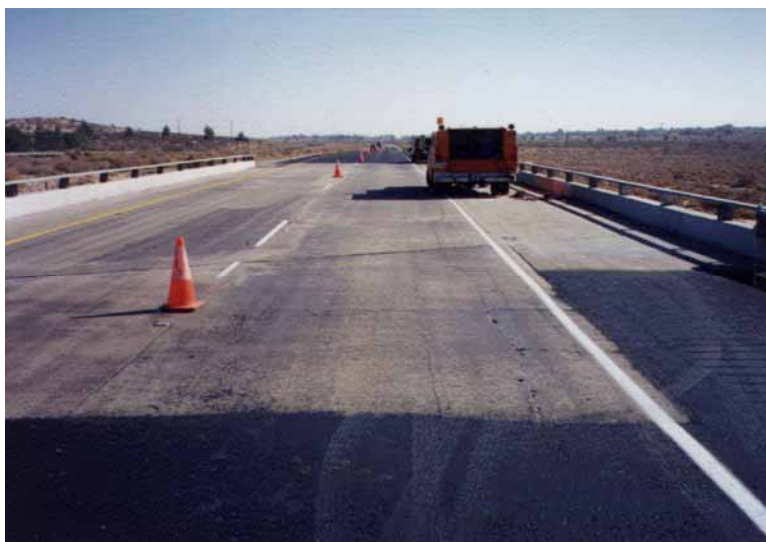
The Boron overhead, Bridge No. 50-353R 9-KER-58-R141.5, consists of two parallel structures carrying State Route 58 over the rail spur leading to the U.S. Borax mine in Boron, CA. Each structure consists of a three-span continuous bridge with no expansion joints. Each bridge has two traffic lanes and a shoulder. The bridge beams were cast integrally with the deck slab. The entire deck appears to be undergoing significant ASR, as manifested by widespread visible map cracking. The deck surface was treated with a methacrylate (HMWM) in 1995, into which a coarse, rounded sand was broadcast. Figure 35 shows a photograph of the deck surface.

Figure 35. Treated section on Boron overhead structure over State Route 58 looking east (Boron, CA).

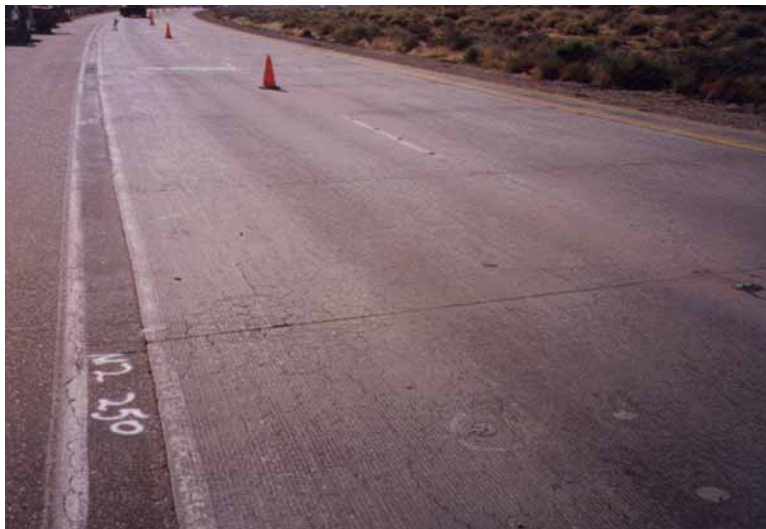
Figure 36. Photograph showing part of Boron, CA, test site, M2, Station 250.

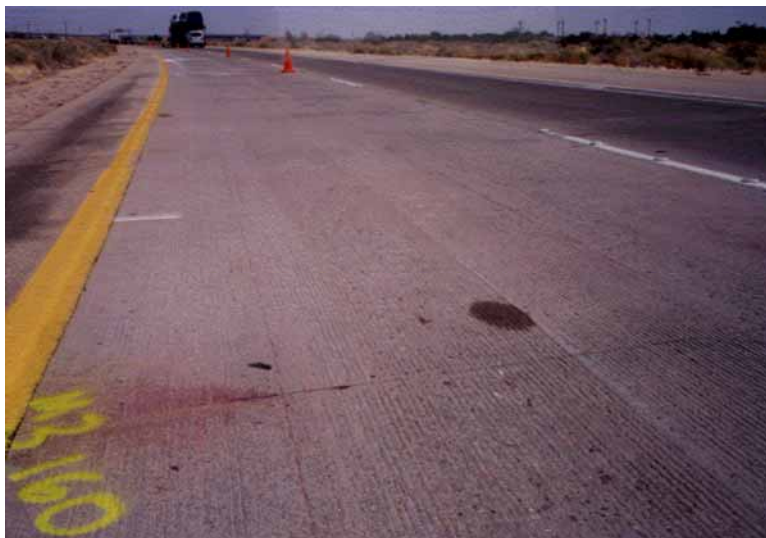
Figure 37. Photograph showing part of Boron, CA, test site, M3, Station 160.

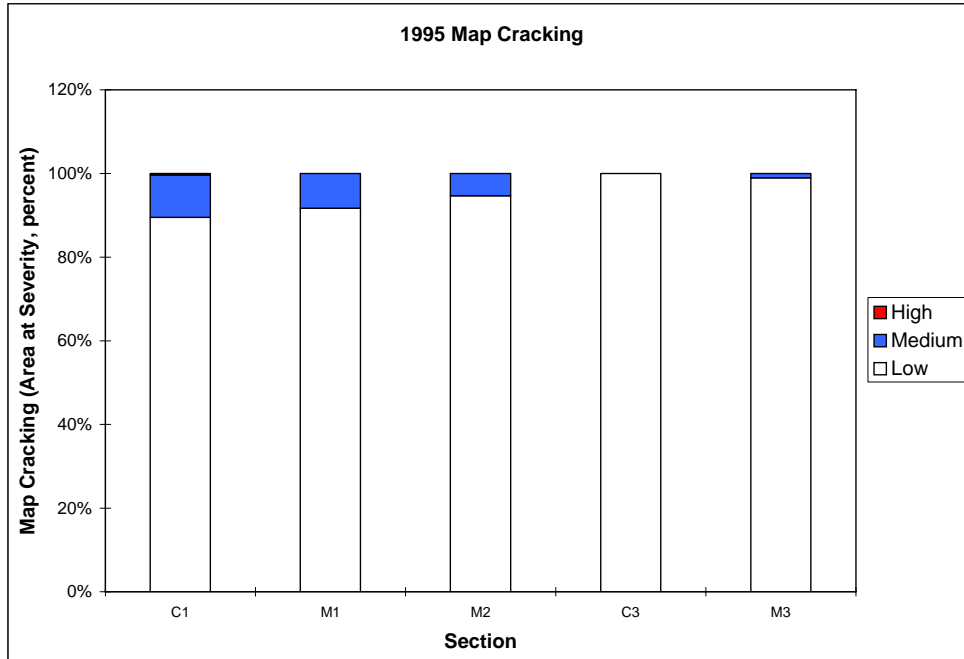
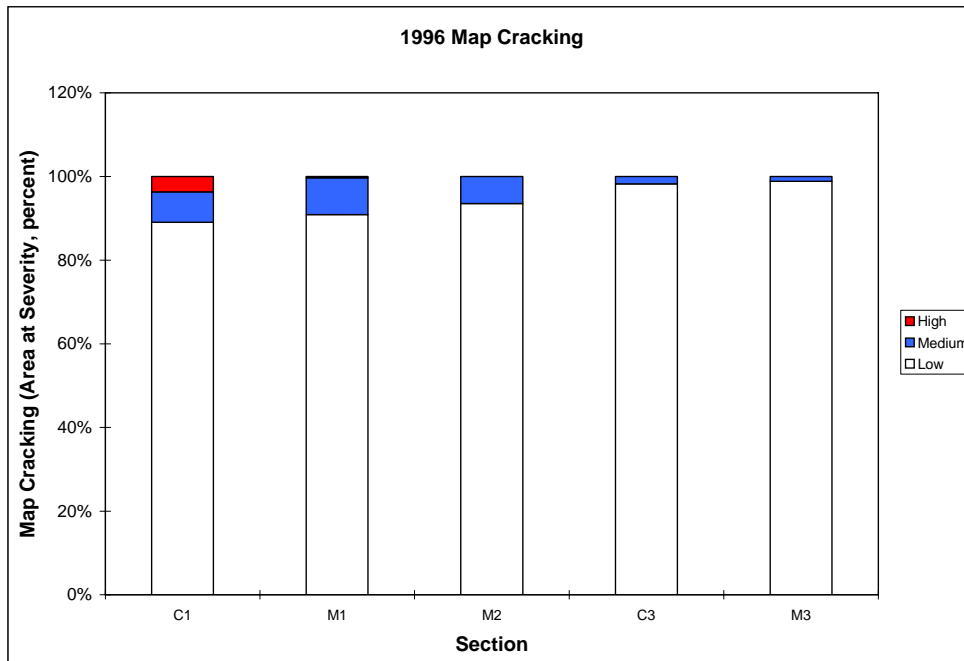
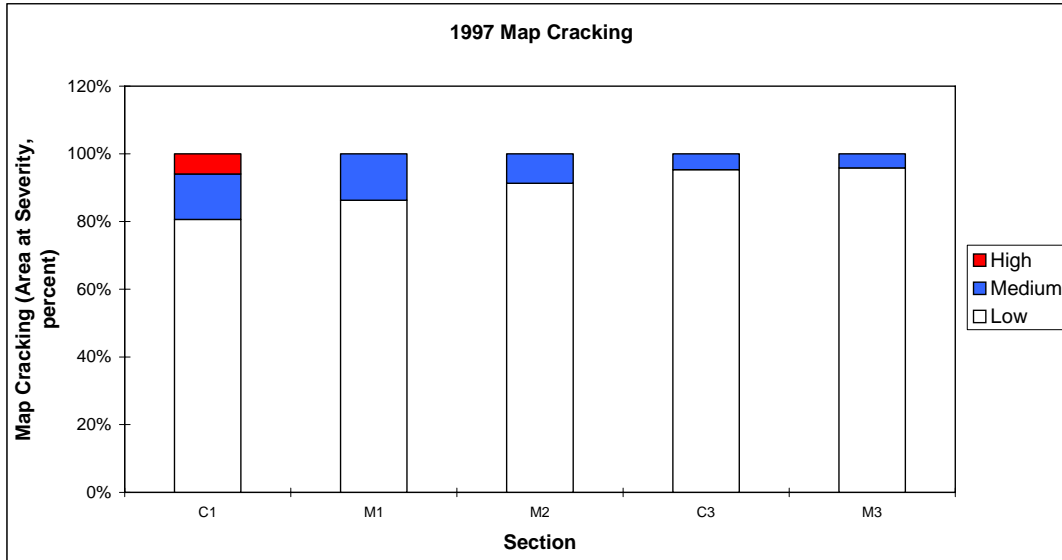
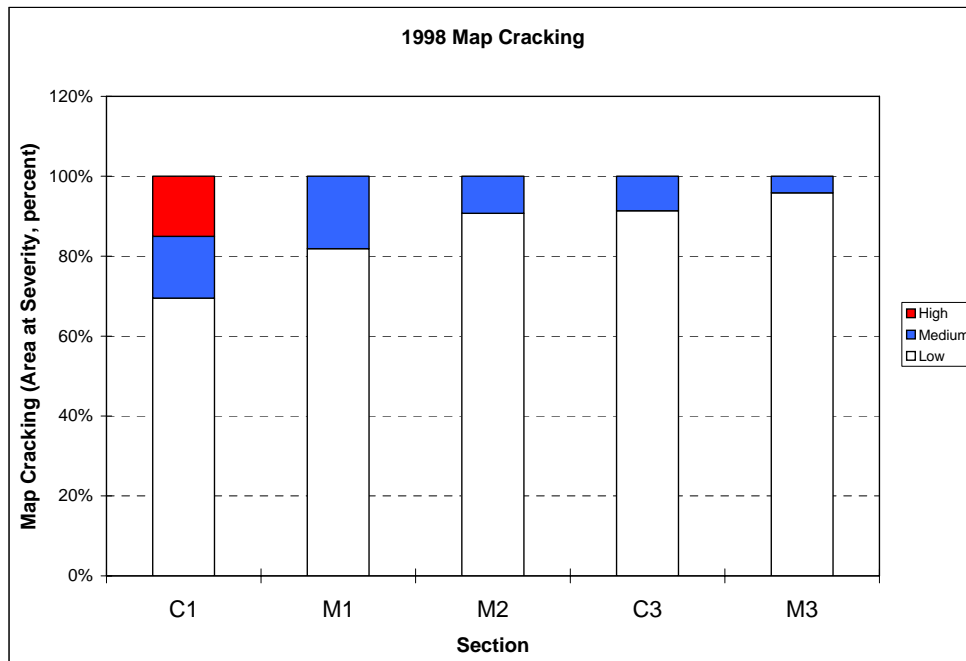
All the sections making up the Boron, CA, test site had map cracking over 100 percent of their area in 1998. Most of the map cracking was of low severity, but there was some medium and high severity also. Figure 39 shows an example of high-severity map cracking. Figure 40 shows a close-up view of typical map cracking at the Boron site. Figures 41 through 44 show the amount of each level of severity as a percentage of the total area for each section for all 5 years of the study. In the travel lane, control section 1 (C1) had more severe map cracking than the methacrylate sections (M1 and M2). The cracking was less severe in M2 than in M1. It appears that the second application of methacrylate to section M2 in 1995 has helped reduce cracking. In the passing lane, methacrylate section 3 (M3) is performing better than control section 3 (C3). Overall, the passing lane sections are performing better than the travel lane sections. A description of the map cracking in each section is as follows:

Figure 41. Map cracking as a percentage for each level of severity (Boron, CA, 1995).

Figure 42. Map cracking as a percentage for each level of severity (Boron, CA, 1996).

Figure 43. Map cracking as a percentage for each level of severity (Boron, CA, 1997).

Figure 44. Map cracking as a percentage for each level of severity (Boron, CA, 1998).

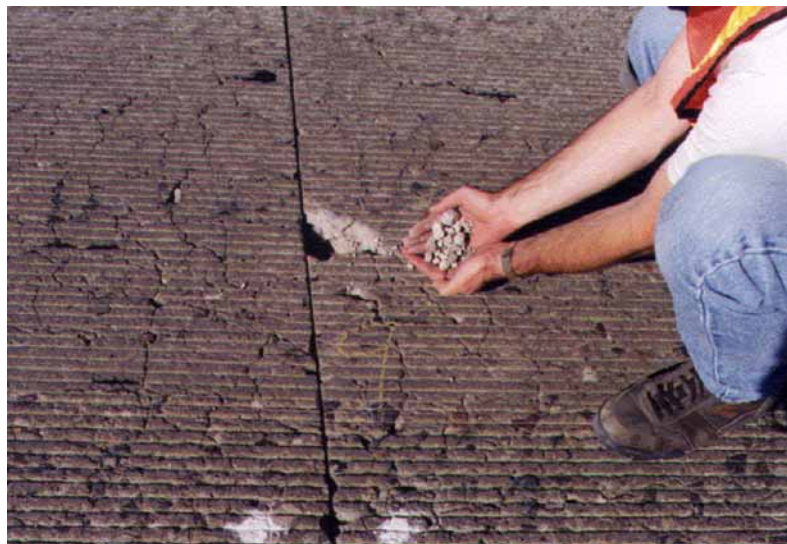
The widespread map cracking in the test sections made exact crack recording impossible. Therefore, only the large, clearly visible cracks were noted. The transverse joints were all completely distressed, with cracks and spalled areas occurring over the entire length of the joints. Figure 45 shows a photograph with an example of medium-severity joint distress. Figure 46

Figure 46. Photograph showing an example of high-severity joint distress (Boron, CA).
