Highway Concrete Pavement Technology Development and Testing: Volume I— Field Evaluation of Strategic Highway Research Program (SHRP) C-202 Test Sites (Alkali-Silica Reaction (ASR))

PUBLICATION NO. FHWA-RD-02-082

AUGUST 2006

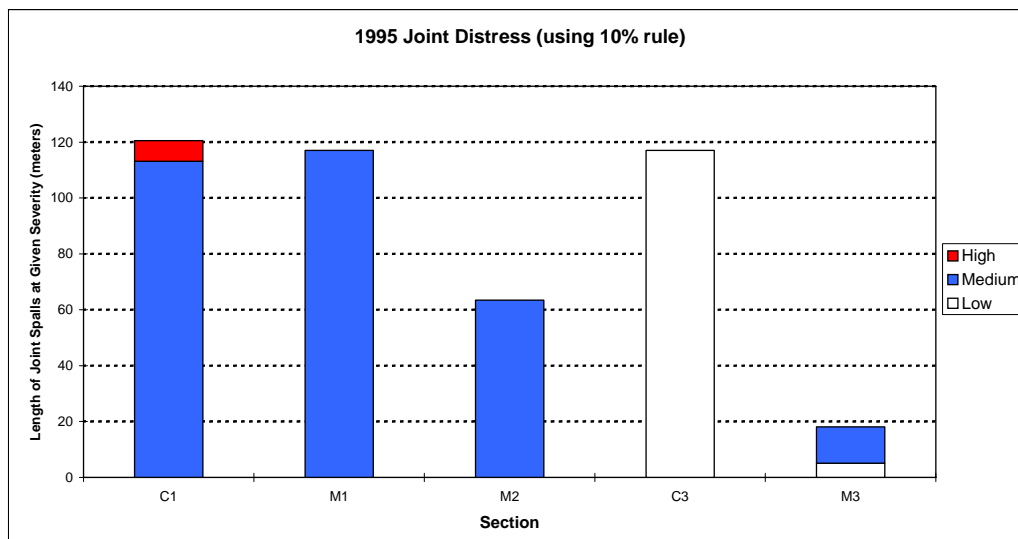
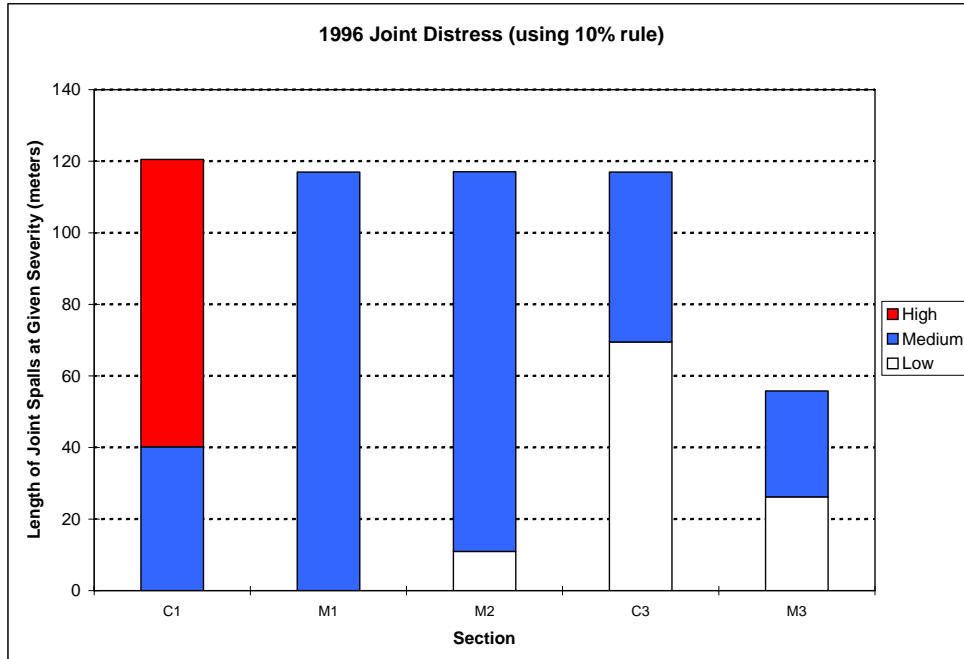
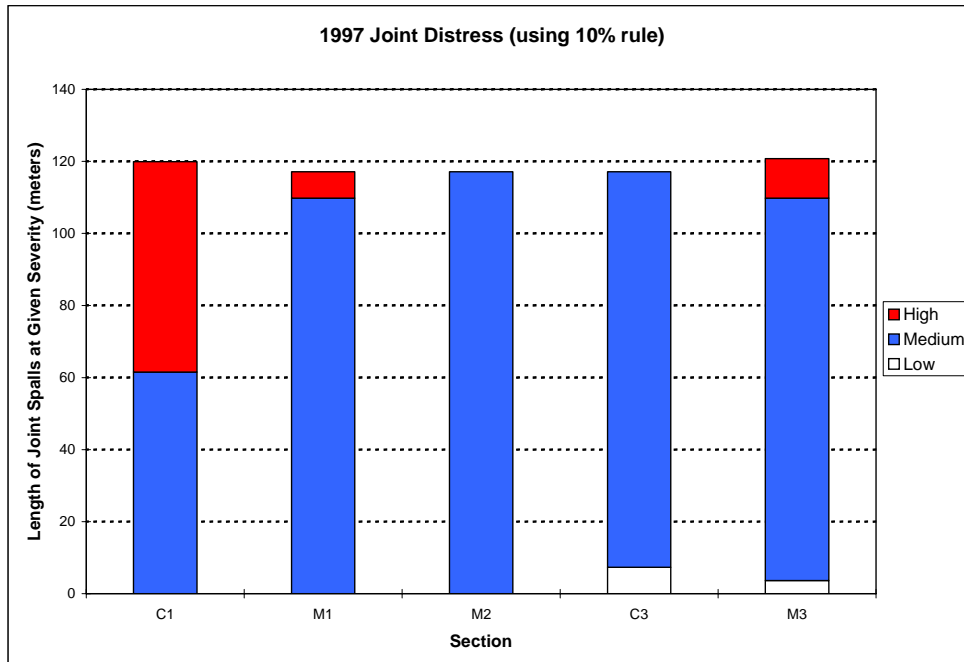
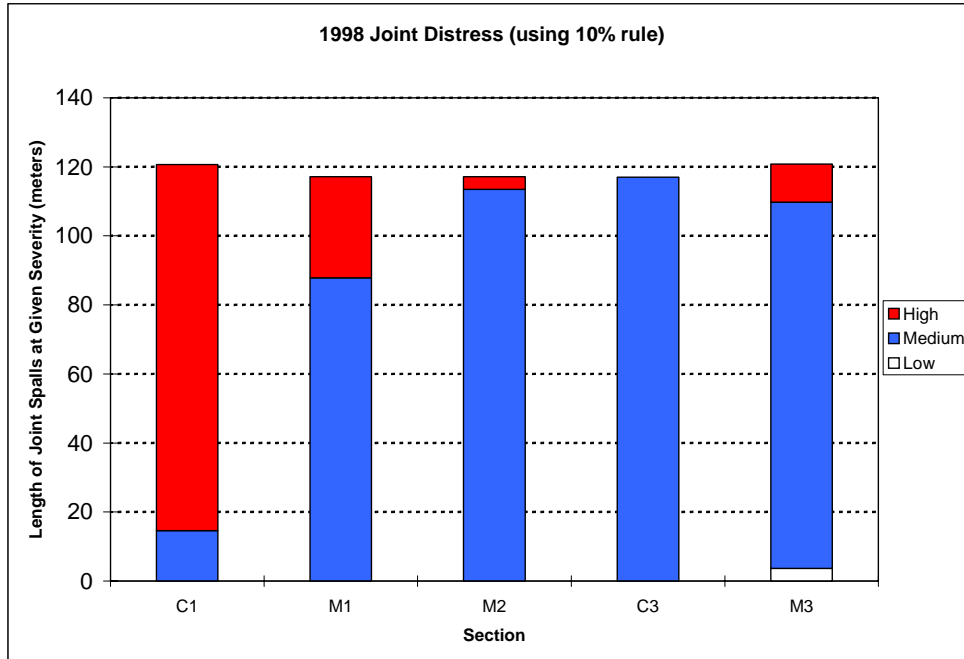
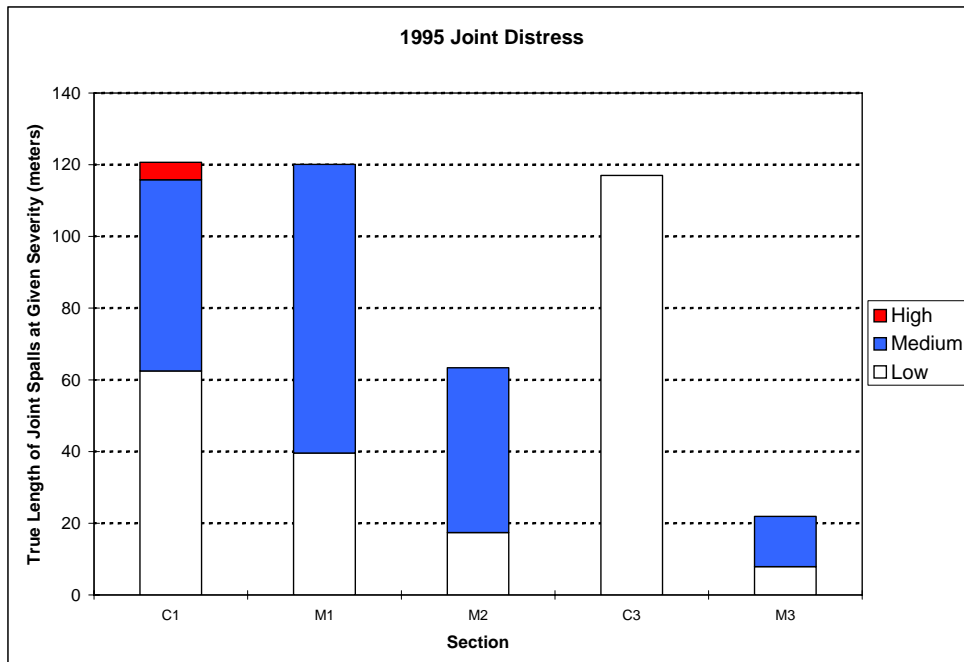
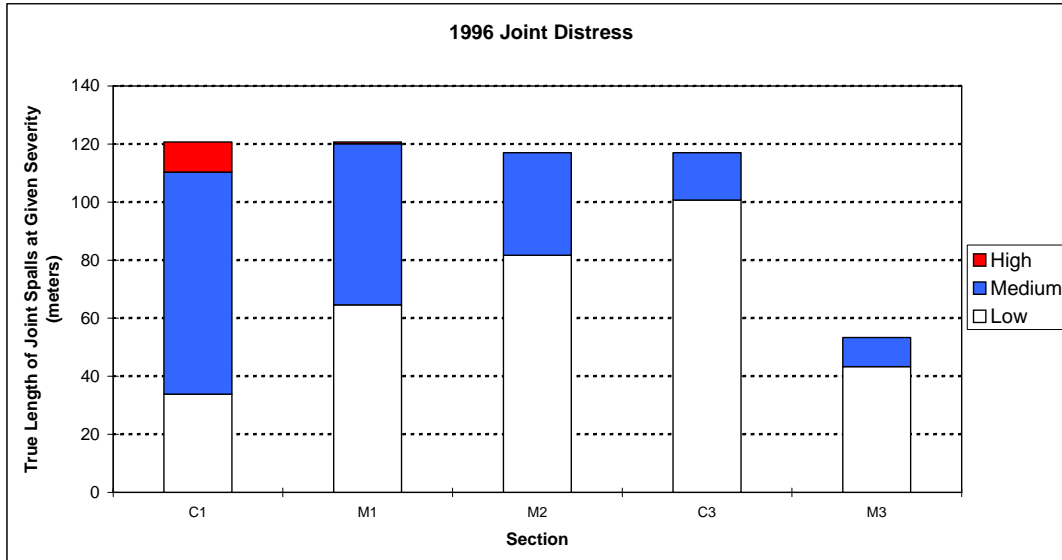
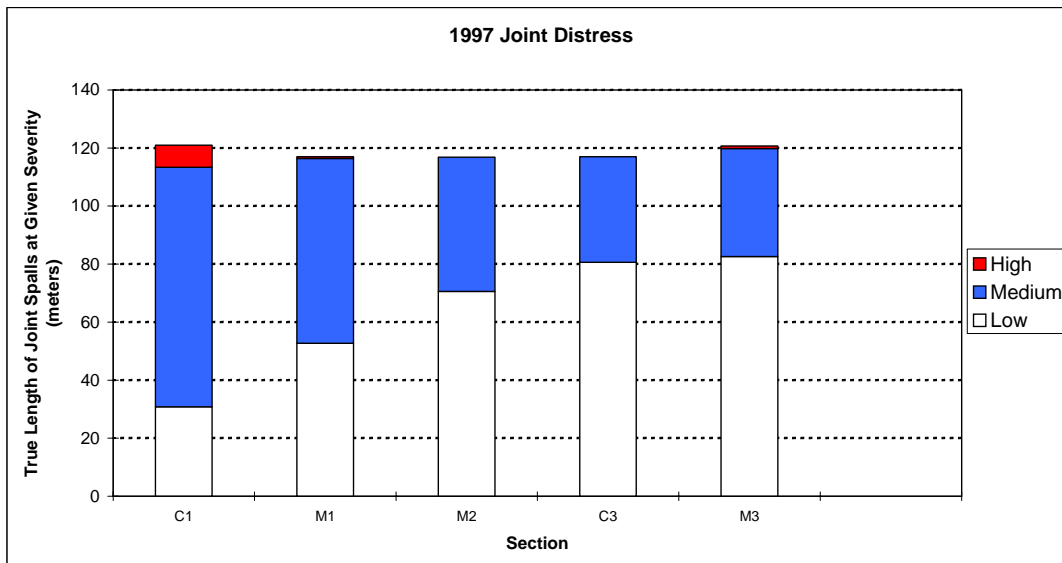
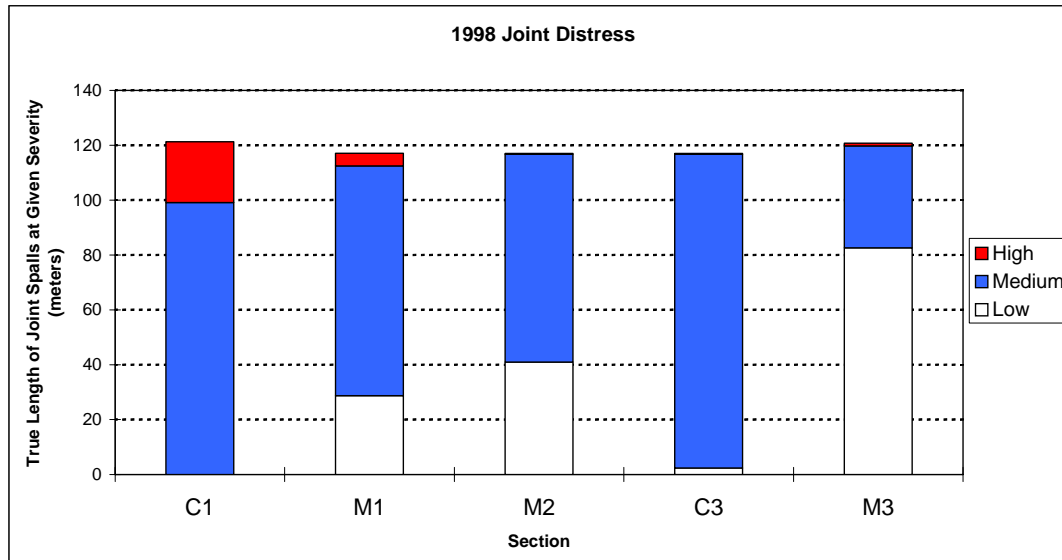
Figures 47 through 50 are a series of graphs illustrating the amount and severity of joint distress for each section. There is also a series of graphs showing the actual lengths of distress at each level in figures 51 through 54. Both series compare all sections for each year. The 1998 observations of the joint distress for individual sections are as follows:

- Control 3—section control 3 has a rating of medium severity over the full joint length using the 10 percent rating scheme, but the true lengths show a small amount of low severity. Section C3 in the passing lane is much better than the control C1 in the travel lane.

- Methacrylate 3—the joint distress in section M3 appears to be more severe than that of C3 when using the 10 percent rule. Using this rule, C3 is performing better than M3 with C3 having all medium severity and M3 having mostly medium-, some high-, and a very small amount of low-severity distress. The actual length of each severity shows M3 has about two-thirds of its joint length rated as low severity, one-third medium severity, and a very small amount of high severity. If the actual length of each severity is used for comparison, M3 is performing much better than C3.

Figure 47. Amount and severity of joint distress (Boron, CA, 1995).

Figure 48. Amount and severity of joint distress (Boron, CA, 1996).

Figure 49. Amount and severity of joint distress (Boron, CA, 1997).

Figure 50. Amount and severity of joint distress (Boron, CA, 1998).

Figure 51. True length of joint spalls at each level of severity (Boron, CA, 1995).

Figure 52. True length of joint spalls at each level of severity (Boron, CA, 1996).

Figure 53. True length of joint spalls at each level of severity (Boron, CA, 1997).

Figure 54. True length of joint spalls at each level of severity (Boron, CA, 1998).

In general, the sections in the travel lane had more severe joint distress than those sections in the passing lane. The control sections had the most severe joint distress in each lane relative to the treated areas. The second application of methacrylate to section M2 appeared to have helped, the severity of distress in M2 being less than that in section M1.

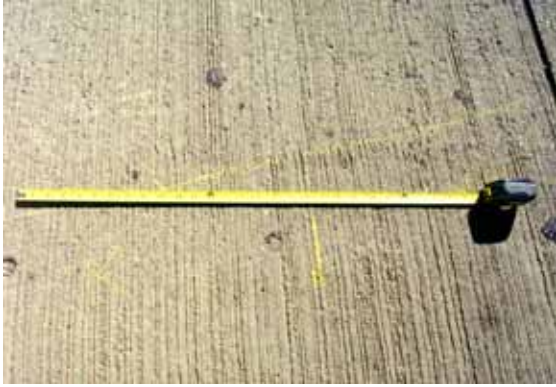
(a) 1% LiOH—Shakespeare aggregate

Test Section	Treatment –Aggregate Source	Observations
1	1 percent LiOH—Shakespeare	Fine map cracking developing in areas of the right wheelpath. In the left wheelpath, there is slightly visible map cracking. The centerline has light, barely visible map cracking. In general, the entire section except along the curb has faint to light map cracking.
2	0.5 percent LiOH—Shakespeare	The entire section has light map cracking that is slightly more visible than in section 1. The left wheelpath has slightly more visible cracking than the right wheelpath.
3	Lomar—Shakespeare	Occasional cracking was noted but no map cracking except for one faint area in the right wheelpath. Very rough original surface texture in approximately 80 percent of the test area due to rain damage while plastic.
4	Class F Fly Ash—Shakespeare	Areas of occasional very light surface cracking exist in first slab in left wheelpath. A few cracks exist near the lane centerline.

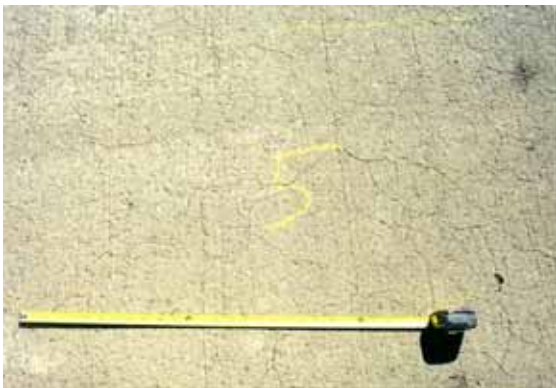
(e) Class C Ash—Shakespeare

5	Class C Fly Ash—Shakespeare	Two full-width transverse cracks, well-defined transverse and longitudinal cracks, well-defined map cracking over entire surface with some raveling of the cracks were observed. Cracking is worse in wheelpaths. The average size of the pieces between cracks is 7.6 cm (3 inches).
6	Control—Shakespeare	Entire section, except along curb, has faint map cracking. Fine cracks have developed at a transverse joint.
7	Blended C & F Fly Ash—Shakespeare	Some areas of faint map cracking were found.
8	Class F Fly Ash—Grevey	The entire area has faint to light map cracking. Concentrated in the left wheelpath. Some joint spalling is present.
9	Control—Grevey	Very faint map cracking was observed over the entire section.
10	1 percent LiOH—Grevey	Very faint map cracking was found but less visible than in section 9. Areas of rough and irregular finish exist.
11	Class C Fly Ash—Grevey	Longitudinal cracks were found in left wheelpath and along centerline, fine wheelpath map cracking and transverse cracks were also developing, and areas of rough and irregular finish exist. Severity of map cracking is between that of sections 9 and 10.

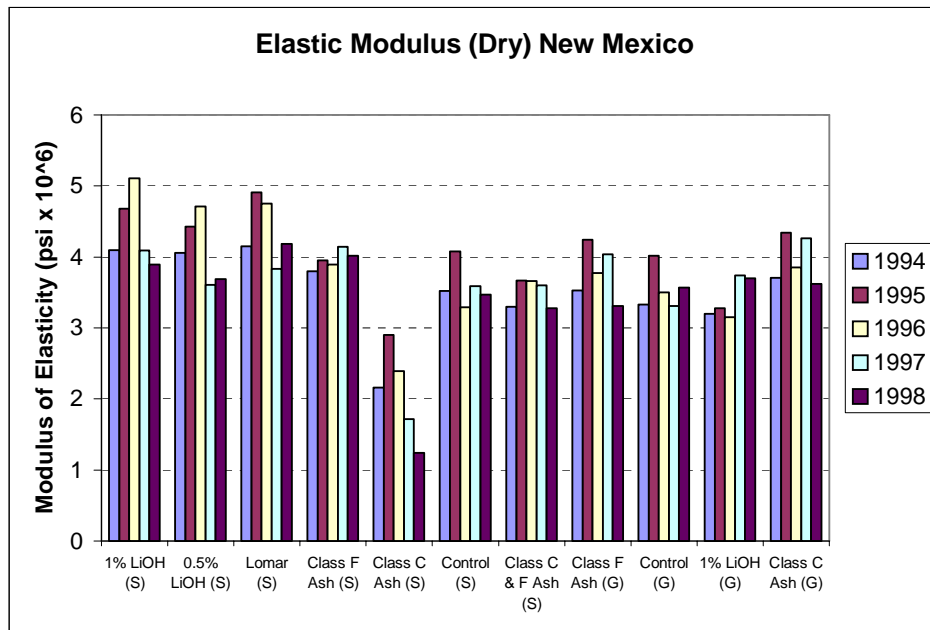
Figure 59. Modulus of elasticity test results for cores in the dry condition (all sections, Albuquerque, NM).

The results of the modulus of elasticity tests cores in the dry condition for all 5 years are given in table 38. The test results for the cores in the wet or saturated condition are shown in table 39. The cores were not tested in the wet condition in 1994. Except from 1994 to 1995, the overall annual average moduli, both wet and dry, declined. The overall standard deviation generally increased over this same time. The moduli of all the sections did not decrease the same amount. Figure 59 shows the modulus of elasticity tested in the as-received state for all the sections over the four years. There are no obvious trends in most sections. The Class C fly ash section with the Shakespeare aggregate (S) is the only section that showed a uniform decrease in the modulus over the past four years. The modulus results from testing in the wet state are shown in figure 60. Here, the trend of decreasing modulus over the four years is more distinct. Most sections show a decrease in elastic modulus from 1995 to 1998. Again the Class C fly ash with Shakespeare aggregate section has the largest and most consistent decrease in modulus. The other sections maintained moderately high modulus properties.

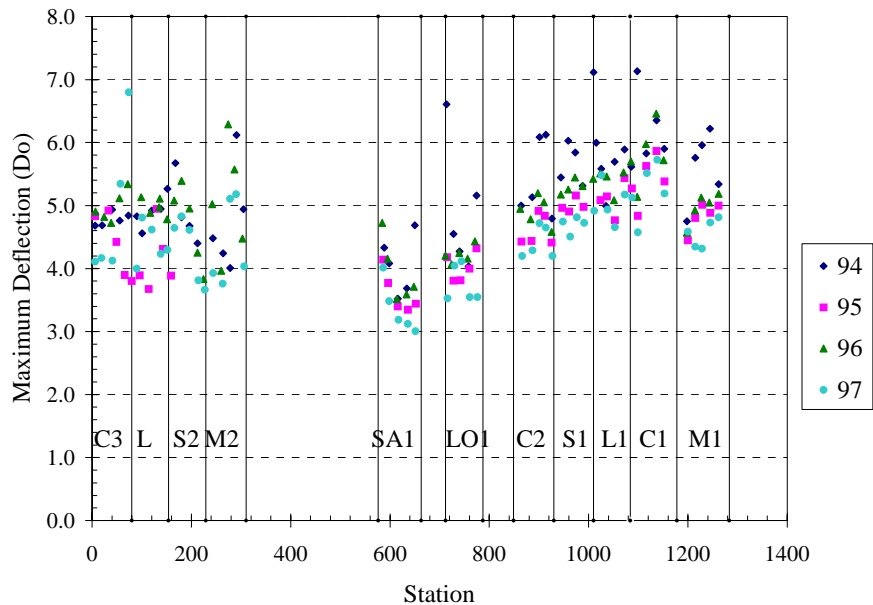
Figure 64. Nevada test site— D_o from center slab.

In figure 64, the variation of the maximum pavement deflection, D_o , measured from the basin test, was plotted for the various treatment sections. Each year in which the data was collected was plotted as a separate series. It can be seen from the figure that D_o varies greatly from section to section and from year to year. Comparing figures 63 and 64, the main cause of variation between the sections appears to be due to differences in subgrade support. For example, it can be noted from figure 63 the static k-value for the SA1 and LO1 treatment sections have the highest value for subgrade support. Thus, it is not surprising that these sections have the lowest deflection. However, what is unexpected is that the average deflection for each section appears to be decreasing slightly from year to year. Thus, the D_o parameter does not appear to have any correlation with the observed map cracking, which was noted to be increasing with time.

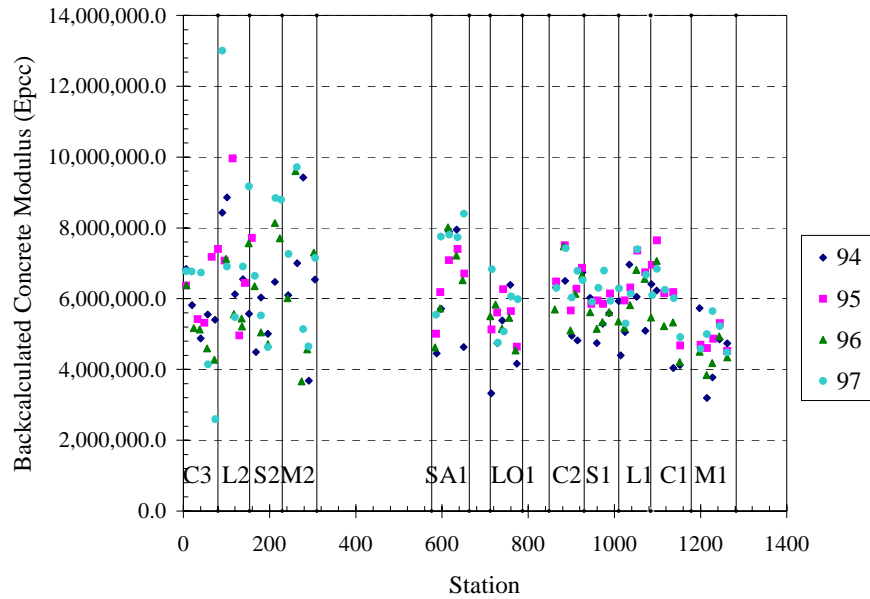
Figure 65. Nevada test site— E_{PCC} from center slab.

Figure 65 presents the section-to-section and year-to-year variation of backcalculated E_{PCC} for the Nevada site. Unlike the center slab D_o data, the backcalculated E_{PCC} data shown in the figure is relatively consistent between the sections throughout the site. Because the k-value is accounted for in the backcalculation process, the difference in subgrade support conditions does not cause the large section-to-section variability seen with the D_o parameter. Further, unlike what was found from laboratory modulus testing, no significant difference was noted in the modulus values between sections located on the east end (C1, C2, L1, M1, and S1) and west end (C3, L2, M2, S2) of the test site. However, the times series trends show that the average E_{PCC} for each

section increases slightly with time. This trend is contrary to what was expected, since the increase in map cracking over time should result in a lower E_{PCC} .

Note that in figure 65, the values of E_{PCC} range from 27,579 to 55,158 megapascals (mPa) (4 to 8 million psi). These numbers are higher than the previously reported laboratory values and also are relatively high for a pavement showing medium-to-high severity map cracking. However, it should be kept in mind that the backcalculated moduli do not necessarily agree with laboratory values since the loading rates and test conditions are quite different. Further, in backcalculating the pavement layer moduli, constant pavement and base layer thicknesses were assumed for the pavement layer—an assumption seldom realized in the field due to construction variability. However, despite these discrepancies, the higher E_{PCC} values should not be of concern since only the relative change of modulus along the project and between the various testing instances is being evaluated.

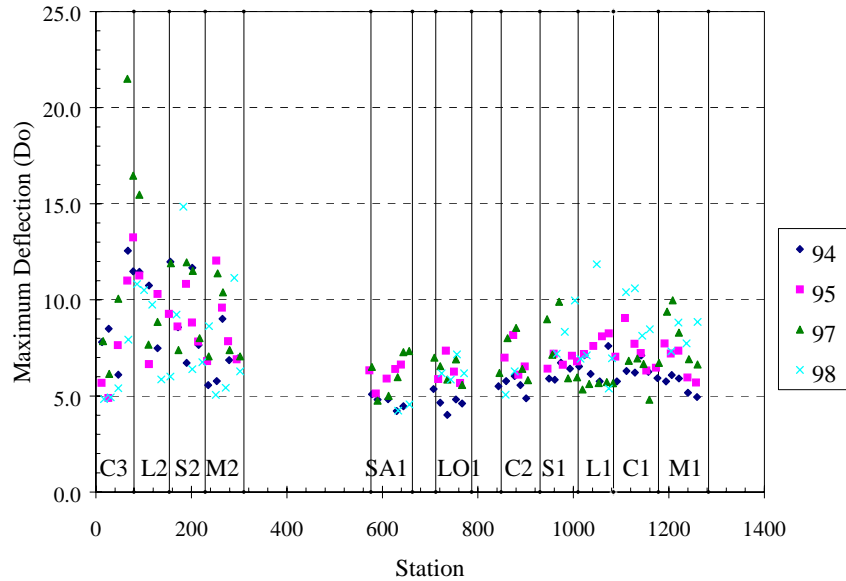
Figure 66. Nevada test site— D_o from leave side; deflection LTE (wheelpath).

The D_o data collected on the leave side of the joint, shown in figure 66, remained relatively consistent throughout the 5-year period. Some variation was identified between the years, but D_o was increasing in some years and decreasing in others. The variation in D_o appears to be temperature-related rather than ASR-related. No trend of increasing D_o with time was observed, belying expectations. Thus, this parameter did not correlate with the observed joint distress data, which was increasing with time. However, as expected, the mean D_o values for each treatment section were relatively greater than those at the mid-slab location.

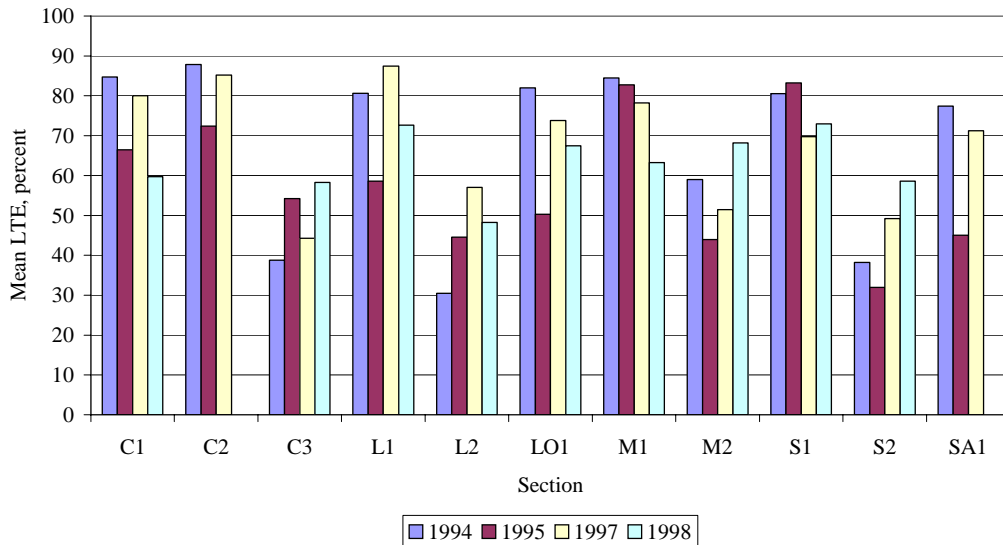
Figure 67. Average LTE values for the various treatment sections for the Nevada site.

The average joint load transfer data for each treatment section is plotted in figure 67 for each year in which testing was conducted. The LTE values do not show a downward trend corresponding to the increased joint distress, as was noted in figure 10. LTE values range from approximately 30 to 88 percent with a significant amount of the data above 50 percent. The higher LTE values are inconsistent with a deteriorated, undoweled joint. A careful examination of the data revealed that the temperature at the time of testing was major confounding factor affecting the LTE values computed and can be used to explain some of the inconsistent and highly variable results. The average temperatures at the time of FWD testing for each treatment section are presented in figure 68. Ideally, the pavement temperature should be relatively constant for the entire data collection effort to make valid comparisons.

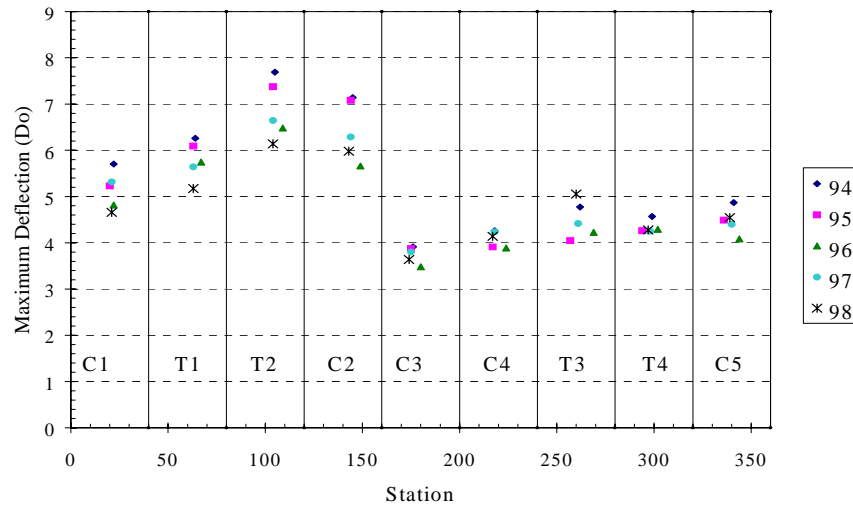
Figure 70. Delaware test site—Do from center slab test.

The variation of the maximum pavement deflection, D_o, measured from the center slab test is plotted in figure 70 for the various treatment sections. Section-by-section analysis of the data revealed that the C2, T1, T2, and C2 sections have a substantially higher D_o than the other test sections. This result does correspond to the observed distress data, which also showed higher level of map cracking in these areas. This can be explained by the drainage and subgrade

conditions. As described in the visual distress portion of this report, the first few sections of the Delaware test site were located in the low portion of a sag vertical curve and thus were exposed to more water during the wet months. This higher exposure could have weakened the pavement layers and increased the potential for materials-related distresses, including ASR. Further, as noted in figure 69, static mean k-value for this group of sections is lower than that for the remaining sections. This could be due to poor drainage or soil conditions. Regardless of the cause, the lower k-values could also have led to poorer structural performance.

It can be noted from figure 70 that D_o varies slightly from year to year. When each section was analyzed individually on a year-to-year basis, D_o remained relatively constant for most sections, with some sections showing a slight downward trend. This result is contrary to the observed distress data, which shows map cracking is increasing with time. Variations in layer thicknesses, which were assumed to be constant in the backcalculation procedure, and variations in subgrade support conditions are likely responsible for this apparent discrepancy.

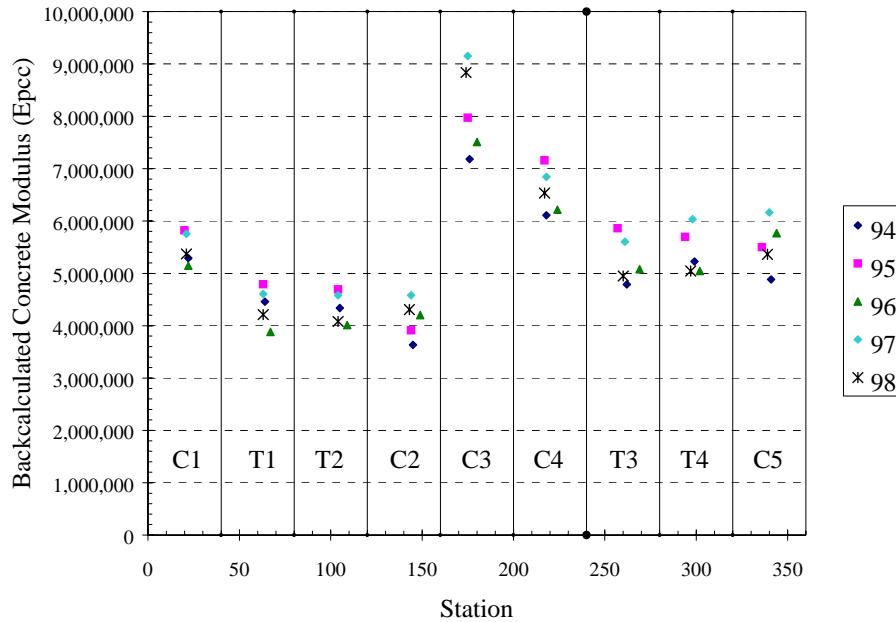
Figure 71. Delaware test site—EPCC from center slab.

Figure 71 shows the variation of the E_{PCC} along the section. Once again, there is a clear distinction in the modulus values of sections C1, T1, T2, and C2 compared to the remaining sections. The modulus values for these sections are lower and, as explained before for the D_o data, are perhaps influenced by the map cracking prevalent in these sections. A similar trend was observed from the laboratory tested modulus values. However, the absolute magnitudes of the backcalculated moduli are far greater than their laboratory counterparts.

An examination of the time series data reveals that, similar to the D_o pavement response, the backcalculated E_{PCC} remained relatively constant with time. A few sections showed a slight upward trend with time. Based on these results, the E_{PCC} parameter is not able to pick up on the observed data, which shows map cracking to be increasing with time. Thus, map cracking is not affecting the apparent structural capacity of the pavement, or more likely, the effects of slight

variations in layer thickness and subgrade support conditions are interfering with the FWD's ability to distinguish between the different levels of map cracking observed in this section.

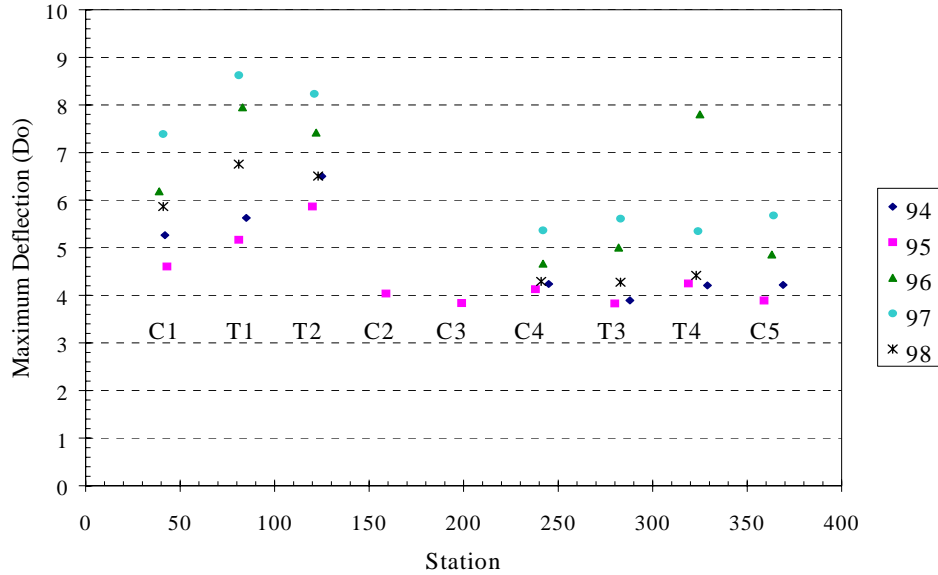
Figure 72. Delaware test site—Do from leave side.

Figure 72 presents the variation of the maximum deflection data collected at the joints along the Delaware site. The data in the figure suggests that D_o did show a slight increasing trend with time from 1994 through 1997. However, the measured D_o dropped sharply in 1998, and overall the leave side D_o response did not reveal a difference between the treated and the non-treated sections. For the Delaware test site, both the FWD data and the observed distress data indicated that the drainage differences between the sections has a far greater influence on pavement performance than the treatment type.

Of the four pavement response parameters analyzed, D_o on the leave side of the joint showed the best correlation with the observed joint distress data. A statistical analysis consisting of a Duncan grouping was performed on this data. Because the Delaware site contained only one test point per section, the data from all years was grouped together. The Duncan grouping confirmed that the D_o parameter mirrored the observed joint distress data. The observed data showed that sections in the poor drainage areas of the site exhibited the highest levels of joint distress. Likewise, the Duncan grouping showed that maximum mean deflection for treatment sections C1, T1, and T2 were higher than and statistically different from the maximum mean deflections in sections C4, C5, T3, and T4. The results of the Duncan grouping are shown in table 48.

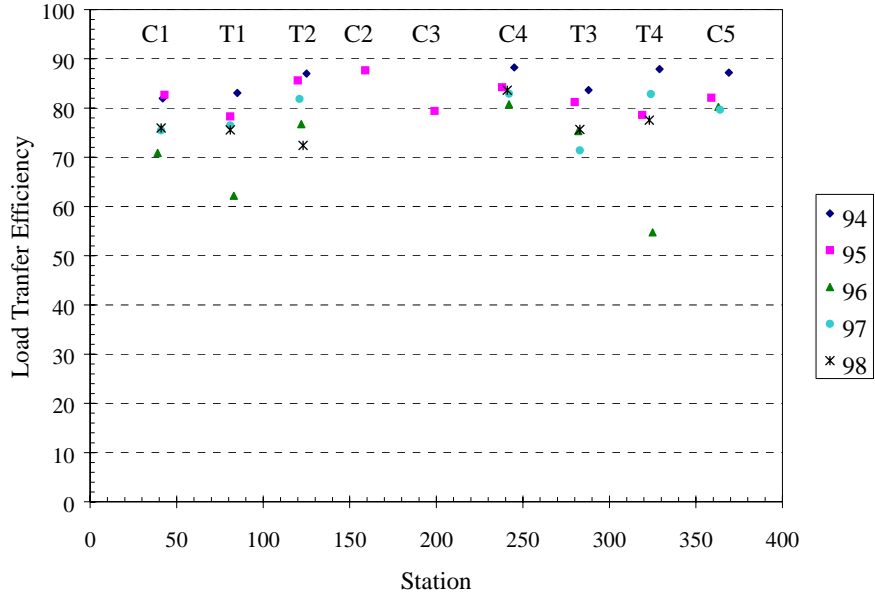
Figure 73. Delaware test site—LTE.

The variation of the LTE values along the project is presented in figure 73. The LTE data is presented both on a yearly and treatment section basis. In both cases, the calculated LTE values remained relatively constant. The magnitudes of the LTE values were also in the high range (between 70 and 90). This is not a totally unexpected finding since most of the joint deterioration (spalling) observed was of low severity. It is possible that the low severity spalling did not cause deterioration to an extent that would destroy the LTE at the joints. Further, unlike the Nevada section, temperature was not a confounding variable. Figure 74 presents the average testing temperature for each year in which the survey was performed. It can be observed from the figure that the temperature was fairly consistent between visits, as well as from the first to the last section during each visit.

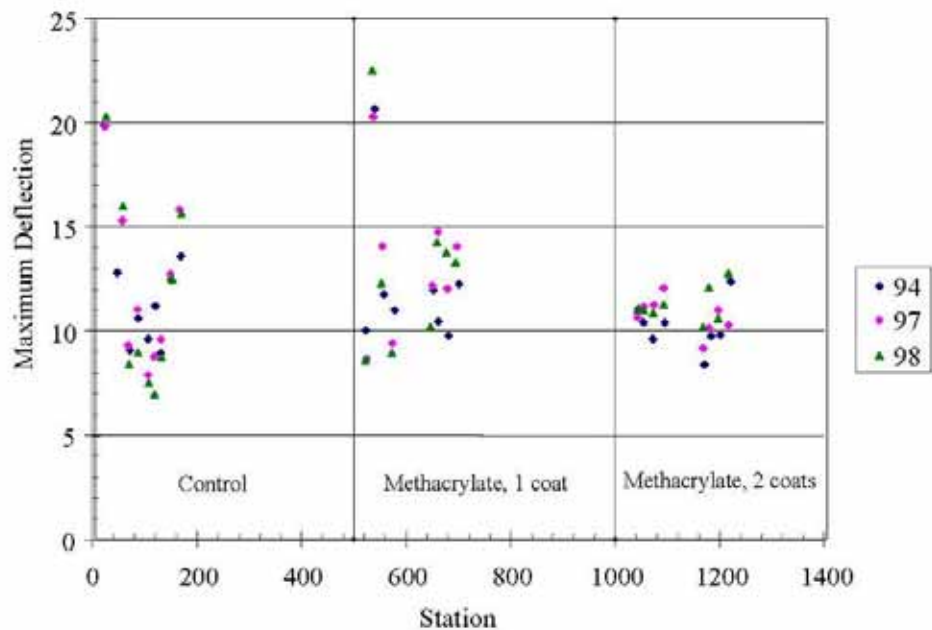
Figure 78. California test site—D_o from leave side.

An analysis of the maximum joint deflection data shown in figure 78 showed that the D_o values have a slight increasing trend over time. However, the differences were relatively slight and are

not proportional to the increase in the amount of observed joint distress data. Overall, the levels of maximum joint deflection were about double the maximum interior deflection (mid-slab values), which is as expected. An examination of the average values for each section revealed that the methacrylate 1 section had the highest deflection, followed by the control and the methacrylate 2 sections. It is difficult to postulate what the expected joint deflection over time is expected on jointed pavement having ASR distress. In jointed pavements, without dowels, joint deflection and curling can be large. As ASR develops, the concrete expands reducing joint openings and increasing aggregate interlock across the joint. Joint curling is essentially eliminated and the ride (smoothness) is improved.

As ASR deterioration continues, spalling and loss of integrity at the joints occurs. However, even though the concrete is disintegrating, the joints remain very tight.

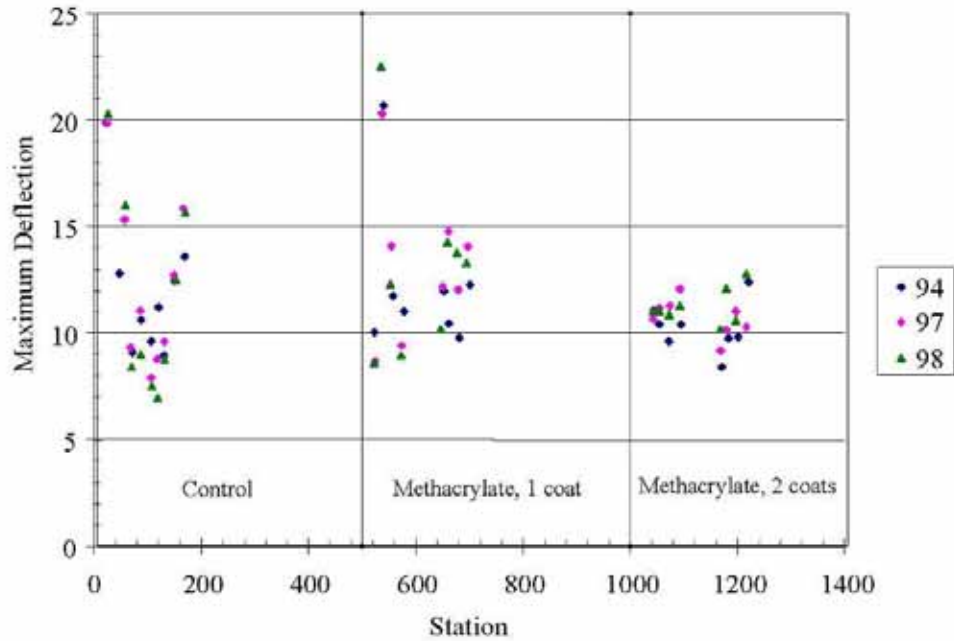
Figure 79. California test site—LTE.

The variation of the LTE along the project is shown in figure 79. Although the load transfer efficiencies are relatively high, the LTE has the best correlation with the observed joint distress data. The average values for each section decrease substantially from 1994 through 1997. There is a slight increase in the LTE from 1997 to 1998 in the methacrylate 1 and control sections, but this is expected given the temperature at the time of testing. For these sections, the test temperature in 1998 was approximately 10 degrees higher than in 1997. For the methacrylate 2 section, the 1997 and 1998 test temperatures were approximately equal, and the LTE continued to decrease. Ranking the average LTE for each section shows the expected correlation with the joint distress data. The methacrylate 2 section has the highest average LTE, followed by the methacrylate 1 section, followed by the control section. A statistical analysis was performed to

determine if the difference in LTE between the treatment types was significantly different. This analysis consisted of a Duncan grouping at an alpha level of 0.05. This analysis confirmed that the LTE for the methacrylate-treated sections was significantly higher than the LTE for the control section. The results of the Duncan grouping are shown in table 49.

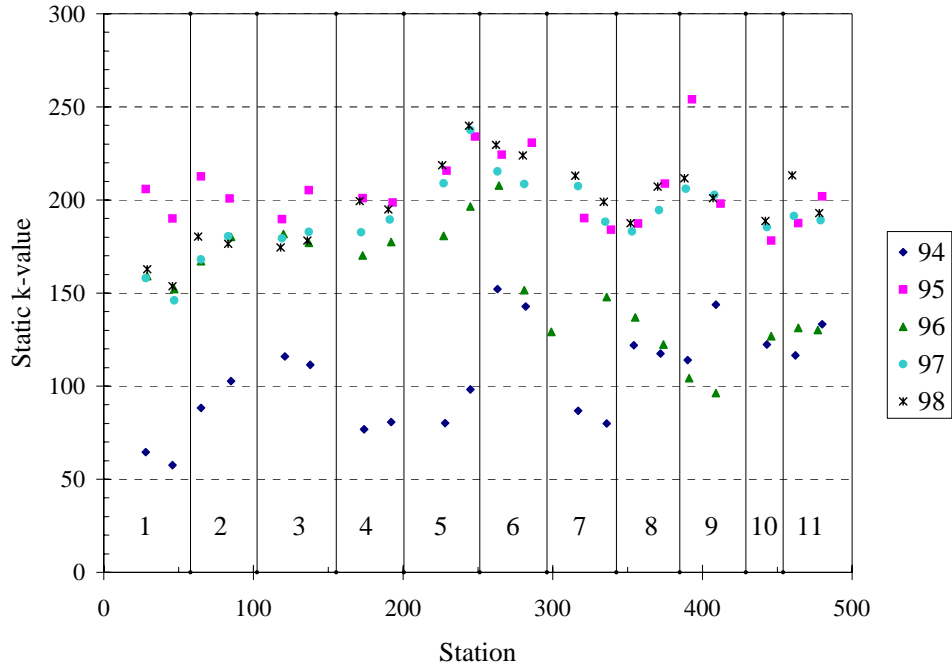
Figure 80. Static k-value for New Mexico test.

A plot of the variation of the backcalculated subgrade support value along the project is presented in figure 80 for each year the data was collected. The subgrade support value is relatively constant within each visit and between visits for the years 1995, 1997, and 1998. The mean k-value for the various sections based on this data is 1,379 kPa/2.54 cm (200 psi/inch). The k-value is quite variable in 1994 and 1996, with the lowest k-values being recorded in the former year. The type of subgrade soils present at the site location and the saturation state of the soils during the time at which the FWD testing was conducted could likely explain these findings. For example, an intense rainfall event a few days prior to the testing in combination with a moisture-sensitive subgrade soil and poor drainage conditions could lead to a weak subgrade support condition. However, actual occurrence of this event could not be ascertained from the data collected.

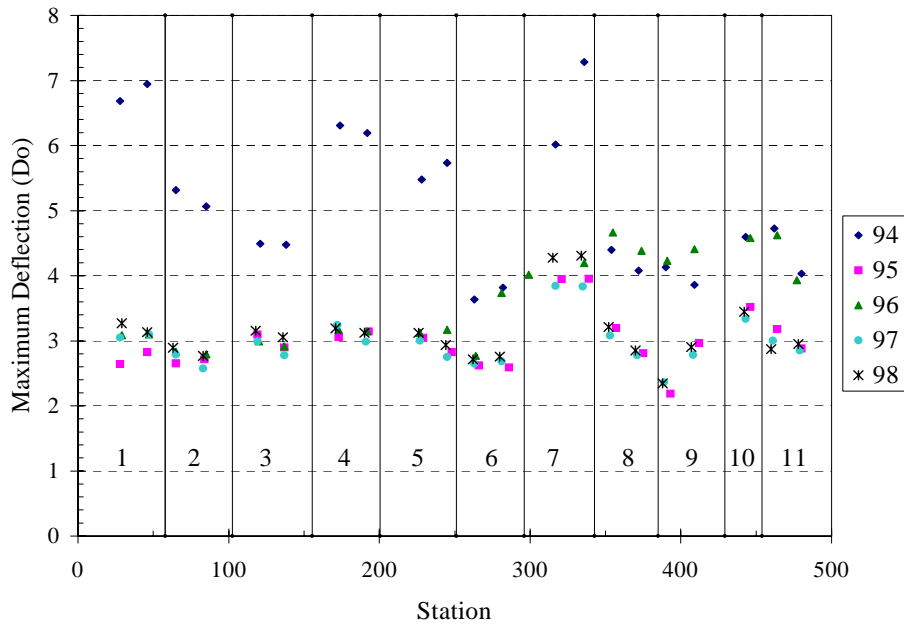
Figure 81. New Mexico test site—Do from center slab.

In figure 81, the project variation of D_o is presented for the multiple years in which data was collected. From this figure it can be seen that D_o varies greatly, especially for the 1994 data. The D_o values follow the expected trends based on the subgrade support conditions shown in figure 80. It seems likely that saturated subgrade conditions were present during the 1994 data collection. This would explain the substantially higher D_o values obtained for that year.

An examination of the data on a section-by-section basis and on a year-to-year basis did not indicate any clear trend regarding D_o . There does not appear to be any apparent correlation between D_o and map cracking for this section. Recall that map cracking has been reported to increase in all sections between 1994 and 1998, with the exception of sections 3 and 4; with the last 2 years registering a dramatic increase. However, most of the map cracking reported was of low severity, and it is assumed that the FWD test was not sensitive enough to register this distress.

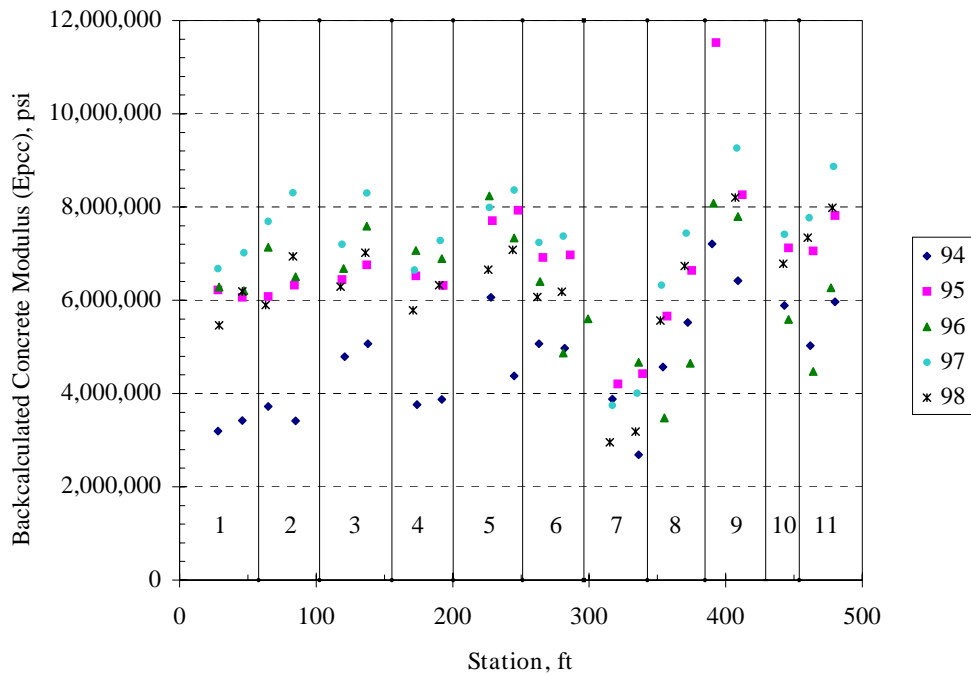
Figure 82. New Mexico test site—EPCC from center slab.

In figure 82, the backcalculated E_{PCC} is plotted for all the treatment sections. Similar to the D_0 pavement response, the backcalculated E_{PCC} remained relatively constant over time. Based on these results, the E_{PCC} parameter is not able to corroborate the observed distress data, which shows map cracking to be increasing over time. Thus, the map cracking is not affecting the apparent structural capacity of the pavement, or more likely, the effects of slight variations in layer thickness and subgrade support conditions are interfering with the FWD's ability to distinguish between the different levels of map cracking observed in this section.

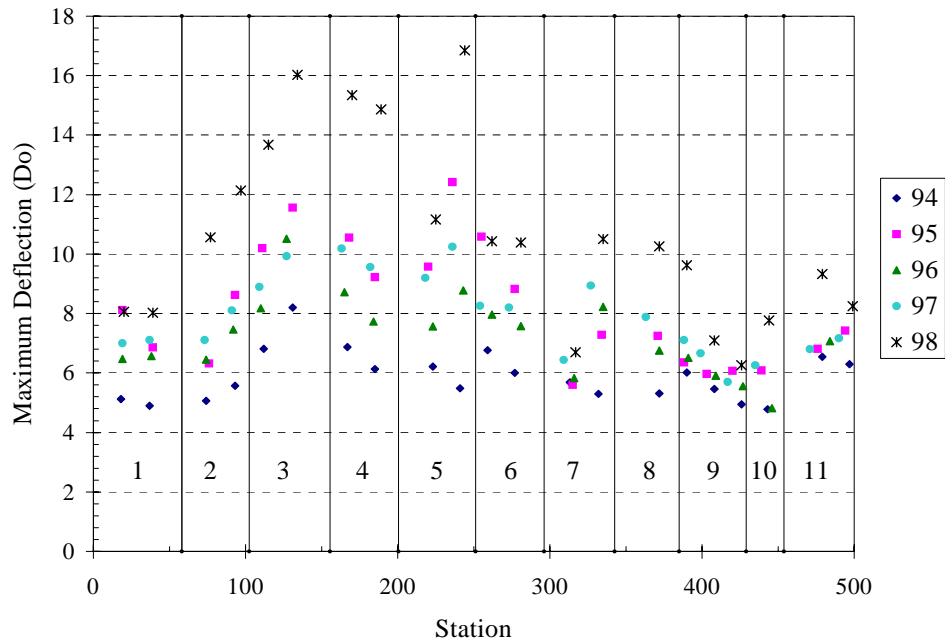
Figure 83. New Mexico test site— D_0 from leave side.

Figure 83 presents the maximum pavement deflection collected from joint testing. As with the D_0 center slab data, the D_0 data taken from the leave side of the joint showed rather large variability. Overall, the data did show a slight upward trend over time corresponding to increased joint distress. However, this trend was not consistent, as the data was confounded by differences in temperatures at testing between sections during each visit. A pictorial representation of the average temperature at the time of FWD testing for each section is presented in figure 84. Other confounding factors include variations in slab thickness due to construction variability and changing subgrade support conditions.

Because the D_0 data did at least show the expected trend of increasing with time, a statistical analysis was performed. This analysis revealed some differences between the treatment types; however, these differences appear to be more closely related to temperature and subgrade support conditions than to ASR-related deterioration.

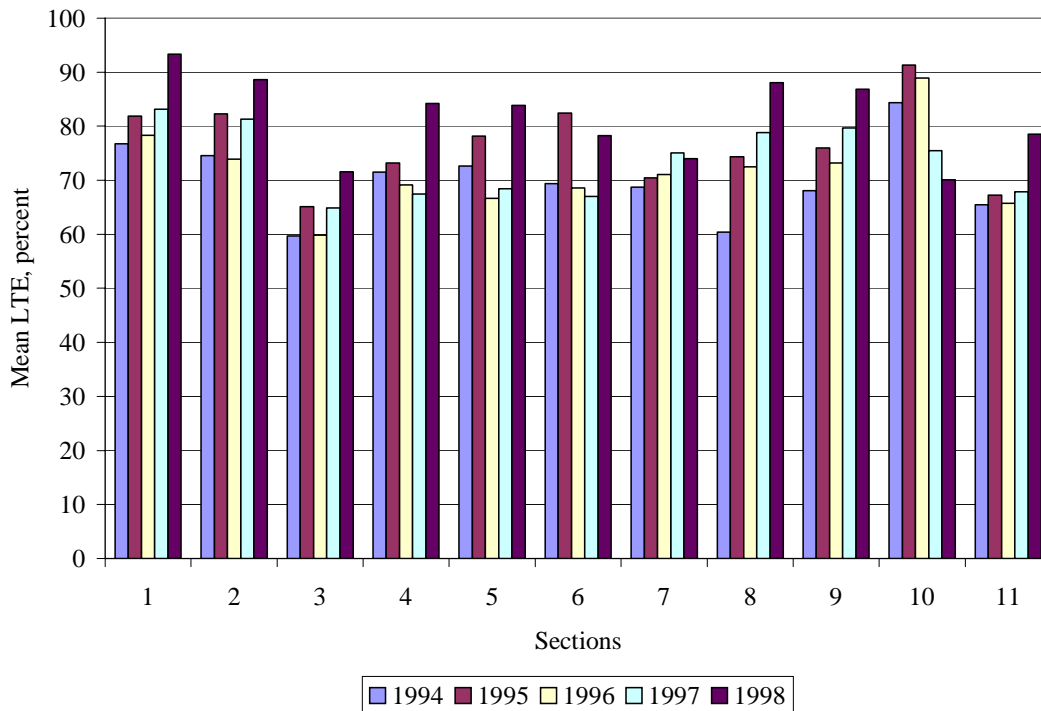
Figure 85. New Mexico test site—LTE.

The variation of the LTE along the project is plotted in figure 85. An examination of the LTE data on both a yearly and section-by-section basis revealed that LTE remained relatively constant. The LTE data did not have a significant correlation with the observed joint distress data, and it could not be used to corroborate the benefit of the Class F fly ash treatment. A statistical analysis revealed that the average LTE values for each section belonged to the same group. Thus, no significant differences in LTE values existed between any of the treatment types.

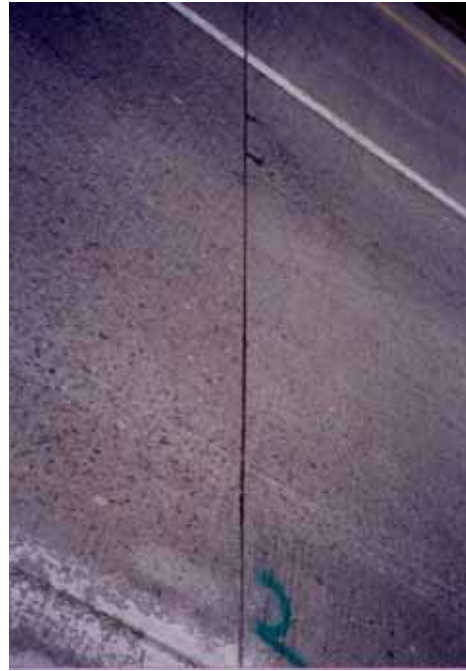
(a) Control section 3 (C3)

Core 97-C3-A: The core is classified as slightly distressed. The wearing surface is severely worn, exposing coarse and fine aggregate particles. Popouts are occasionally identifiable. Eleven cracks and 50 instances of alkali-silica gel were counted. Three coarse and 27 aggregate particles show evidence of distress or reaction. The core is air-entrained with an estimated air content of 5.5 percent.

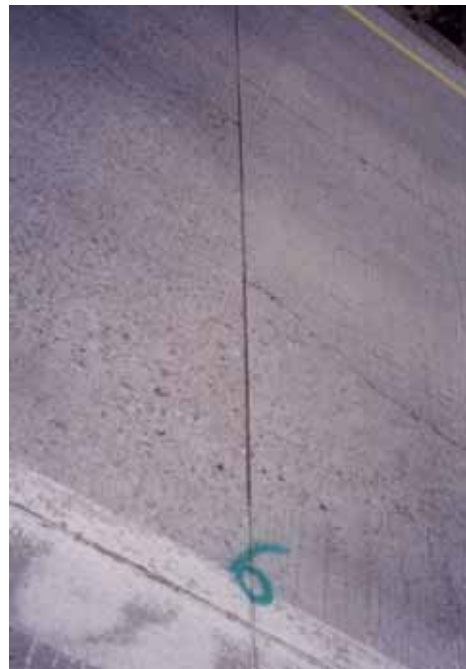
(b) Lithium Hydroxide section 2 (L2)

Core 97-L2-B: The core is classified as slightly distressed. The wearing surface is worn, exposing aggregate particles. Twenty cracks and 32 instances of alkali-silica gel were counted. Twenty-two fine aggregate particles showed evidence of distress or reaction. The core is air-entrained with an estimated air content of 6 percent.

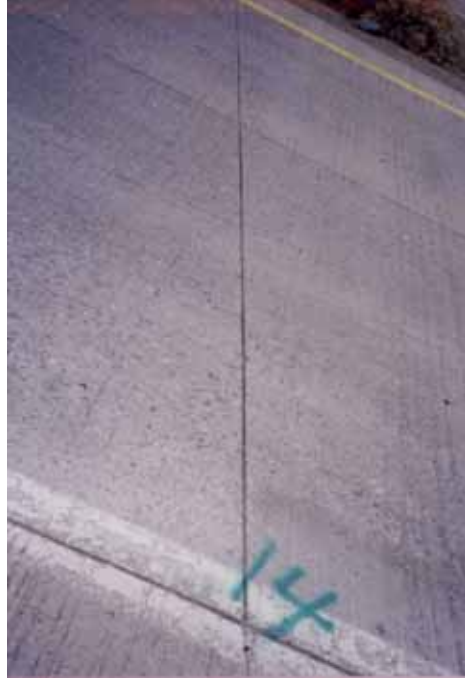
(c) Silane section 2 (S2)

Core 97-S2-A: The core is classified as slightly distressed. The wearing surface is worn; shallow popouts over coarse and fine aggregate particles are frequent; 29 cracks and 40 instances of alkali-silica gel were counted. Fourteen coarse and 53 fine aggregate particles show evidence of reaction or distress. The core is air-entrained with an estimated air content of 6 percent.

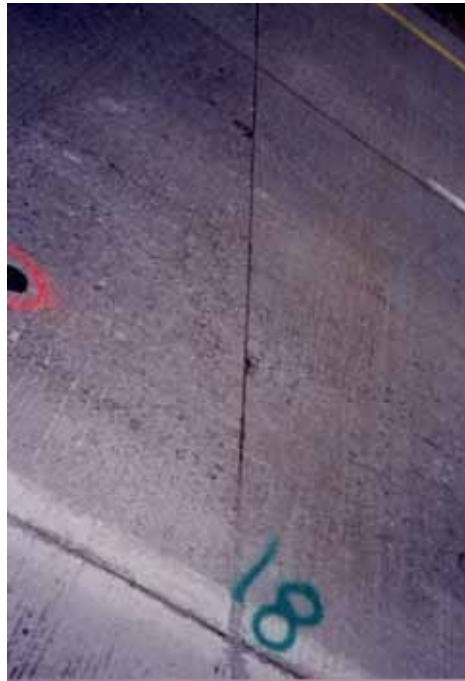
(d) Methacrylate section 2 (M2)

Core 97-M2-B: The core is classified as slightly to moderately distressed. The wearing surface is worn, revealing fine and occasionally coarse aggregate particles; 48 cracks and 75 instances of alkali-silica gel were counted. Five coarse and 27 fine aggregate particles showed evidence of distress or reaction. The core is poorly air-entrained with an estimated air content of 4 percent.
