Highway Concrete Pavement Technology Development and Testing: Volume I— Field Evaluation of Strategic Highway Research Program (SHRP) C-202 Test Sites (Alkali-Silica Reaction (ASR))

PUBLICATION NO. FHWA-RD-02-082

AUGUST 2006

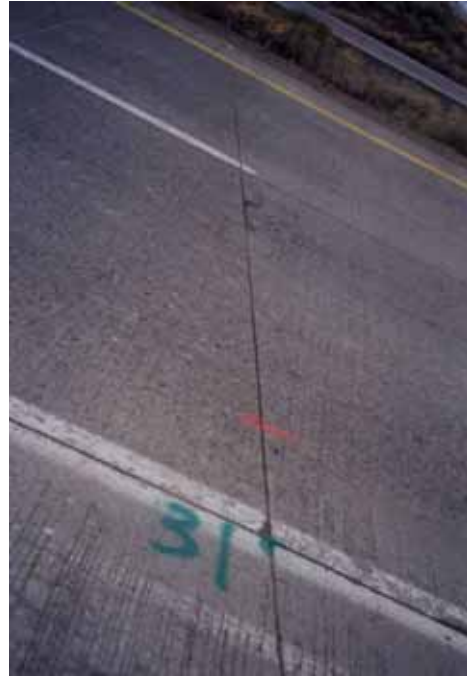
(i) Lithium hydroxide section 1 (L1)

Core 97-L1-C: The core is classified as moderately distressed. The wearing surface is severely worn, exposing coarse and fine aggregate particles. Popouts are frequently identifiable. Sixty-five cracks and 39 instances of alkali-silica gel were counted. One coarse and 21 fine aggregate particles show evidence of distress or reaction. The core is air-entrained with an estimated air content of 6 percent.

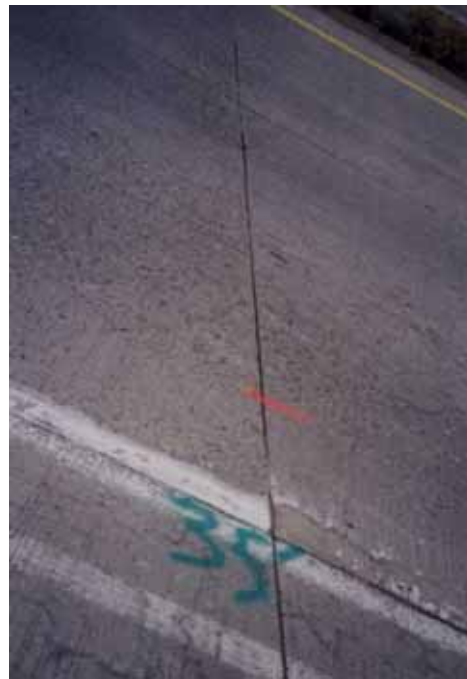
(j) Control section 1 (C1)

Core 97-C1-B: The core is classed as slightly to moderately distressed. The wearing surface is severely worn, exposing coarse and fine aggregate particles. Popouts are occasionally identifiable. Sixty-one cracks (chiefly microscopic) and 54 instances of alkali-silica gel were counted. Eight coarse and 22 fine aggregate particles were distressed or had reacted. The core is marginally air-entrained with an estimated air content of 5 percent.
