Northeast Fisheries Science Center Reference Document 07-07

Evaluation of a Modified Scallop Dredge's Ability to Reduce the Likelihood of Damage to Loggerhead Sea Turtle Carcasses

April 2007

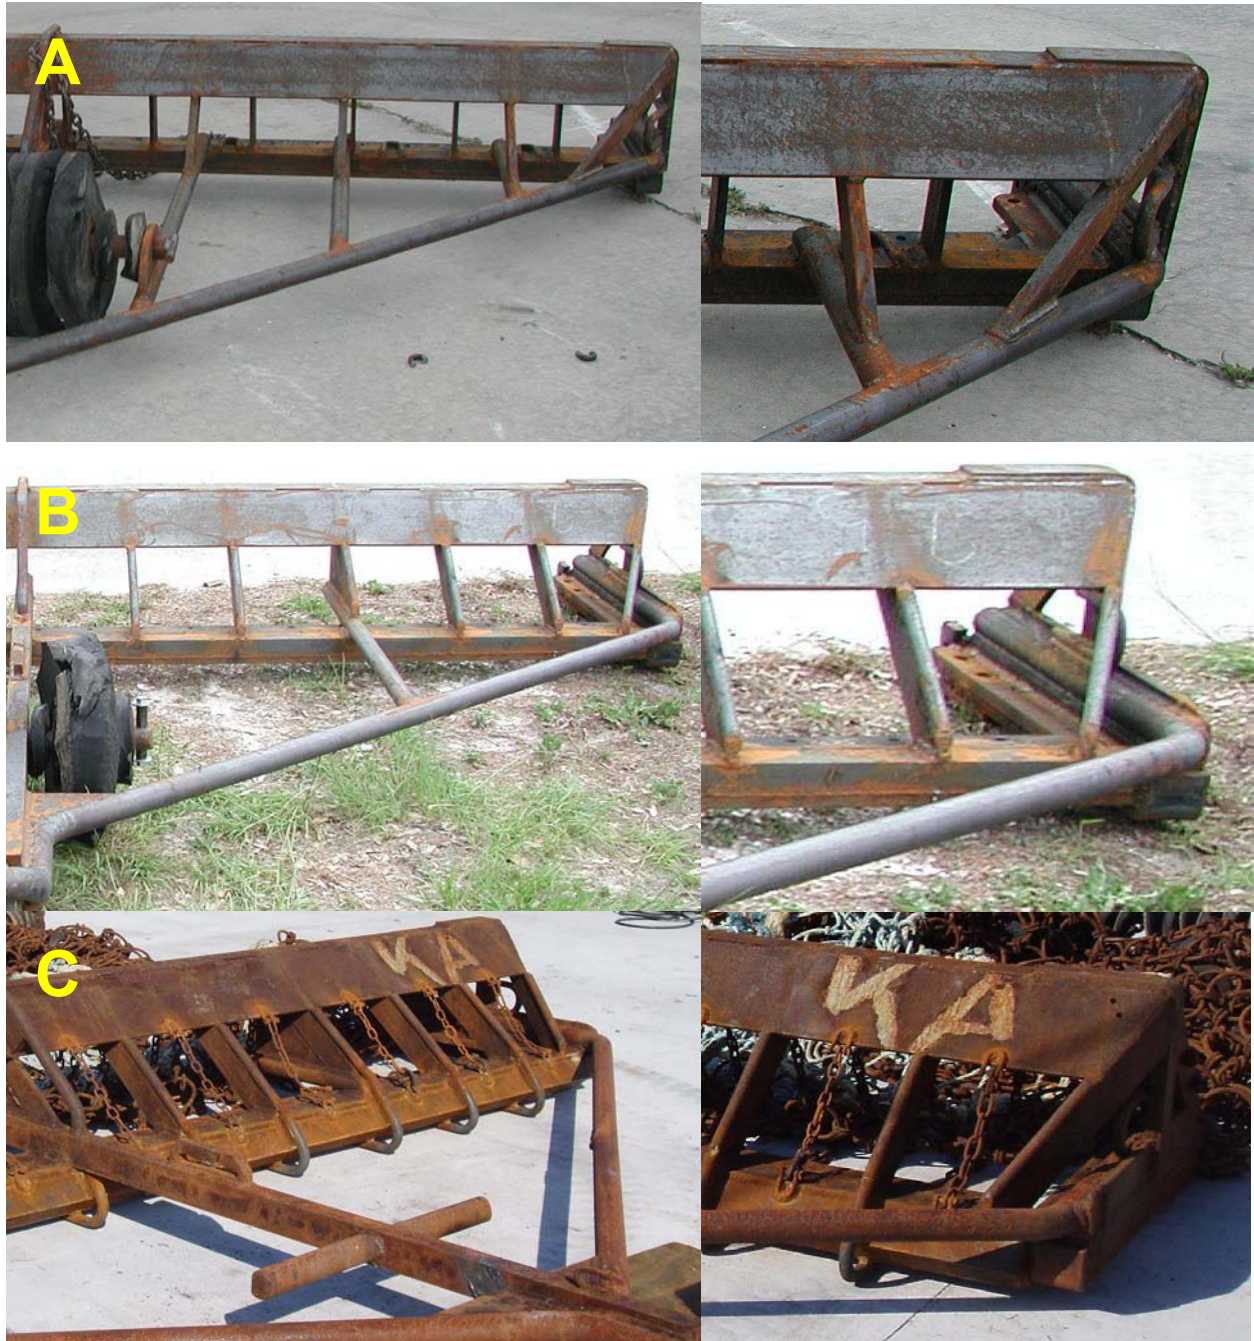
Figure 1. New Bedford style scallop dredge (A) and modified scallop dredge used in 2005 study (B). Modified dredge has cutting bar forward of traditional dredge resulting in a “ramp”. (C) Dredge used in 2006 modified by reducing the vertical flat surface of the cutting bar and removal of all bale support bars.

As a result of the 2005 testing, a new modified dredge prototype was conceived and constructed under contract to Coonamessett Farm for evaluation during 2006. The experimental dredge was a modification of a standard New Bedford style sea scallop dredge (Figure 1A). The modifications consisted of moving the cutting bar forward, removing all brace bars in the bale section, and adding several vertical round stock bars along the face of the dredge between the depressor or "pressure" plate and the cutting bar (Figure 1B). Moving the cutting bar forward changes the geometry of the dredge frame, and the new wedge shape was thought to increase the probability of turtles going over the frame rather than under the cutting bar. Removing the brace bars from the bale section eliminates barriers that might hold a turtle under the bale rather than letting it pass through the bale and escape over the dredge frame. The round stock bars were added to keep contact with the seafloor and to add a structure that might help turtles move up and over the cutting bar.

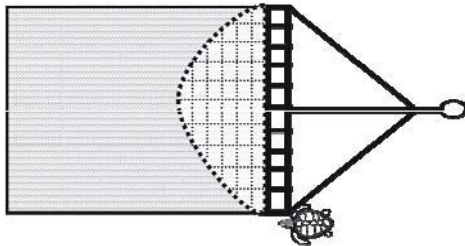
Comments: The carcass was placed in front of the starboard edge of the dredge and did not go under the bale. The carcass deflected off the starboard shoe away from the dredge. Divers deploying the carcass had trouble locating the oncoming dredge due to the length of cable deployed. Also, the captain had trouble making adjustments due to the amount of cable deployed.

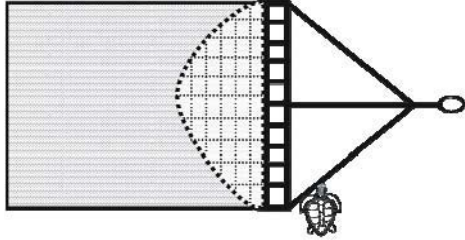
Comments: Cable length was shortened to 125 ft to provide the captain with better maneuverability and allowed divers to adjust to dredge more effectively. The carcass was placed in front of the starboard edge of the dredge and did not go under the bale. The carcass was held on the outer edge of the bale for approximately 30 seconds before it came off and went up and over the dredge. The amount of clearance between the bale and the bottom at this scope did not allow the turtle carcass to pass under the bale. Because of difficulties experienced with the 5:1 ratio, it was agreed that subsequent tows should match the 2005 testing scenario with a 3:1 ratio at 3.0 knots. In 2005, scallop dredge fishermen and industry representatives that attended testing determined that this ratio speed combination provided a dredge attitude that best matched that observed on commercial dredges during normal fishing conditions. The 3:1 ratio also provided better maneuverability, diver response time, and enough clearance to place carcasses under the bale, which was a more conservative testing approach.

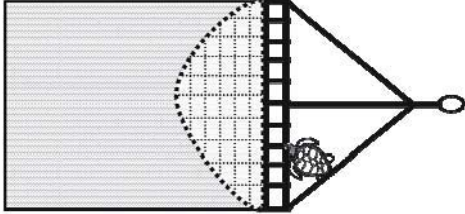
Comments: The carcass was placed under the starboard side of the dredge bale and made contact with the cutting bar in the center of the starboard side of the dredge approximately 3 feet from the edge (Figure 2A). The carcass was facing the dredge and turned slightly to the right, with the left front flipper trapped under the cutting bar by water pressure and the posterior edge of the shell held down by the bale (Figure 2B). The carcass was held in this position for approximately 4 minutes before divers removed it. The front flipper was trapped under the cutting bar and against a vertical piece of round stock that was added to the front edge of the cutting bar and pressure plate (Figure 2C and D).

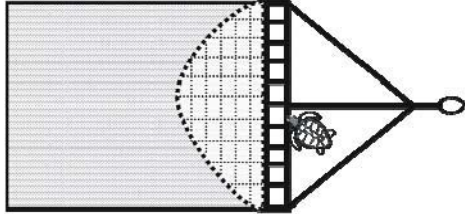
Comments: The carcass was placed under the starboard side of the dredge bale and made contact with the cutting bar just to the starboard side of the center bar approximately 6 feet from the edge of the frame (Figure 3A). The carcass was facing the dredge and turned slightly to the right with the front left flipper and head making initial contact. The carcass then flipped up onto the front of the dredge (Figure 3B and C). The right front flipper was momentarily trapped under the cutting bar before releasing and allowing the carcass to flip up and over the dredge (Figure 3C and D).

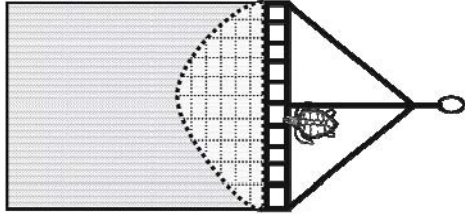
Comments: The carcass was placed under the starboard side of the dredge bale and made contact with the cutting bar just to the starboard side of the center bar approximately 6 feet from the edge of the frame (Figure 4A). The carcass was facing the dredge and made contact head first. The carcasses stayed in position for a few seconds and proceeded to flip up and over the pressure plate where it was recovered by divers (Figure 4B).

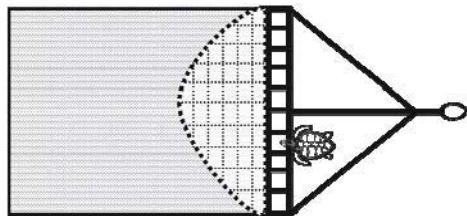
Comments: The carcass was placed under the starboard side of the dredge bale and made contact with the cutting bar near the middle of the starboard side of the dredge approximately 4 feet from the edge of the frame (Figure 5A). The carcass was facing the dredge and made contact head first. The carcass slid up the face of the dredge immediately after impact and proceeded to go over the pressure plate (Figure 5B).

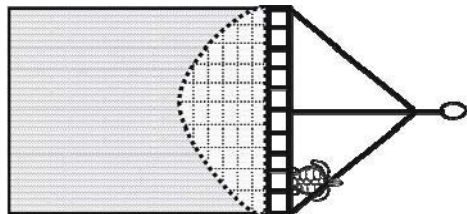
Comments: The carcass was placed under the starboard side of the dredge bale and made contact with the cutting bar near the edge of the starboard side of the dredge approximately 3 feet from the edge of the frame (Figure 6A). The carcass encountered the dredge tail first. The posterior edge of the carapace was caught under the cutting bar while the anterior portion of the carapace was held down by the dredge bale, which prevented the carcass from flipping up and over the dredge frame (Figure 6B).

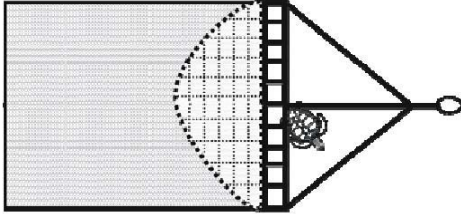
Comments: The carcass was placed under the starboard side of the dredge bale and made contact with the cutting bar near the center of the dredge just on the starboard side of the center brace bar approximately 6 feet from the edge of the frame (Figure 7A). The carcass encountered the dredge tail first and was angled to the right. Upon impact the carcass slid up the face of the dredge and stalled on the pressure plate (Figure 7B and C). The carcass's front left flipper was trapped under the cutting bar and against a vertical piece of round stock (Figure 7D). The carcass was held in this position for approximately one minute before it moved the rest of the way over the dredge.

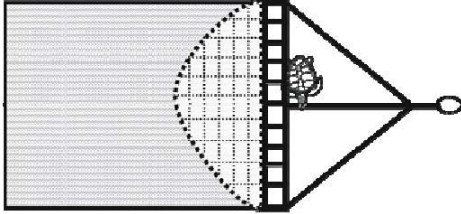
Comments: The carcass was placed under the port side of the dredge bale and made contact with the cutting bar near the center of the dredge just on the port side of the center brace bar approximately 5 feet from the edge of the frame (Figure 8A). The carcass was facing to the right and encountered the dredge along its entire right side. Upon impact the carcass flipped up and over the dredge (Figure 8B).

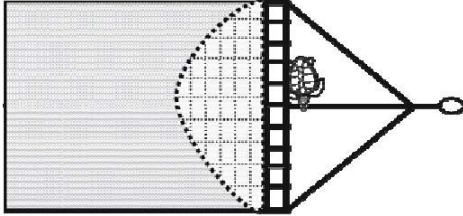
Comments: The carcass was large and bloated and required the addition of thirty pounds of weight to sink. The carcass was placed under the port side of the dredge bale and made contact with the cutting bar just to the port side of the center brace bar approximately 5 feet from the edge of the frame (Figure 9A). The carcass was facing to the right and encountered the dredge along its entire right side. Upon impact the carcass slid up the face of the dredge and stopped (Figure 9B). The attached weights may have hung on the face of the dredge preventing it from sliding completely over the dredge. In addition, both front flippers were under the cutting bar which may have also prevented the carcass from sliding any further up the face of the dredge (Figure 9B).

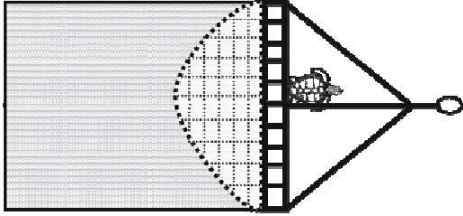
Comments: This was the same carcass used on the previous tow and required the addition of weights to sink. The carcass was placed under the port side of the dredge bale and made contact with the cutting bar on the port side of the center brace bar about 5 feet from the edge of the frame (Figure 10A). The carcass encountered the dredge tail first. Upon impact the carcass flipped up and over the face of the dredge (Figure 10B).

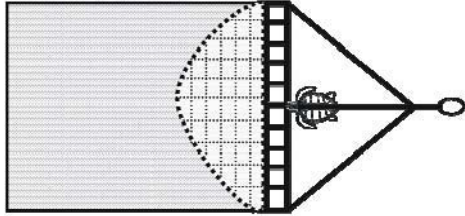
Comments: The carcass was placed directly under the center brace bar (Figure 11A). The carcass encountered the dredge head first and was held under the center brace bar until divers removed it (Figure 11B).

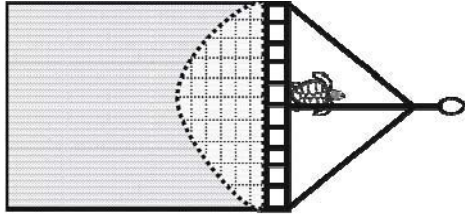
In addition to the twelve trials with carcasses, one trial (tow 17) used a fiberglass turtle. The fiberglass turtle became trapped under the bale by its rigid flippers (see Figure 12 in Appendix 1). Because of the rigidity of the appendages, it is difficult to infer very much from this interaction.

Comments: The model was placed under the port side of the dredge bale and made contact with the cutting bar near the center of the dredge just on the port side of the center brace bar 5 feet from the edge of the frame (Figure 12A and B). The model encountered the dredge tail first. Upon impact the model started to flip up but the head caught under a cross bar where wheels had been previously mounted on the center bar. This prevented the model from flipping up and over the dredge (Figure 12C). In addition, the right rear flipper was trapped under the cutting bar (Figure 12D).
