National Transportation Safety Board

Safety Recommendation

In reply refer to: A-06-24 through -26

The National Transportation Safety Board is currently investigating two accidents involving fractures of tension-torsion (T-T) straps in MD Helicopters, Inc. (MDHI), model MD900 helicopters. Thirteen T-T straps are part of the anti-torque fan assembly in the no tail rotor (NOTAR[®]) systems in the MD900 helicopter. Fracture of a T-T strap results in failure of the anti-torque fan and loss of thrust for yaw control.

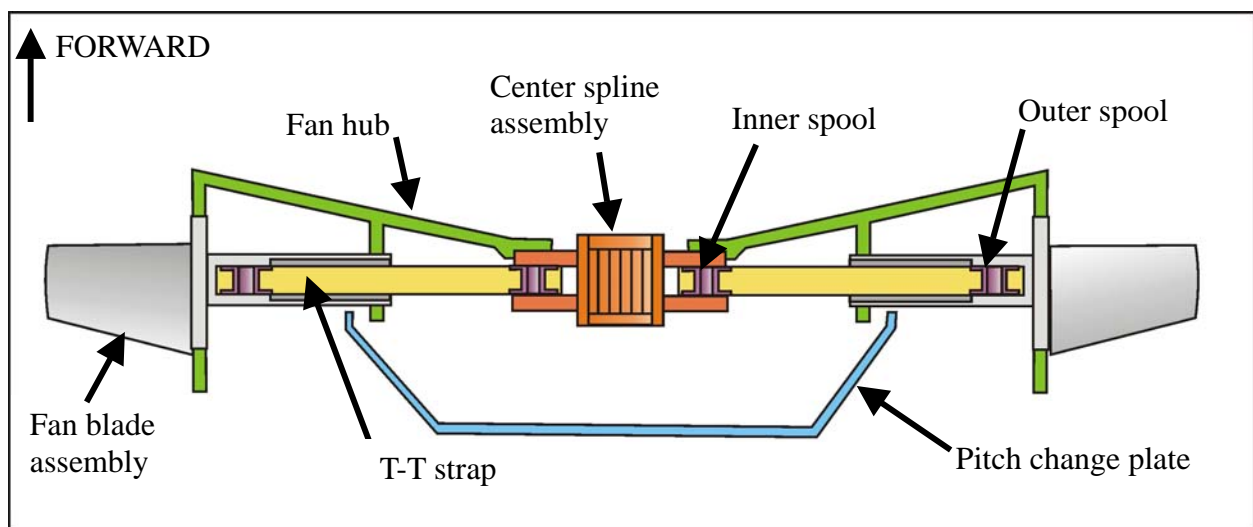
Figure 2. Schematic of the anti-torque fan assembly cross-section.

A schematic cross-section of the MD900 anti-torque fan assembly is shown in figure 2. Within the fan assembly, each T-T strap extends radially from the center spline assembly like spokes from a hub, connecting the blade assemblies at their outer spools to the center spline assembly at their inner spools. The fan assembly rotates counterclockwise about the center spline assembly axis as viewed looking forward. In addition, the blade assemblies rotate within openings in the inner and outer rims of the fan hub, producing changes in pitch, which are controlled through a sliding pitch

change plate that is attached to arms on the blade assemblies. The centrifugal force produced by the fan blade assemblies rotating about the center of the anti-torque fan assembly causes the straps to be loaded in tension while changes in pitch cause the straps to be twisted.

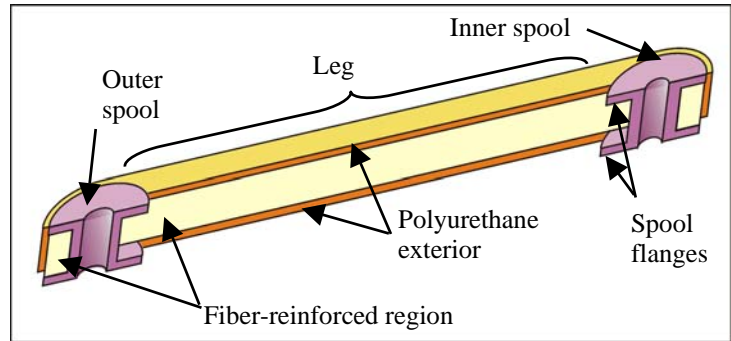
Figure 3. Cutaway schematic showing the T-T strap construction.

Kevlar[®] fibers wrapped around corrosion-resistant steel spools. The spools have circular flanges at each end of a cylindrical spindle, and the strap attachment hardware is inserted through bolt holes at the center of the spool spindles. Polyurethane is incorporated between the individual Kevlar[®] fibers, creating a fiber-reinforced region, which is surrounded by an exterior of pure polyurethane. The legs of the strap are the two fiber-reinforced regions located between the spools and are separated by a distance equal to the diameter of the spool hub.

A cutaway schematic showing the T-T strap construction is shown in figure 3. The T-T straps are made of continuous-wound
