Reactor Vessel Head Inspection Current Status and Future Plans

Calvert Cliffs
Nuclear
Power Plant
Unit 2

March 18,
2003

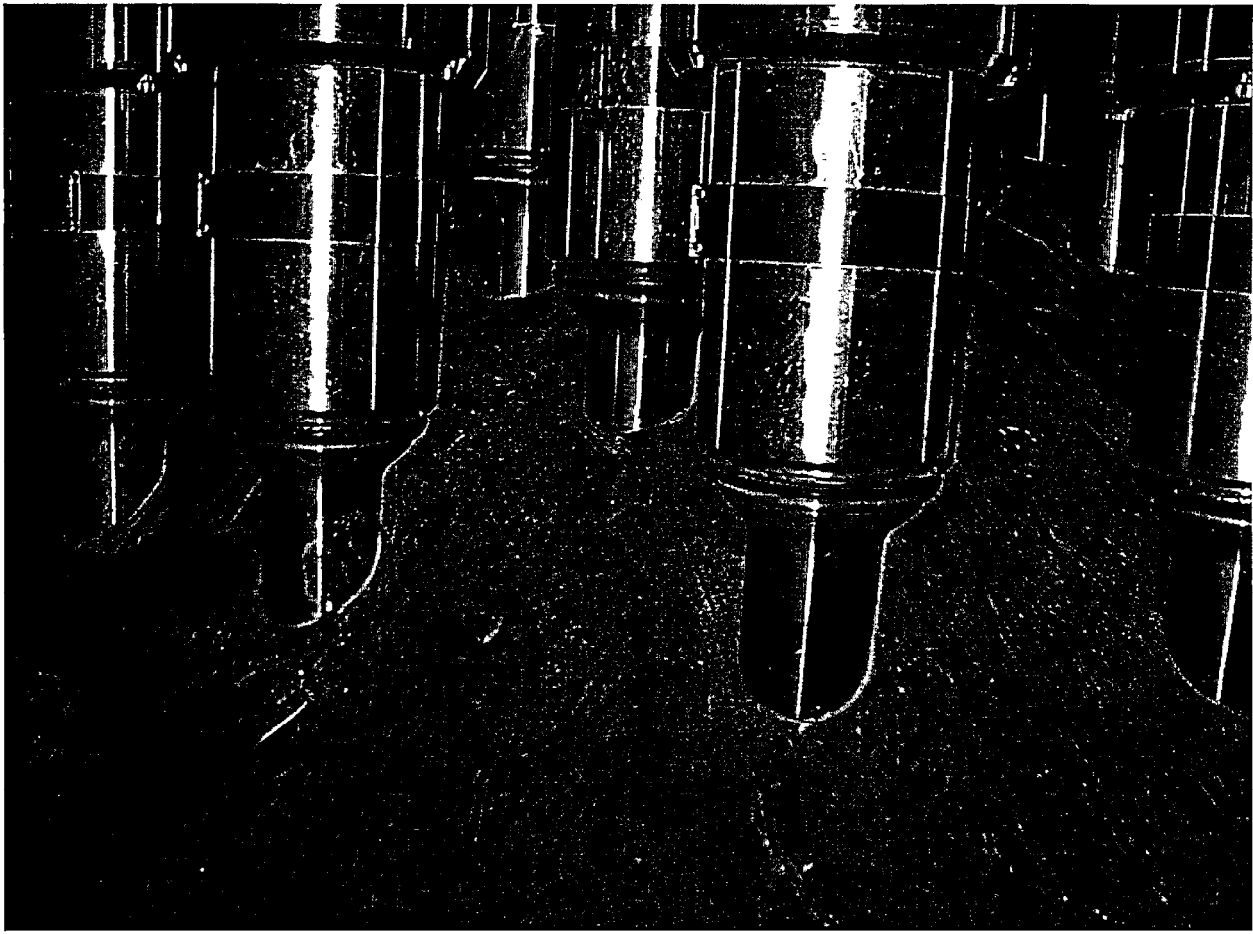
RV Head Materials

- PWSCC driven by stress
 - Lower yield strength results in lower driving force for cracking
 - PWSCC also driven by time at temperature
- All CEDM nozzles consist of only 2 heats
