Bottom Mounted Instrument Penetration Condition Resolution

South Texas Project's Failure Modes and Effects Analysis for Bottom Mounted Instrument Nozzle Leakage

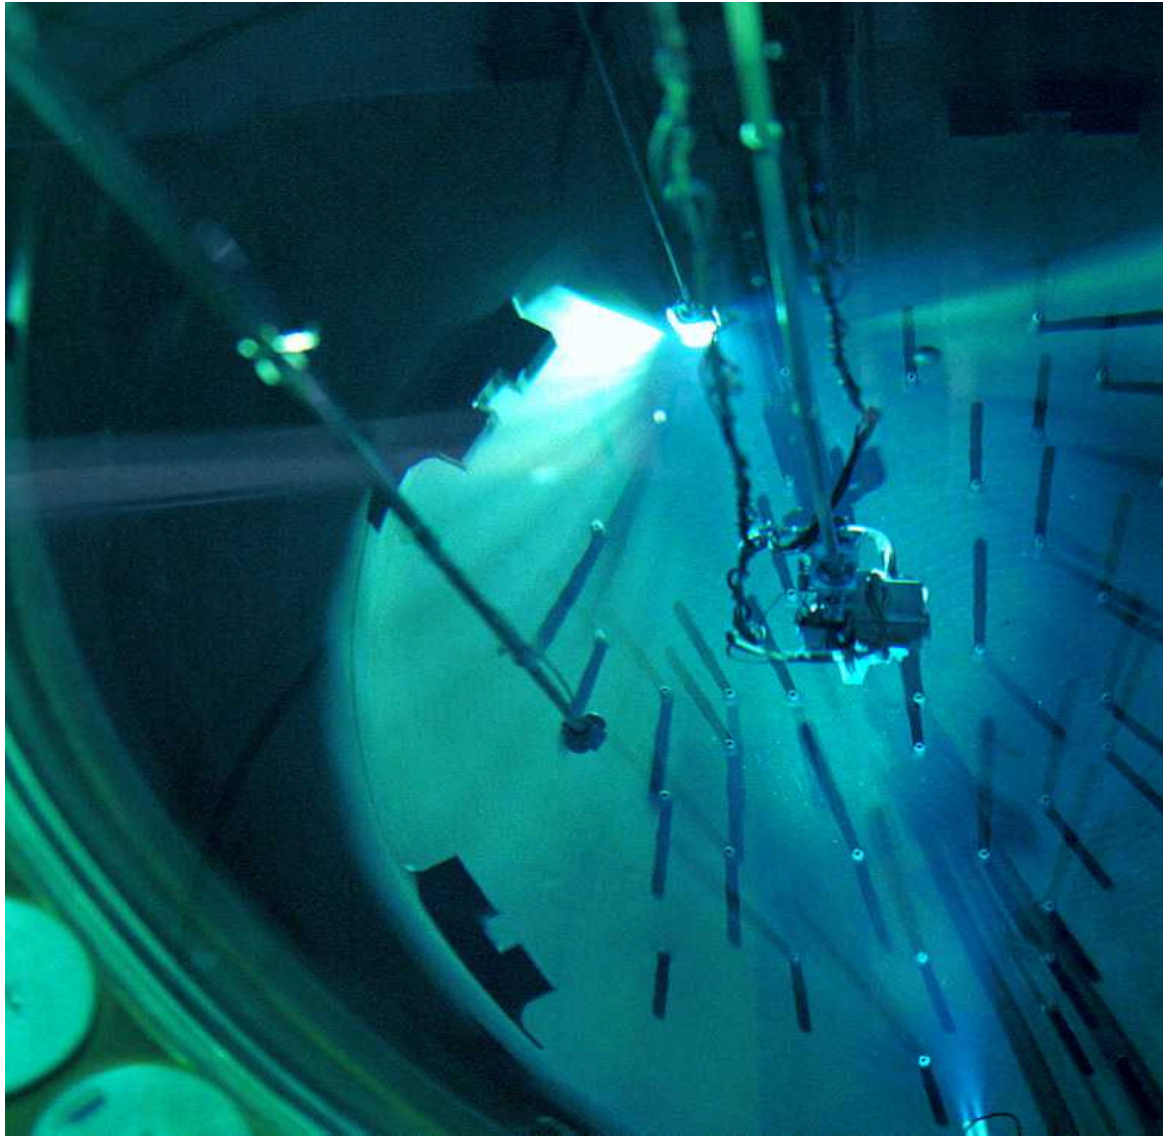
Extensive NDE Campaign Conducted

- UT from penetration tube ID
- Enhanced visual exam of J-groove weld surface
- Volumetrically interrogate vessel base metal for wastage
- ET from penetration tube ID
- ET of J-groove weld surface
- Profilometry
- Borescope examinations
- Helium tests
- Metallurgical analyses of removed nozzle remnants
- Boat sample analyses

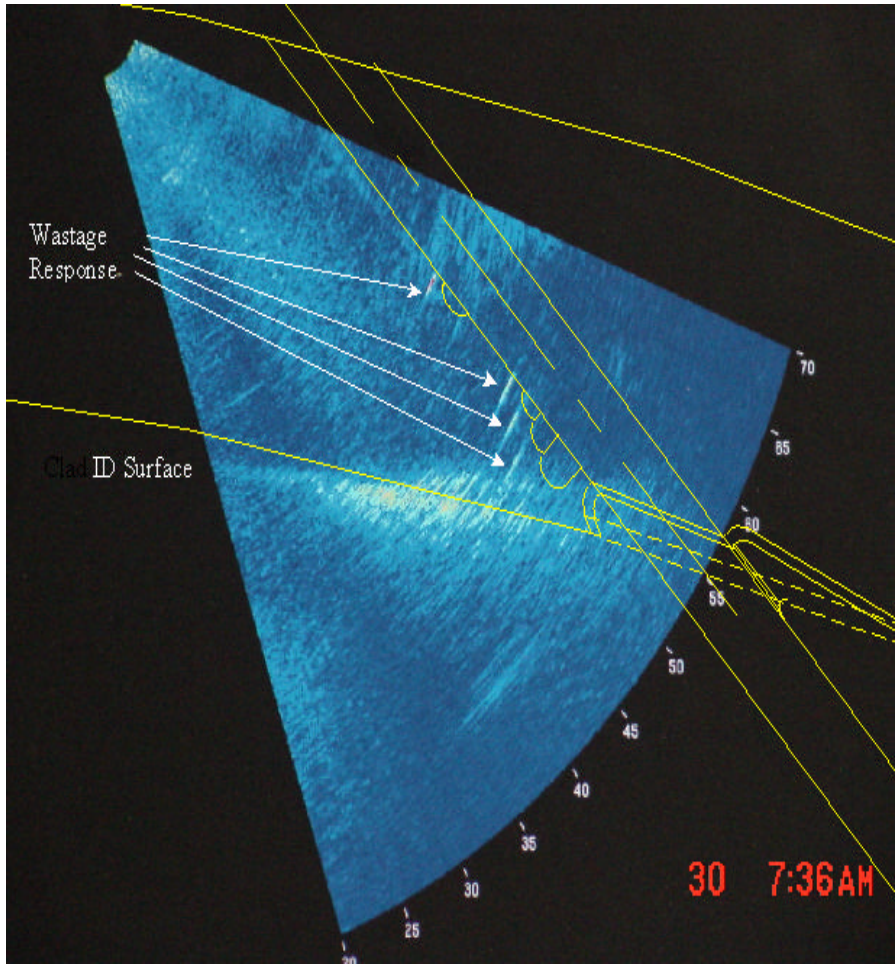
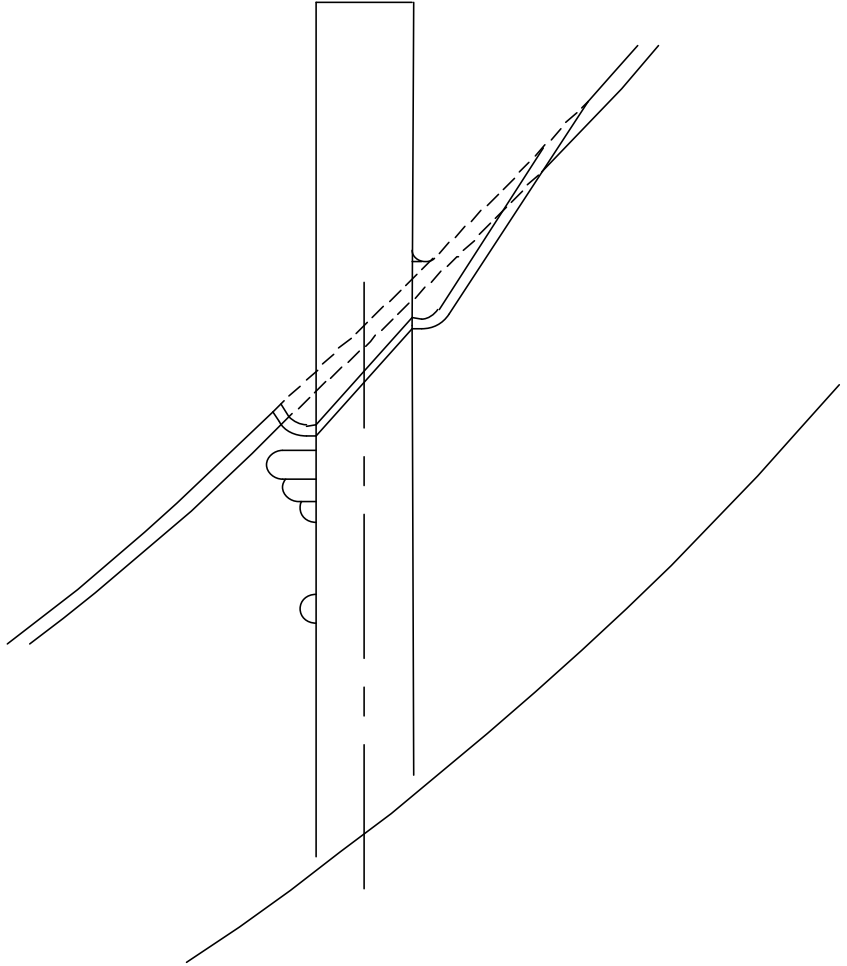
Developed Technology to Identify Wastage

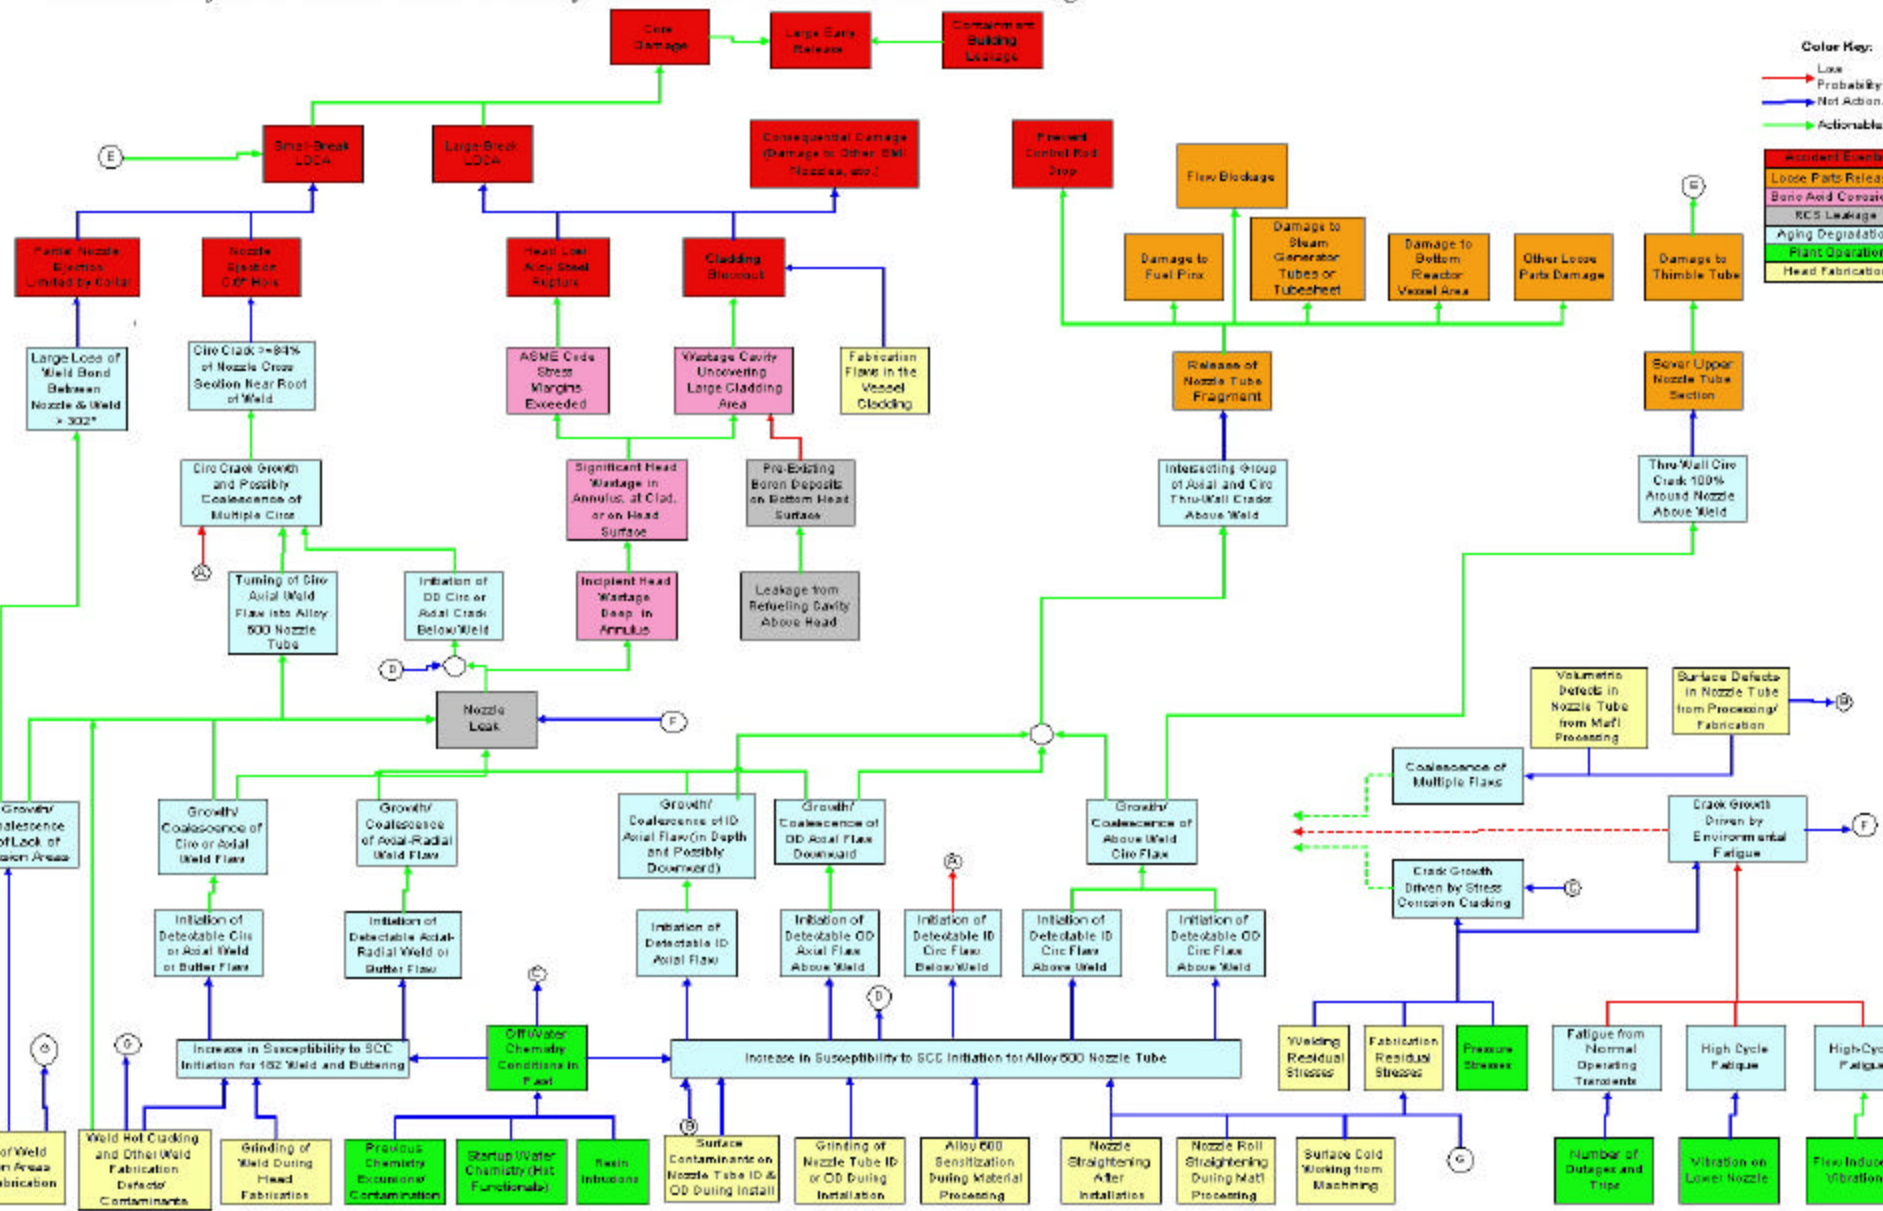
- Low Probability
- Not Actionable
- Actionable

Welded Events
Loose Parts Release
Boric Acid Corrosion
RCS Leakage
Aging Degradation
Plant Operation
Head Fabrication

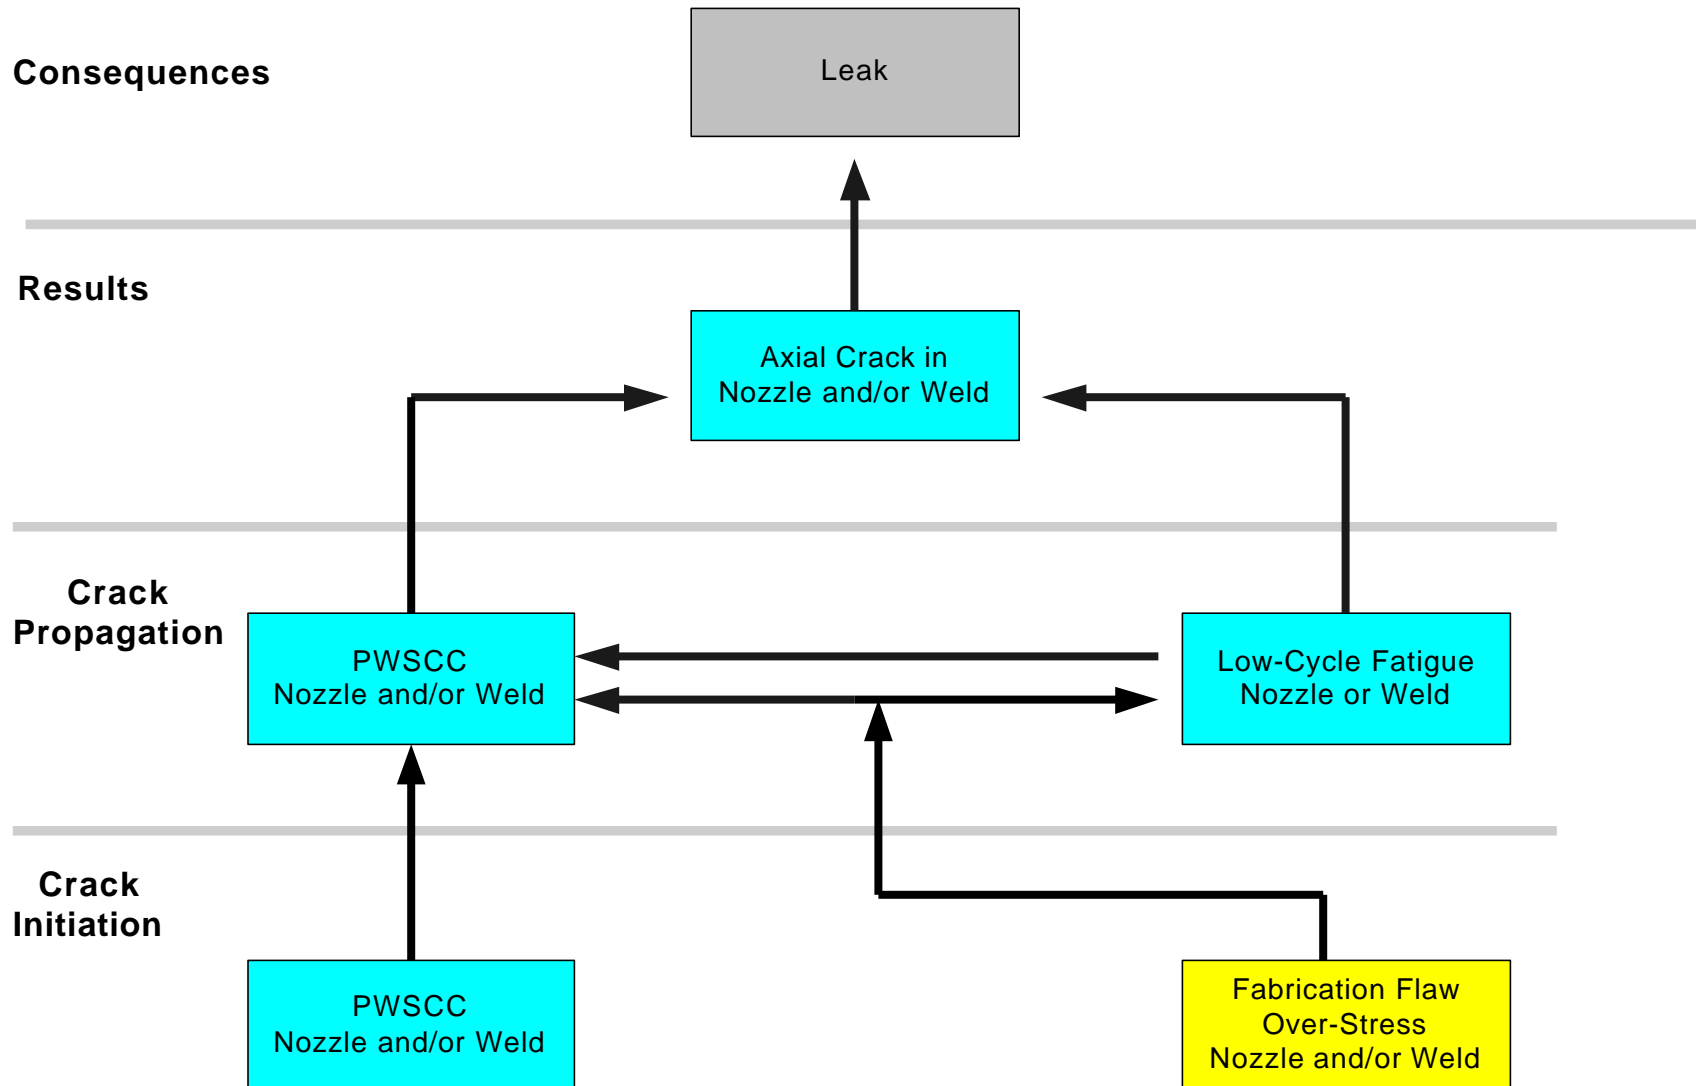
Two Possible Causes

Facts Inconsistent with PWSCC

- No cracks identified except in #1 and #46
- Cracks relatively old (3-5 yrs), about same age
- Cracks not ID initiated

- Cracks not at highest residual stress locations
- Penetrations #1 and #46 are different in terms of residual stress
- Some cracks do not appear to be in contact with primary water
