#### **South Texas Project Unit 1**

Bottom Mounted Instrument Penetration Condition Resolution

## EXTENT of CONDITION, CAUSE, CORRECTIVE ACTION

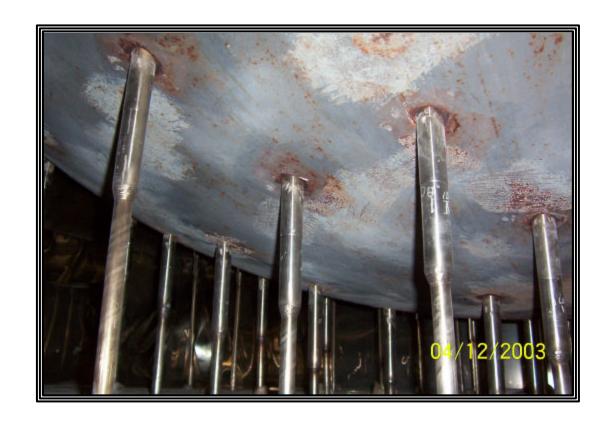
#### **Our Inspection Process Works**

We inspect the exterior of our vessels every time we shutdown for a refueling outage. Previous inspections did not reveal indications of seepage.
