# In-stream Remediation of a Hydrocarbon Release in North Central Alberta, Canada

Wayne Wiebe, A.Sc.T., CCEP  
General Manager

May 2-4, 2006

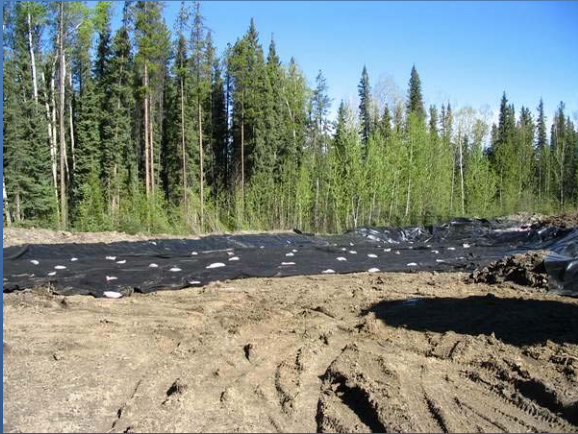
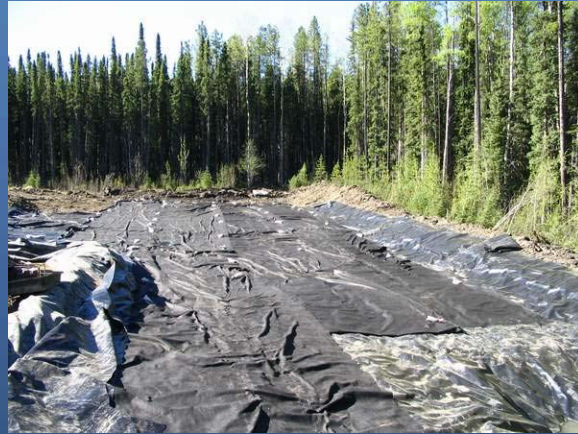
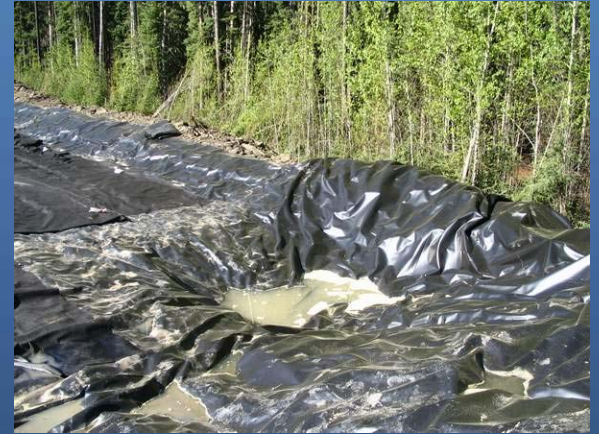
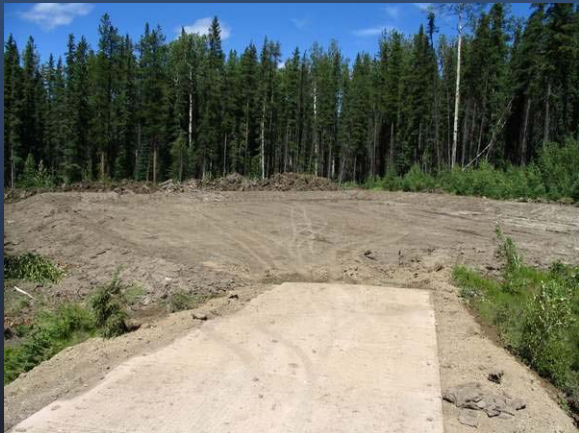
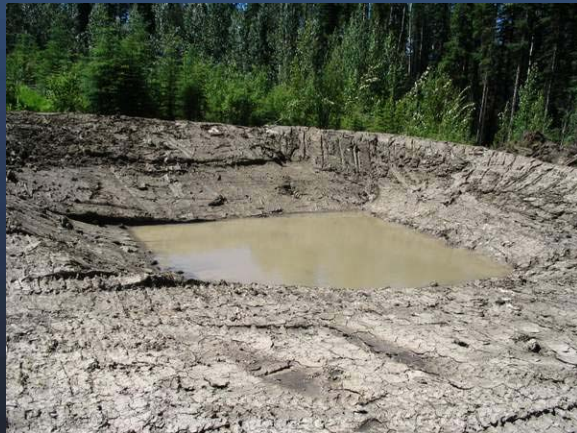
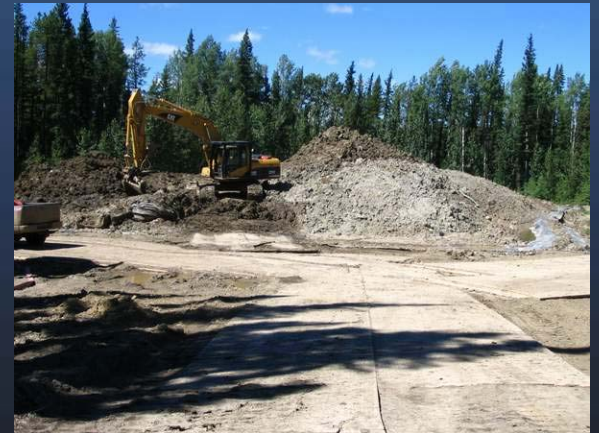
# Treatment Area Construction

- Two treatment cells constructed at an adjacent inactive oil wellsite
- To ensure proper containment, clayey backfill material was placed and compacted at the base and on the berms of the treatment cells
- To contain fluids and prevent contaminant migration, berms with a height of approximately 4 ft were constructed around the treatment cells
- Each treatment cell was contoured to allow for drainage toward a leachate collection area
- The treatment cells were lined with a 30 mil Enviro-Liner

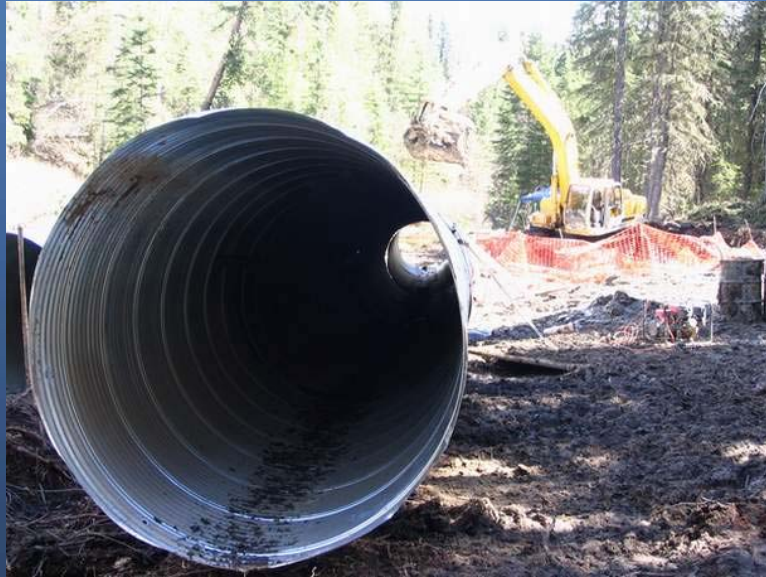
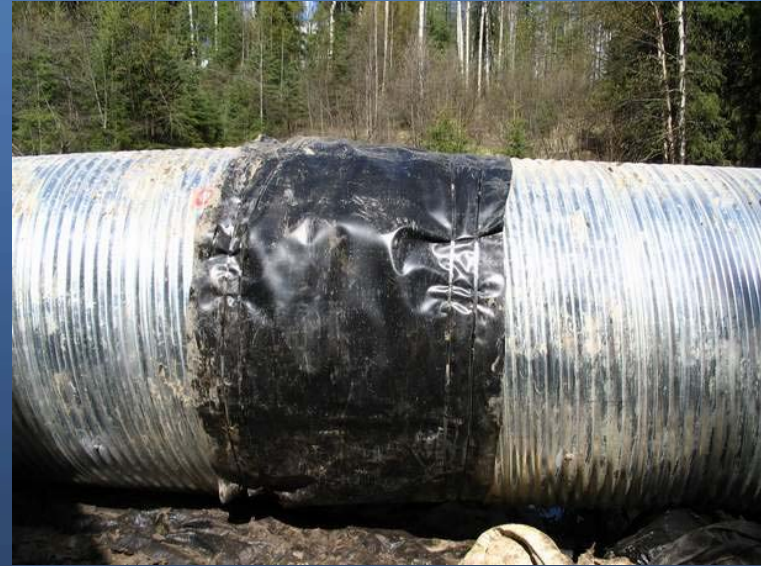
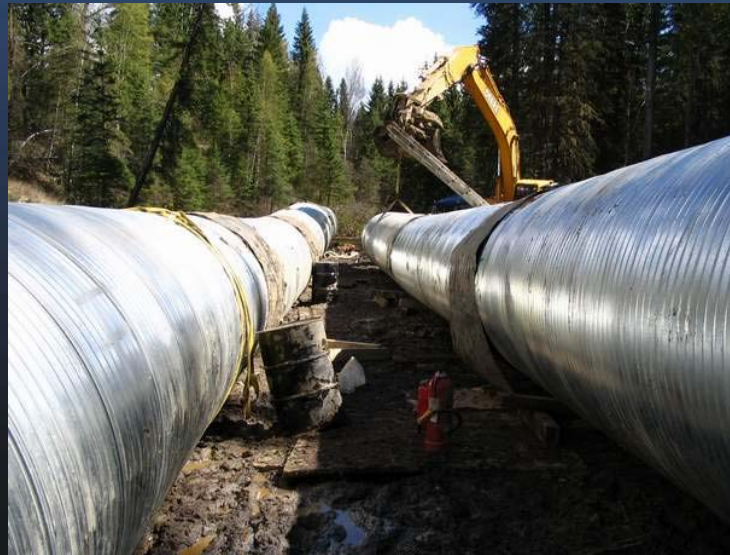
# Diversion Flume Construction

- The flume consisted of two steel culverts 6.5 ft in diameter and 118 ft in length fastened together and moved into place using excavators
- To direct water from the stream into the flume, and to prevent backflow from the downstream portion, two diversion walls were constructed
- The diversion walls consisted of concrete blocks (Jersey blocks) installed on a prepared (levelled) portion of the stream
- A 30 mil Enviro-Liner weighted with bulk sand bags was used to seal the diversion walls

- To prevent bank erosion and stream siltation, the north bank of the stream along the intake and the discharge portion of the flume were lined with woven polypropylene (PP) geotextile
- Non-woven geotextile was installed at the discharge portion of the flume to prevent scouring of the river bed
- A “grey water” pit, and a series of bellholes excavated along the isolated portion of the stream bed were used to collect fugitive flow through the flume, and dewater the work area

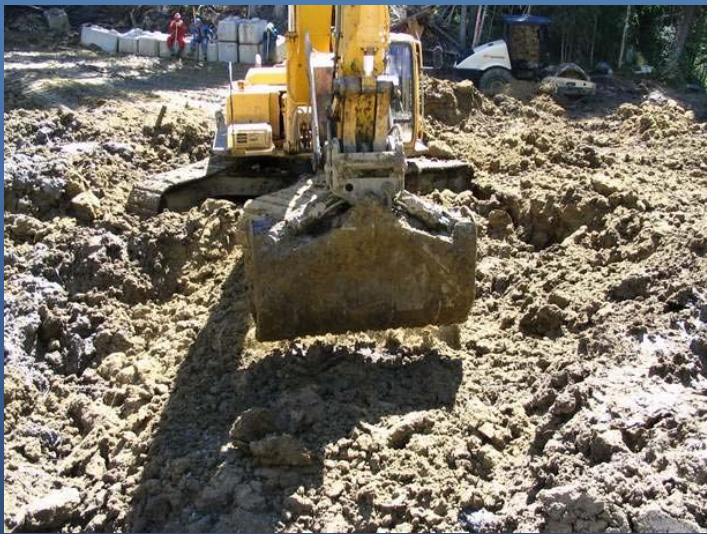
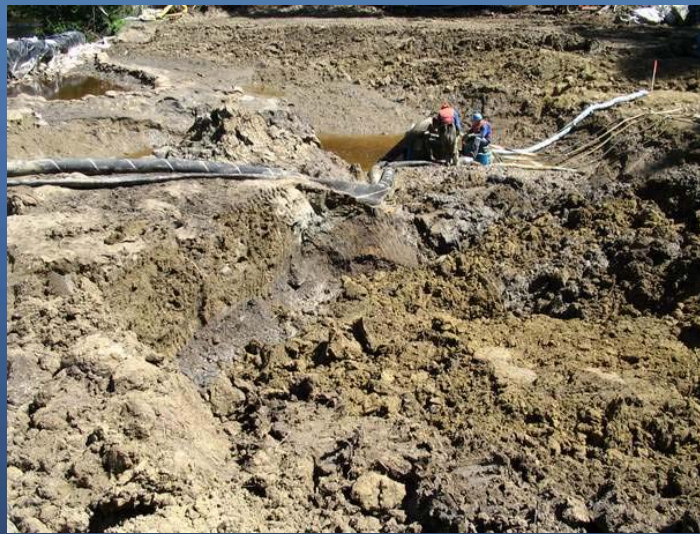
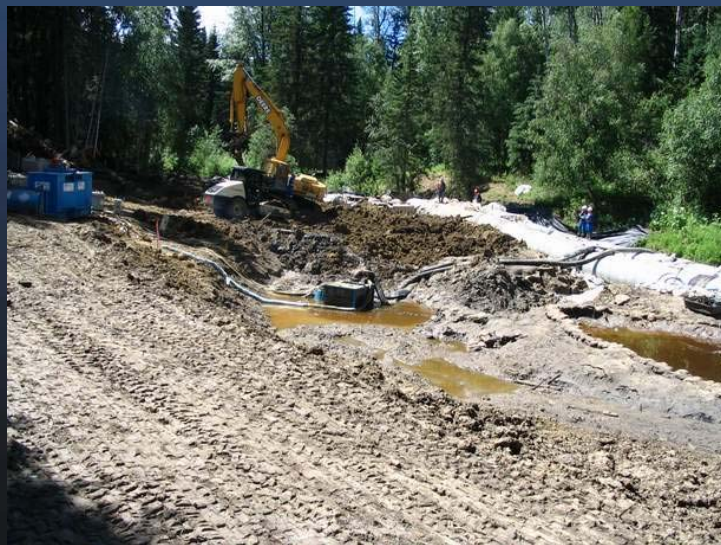
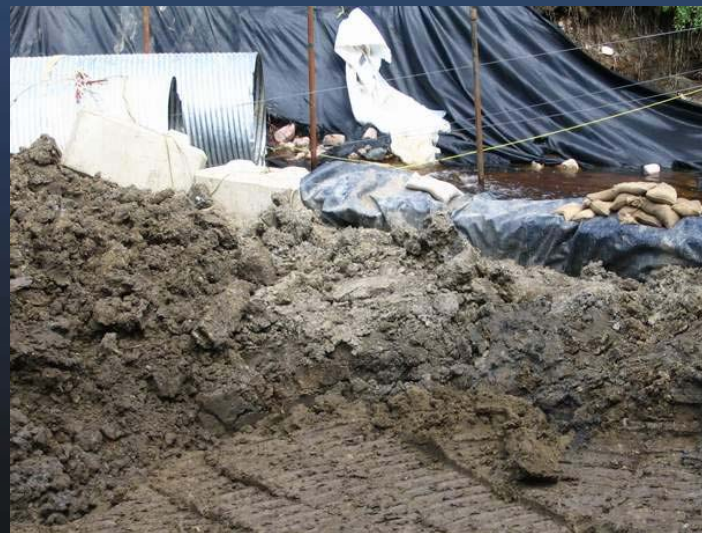
# Remediation Program

- Removal of impacted material from the pipeline break point was initiated on May 07, 2005
- Excavation activities resulted in exposure of the pipeline and identification of the break point on May 11, 2005
- Removal of impacted material from the pipeline break point, and the south bank of the stream were completed on June 16, 2005

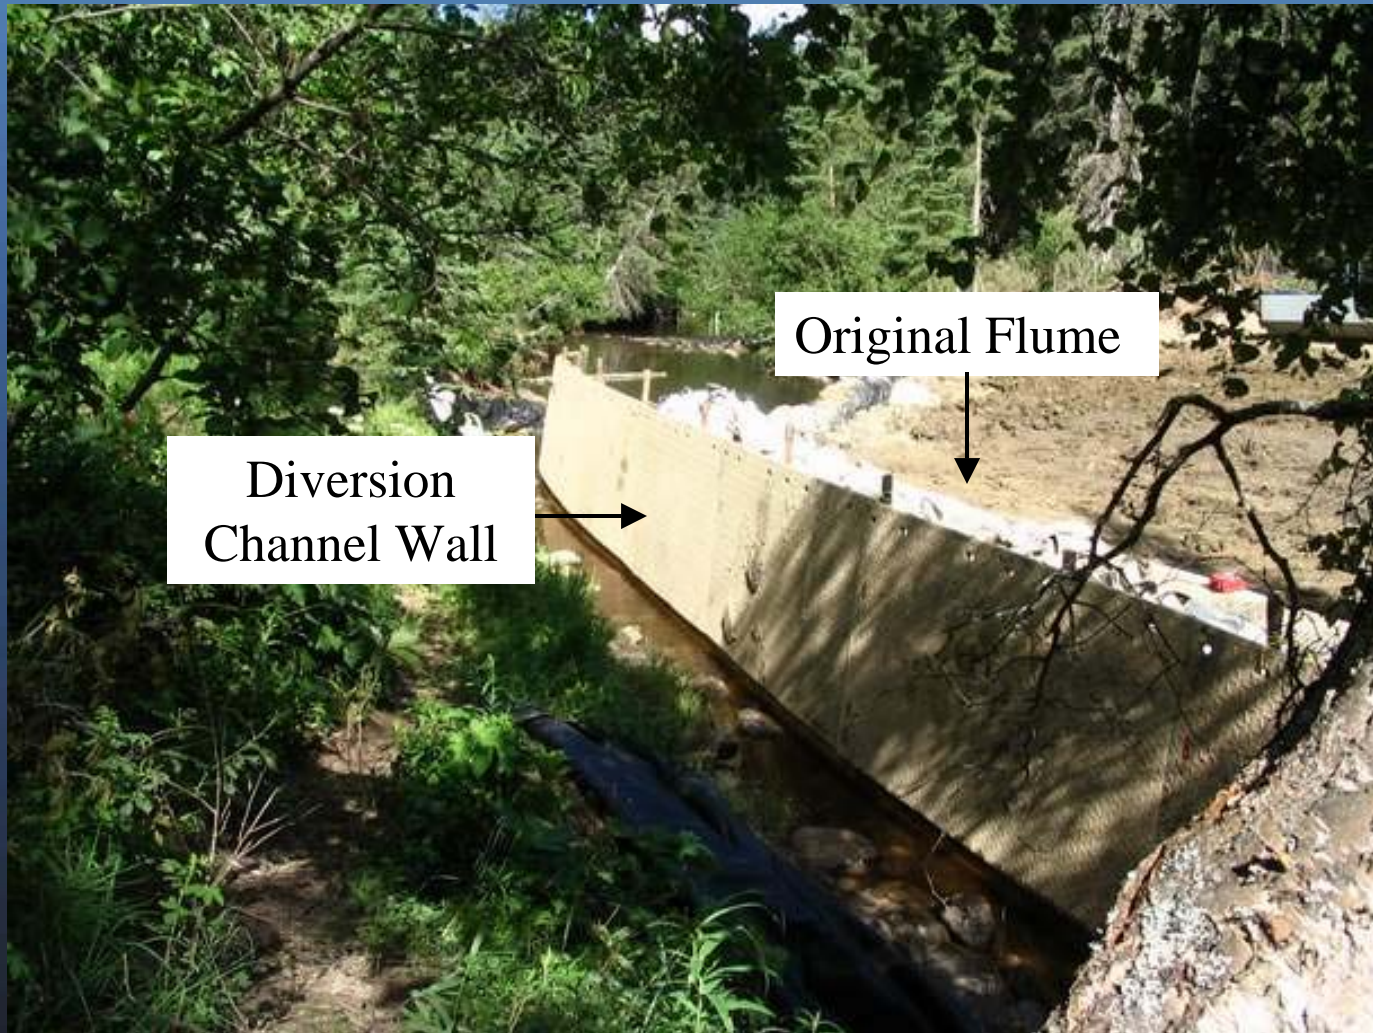
# Diversion Channel

- The diversion structure consisted of swamp mats keyed together, and installed as a wall along the north bank of the stream
- Steel piping anchored into the stream bed was used to support the structure
- A 40 mil Enviro-Liner was used to seal the constructed diversion channel
- The liner anchored onto the constructed swamp mat wall and on the north bank of the stream
- The upstream diversion wall was extended and keyed into the constructed structure

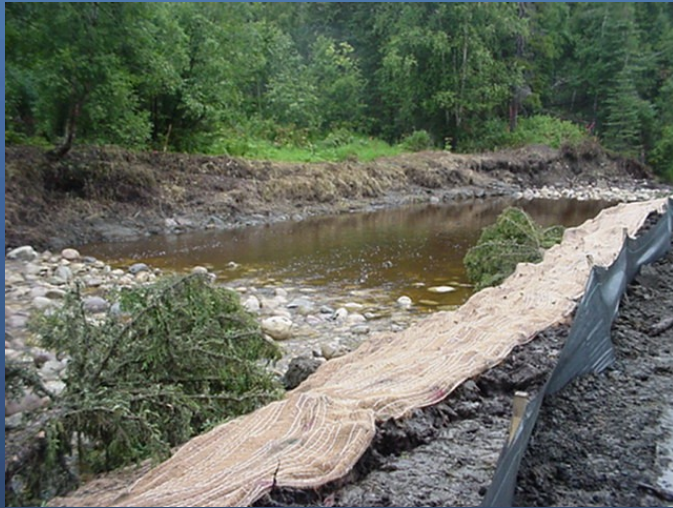
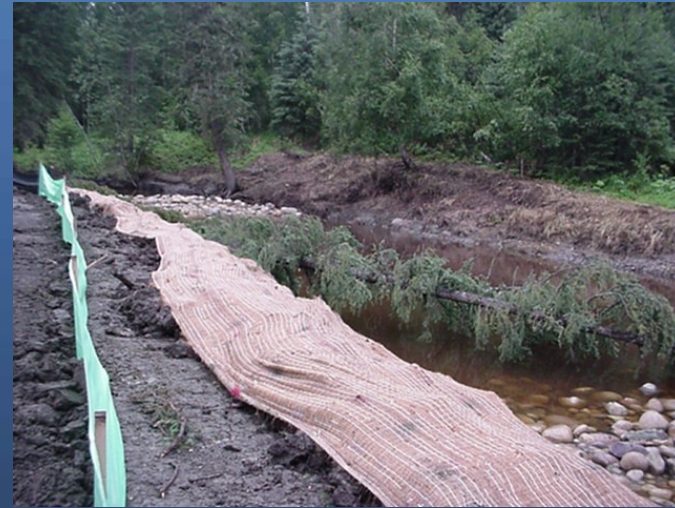
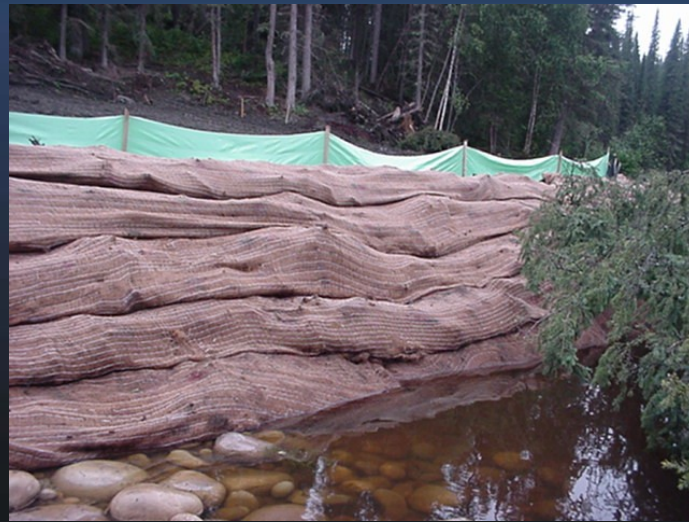
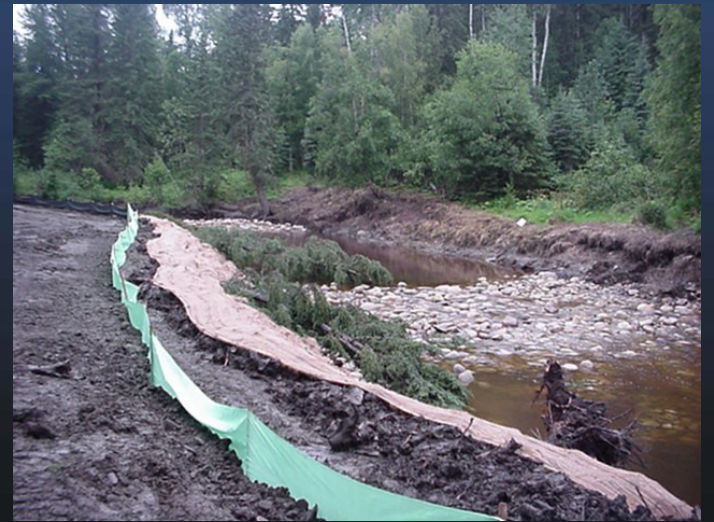
# Streambed Reconstruction

- The streambed reconstruction program was initiated on Aug. 08, 2005 and completed on Aug. 11, 2005
- The program was initiated upon completing the remediation activities and removal of the stream diversion structure
- The reconstruction activities were planned and supervised by a consulting team specializing in aquatic/biological engineering
- Including re-contouring, placement of boulder and cobble rip rap, stabilization of stream banks, placement of habitat structures
