January 14, 2002

SUBJECT: Potential manufacturing problem with certain limit switch assemblies used in ASCO General Controls Hydramotor® Actuators.

December 21, 2001

**POTENTIAL MANUFACTURING PROBLEMS WITH
LIMIT SWITCH ASSEMBLIES USED IN ASCO GENERAL CONTROLS
HYDRAMOTOR® ACTUATORS**

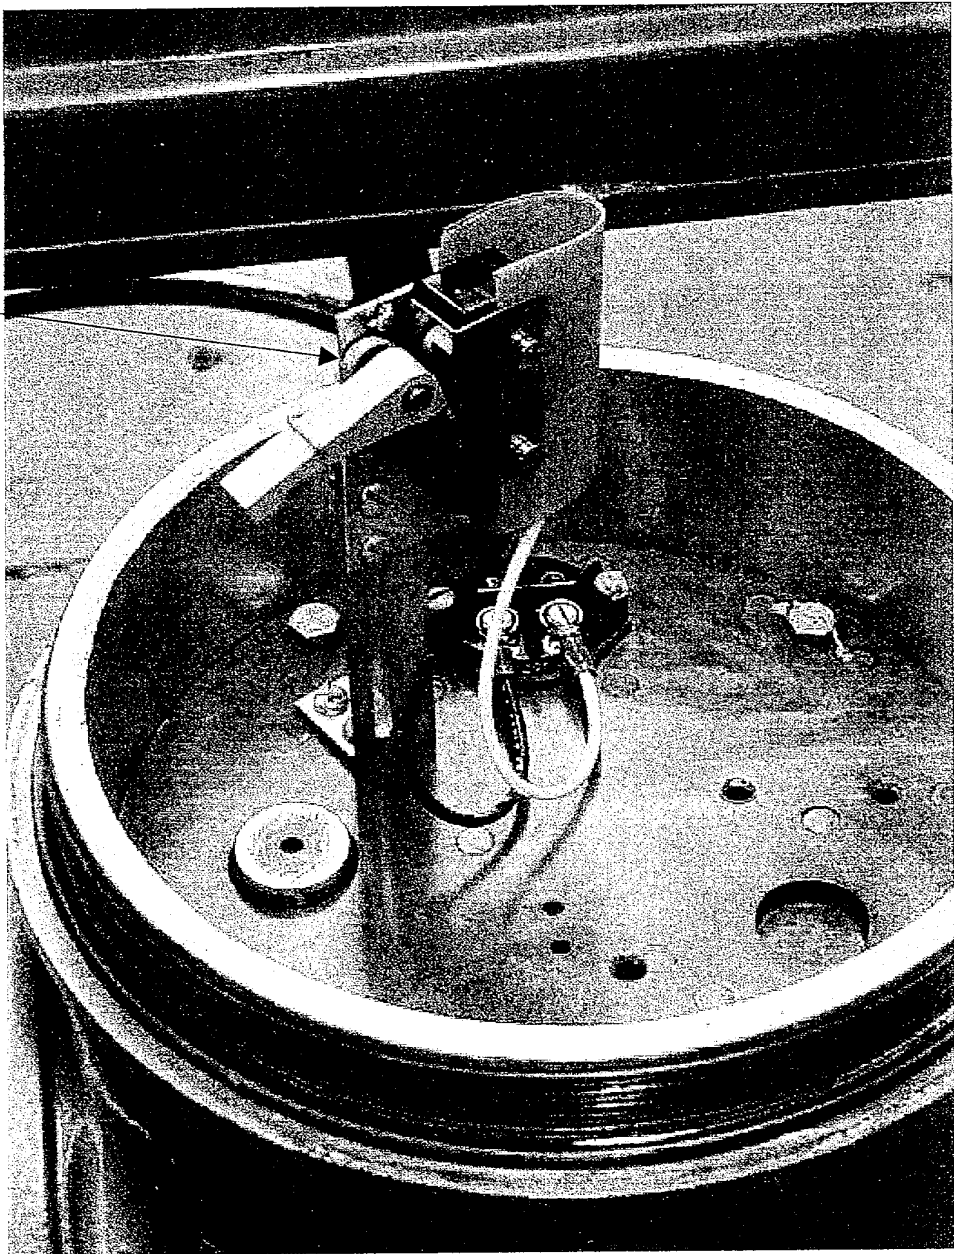
Analysis of the returned Limit Switch Assembly (see attachment 1) revealed that the shaft on which the position sensing lever operates was not secured tightly to the plate, causing wobble of the shaft. This wobble may result in the rotation of the lever past its actuation point, which would leave the switch contacts in the normally open (N.O.) position. This condition will result in the failure of the actuator piston to retract when the Hydramotor® is powered. The shaft is staked to the plate assembly. Manufacturing instructions for this assembly defines the maximum pressure to be applied for the staking press, but no minimum value. This led to variation of the staking process, which resulted in inconsistent and incomplete attachment of the shaft to the plate. (See attachment 2). In addition to the field return, Asco has found several limit switch assemblies in our inventory with this condition.

TYPICAL INSTALLATION
NH95 LIMIT SWITCH ASSEMBLY
