## Appendix D3

# ESEM and SEM/EDS Data for Test #2, Day-30 Drain Collar Fiberglass

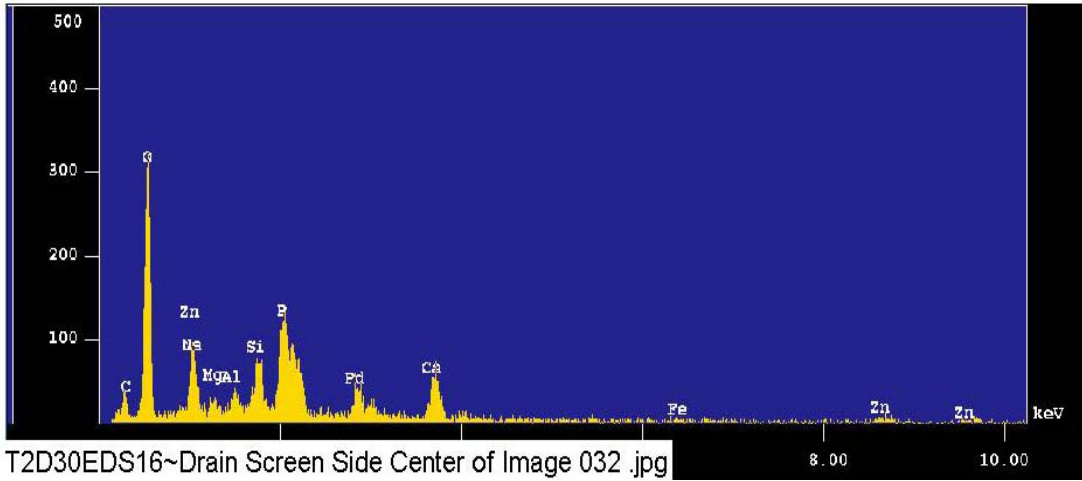
**Figure D3-5. EDS counting spectrum for the center of the image shown in Figure D3-4. (T2D30EDS16~Drain Screen Side Center of Image 032)**

The results from the chemical composition analysis for T2D30EDS16 are given in Table D3-1.
