Atmospheric Hazards

FACE 84-11: Fire At A Wastewater Treatment Plant

FACE 84-13: Two Confined Space Fatalities During Construction of a Sewer Line

FACE 85-23: Use of Sulfuric Acid Results in Two Deaths in Waste Water Holding Tank in Pennsylvania

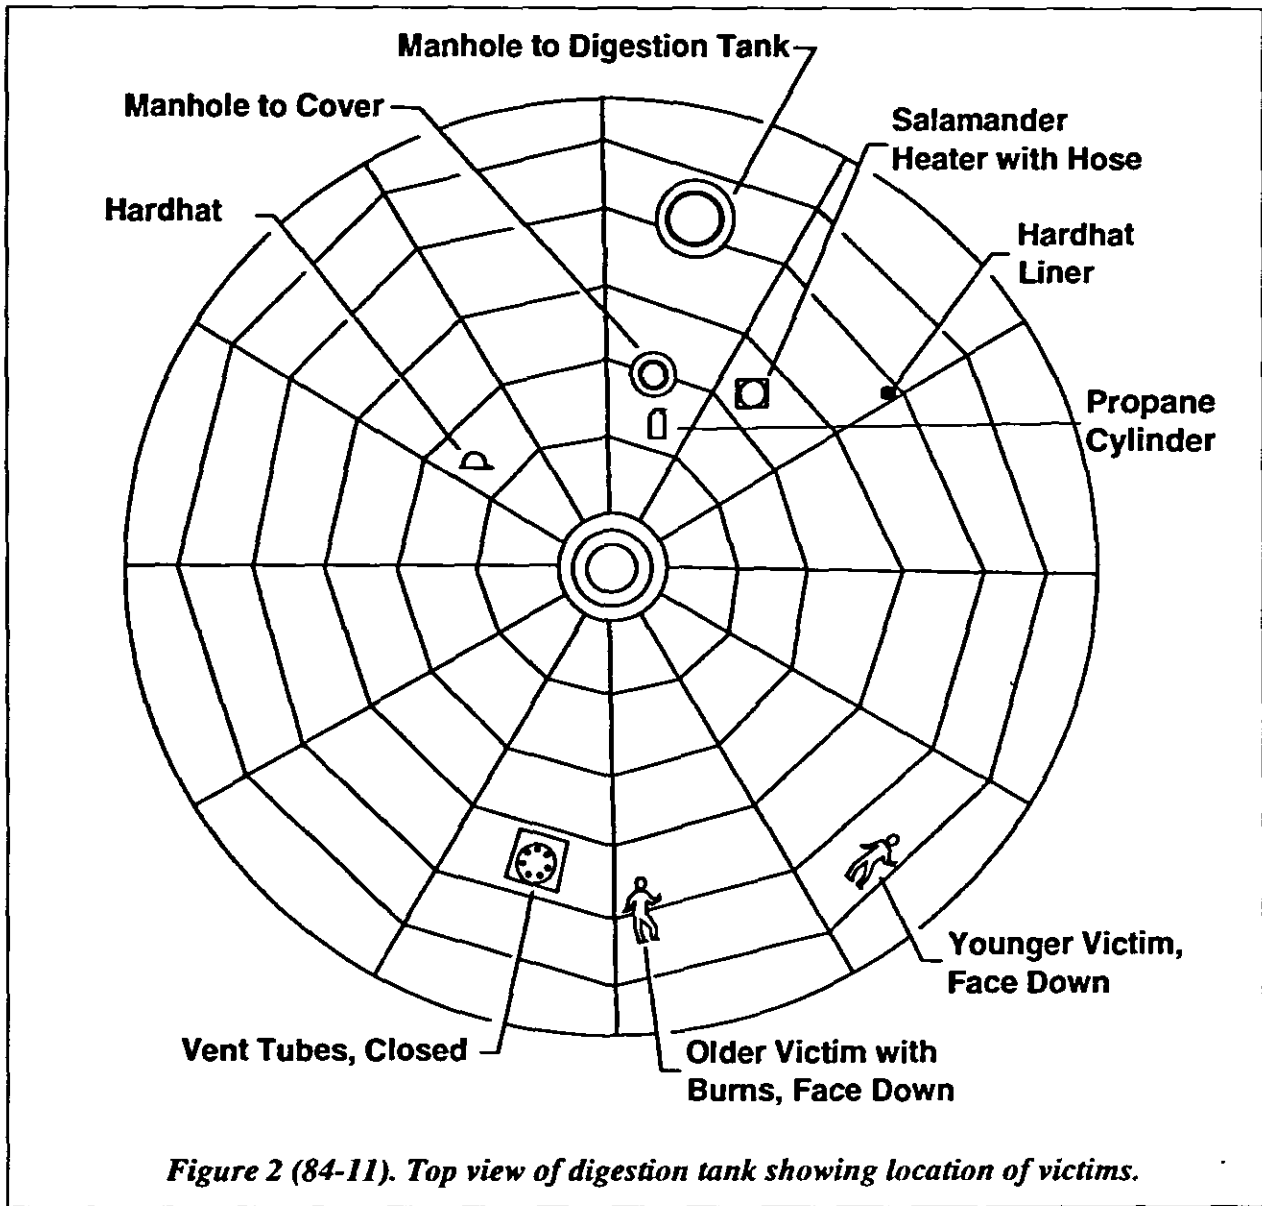
The floating circular cover consisted of a confined space of approximately 6,400 cubic feet with a five-foot ceiling height at the apex (see Figure 1). The only entry into the cover was through a 30-inch diameter manhole located approximately ten feet from the apex. Due to the cold and windy winter weather, the carpenters built a temporary roof (2 by 4 studs covered with 8 to 10 mil. plastic sheeting) over the floating cover.

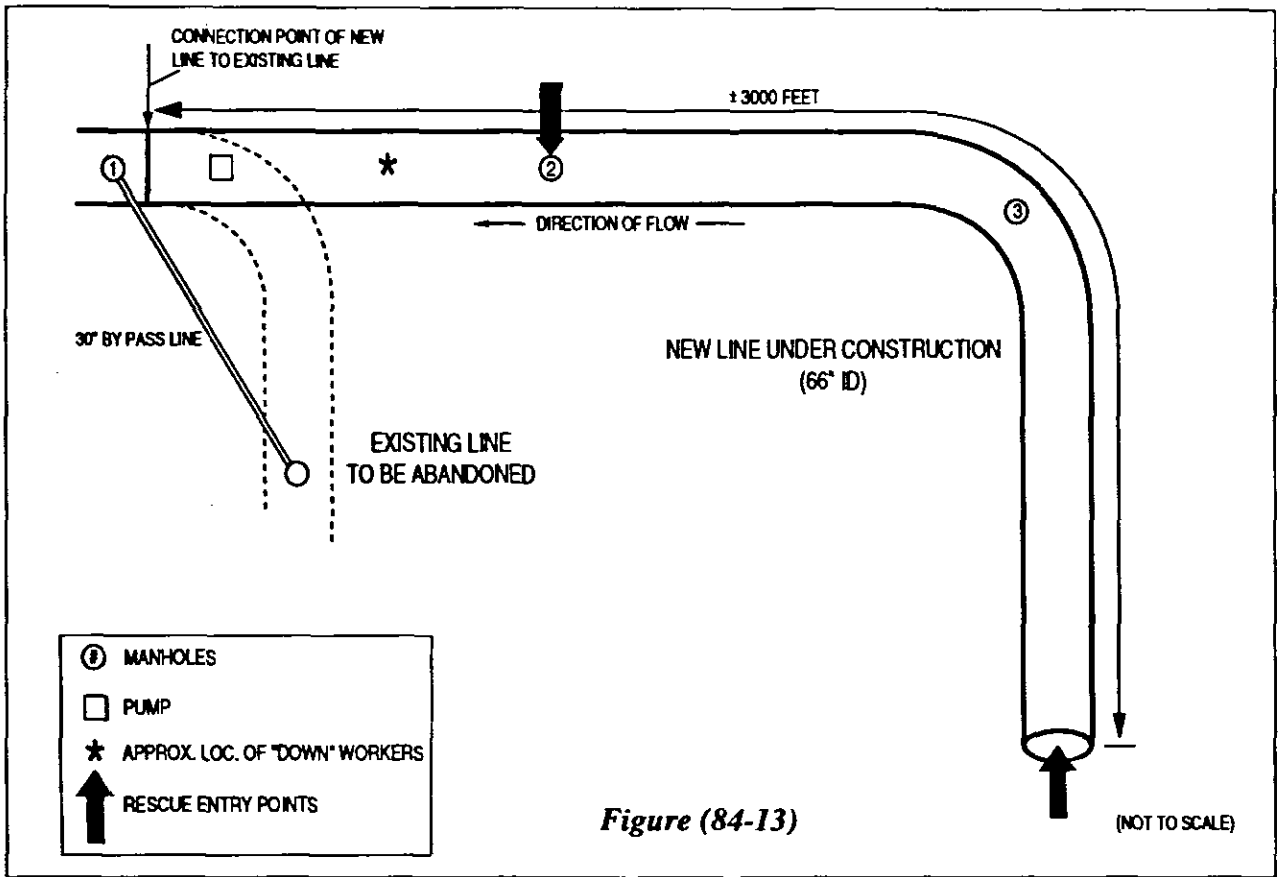
The contractor replaced the sand bag dike with a steel plug to eliminate further seepage. A gasoline engine driven pump was placed upstream of the plug so that the existing sewage could be removed from the pipe. The pumping procedure required a laborer to enter the new line at Manhole No. 2, walk downstream approximately 1,200 feet to the pump, fuel the gasoline engine, start it and exit back through Manhole No. 2. This procedure was performed on a 3-day cycle. At no time was the atmosphere in the pipe tested prior to entry, nor was there mechanical ventilation to remove air contaminants.

Given the industrial hygiene survey results and the toxicologic findings, the cause of death was determined to be exposure to high concentrations of CO, a by-product of the gasoline-powered pump, in an area with no natural ventilation, i.e., a confined space.

3. A static ventilating condition was created when the plug was installed in the new sewer next to Manhole No. 1.

Recommendation: An analysis of the conditions surrounding the connection at Manhole No. 1 should have generated several safe alternatives for an effective temporary barrier in the new sewer which also considered safe atmospheric conditions.

Recommendation: The pump should have been located on the outside of the sewer with a hose running to the sewage via an access hole or an electric motor driven pump should have been considered.

Recommendation: *Since it was necessary for workmen (either those servicing the pump or those planning to do the grouting) to enter the sewer, adequate ventilation should have been provided. If ventilation could not create a safe atmosphere, the use of SCBA should have been mandatory.*
