Hazardous Materials and Environmental Assessment Report

Destruction Island, Washington

January 2000

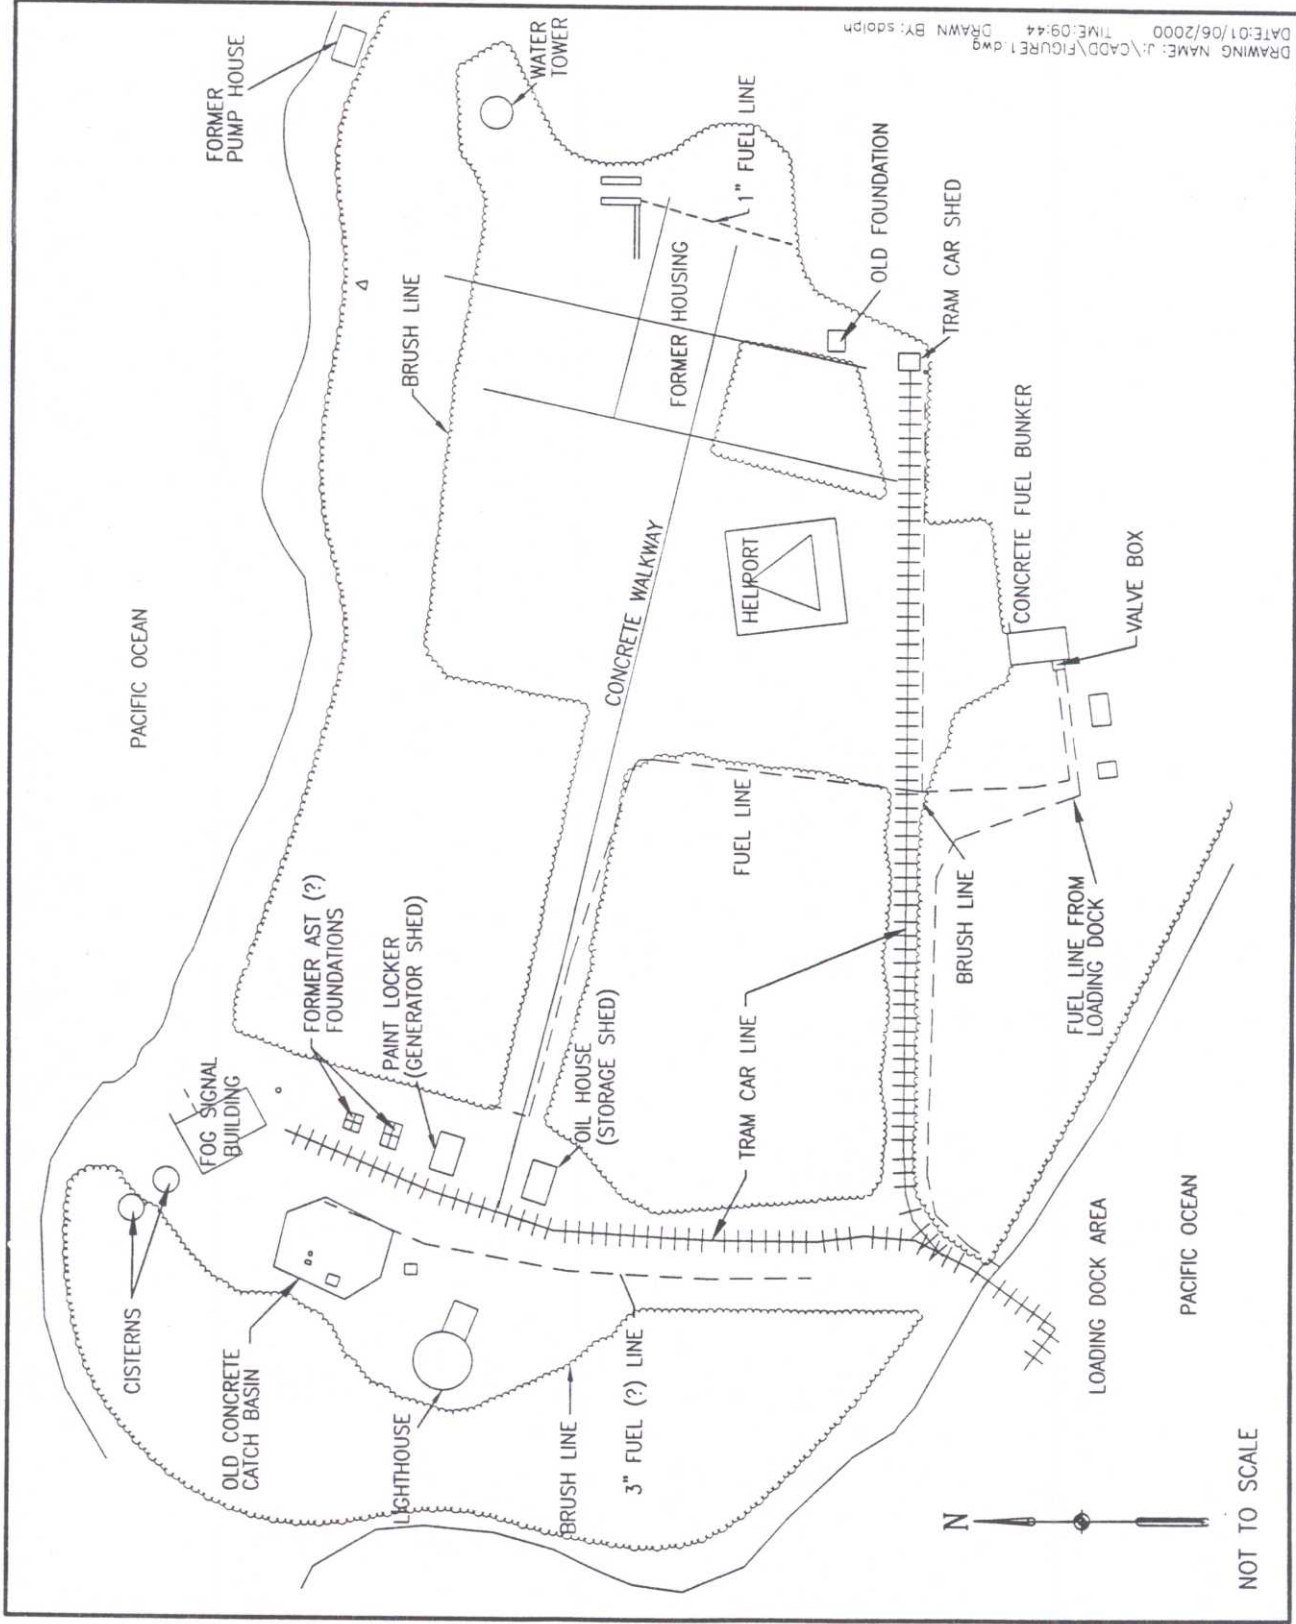
Figure 1. Western Portion of Destruction Island, Washington

These areas of concern are restricted to the western portion of Destruction Island and are shown on Figure 1. Specific areas of concern are detailed on Figures 2a and b, 3a and b, and 4a and b.

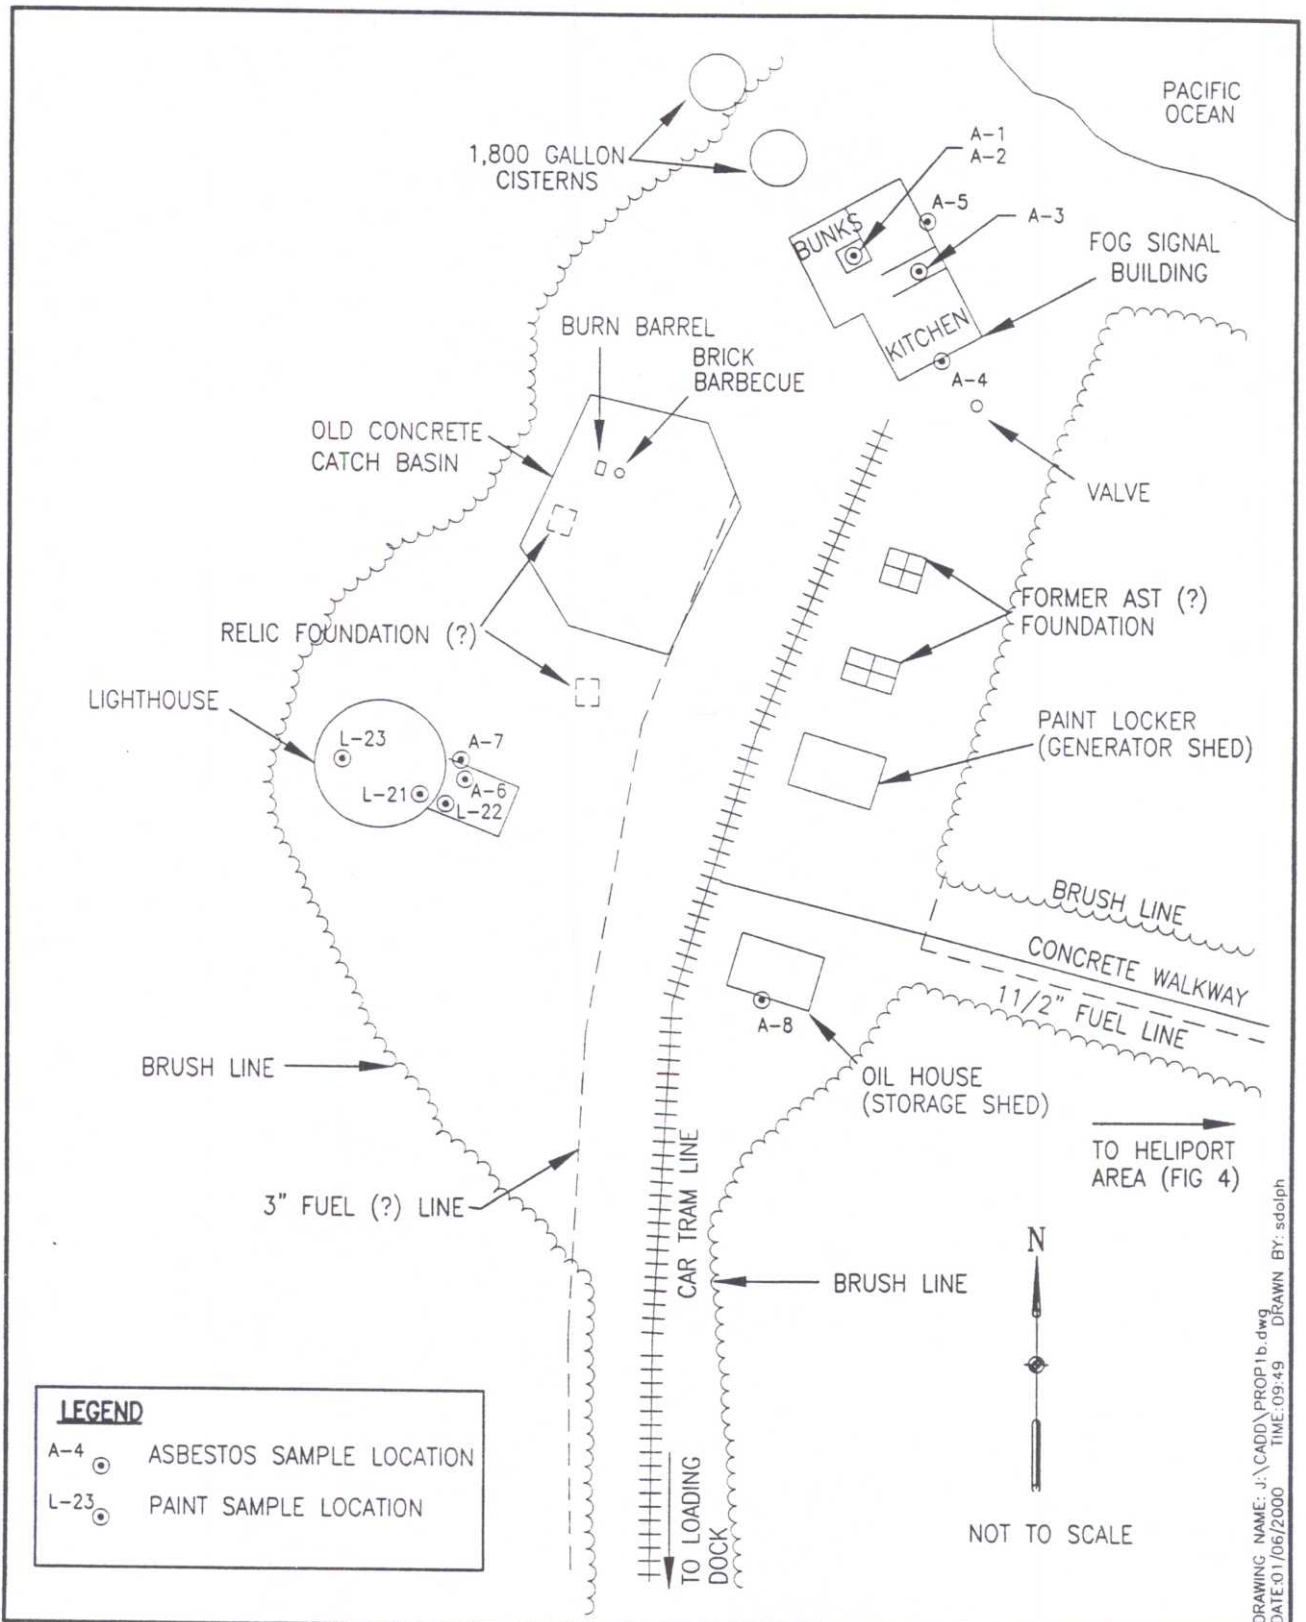
Figure 2b. Asbestos and Paint Sample Locations - Lighthouse Area

Laboratory-reported lead analyses for paint samples are summarized in Table 1. Locations of paint samples are shown on Figures 2b, 3b, and 4b. Analytical results are presented in Appendix A.
