VIRGINIA ELECTRIC AND POWER COMPANY
NORTH ANNA POWER STATION UNITS 1 AND 2
NRC BULLETIN 2002-02 – REACTOR PRESSURE VESSEL HEAD AND VESSEL
HEAD PENETRATION NOZZLE INSPECTION PROGRAMS
REQUEST FOR ADDITIONAL INFORMATION

Response to Request for Additional Information
NRC Bulletin 2002-02

North Anna Power Station Units 1 and 2

**Virginia Electric and Power Company
(Dominion)**

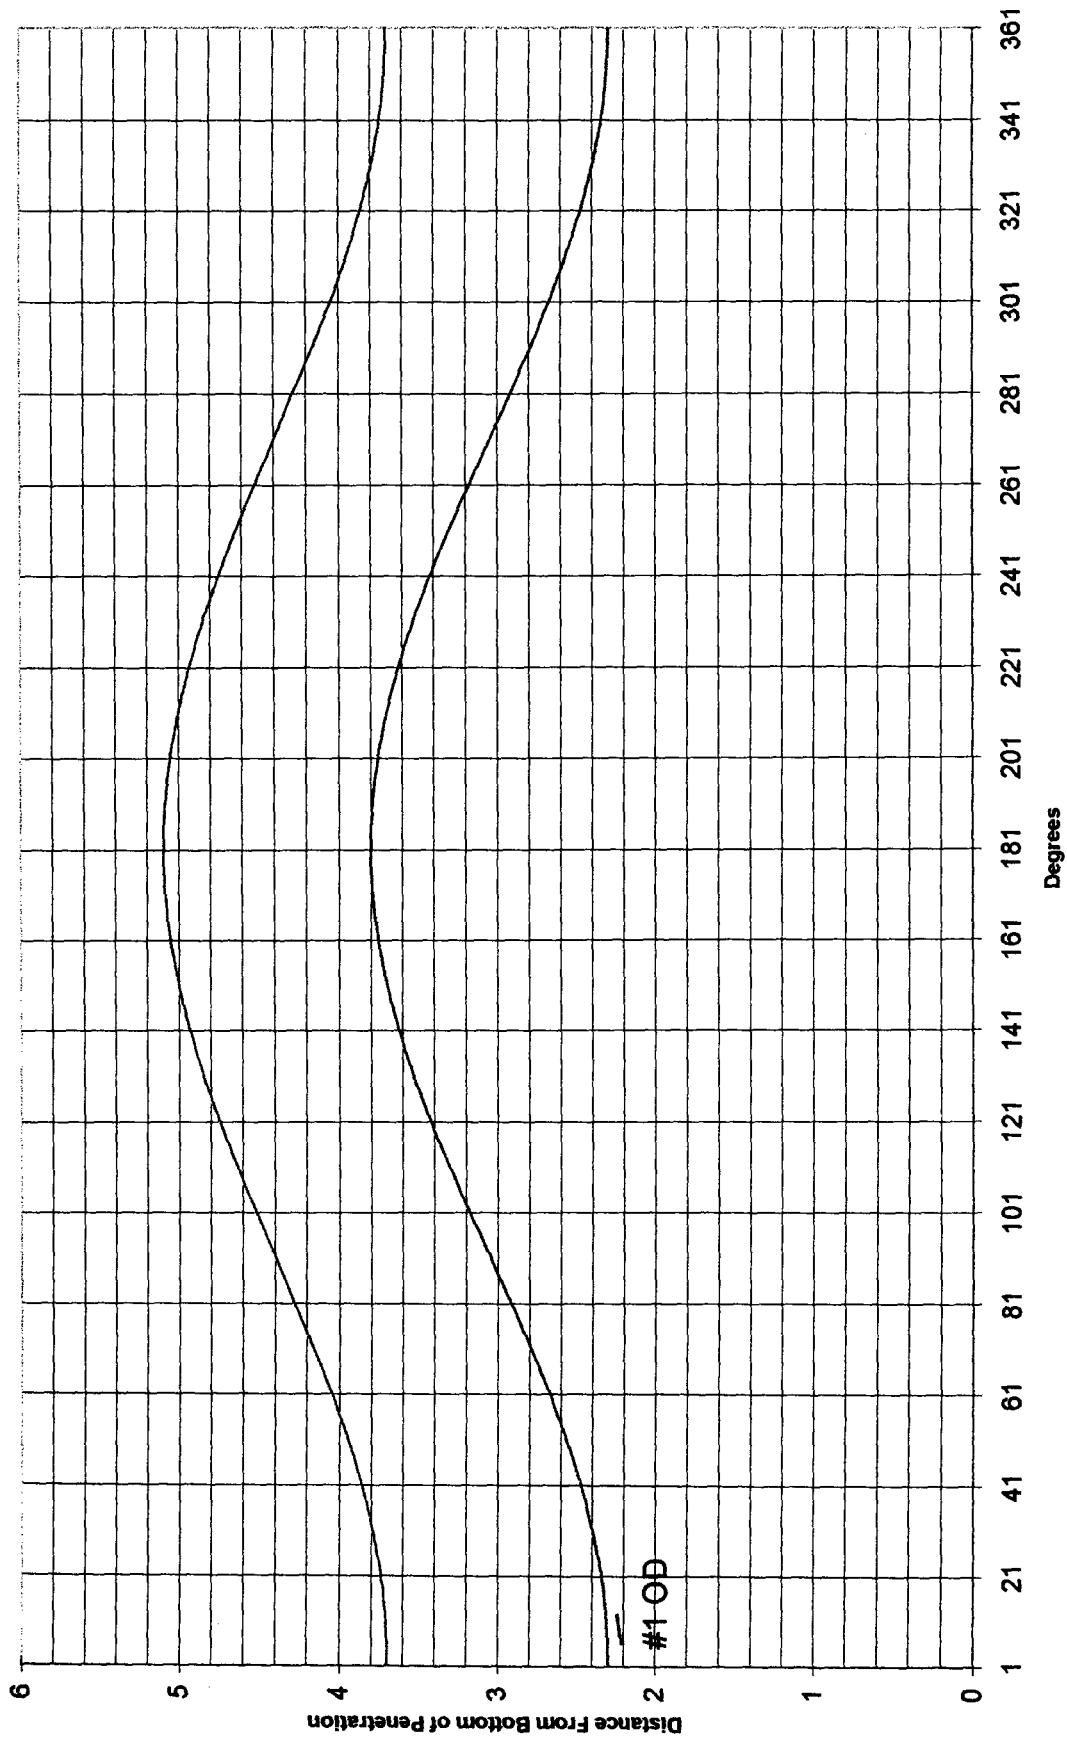
North Anna Unit 2 RVHP Weld Profiles Penetration #15

Penetration #	Characteristics	* Axial Location Relative to Root of J-Groove Weld	Length	Depth
#15	OD Circumferential	-1.12"	7.5 deg. to 12 deg.	0.226"
#21	Potential Leak Path	NA	220 deg.	N/A
#35	OD Axial	-1.12"	0.80"	0.223"
#41	OD Circumferential	-0.52"	357 deg. to 43 deg.	0.097"
#51	Potential Leak Path	NA	210 deg. to 260 deg.	N/A
#54	OD Circumferential	-.040	119 deg. to 198 deg.	0.226"
"	OD Circumferential	-0.276	344 deg. to 16 deg.	0.156"
#59	OD Circumferential	-0.312"	347 deg. to 63 deg.	0.149"
"	OD Circumferential	-0.320	156 deg. to 206 deg.	0.149"
#63	Potential Leak Path	NA	320 deg. to 0 deg.	N/A
#65	OD Circumferential	-0.320	330 deg. to 42 deg.	0.152"
"	OD Circumferential	-0.200	160 deg. to 190 deg.	0.078"
#67	OD Circumferential	-0.800	343 deg. to 27 deg.	0.094"

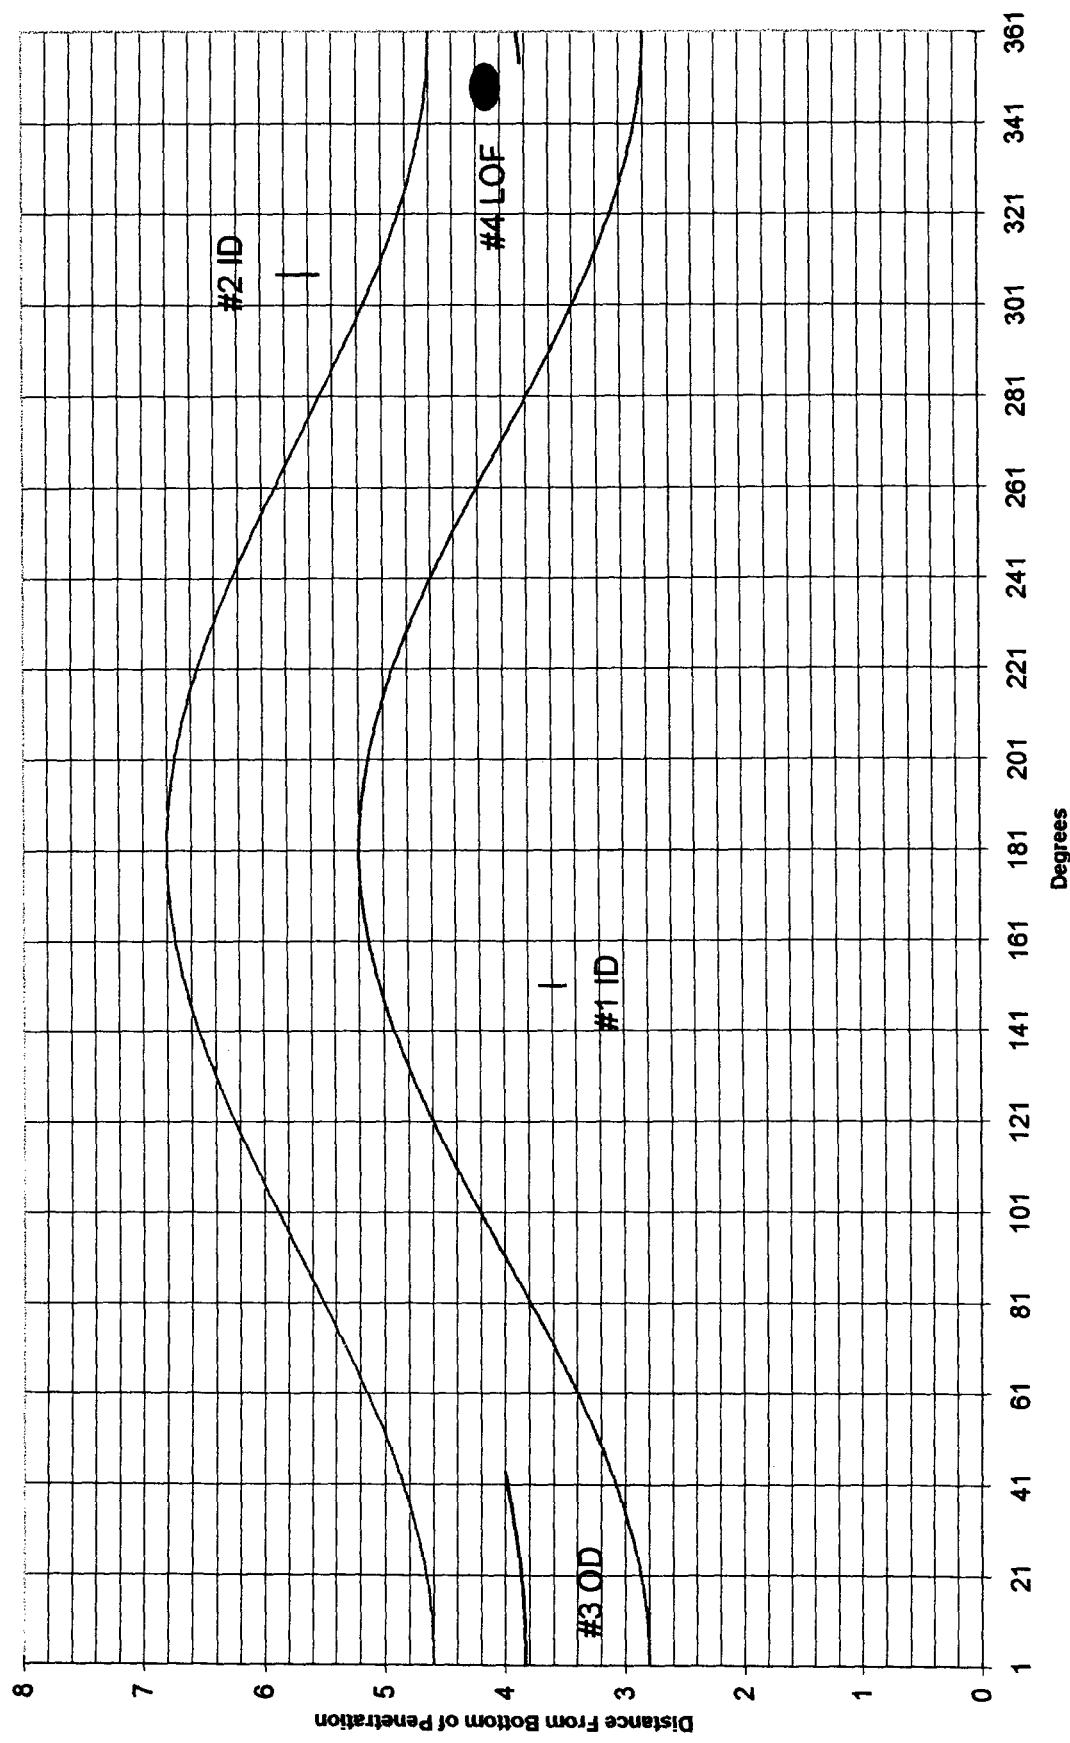
North Anna Unit 2 RVHP Weld Profiles Penetration #41

41	3	OD/CIRC	357 - 43	3.82 - 4.02	0.097"	BELOW	YES
41	4	OD/NA	342 - 351	3.86 - 4.22	NA	BELOW	NO/LOF
44	1	NA	69 - 161	0 - 2.14	NA	BELOW	NO/LOC
44	2	OD/NA	119 - 125	6.38 - 6.22	NA	BELOW	NO/IPA
44	3	OD/NA	139 - 220	5.58 - 5.58	NA	BELOW	NO/WWI
44	4	OD/NA	177 - 189	6.90 - 7.18	NA	BELOW	NO/LOF
44	5	OD/NA	347 - 17	4.30 - 4.82	NA	BELOW	NO/LOF
46	1	OD/NA	4 - 22	2.56 - 3.24	NA	BELOW	NO/WWI
47	1	OD/NA	10 - 24	3.48 - 3.48	NA	BELOW	NO/WWI
47	2	OD/NA	154 - 235	5.72 - 6.24	NA	BELOW	NO/WWI
47	3	OD/NA	201 - 220	7.64 - 7.52	NA	BELOW	NO/WWI
47	4	OD/NA	Several spots	Several Spots	NA	BELOW	NO/LOF
48	1	OD/NA	208 - 272	0.00 - 1.38	NA	BELOW	NO/LOC
48	2	OD/NA	355 - 22	3.18 - 3.30	NA	BELOW	NO/WWI
48	3	OD/NA	67 - 82	5.18 - 5.22	NA	BELOW	NO/WWI
48	4	OD/NA	205 - 208	9.50 - 9.58	NA	ABOVE	NO/IPA
48	5	OD/NA	303 - 316	5.54 - 8.74	NA	ABOVE	NO/IPA
48	6	OD/NA	Several spots	Several Spots	NA	BELOW	NO/LOF
50	1	OD/NA	319 - 324	10.12 - 10.48	NA	ABOVE	NO/IPA

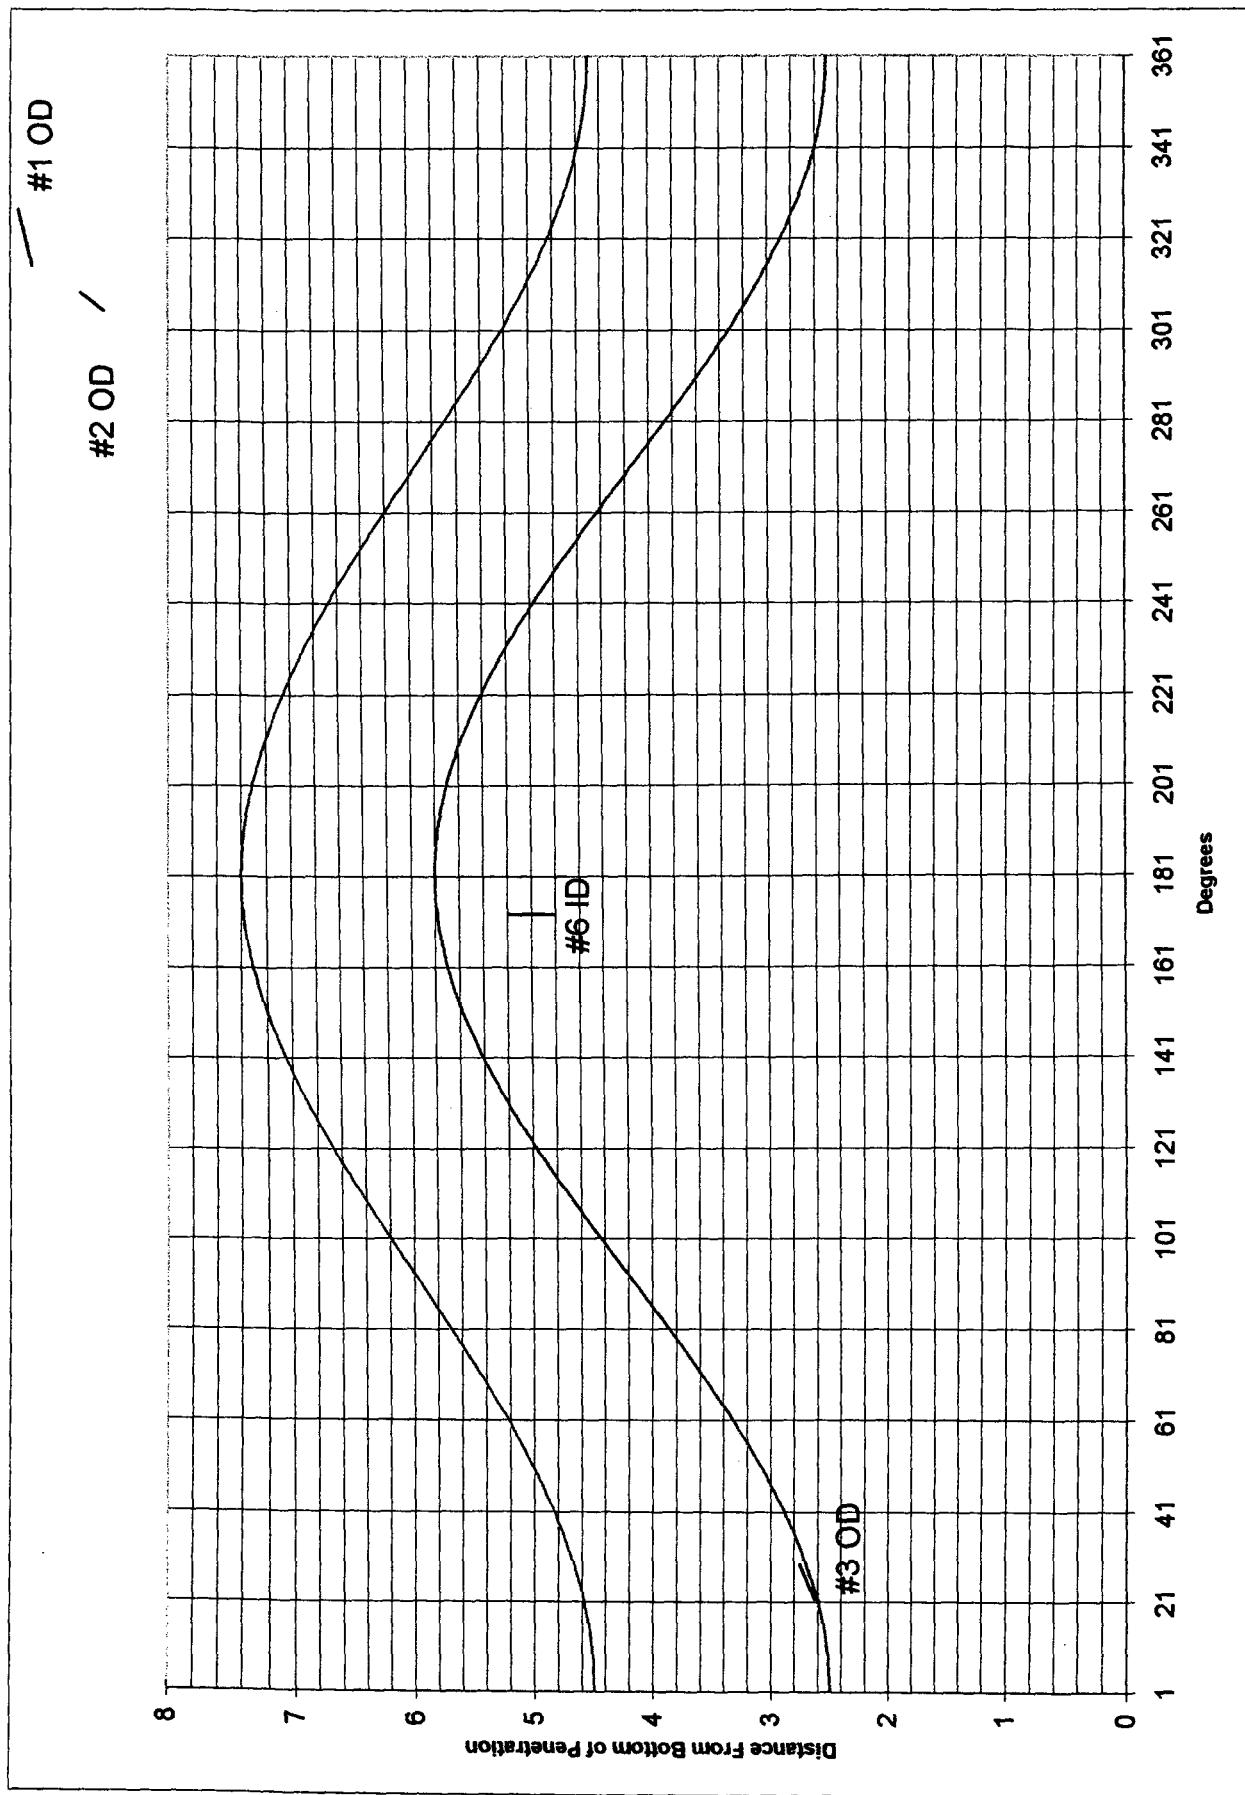
North Anna Unit 2 RV/HP Weld Profiles Penetration #50

50	2	OD/NA	301 - 305	8.50 - 8.92	NA	ABOVE	NO/IPA
50	3	OD/NA	20 - 27	2.40 - 2.72	NA	BELOW	NO/IPA
50	4	NA	@ 299	4.48 - 5.60	NA	NA	NO/NOISE
50	5	NA	@ 279	3.02 - 4.20	NA	NA	NO/NOISE
50	6	ID/AXIAL	169 - 169	4.76 - 5.12	TSM	BELOW	YES
51	1	ID/AXIAL	153 - 174	3.07 - 4.43	TSM	BELOW	YES
51	2	ID/AXIAL	337 - 337	3.59 - 3.95	TSM	ABOVE	YES
51	3	ID/AXIAL	13.5 - 13.5	4.63 - 5.19	TSM	ABOVE	YES
51	4	OD/NA	237 - 243	5.51 - 5.51	NA	BELOW	NO/WWI
51	NA						PLP

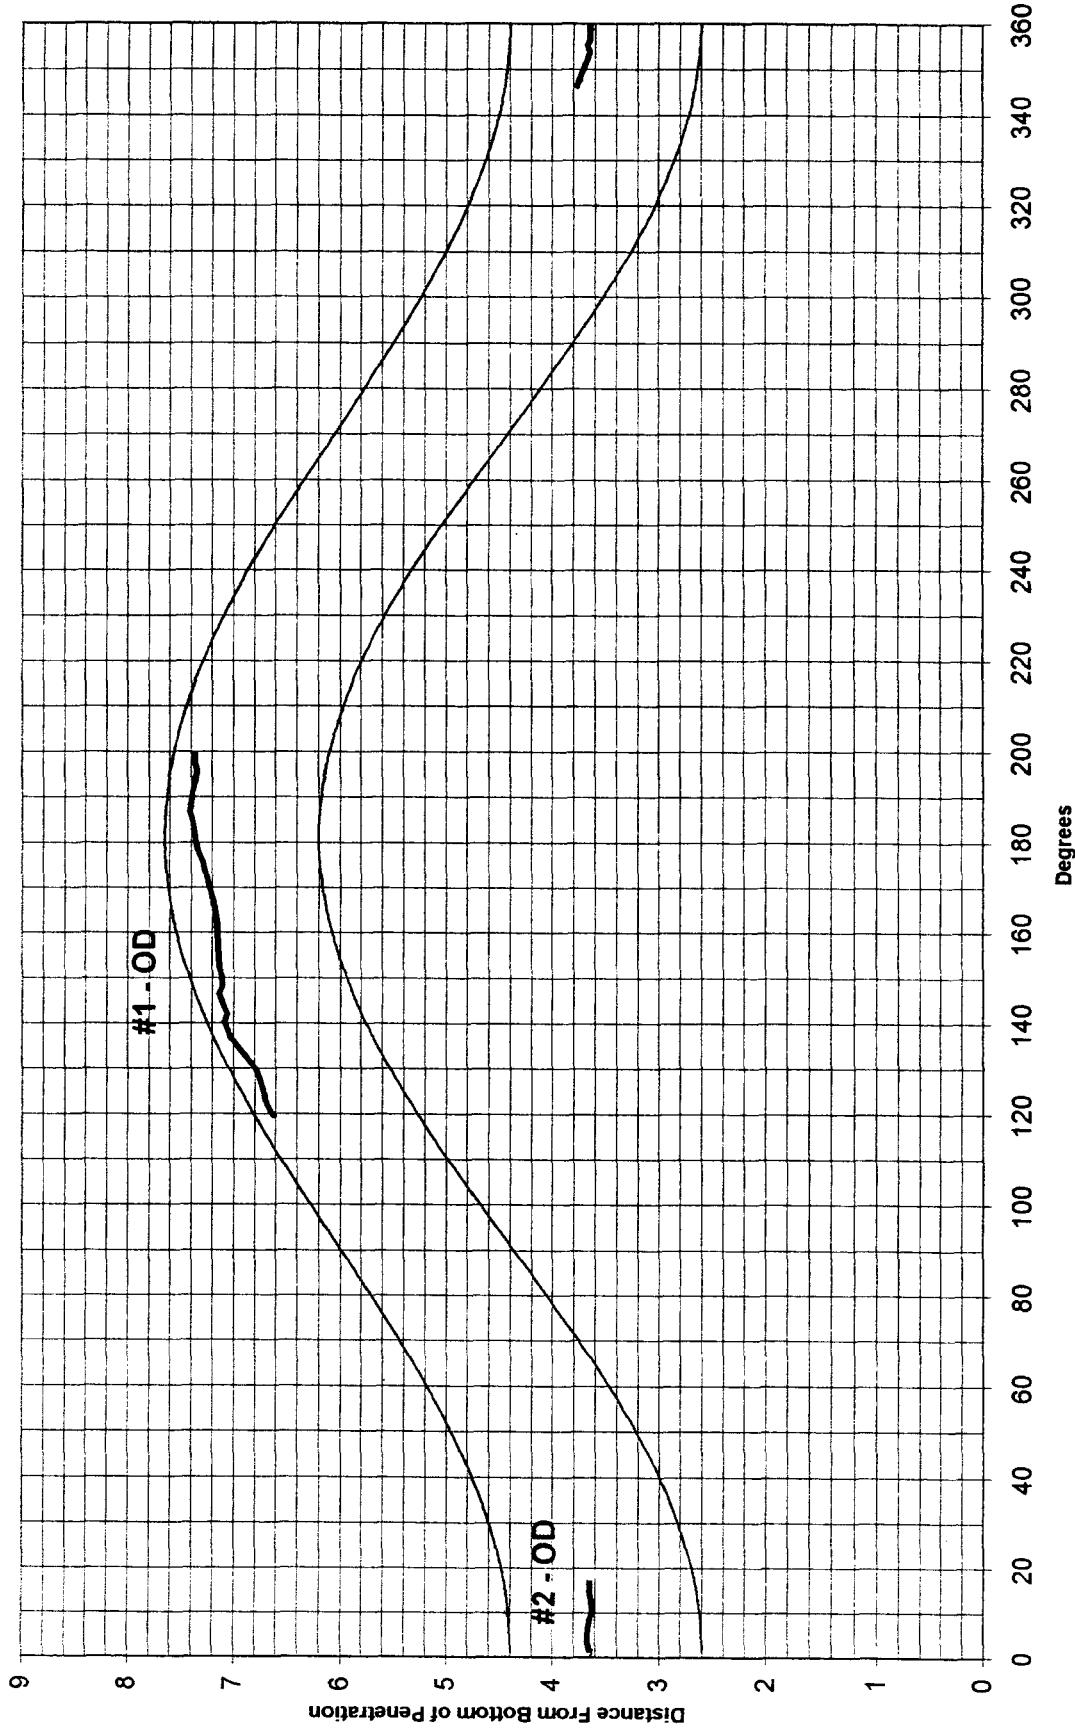
North Anna Unit 2 Well Hole Penetration #54

**Indication in Penetration # 54 at 119 to 198 Degrees
Plotted at 5 Degree Increments Along the Length**

Degree	Indication Axial Location	Top of J-Groove Location
119	6.80	6.96
124	6.88	7.16
129	7.04	7.24
134	6.92	7.28
139	7.32	7.36
149	6.88	7.48
154	7.16	7.52
159	7.28	7.56
164	7.40	7.56
169	7.28	7.56
174	7.40	7.60
179	7.56	7.64
184	7.40	7.60
189	7.44	7.56
194	7.36	7.52
197	7.24	7.48

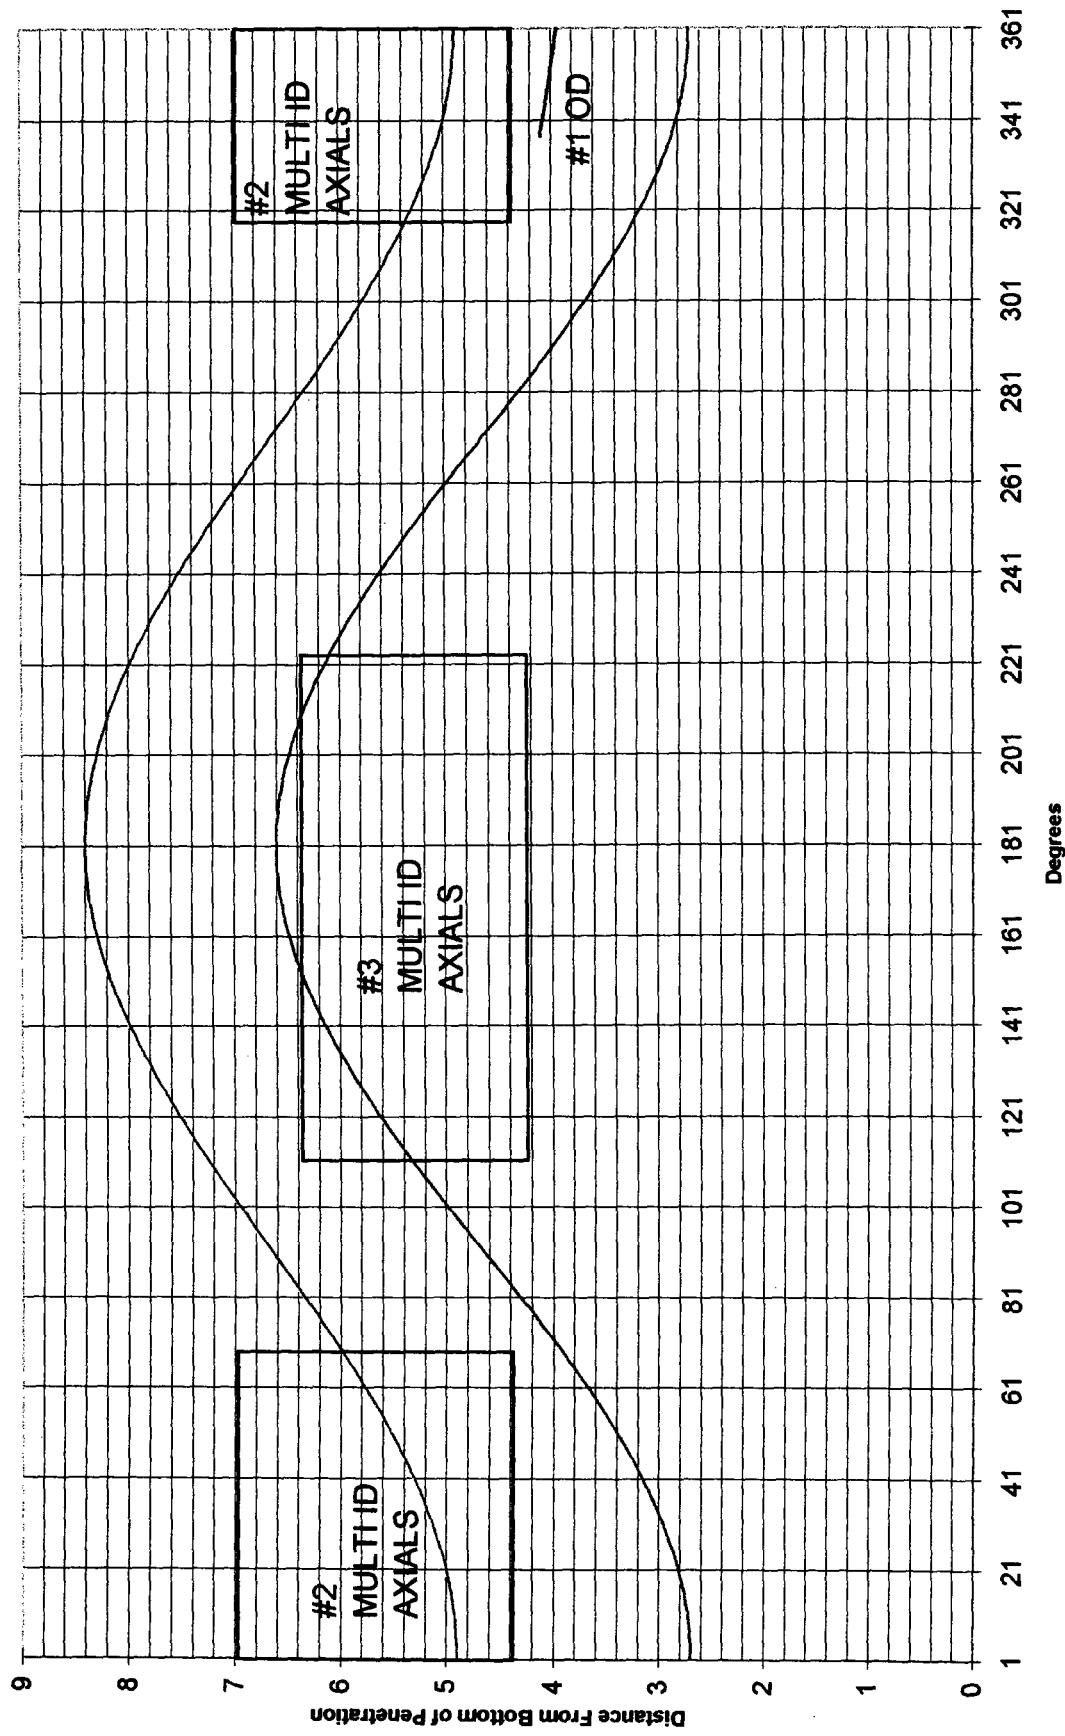
North Anna Unit 2 RVHP Weld Profiles Penetration #64

59	2	OD/CIRC	156 - 206	7.66 - 8.08	0.149	BELOW	YES
59	3	ID/AXIAL	159 - 159	8.04 - 8.48	TSM	ABOVE	YES
60	1	OD/NA	140 - 294	4.56 - 6.68	NA	BELOW	NO/WWI
60	2	OD/NA	298 - 298	4.48 - 5.20	NA	BELOW	NO/WWI
61	1	OD/NA	119 - 260	5.52 - 5.80	NA	BELOW	NO/WWI
61	2	ID/AXIAL	157 - 166	3.84 - 4.64	TSM	BELOW	YES
61	3	ID/AXIAL	141 - 141	4.72 - 5.16	TSM	BELOW	YES
61	4	ID/AXIAL	178 - 190	4.04 - 5.56	TSM	BELOW	YES
62	1	OD/NA	168 - 175	7.08 - 7.48	NA	BELOW	NO/WWI
62	2	OD/NA	186 - 206	7.00 - 7.44	NA	BELOW	NO/WWI
62	3	OD/NA	224 - 224	6.56 - 6.80	NA	BELOW	NO/IPA
62	4	NA	302 - 286	3.64 - 11.08	NA	ABOVE	NO/LOC
62	5	OD/NA	164 - 162	6.92 - 7.44	OD/NA	BELOW	NO/WWI
62	6	ID/AXIAL	318 - 88	4.88 - 6.68	TSM	ABOVE	YES
62	7	ID/AXIAL	118 - 226	2.68 - 5.64	TSM	BELOW	YES
63	1						PLP
63	2	ID/AXIAL	172 - 172	4.02 - 4.82	TSM	BELOW	YES
63	3	ID/AXIAL	358 - 358	4.70 - 5.22	TSM	ABOVE	YES
64	1	OD/NA	346 - 335	4.00 - 4.00	NA	BELOW	NO/WWI
64	2	ID/AXIAL	316 - 68	4.44 - 6.96	TSM	ABOVE	YES

64	3	ID/AXIAL	110 - 222	4.32 - 6.36	TSM	BELOW	YES
65	1	OD/CIRC	330 - 42	3.20 - 5.08	0.152	BELOW	YES
65	2	OD/CIRC	160 - 190	7.84 - 8.36	0.078	BELOW	YES
65	3	ID/AXIAL	142 - 198	4.68 - 6.48	TSM	BELOW	YES
66	1	ID/AXIAL	152 - 154	3.88 - 5.24	TSM	BELOW	YES
66	2	ID/AXIAL	200 - 197	4.16 - 5.64	TSM	BELOW	YES
66	3	ID/AXIAL	320 - 328	5.60 - 6.76	TSM	ABOVE	YES
66	4	OD/NA	315 - 319	6.76 - 6.76	NA	ABOVE	NO/IPA
66	5	OD/NA	96 - 106	1.84 - 2.28	NA	BELOW	NO/IPA
66	6	ID/AXIAL	84 - 84	7.20 - 7.60	TSM	ABOVE	YES
66	7	OD/NA	80 - 104	5.00 - 5.88	NA	BELOW	NO/IPA
66	8	ID/AXIAL	306 - 348	5.60 - 6.72	TSM	ABOVE	YES
66	9	ID/AXIAL	118 - 216	3.60 - 6.36	TSM	BELOW	YES
67	1	ID/AXIAL	355 - 47	4.04 - 6.67	TSM	ABOVE	YES

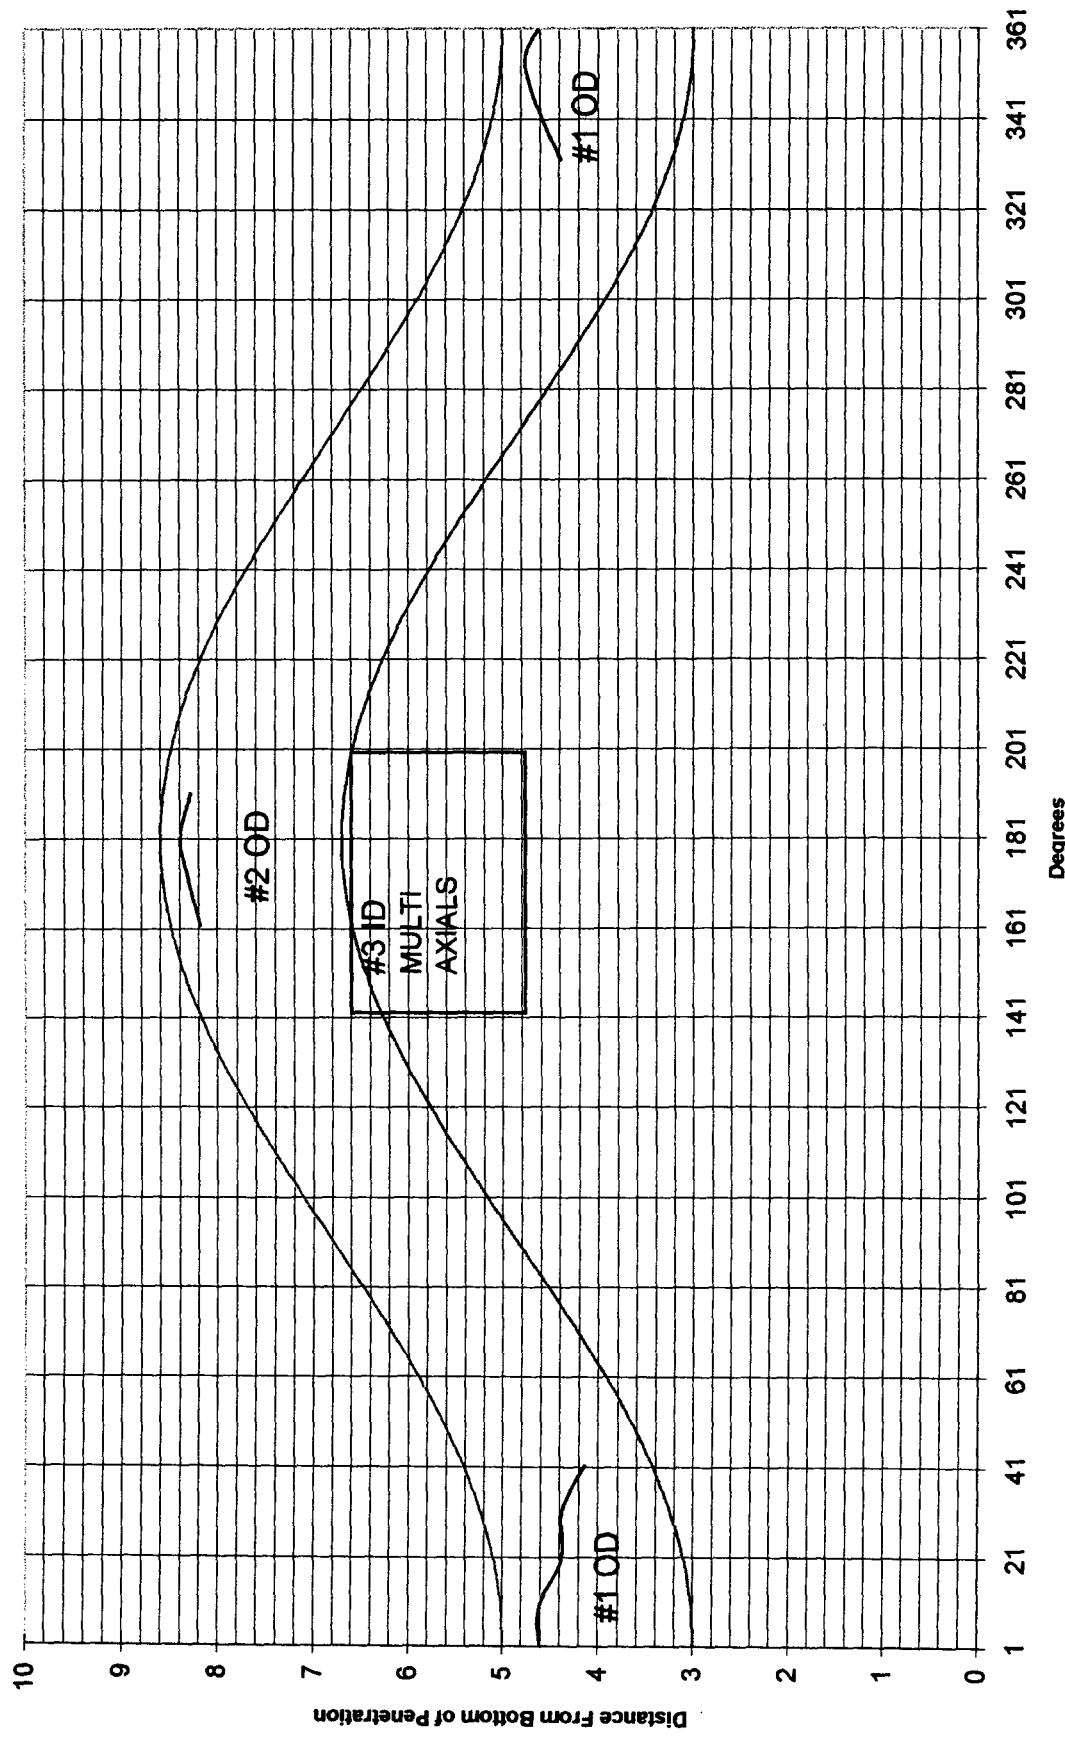
North Anna Unit 2 RVHP Weld Profiles Penetration #65

Indication in Penetration # 65 at 160 to 190 Degrees
Plotted at 5 Degree Increments Along the Length

Degree	Indication Axial Location	Top of J-Groove Location
160	8.28	8.48
165	8.24	8.52
170	8.16	8.56
175	8.16	8.60
180	8.32	8.60
185	8.36	8.56
190	8.24	8.52
