**Second
Five-year Review Report**

**Valley Park TCE Site
Valley Park
St. Louis County, Missouri**

September 2008

**Region 7
United States Environmental Protection Agency
Kansas City, Kansas**

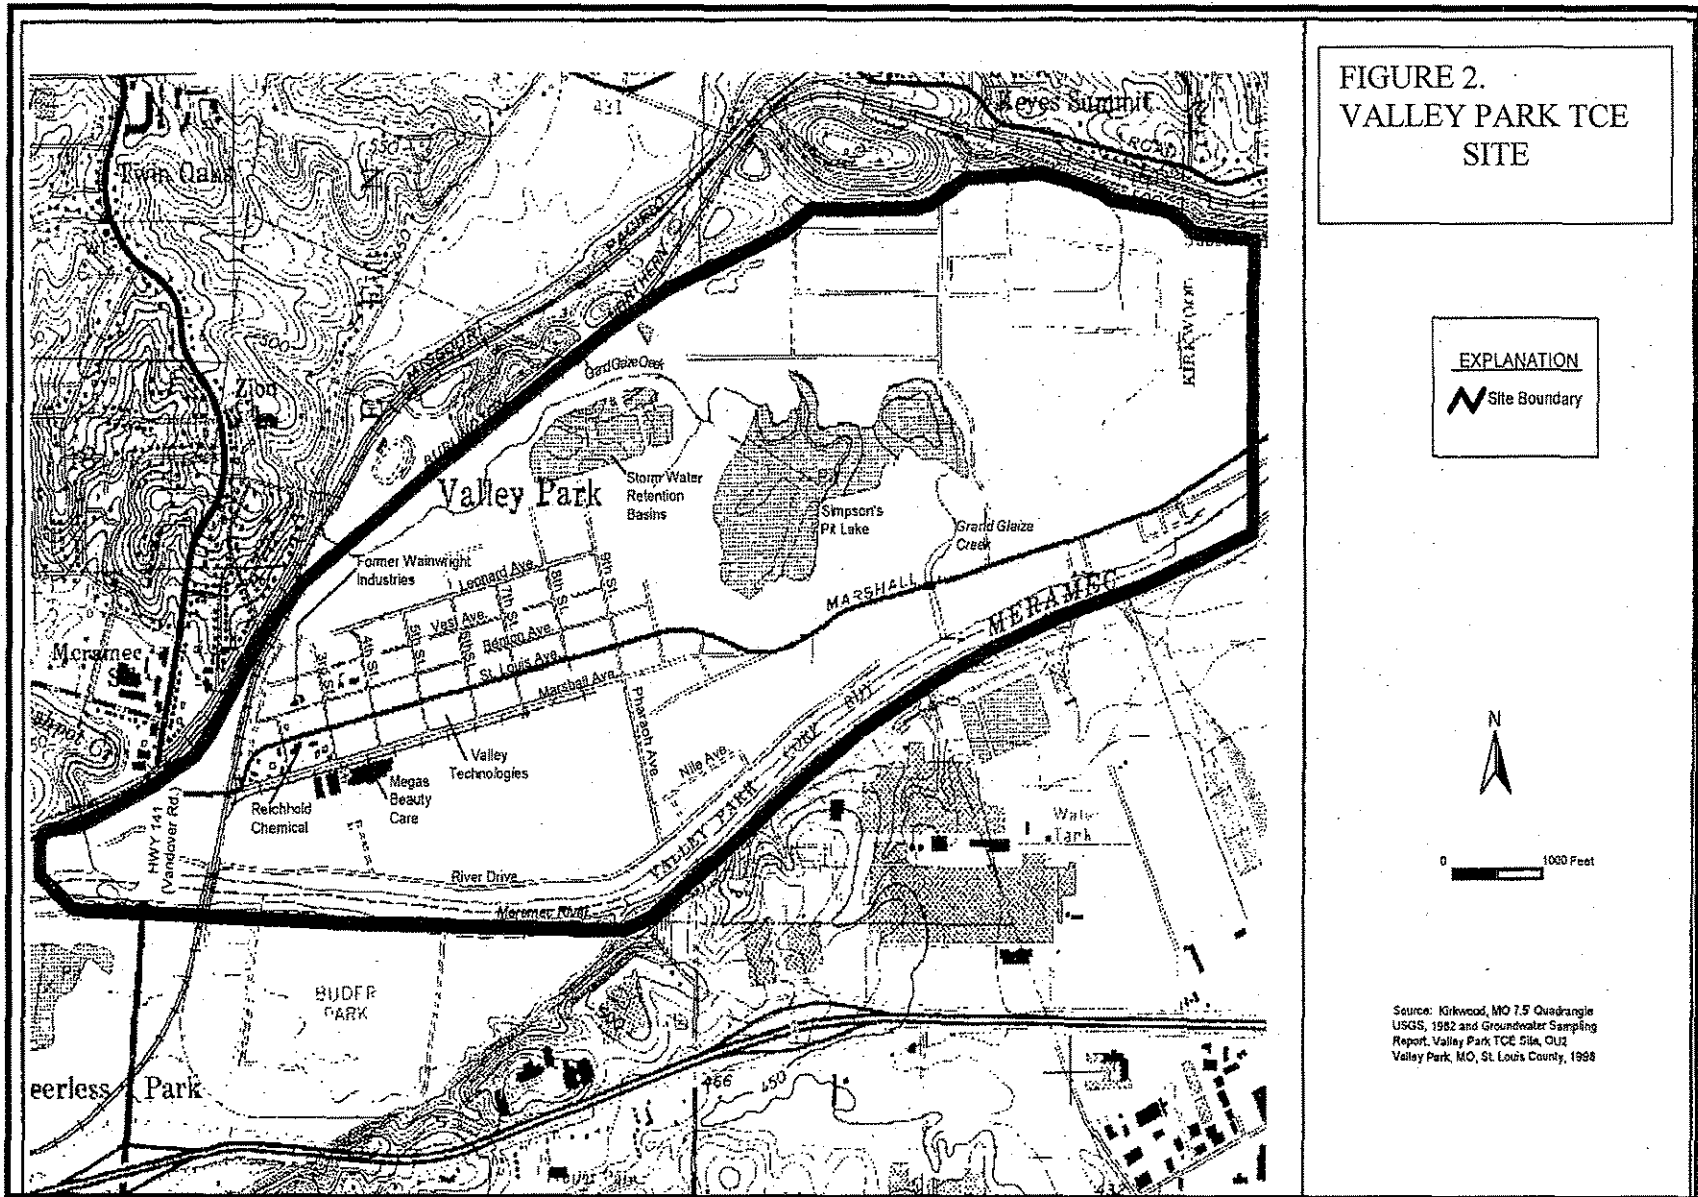
FIGURE 2.
VALLEY PARK TCE
SITE

As shown in Figure 2, the area-wide groundwater plume addressed by OU2 extends east from Highway 141, north of the Meramec River, west of 9th Street, and south of the railroad just north of Leonard Avenue. In previous reports, the area-wide plume has been shown to extend east of 9th Street and to the Kirkwood water supply wells due to the potential for groundwater contamination to migrate that direction. However, groundwater contamination due to this Site has not been found east of 9th Street to date.

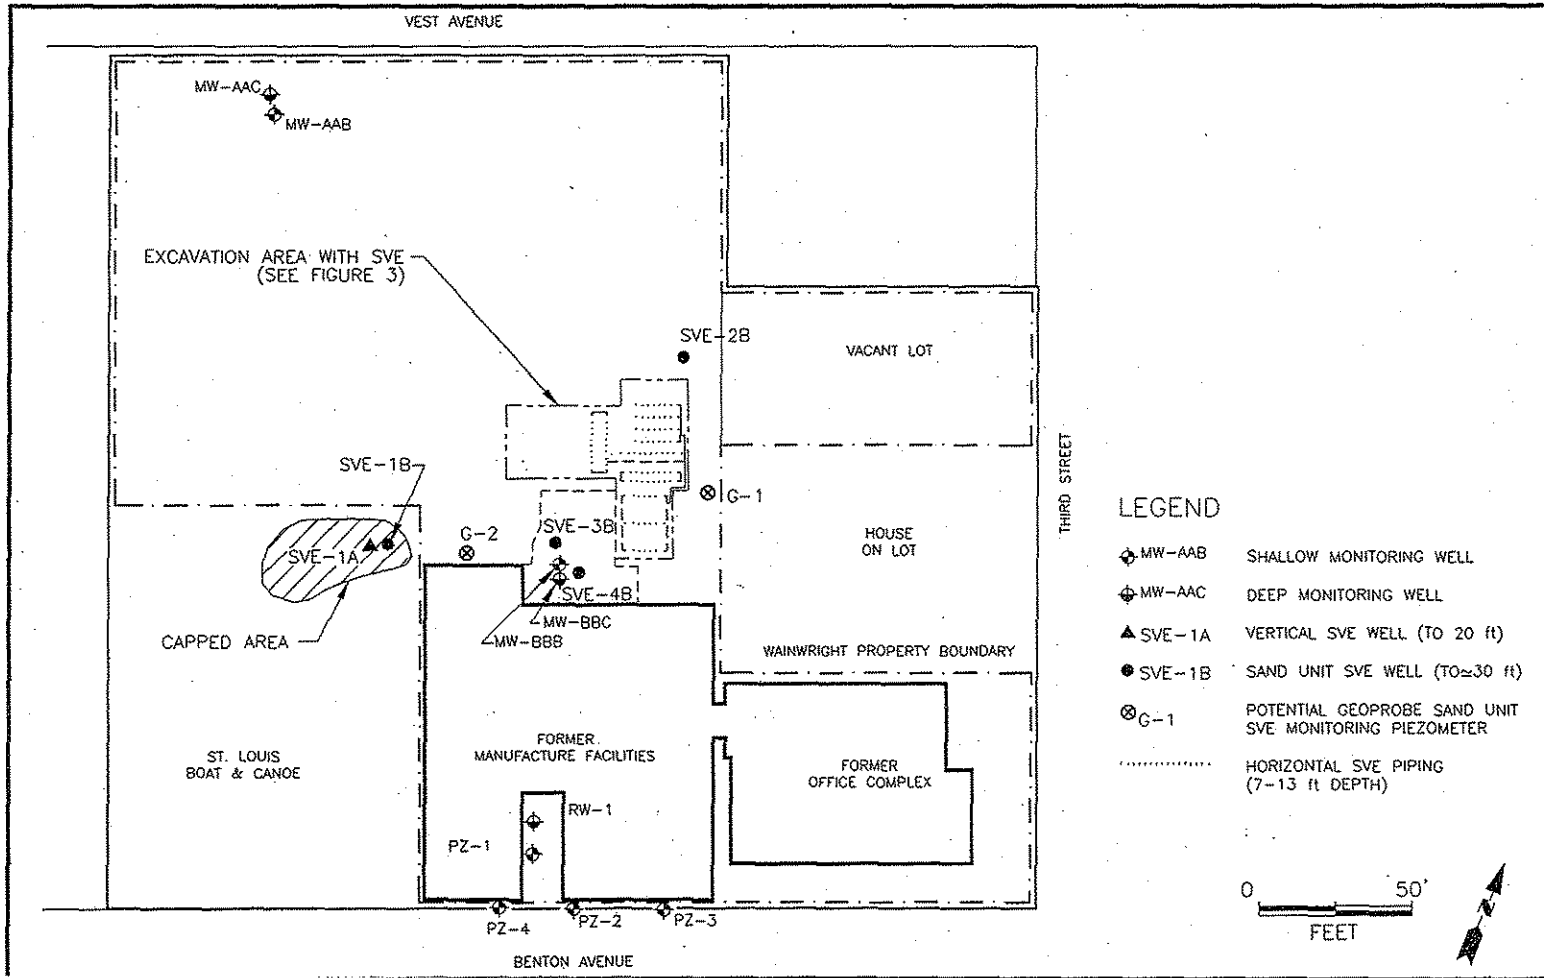
FIGURE 3. WAINWRIGHT OPERABLE UNIT

- A deed restriction to be placed on WOU properties to prohibit the installation and operation of groundwater supply wells.
- Groundwater monitoring including existing and new groundwater monitoring wells to assess the effectiveness of the remediation. The WOU is shown in Figure 3.

The SVE system is currently operating to remediate shallow silty-clay and deeper sand-gravel soil units. The area of WOU where the SVE system is operating is covered by asphalt-paving material which is used as a parking lot. The layout and features of the SVE system are shown in Figure 3.

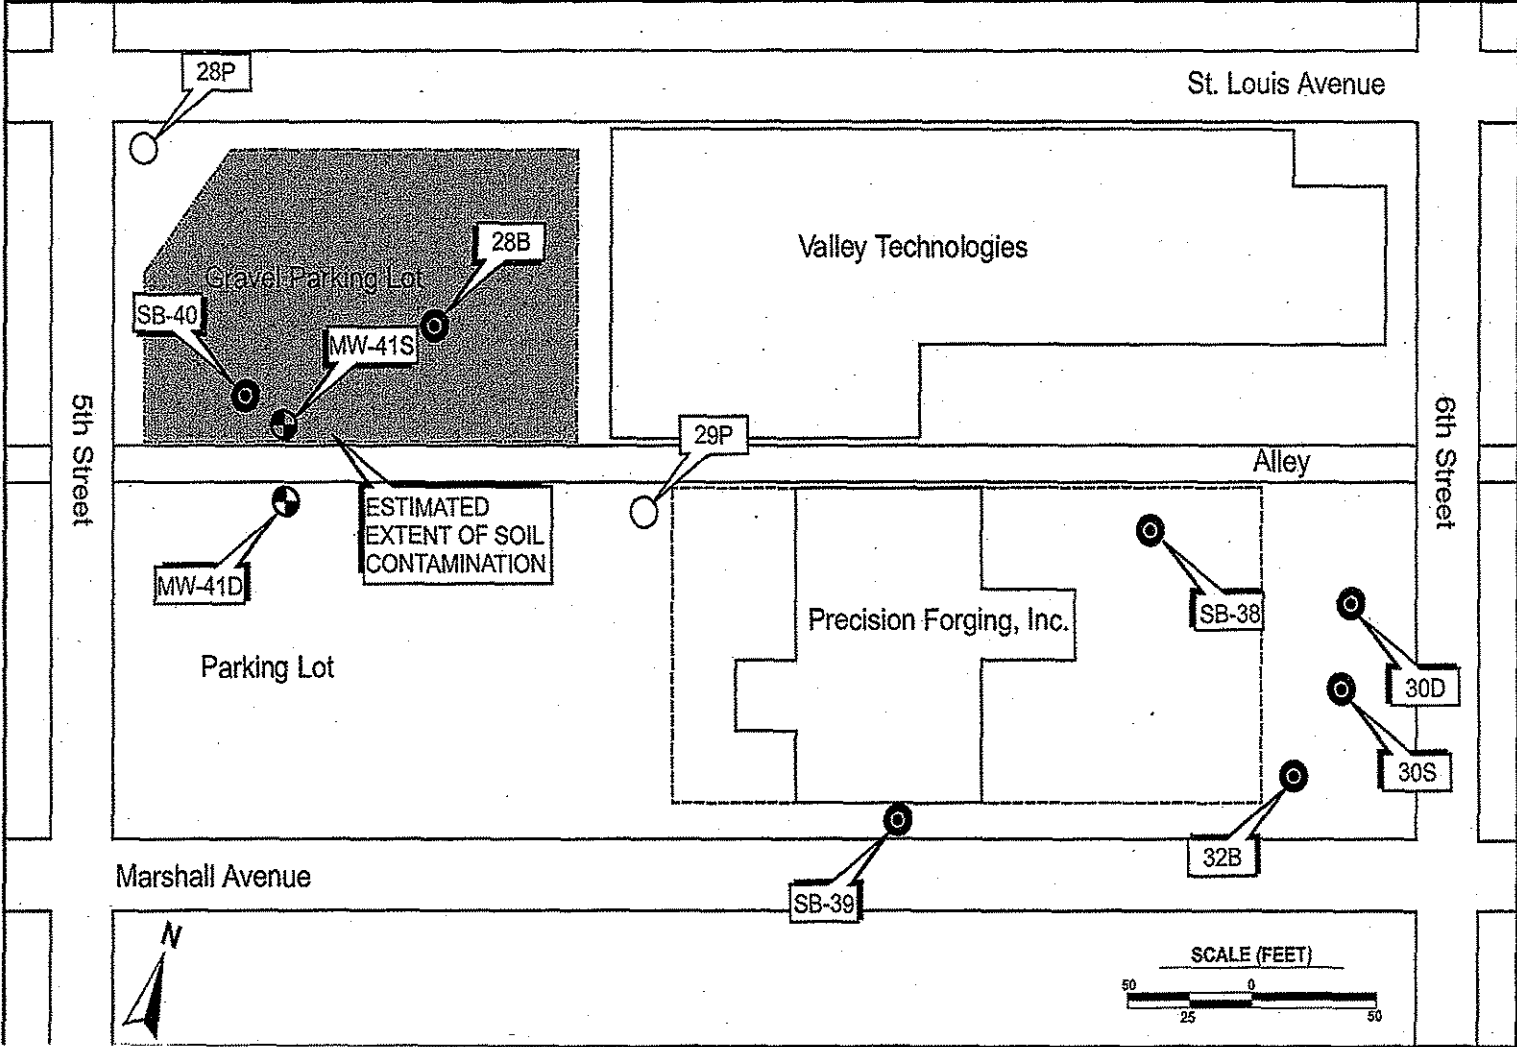
FIGURE 4. VALLEY TECHNOLOGIES PROPERTY DURING RI/FS

The Valley Technologies' source area is shown in Figure 4.

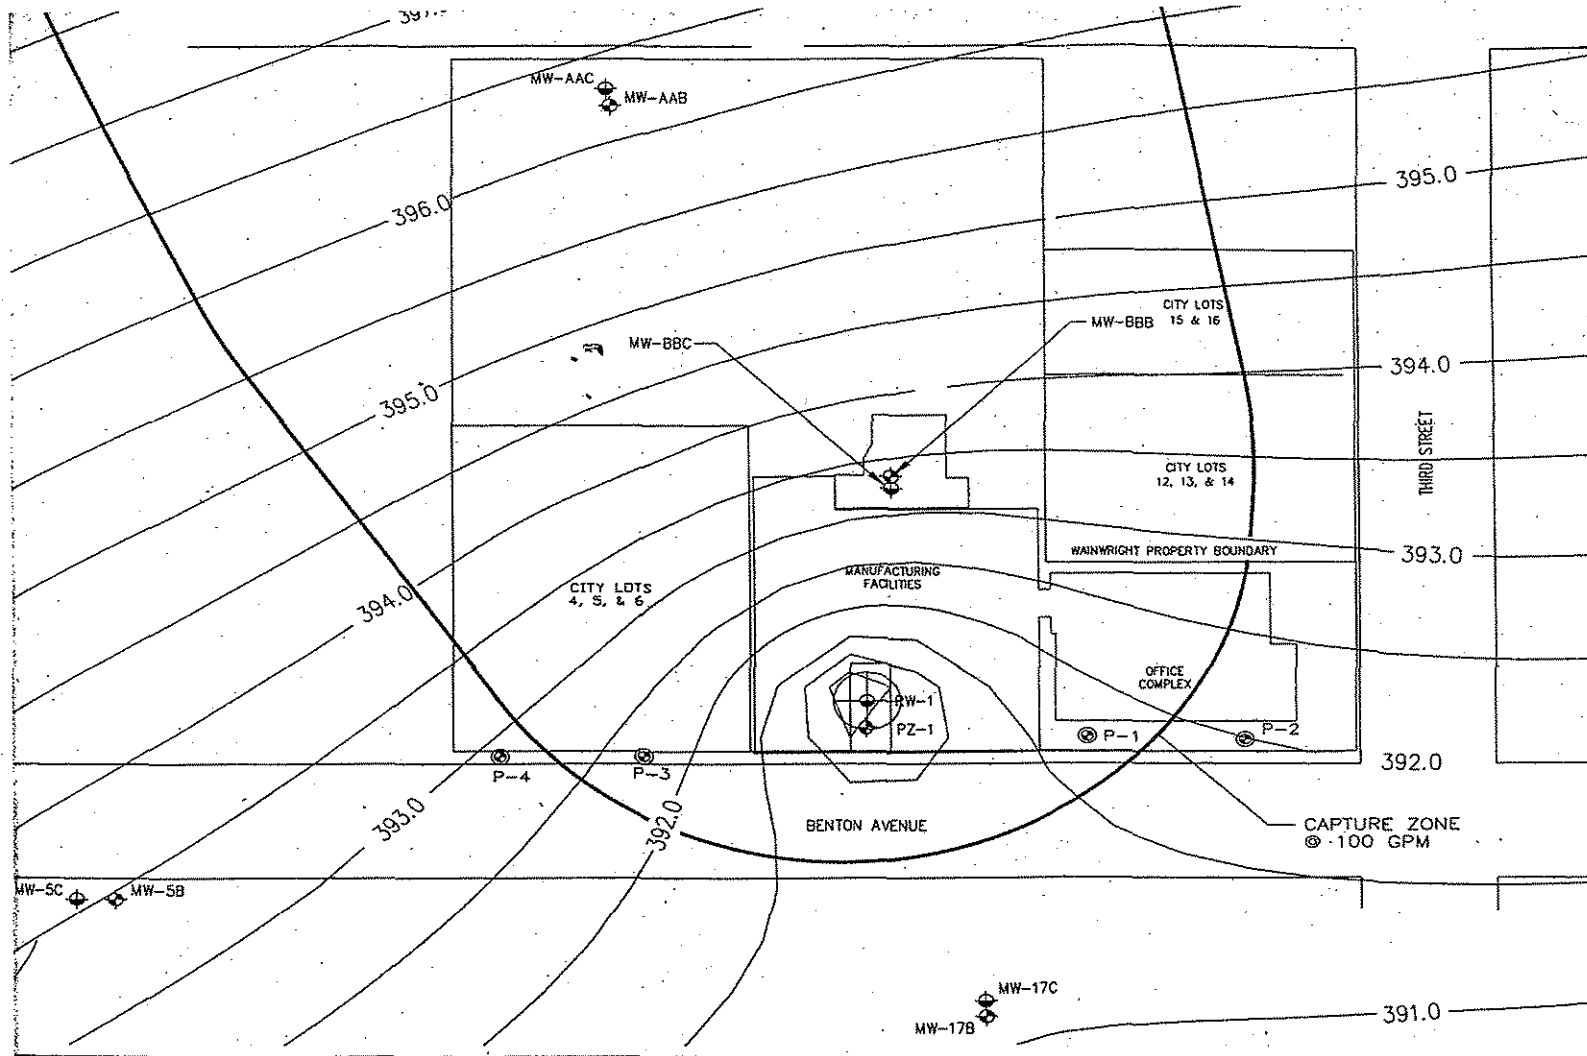
Figure 6. WOU Monitoring Well Locations
(Figure produced from design computer model; not actual water elevations presented)

The Department is concerned that a reduction in the GETS extraction well pumping rate has impaired the effectiveness of the hydraulic control of the groundwater beneath WOU. Effectiveness is assessed by evaluating water levels and groundwater quality. In May 2007, concentrations of TCE and PCE detected in monitoring well MW17C, located 225 feet downgradient from the WOU source area, increased to 47.8 ppb PCE and 13.6 ppb TCE from previous nondetection levels in 2006 (refer to Table 4 for a WOU summary of monitoring well results and Figure 6 for well locations). The increased downgradient contaminant levels indicate the potential that hydraulic control has not been maintained. Groundwater quality data from other wells that were monitored over this same period are essentially stable.

Sample Location	PCE Results (µg/l)			TCE Results (µg/l)		
	2006	2007	2008	2006	2007	2008
MWAAC (upgradient)	0.53	ND	ND	2.94	1.92	2.62
MWBBC (source area)	278	288	416	729	791	1800
MW5C (crossgradient)	0.61	0.91	1.33	3.11	3.81	5.46
MW17C (downgradient)	ND	47.8	42.8	ND	13.6	21.7

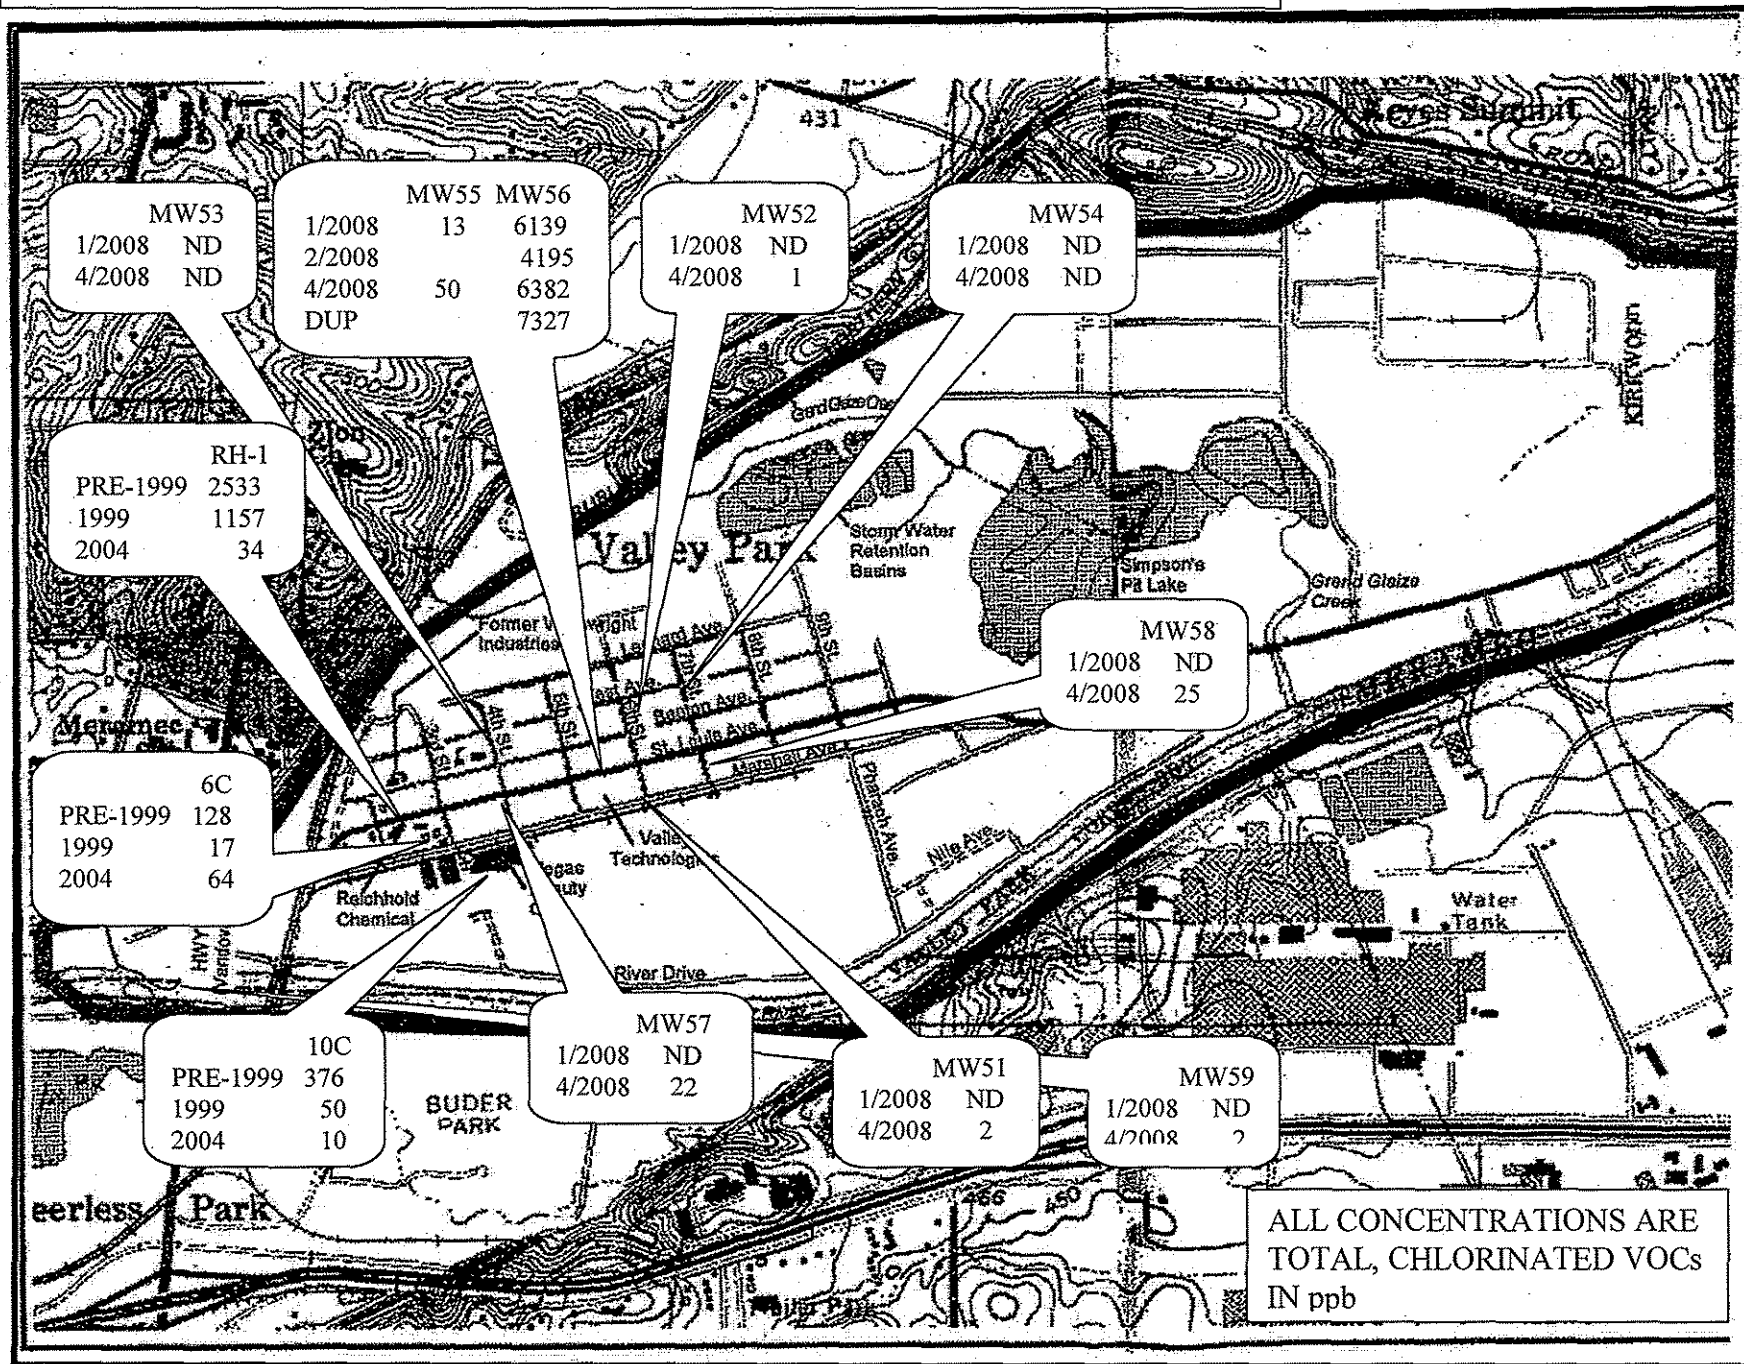
FIGURE 8. MAP OF MONITORING WELL LOCATIONS AND SAMPLING

- Groundwater Monitoring System – The groundwater monitoring system includes nine monitoring wells located to track upgradient, sidegradient, and downgradient groundwater levels and contaminant concentrations (see Figure 8). The monitoring wells have worked without incident in two sampling events.

- Figures 8 and 12 present a summary of data for the nine wells installed during the OU2 construction (wells MW51 through MW59); four wells installed as part of the RI/FS process (6C, 10C, 14C, and the Reichhold production well RH-1); two historic wells on the Valley Technologies' property which no longer exist (41S and 41D); and the closest Kirkwood water supply well.

The Agencies do not believe the area-wide IC is required at the Site because the combined pumping of the WOU GETS, the Reichhold production well, and the OU2 GETS has significantly decreased groundwater contamination levels in monitoring wells located around the Site (refer to Figure 8). For example, the Reichhold production well is located less than two blocks from the WOU extraction well, and the contamination level in the Reichhold well has decreased 97 percent since the WOU system was started. Also, prior to flood conditions, all peripheral OU2 monitoring wells were not contaminated which is a significant change compared to data used to develop the ROD.

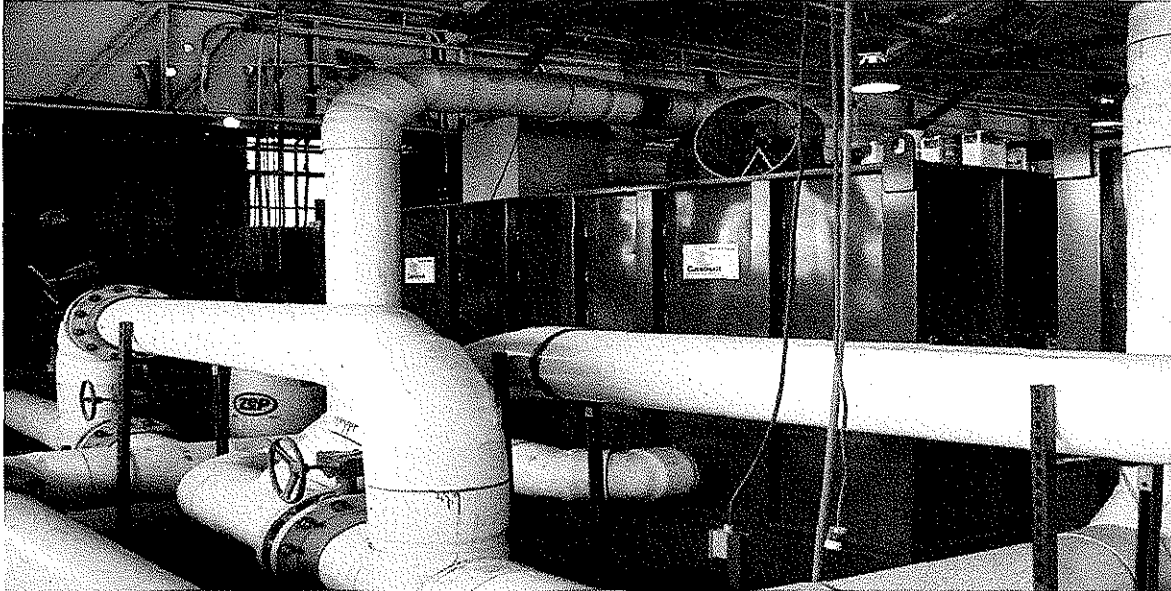
Activated Carbon Dual-Bed Adsorption System Wainwright Operable Unit (WOU)

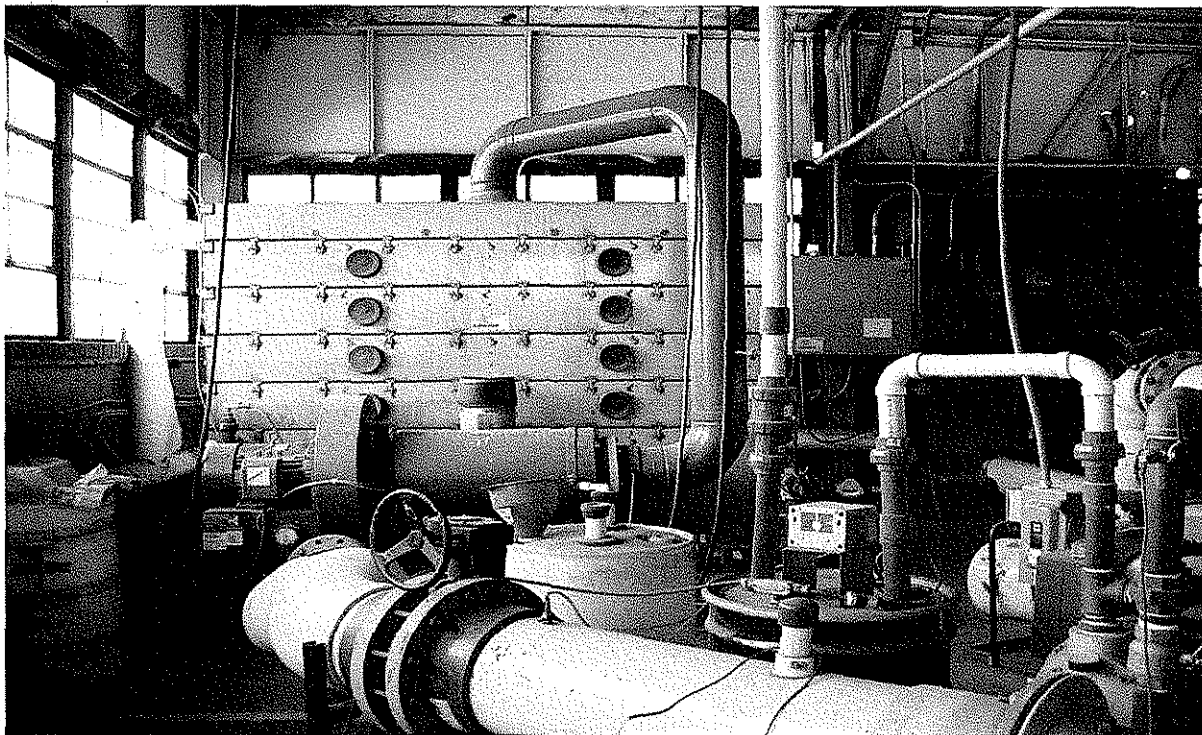
Wainwright Operable Unit (WOU) GETS Air Stripping Tower (background) and Exhaust (foreground); SVE Exhaust Vent System (foreground, right)

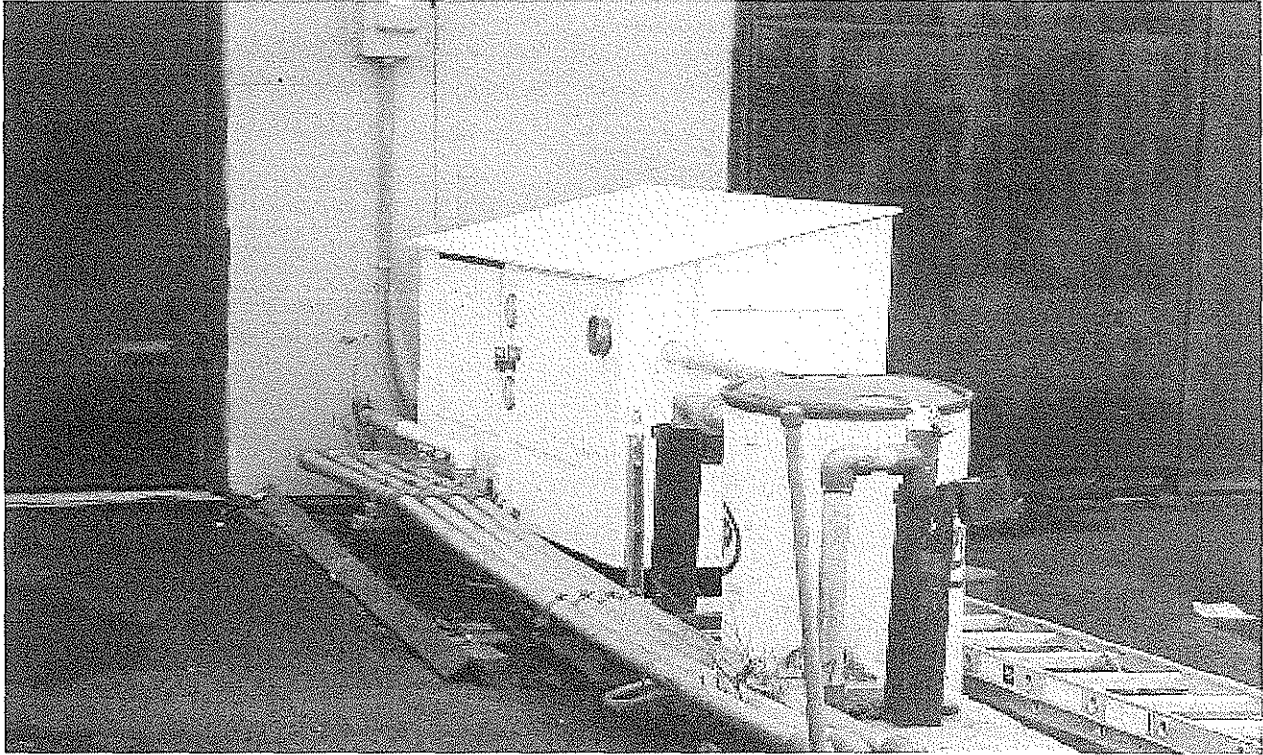
**SVE Manifold Control Box For Horizontal and Vertical SVE Wells \\
Wainwright Operable Unit (WOU)**

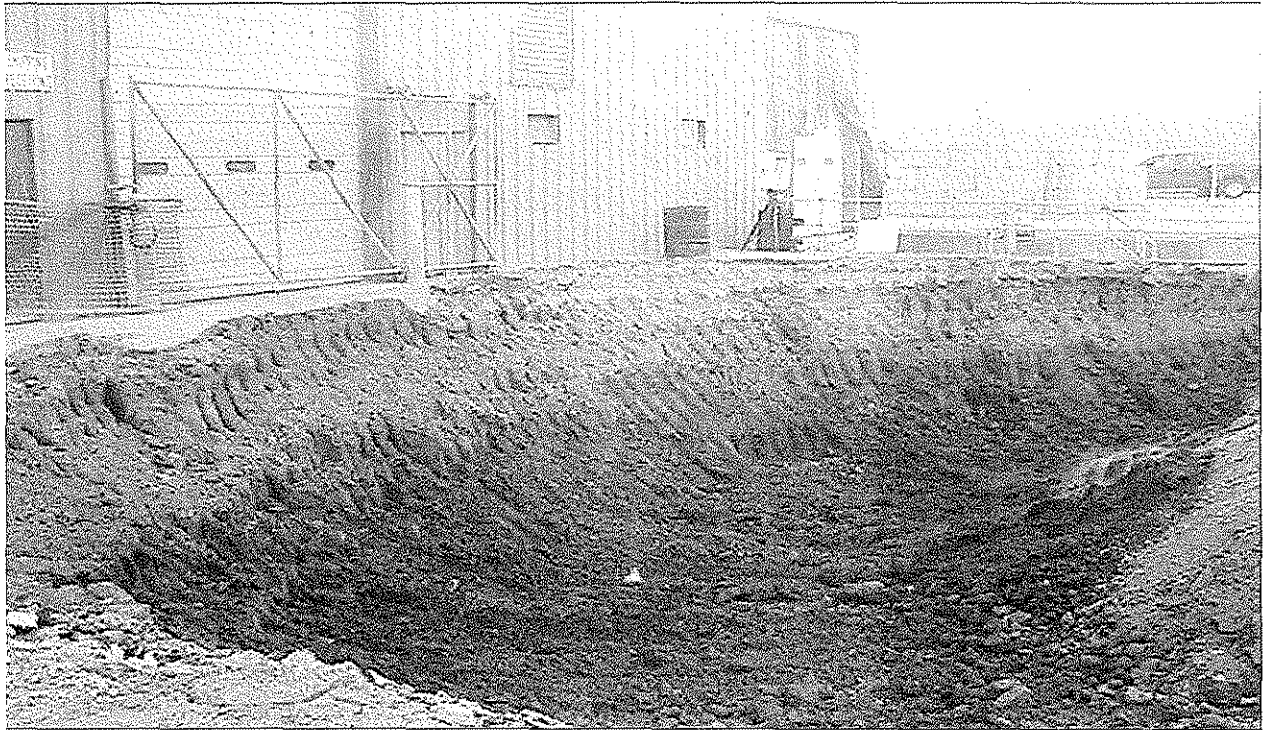
SOIL SOURCE AREA NEXT TO VALLEY TECHNOLOGIES BUILDING

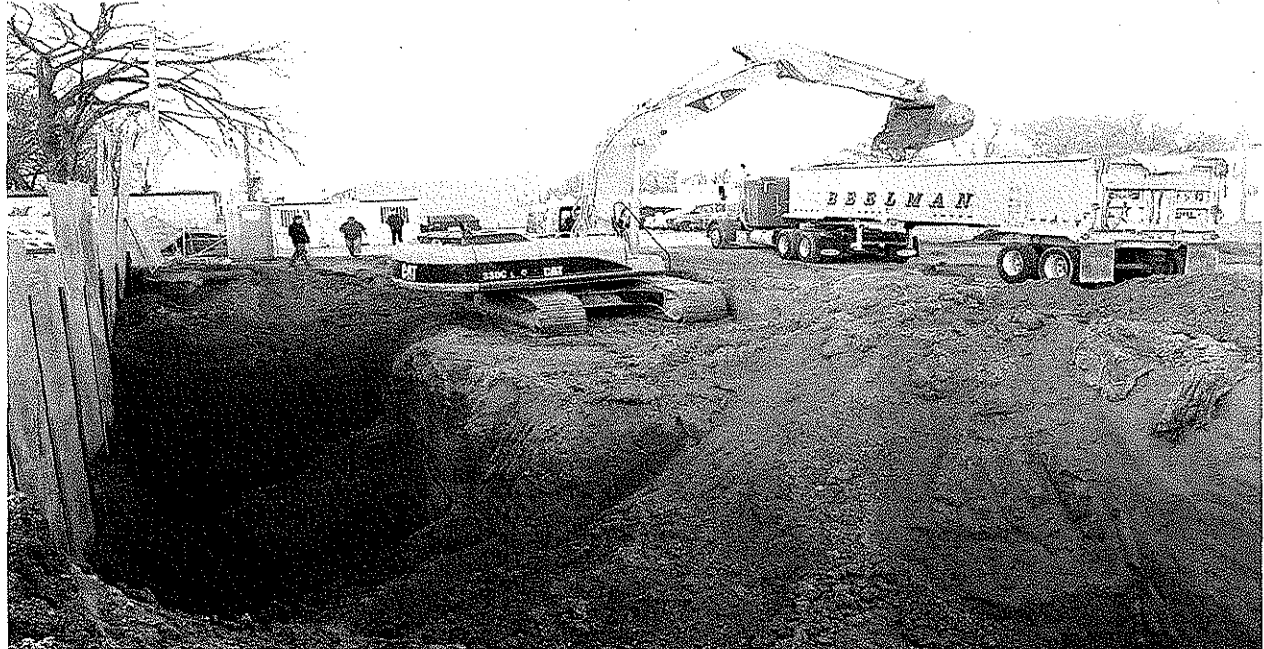
SOIL SOURCE AREA NEXT TO ALLEY ON VALLEY TECHNOLOGIES PROPERTY
