MRP - Alloy 600 ITG RPV Penetrations

Presentation To ACRS Subcommittees
July 10, 2001

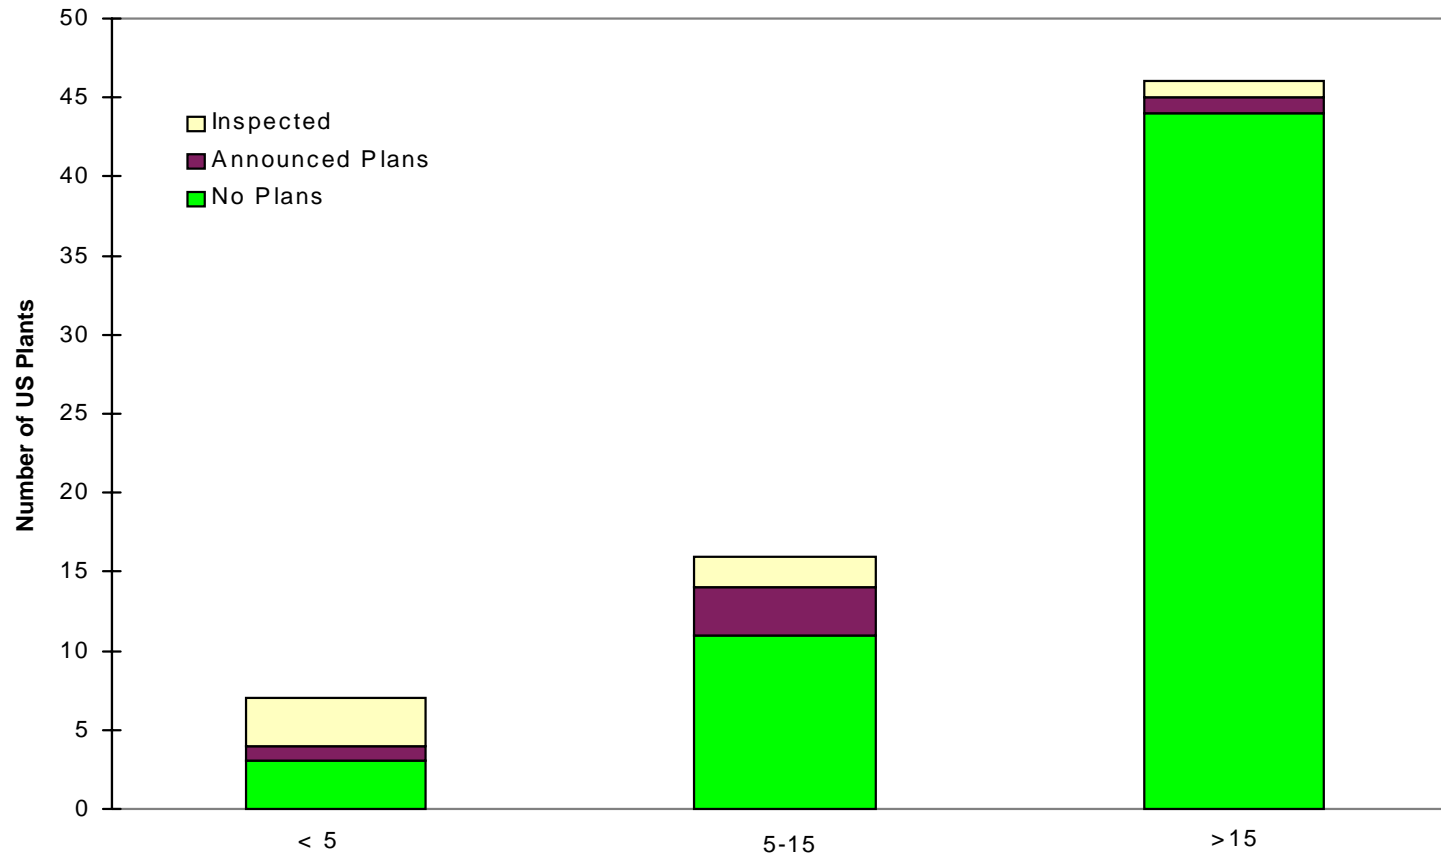
Figure 1: Effective Full Power Years, Measured from January 1997

- GL 97-01 Issued April 1, 1997
- Owners Groups Prepared Generic Responses
- Responses Coordinated Between Owners Groups by NEI Task Force
 - Histogram Ranked Plants, Normalizing Both Industry Models to DC Cook 2
- Individual Utilities Supplied Information for Their Plants
- Lead Plants Scheduled for Inspections Based on Histogram
 - ET for Detection
 - UT for Sizing of ID Flaws

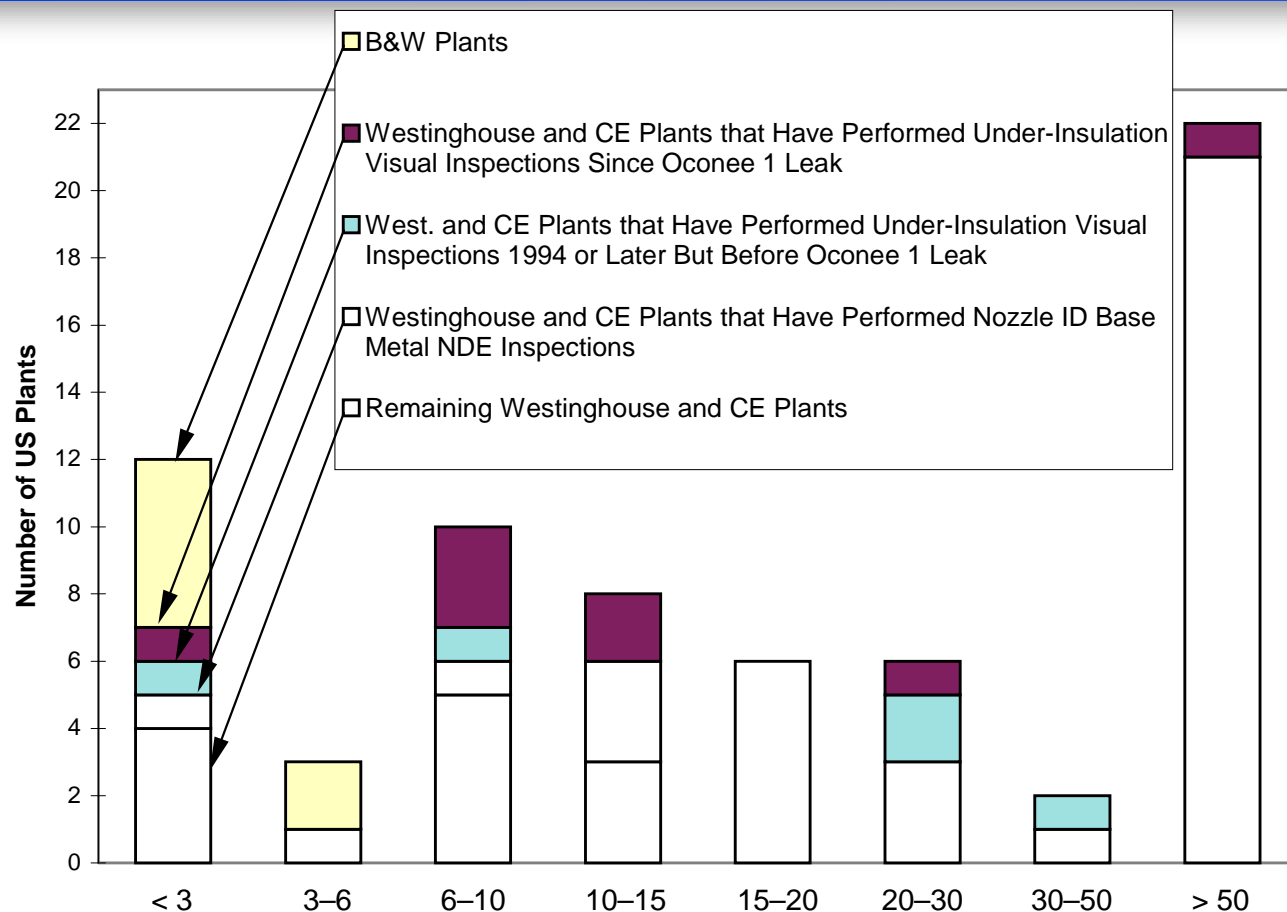
Time-Temperature Histogram Chart in MRP-44 Part 2 Interim Safety Assessment

Effective Full Power Years (EFPYs) from 3/1/2001 until Reaching Oconee 3 EFPYs at Time of its Spring 2001 Outage, Normalized For Differences in RV Head Temperature Using the Arrhenius Relationship and a Standard Activation Energy of 50 kcal/mole

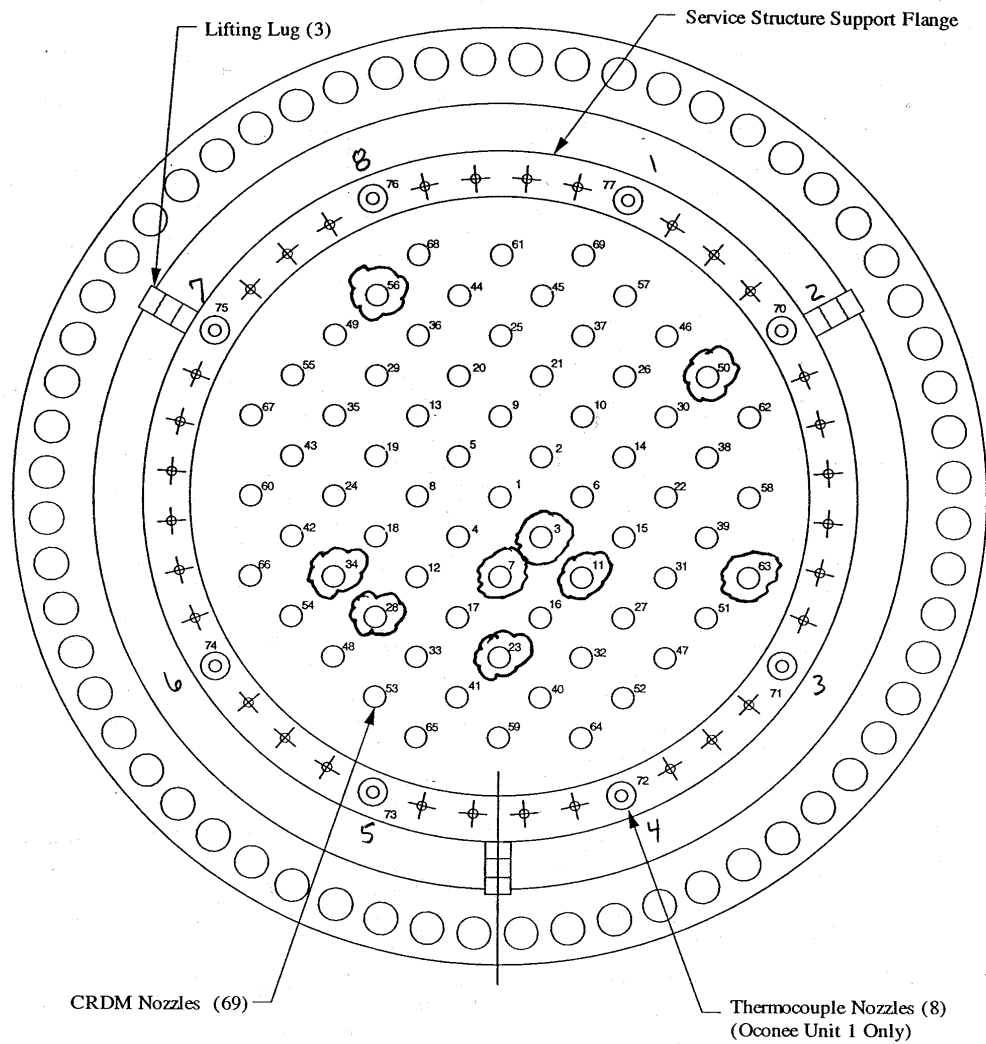
CRDM Nozzle Layout

- ONS-1:
 - All eight thermocouple nozzles contained flaws predominantly axial in orientation
 - Five nozzles identified as leaking
 - ID cracking observed on all eight nozzles
 - Cracking penetrated into all eight nozzle welds
 - CRDM nozzle 21 did not contain ID flaws
 - Flaws in weld material, predominantly axial/radial in orientation, identified as leak source
 - Flaw propagated through the weld and nozzle base material

- ONS-3:
 - Nine CRDM nozzles found leaking
 - Numerous axially oriented flaws identified
 - OD-initiated circumferential flaws (relatively deep and below the weld) identified on four nozzles
 - OD-initiated circumferential flaws (above the weld and up to through-wall) identified on two nozzles
 - Some weld cracking also identified

- ANO 1 CRDM nozzle 56 found leaking
 - No ID axially oriented flaws identified
 - One OD-initiated circumferential flaw below the weld that turned axial identified
 - Flaw propagated through the weld area along the nozzle OD

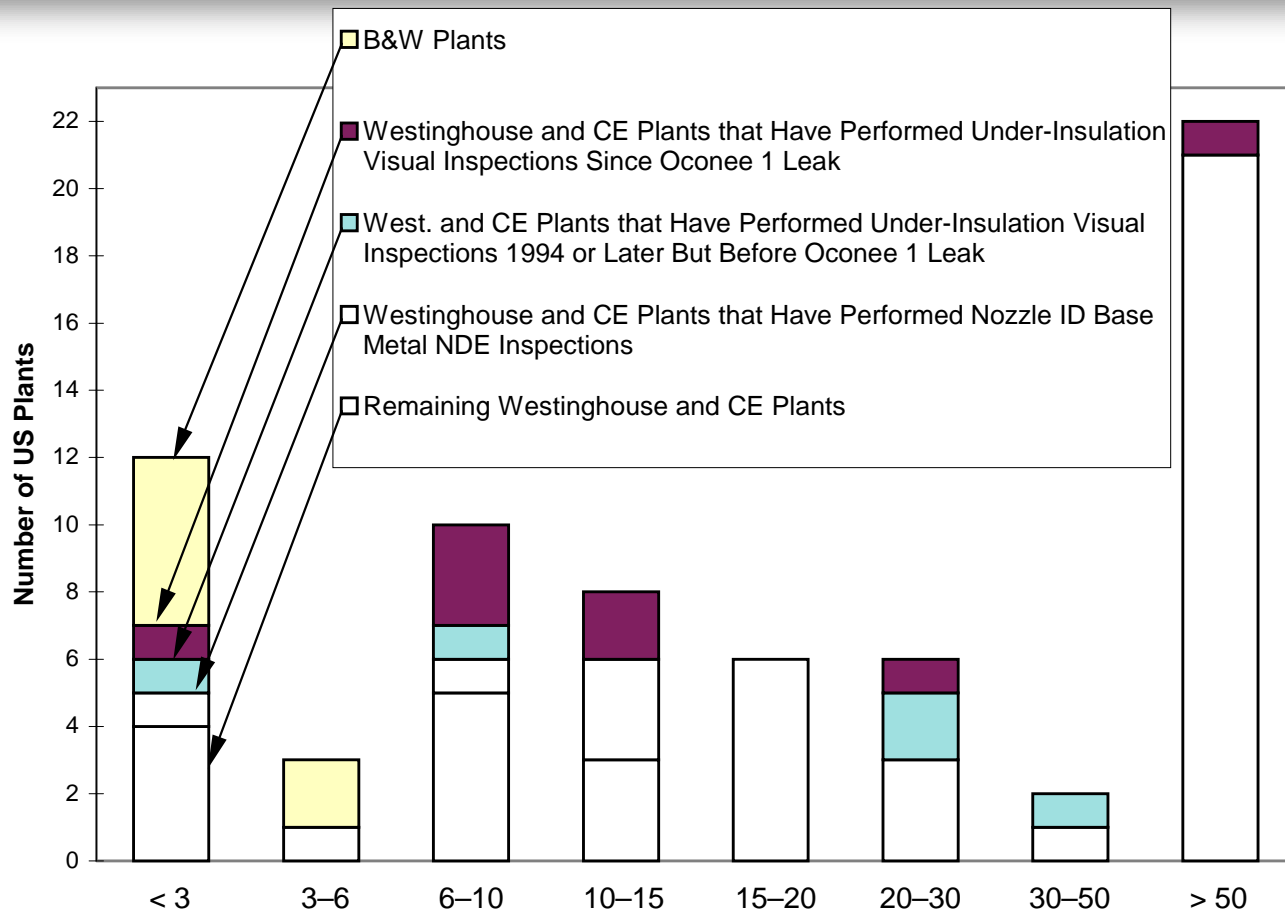
Time-Temperature Histogram Chart in MRP-44 Part 2 Interim Safety Assessment

Effective Full Power Years (EFPYs) from 3/1/2001 until Reaching Oconee 3 EFPYs at Time of its Spring 2001 Outage, Normalized For Differences in RV Head Temperature Using the Arrhenius Relationship and a Standard Activation Energy of 50 kcal/mole
