Davis-Besse Nuclear Power Station

Reactor Vessel Incore Nozzles

Incore Nozzles Configuration

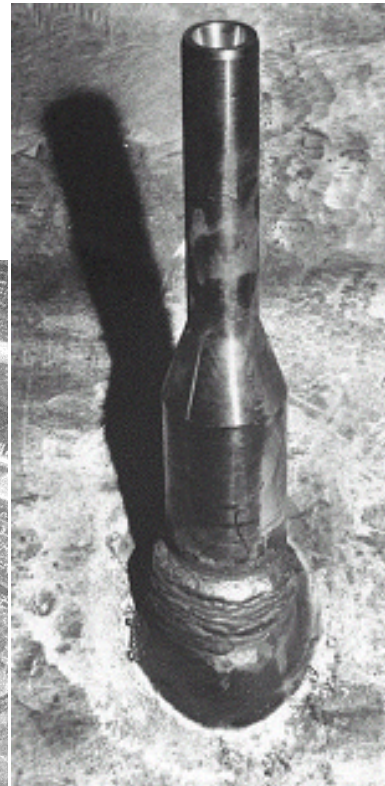
Repair in Process

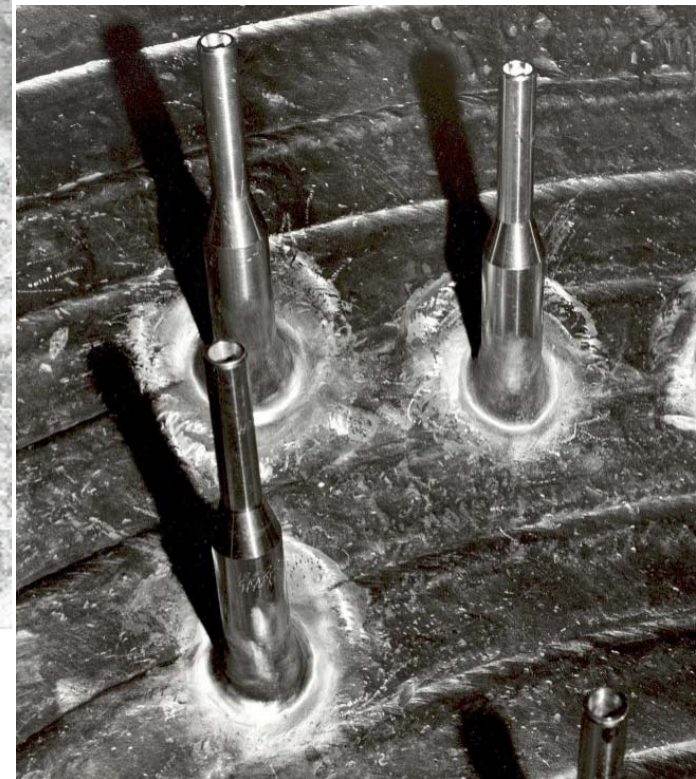
Completed Repair

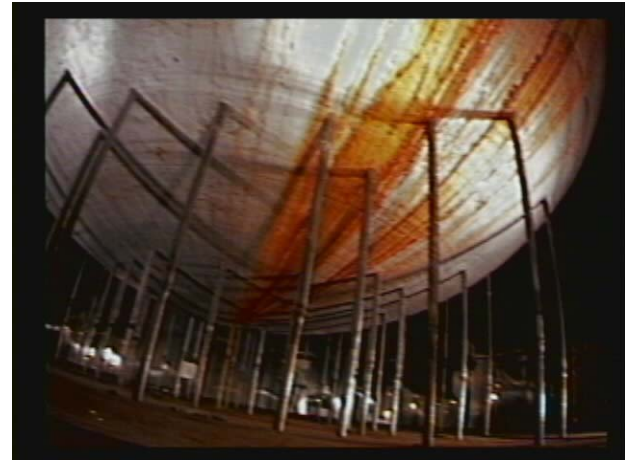
Bottom of Reactor Vessel

- Boron and rust deposit trails were observed on the sides and bottom of the reactor vessel
- Similar deposits observed on several incore nozzles
- Tape remnants and residue observed on incore nozzles
- No build-up of boric acid or corrosion products on top of insulation
- No evidence of wastage on bottom of reactor vessel

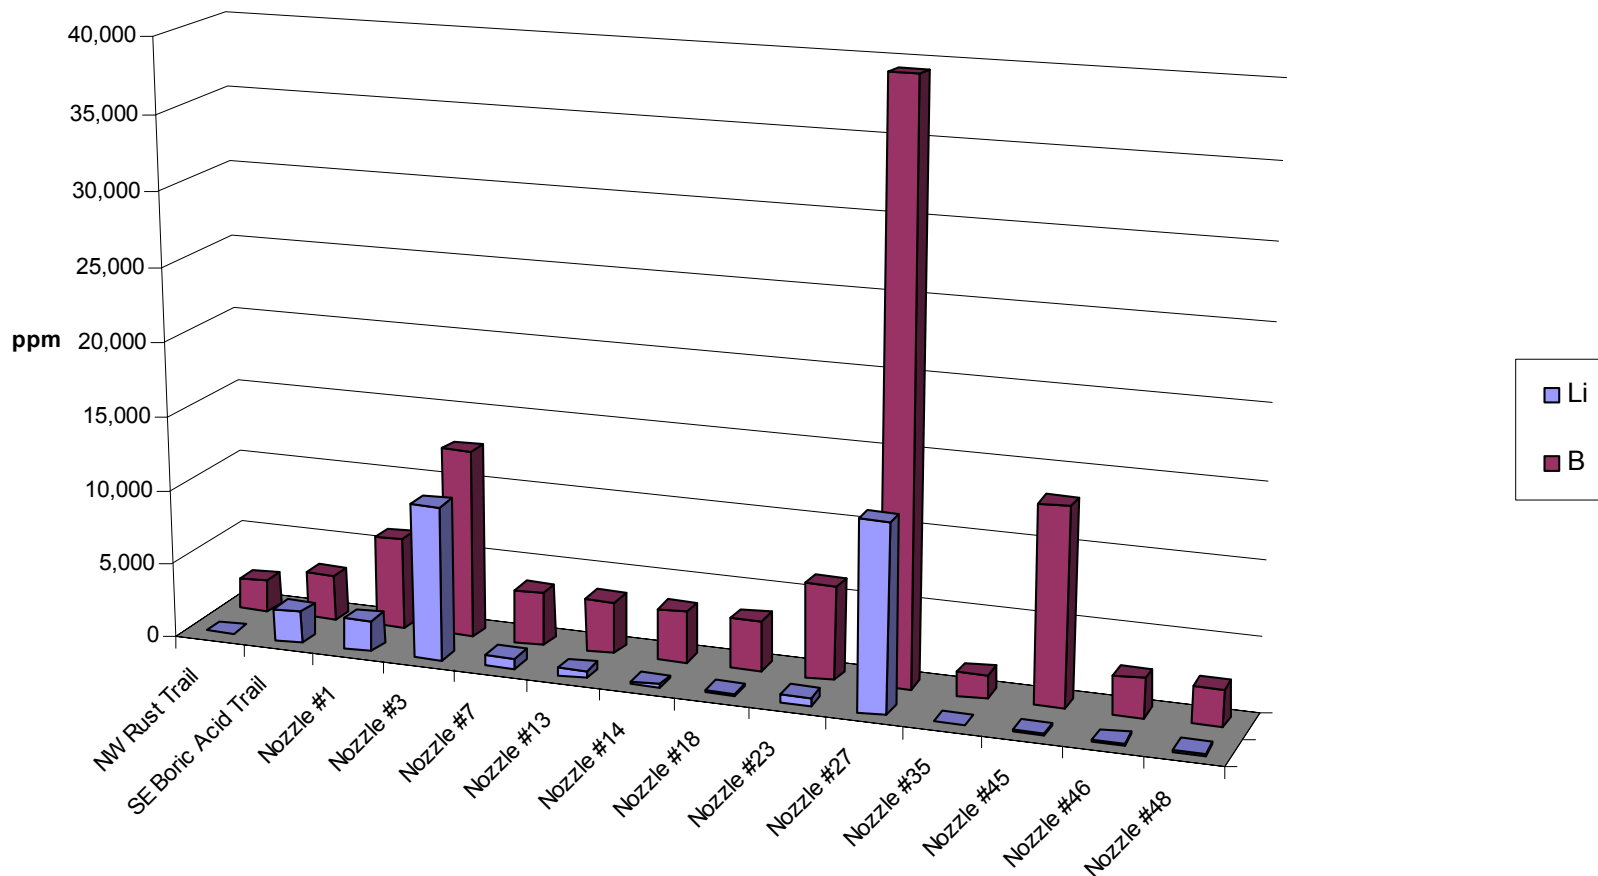
Comparison of Normalized Boron and Lithium Concentrations
(Flow trails at bottom of reactor head and incore nozzle deposits)

- Boron and Lithium were higher at several incore nozzle locations than in flow trails and more comparable with previously analyzed upper head deposit samples (shown next slide)
- Minor species (Uranium, Barium, Thorium, Strontium, & Zirconium) were higher at several incore nozzle locations than in the flow trails. However, the lack of activity associated with these species did not support reactor coolant as the source
- Cobalt (Co^{60}) and Iron (Fe^{59}) were higher in the flow trails than at the incore nozzle locations
- Inconsistent concentration gradients along possible flow trail paths

From the results of the analysis,
it is inconclusive whether the flow trails at the bottom of the
reactor head and nozzle deposits had a common source
