3 General Assessment and Characterization of Damage

3.1 PROPERTY PROTECTION

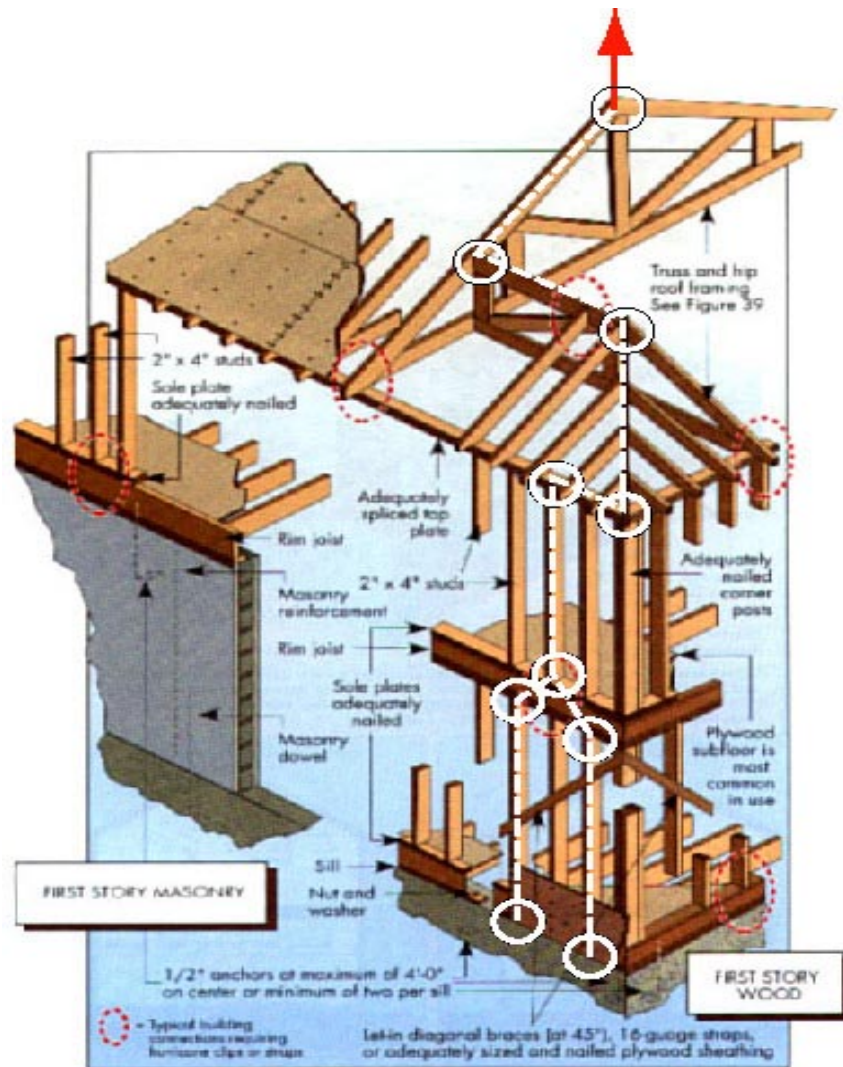
Primary structural systems are those that support the building against all lateral and vertical loads. Many buildings inspected had structural systems capable of providing a continuous load path for downward acting gravity loads, but were unable to provide a continuous load path for the lateral and vertical uplift forces generated by the tornado winds. The team looked at how this property damage could have been prevented or reduced in all areas of the windfield with the exception of directly under the vortex of violent tornadoes. Figure 3-1 shows a continuous load path in a wood frame (stick built) house.

Figure 3-1: Diagram showing a continuous load path for a two-story wood frame building.

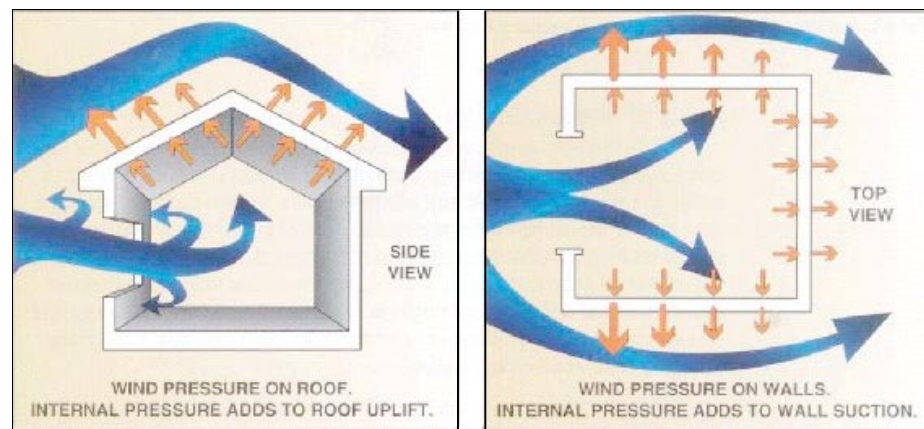
diagram illustrating the increased loads due to a breach in the building envelope is shown in Figure 3-4.

Depending on the building size, number of interior rooms, number of stories, size of the breach, etc., laboratory tests, in wind tunnels, indicate that the net increase in uplift on the roof system can exceed a factor of two. The increased load on the roof and wall systems may cause connections between these systems to fail, possibly at wind speeds below the normal design speed. The increased load on the roof and wall systems may cause connections between structural members to fail, possibly at wind speeds below the nominal design speed.

Figure 3-4: Increased loads on roof and walls due to breach in envelope.

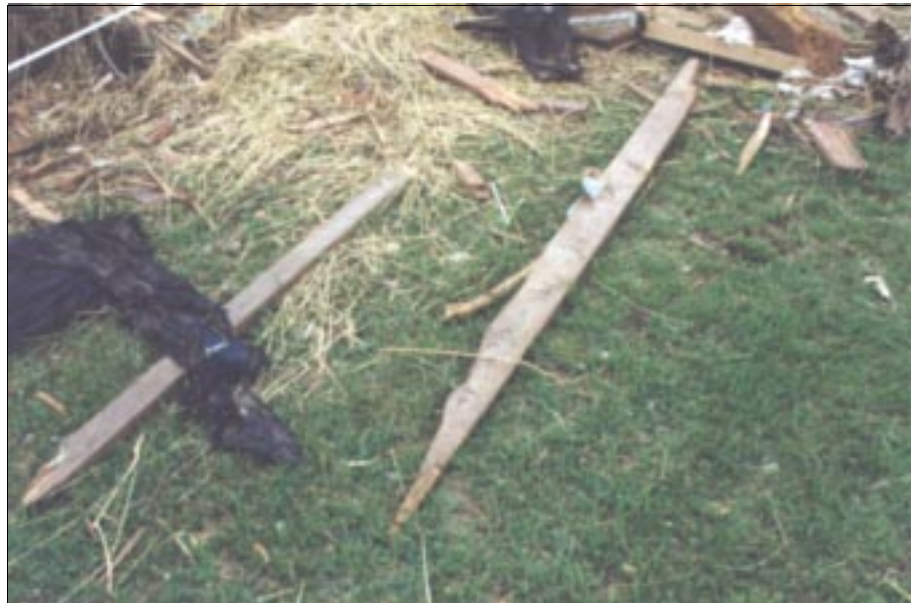
The quantity and size of windborne debris (missiles) generated by tornadoes is unequalled by any other type of wind storm. The smaller missiles (e.g., aggregate [stone] ballast from built-up roofs, pieces of tree limbs, pieces of shredded wood framing members) can easily become airborne and break common window glass causing a rapid increase in internal air pressure within a building, which then results in increased load on the building (Figure 3-11). Moderate sized missiles (e.g., appliances, HVAC units, long wooden members) can also become airborne and cause considerable damage to buildings (Figure 3-12). Large high-energy missiles (e.g., columns, joists, trusses, automobiles) are often observed as rolling debris and may become airborne members (Figure 3-13). These large missiles can easily destroy framing members and structural systems of buildings.

FIGURE 3-11: Small missiles commonly observed during the field investigations.

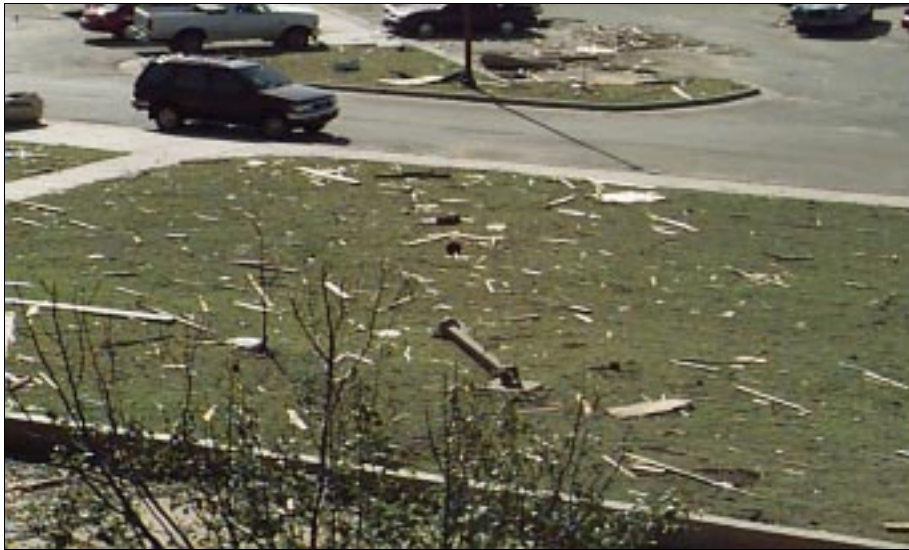
In areas where buildings were totally or nearly totally destroyed by a violent tornado, missiles were in such great quantity (Figure 2-23) that they often made a layer of rubble completely cover the ground (Figure 2-24). In many houses, the floors were covered with small tree branches and fragments of broken framing members. Figures 3-25, 3-26, 3-27, and 3-28 give some idea of the number of missiles that were flying during the storm.

FIGURE 3-23: Wood framing members and plywood sheathing near the periphery of a violent tornado damage area in Moore, Oklahoma, displaying quantity of flying debris.

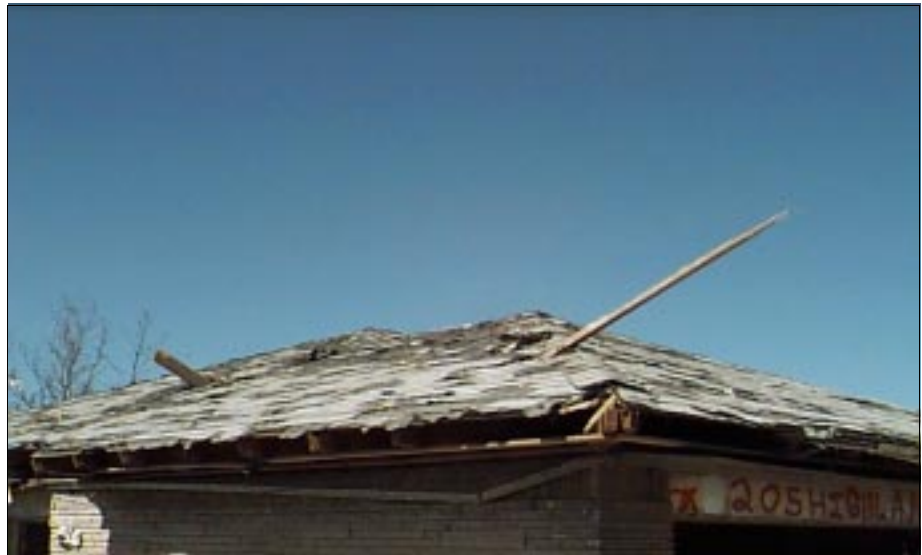
FIGURE 3-26: *This house was on the periphery of a violent tornado damage area in Moore, Oklahoma. Two large missiles struck this area of the roof.*

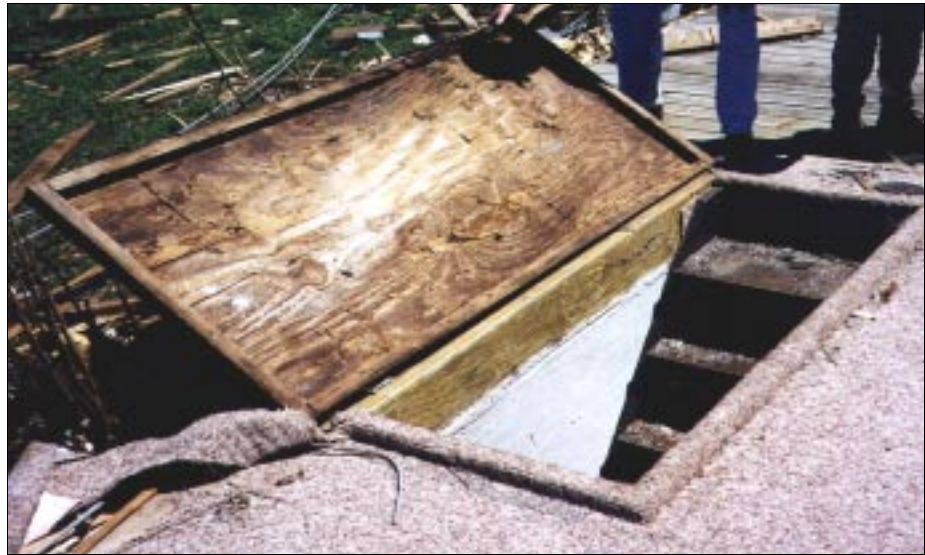
The residential shelters included above-ground in-resident shelters as well as storm cellar and basement types (Figure 3-29). The group shelter observed included one at a manufactured housing park and one at a plastic manufacturing plant. Community shelters observed included one at a manufactured housing park and another at a high school. Shelters are further discussed in Section 4.3.

FIGURE 3-29:
Underground residential shelter, viewing door and stairway leading down to shelter. This shelter was located outside a residence.
