4 Observations on Residential Property Protection

4.1 SINGLE FAMILY CONVENTIONAL CONSTRUCTION

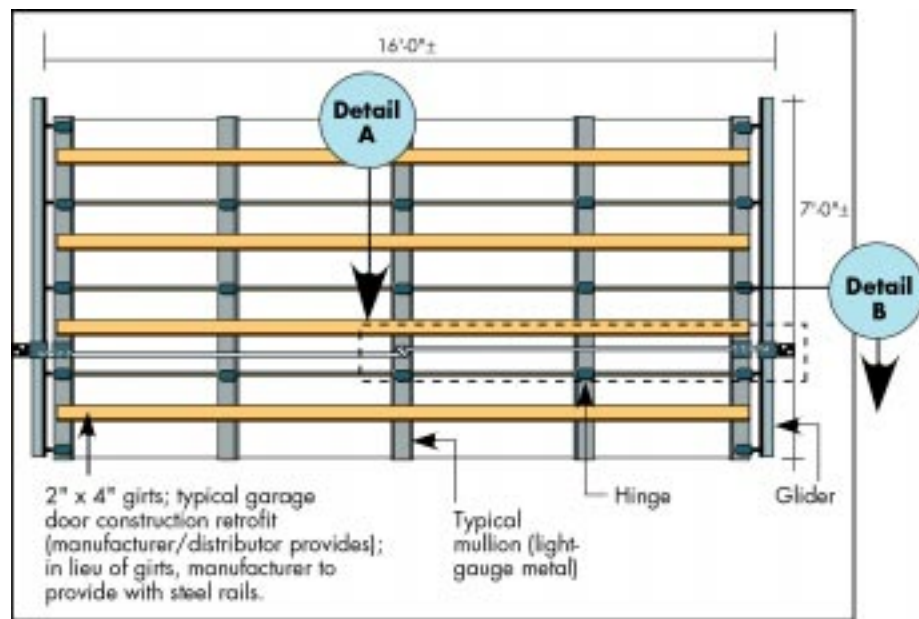
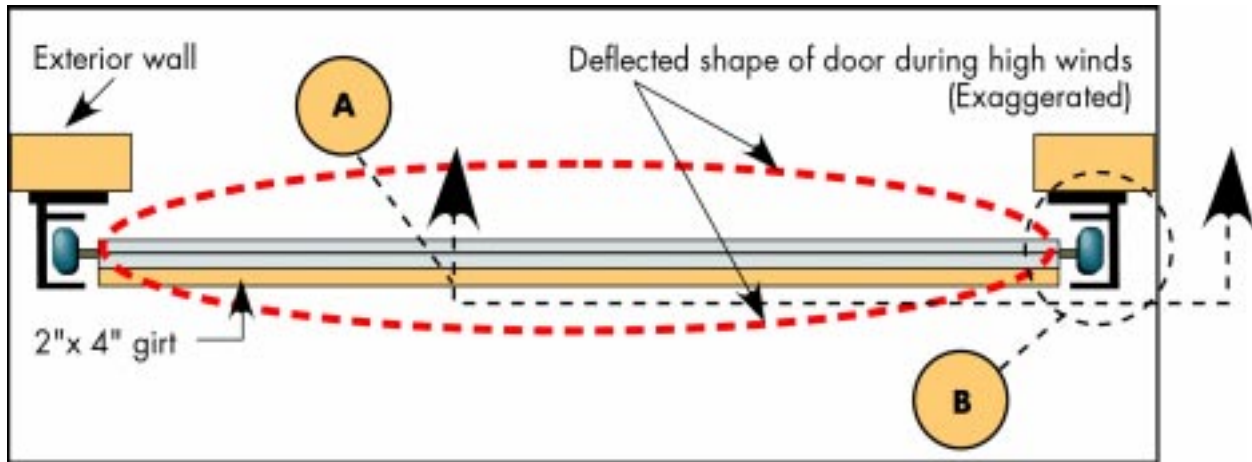
Along the track periphery, it was common to see residential garage door failures (Figure 4-18). The door in this figure likely had a tested load resistance of 12.5 psf; a common test pressure for doors of similar construction. The design load on this door would be 13 psf using UBC 1997 and 18 psf using ASCE 7-98. Hence the load derived from ASCE 7-98 is 44 percent higher than the tested resistance of the door. Had this door met the wind loading derived from ASCE 7-98, this failure may have been avoided. Most of the investigated doors were made of thin metal. Failures were typically caused by wind pressure, rather than by missiles. The most common failure mode observed was the door rollers disengaging from the door tracks. This was likely caused by excessive door deformation (see Figures 18A-18D). Door failure resulted in increased load on the building.

FIGURE 4-18B: Plan view of typical garage door shown in Figure 4-18A.

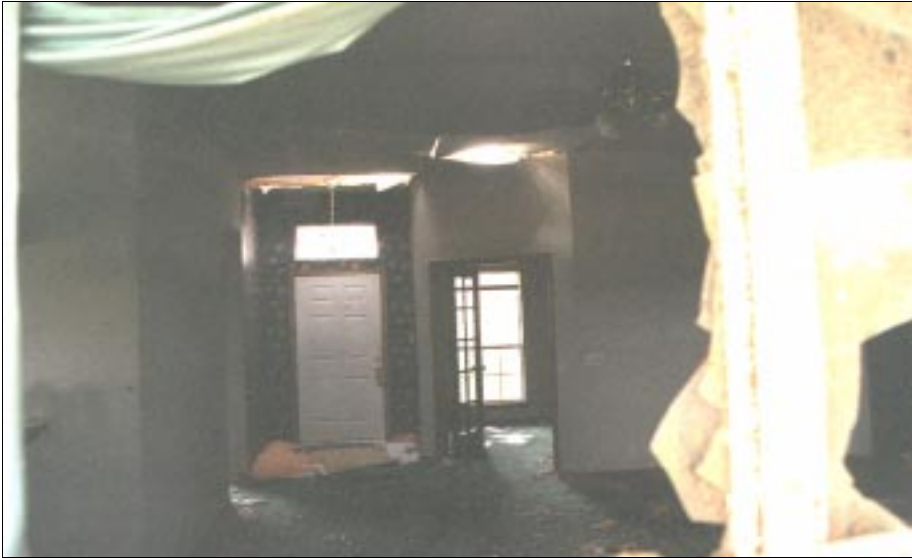
Several window failures at the back of the home located in Country Place, a subdivision of Oklahoma City, are shown in Figure 4-26. These homes were located along the periphery of a violent tornado. Other than a small piece of sheathing missing from the roof edge, the roof damage is limited to the loss of roof covering material only. In contrast, several pieces of roof deck sheathing failed on the front portion of the roof as depicted in Figure 4-27. Note that no breaches to the front exterior wall were observed. Figure 4-28 shows a view of the interior of the same dwelling taken from outside the left hand window breach seen in Figure 4-26. The photograph of the interior suggests the possibility that internal pressurization may have contributed to the roof deck sheathing loss. This is suggested by the holes in the ceiling, in particular the right hand hole above the interior doorway. There is evidence to suggest that internal pressure may have pushed the ceiling away from the top of the interior wall where the ceiling drywall failed. Note that there is no evidence of drywall debris on the floor directly below the drywall failure suggesting the drywall was ejected into the attic. This suggests that internal pressurization may have caused the drywall to fail leading to pressurization of the attic space and contributing to the sheathing failure of Figure 4-27. The drywall debris on the floor in front of the entry door belongs to the collapsed ceiling drywall to the left and was likely the result of rain water damage entering through the roof.

FIGURE 4-28: View of interior of home in Figures 4-26 and 4-27.

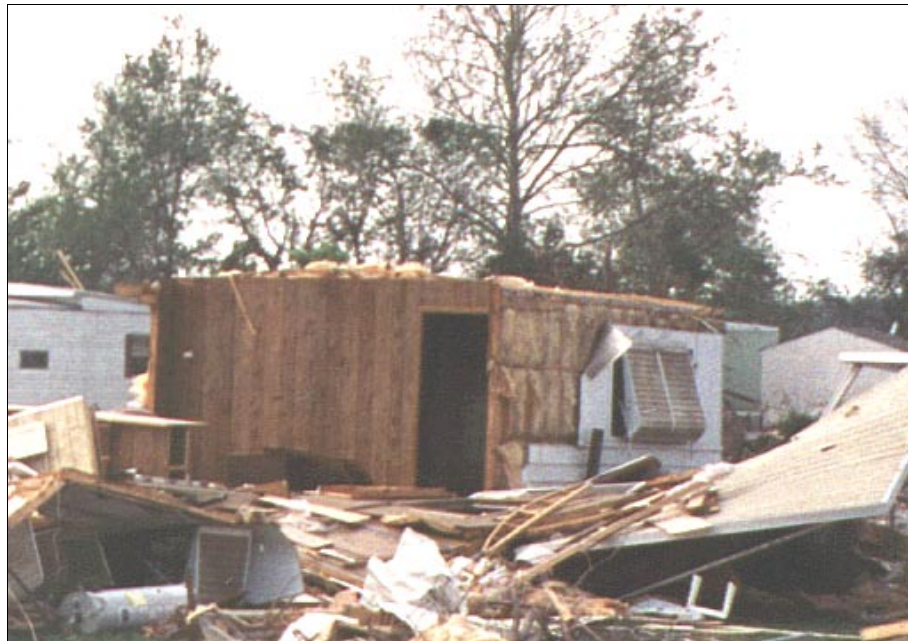
Figure 4-55: Damage to a manufactured home located on the periphery of a severe tornado, Wichita, Kansas.

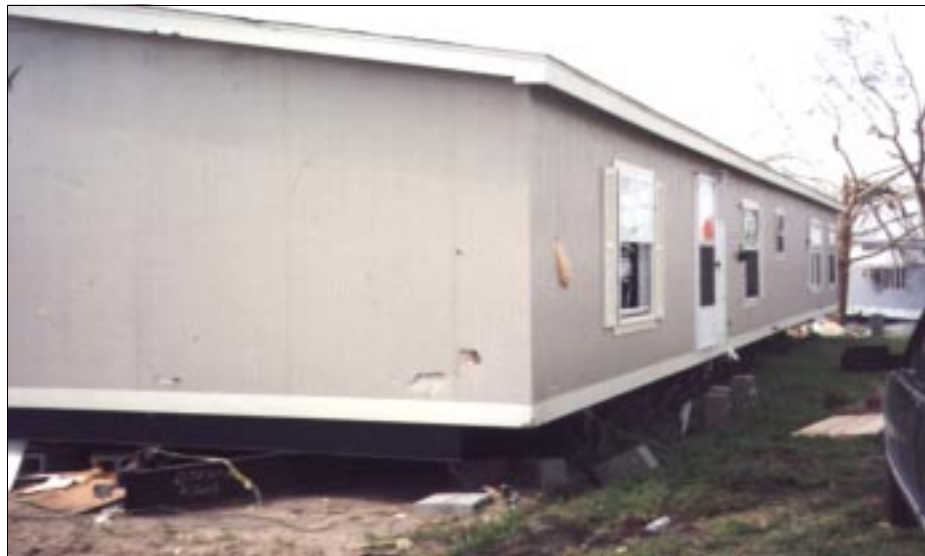
FIGURE 4-61: Manufactured home laterally shifted from wind force generated along the periphery of a violent tornado, Wichita, Kansas.
