Building Performance Assessment Report

Hurricane Georges...

In The Gulf Coast

**Observations,
Recommendations,
and Technical Guidance**

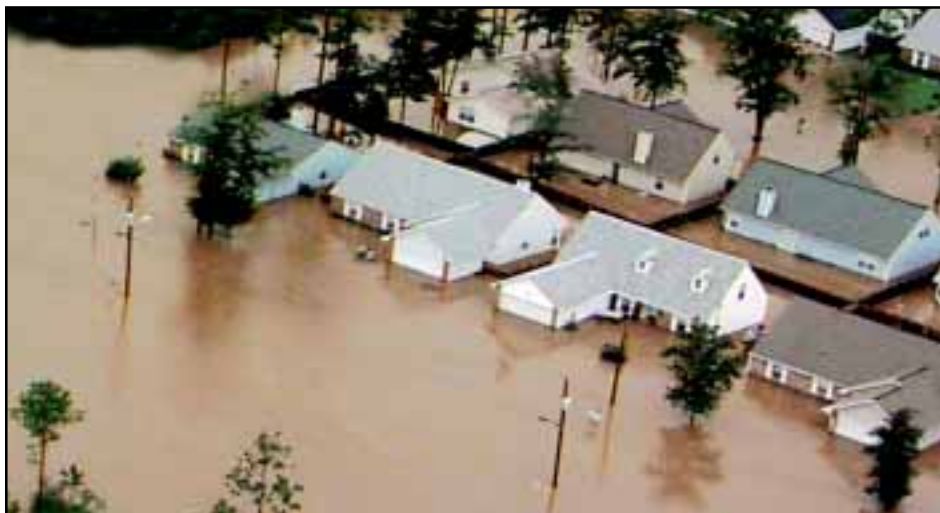
Hundreds of inland residential structures in Alabama, Florida, and Mississippi were inundated with water by riverine flooding. Structural damage, however, was limited; most damages were caused by water inundation (Figures 3-1 and 3-2). Damages observed included loss of contents, flooring, interior finishes, and portions of wallboard and insulation. Elevated homes generally performed well and required only minor cleanup (Figure 3-3).

FIGURE 3-1 Houses inundated by 2 to 3 feet of floodwaters in the Florida Panhandle.

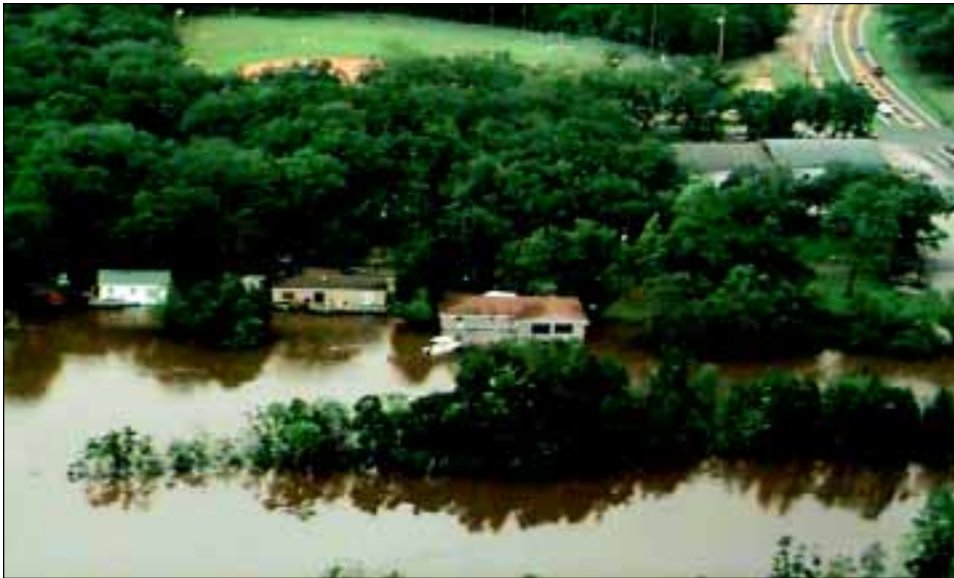
FIGURE 3-2 Typical flooding to homes in low-lying areas.

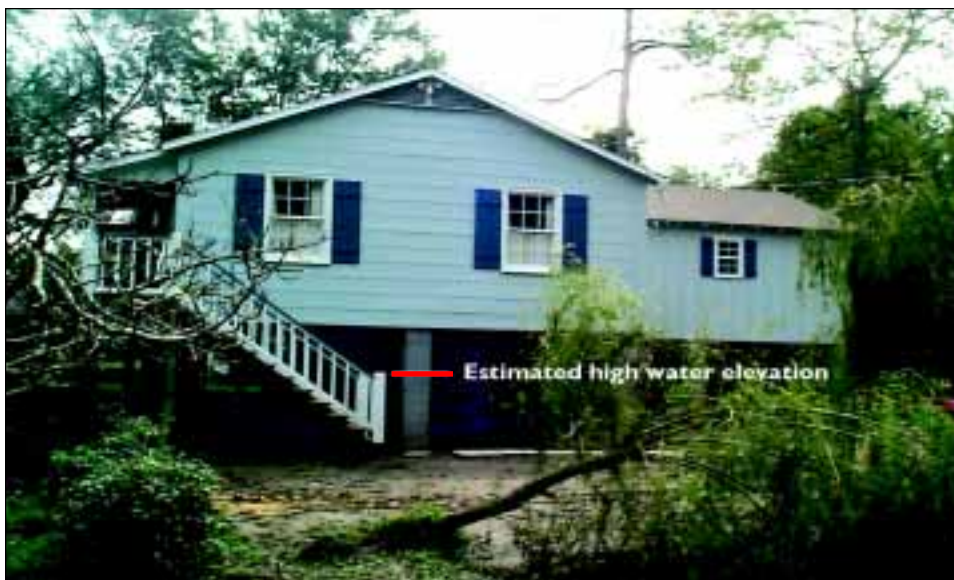
FIGURE 3-3 Elevated home along the Fish River in Baldwin County, Alabama, that received minimal damage.

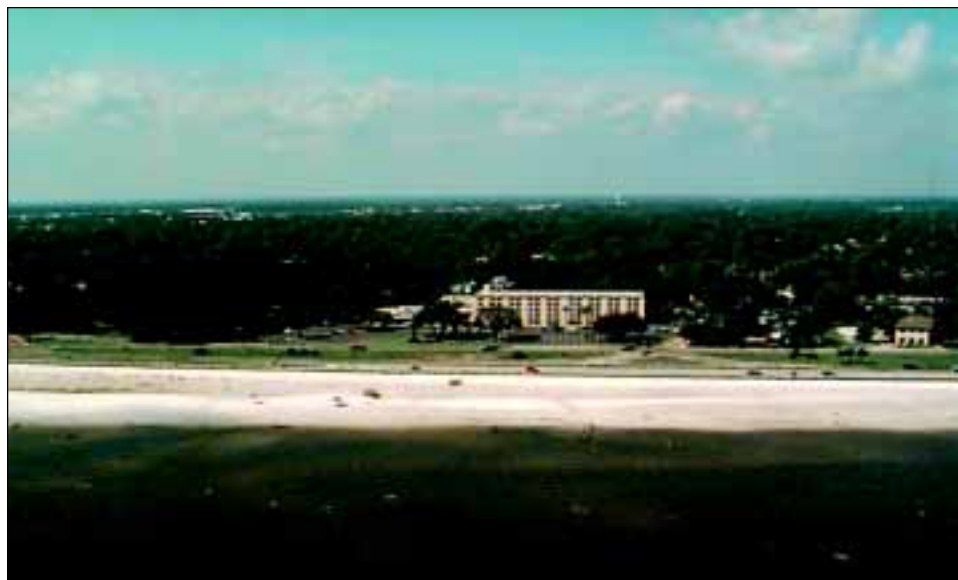
FIGURE 3-5 Mississippi Gulf Coast near Biloxi. Minimal coastal surge damage or overwash was observed.

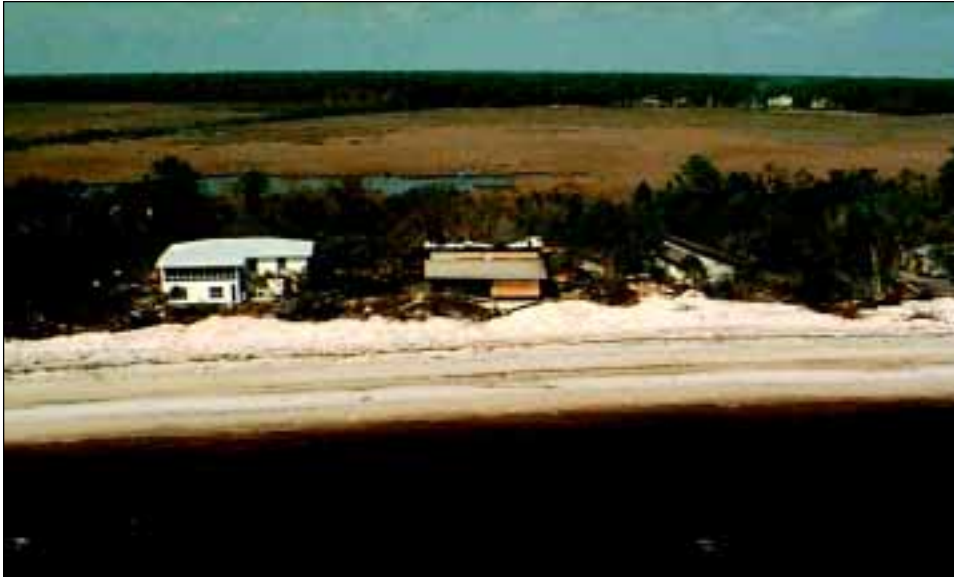
Coastal areas from Gautier to Pascagoula, Mississippi suffered some damage (Figure 3-6). Along Mobile Bay in Alabama, coastal surges severely damaged fishing piers and boatlifts. In addition, scour behind bulkheads caused some damages to front-row buildings (Figures 3-7 and 3-8). In the Florida Panhandle, limited structural damage was observed. Significant sand deposition, however, required extensive cleanup efforts (Figure 3-9).

FIGURE 3-6 Overwashed sand accumulation and minor structural damage near Gautier, Mississippi.

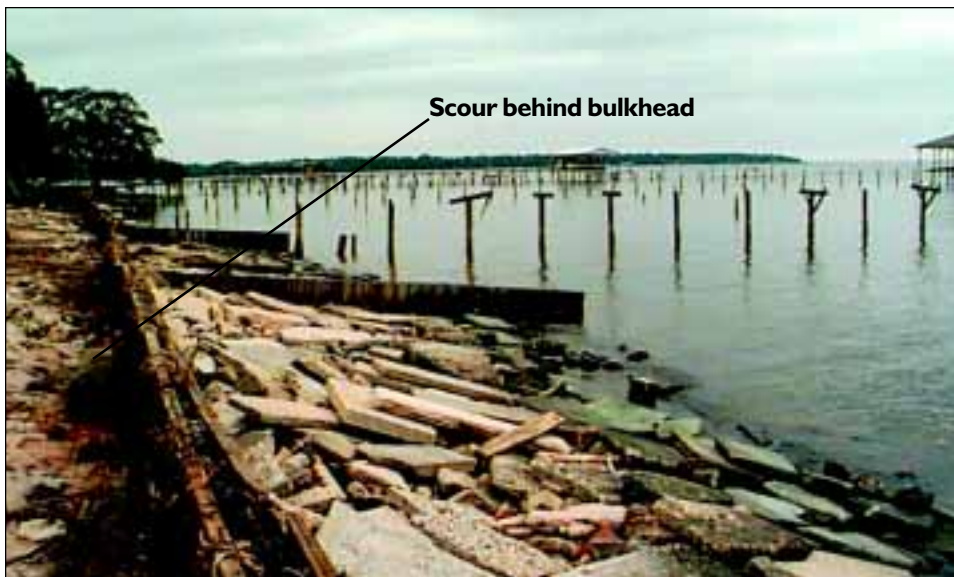
FIGURE 3-7 Remnants of fishing piers in Mobile Bay near Fairhope, Alabama. Note scour behind the bulkhead on the left.

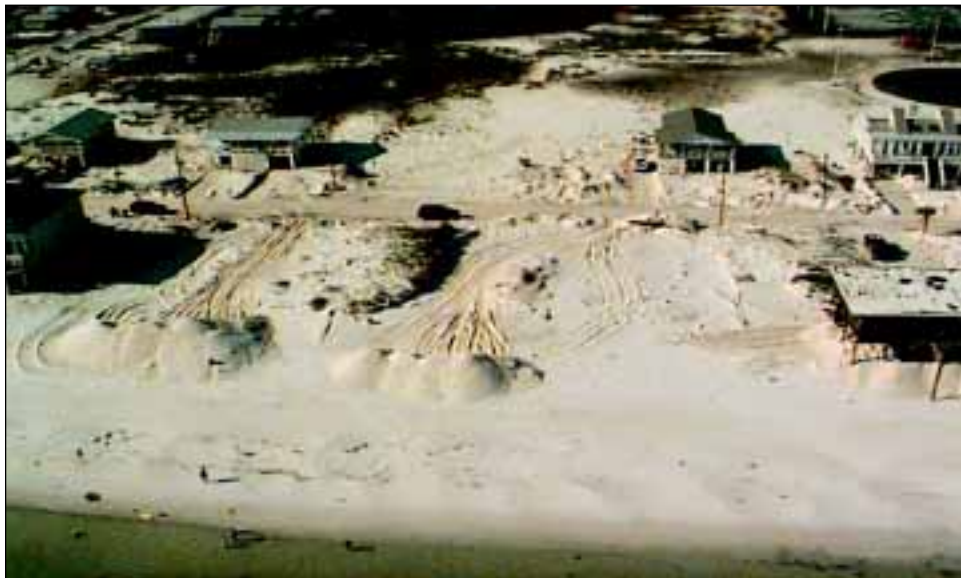
FIGURE 3-9 Sand accumulation from overwash in Pensacola Beach, Florida.

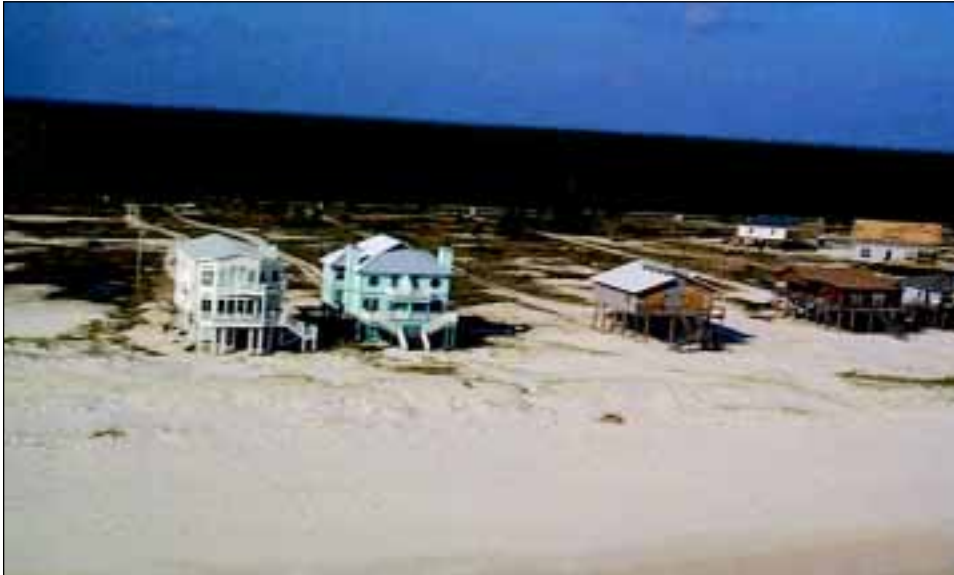
Pre-FIRM structures are those built before the effective date of the first FIRM issued by FEMA for the community in which the structure is located. Similarly, a post-FIRM structure is one built after the effective date of the first FIRM. In general, the effective date of a FIRM corresponds approximately to a community's adoption of floodplain management ordinances incorporating NFIP regulations for new construction and substantial improvements of buildings in special flood hazard areas (SFHAs). These regulations include the requirement for elevation of residential structures in SFHAs. In general, the BPAT observed that post-FIRM, elevated structures set back from the shoreline performed well during Hurricane Georges (Figure 3-10).

FIGURE 3-10 Properly elevated and set back houses sustained little damage.

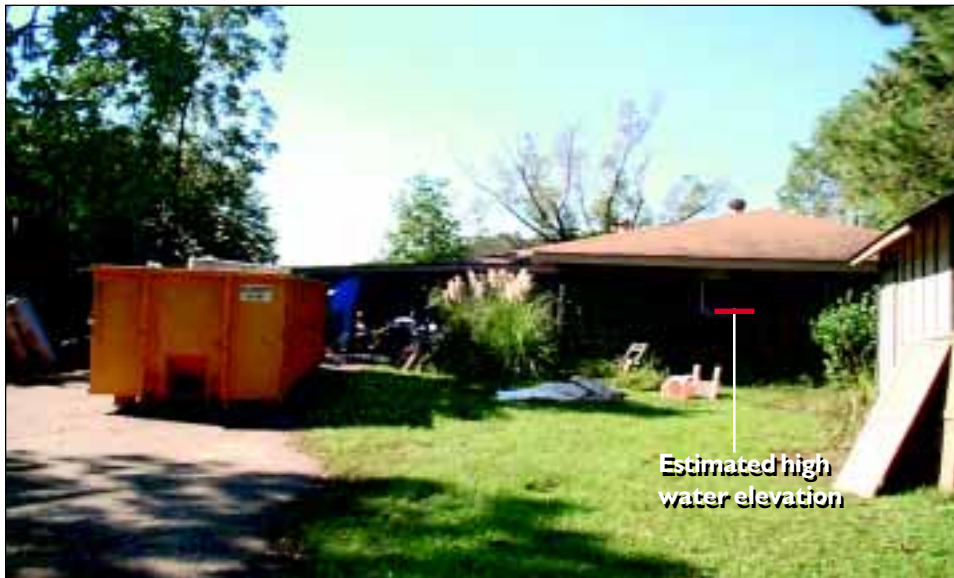
Damage consisted mostly of loss of contents; damage to exterior and interior finishes, including doors, cabinets, carpeting/flooring, and painted surfaces; inundation of air conditioning compressors; and damage to wallboard and insulation. In the Dog River area, houses experienced up to 5 feet of flooding (Figure 4-1). The Fish River area experienced 4 to 5 feet of flooding. In one instance, a pre-FIRM house built on a slab-on-grade foundation sustained damage while a post-FIRM elevated addition apparently was not affected (Figure 4-2).

FIGURE 4-1 Homeowner removing damaged contents from house flooded along the Dog River.

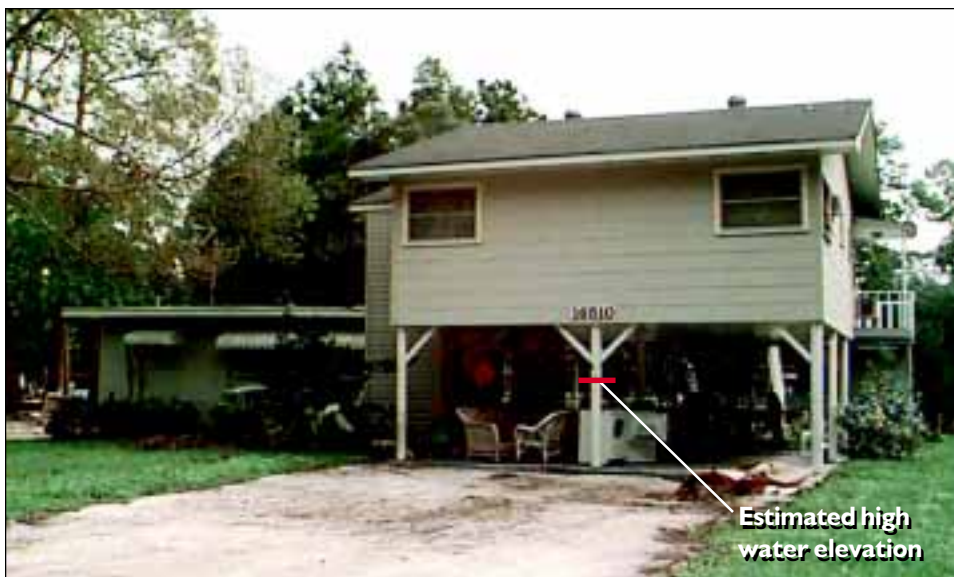
FIGURE 4-2 Approximately 5 feet of flooding at this house along the Fish River caused no damage to the elevated addition.

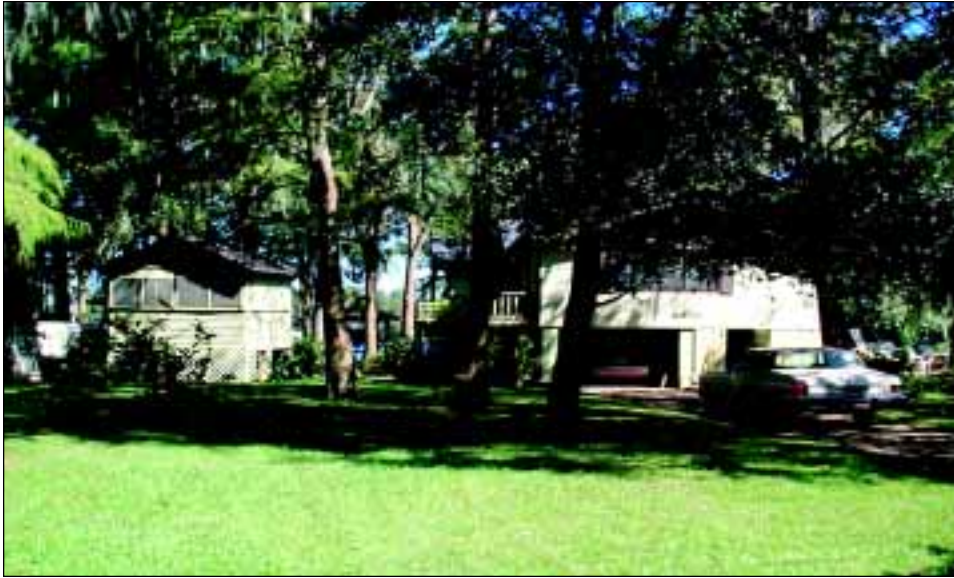
FIGURE 4-4 Elevated house along the Dog River that suffered minimal flood damage.

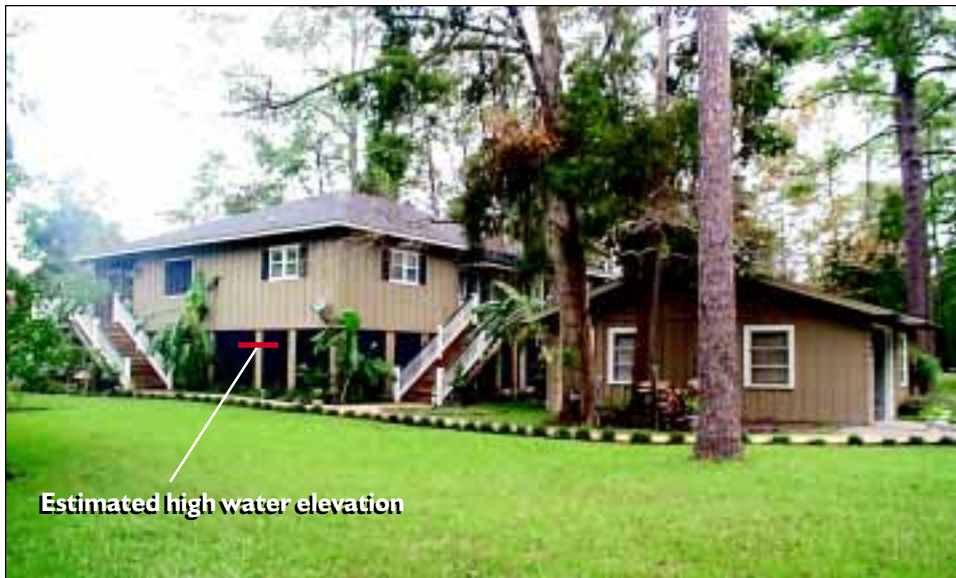
FIGURE 4-5 House along the Fish River, elevated through FEMA's HMGP that suffered minimal flood damage.

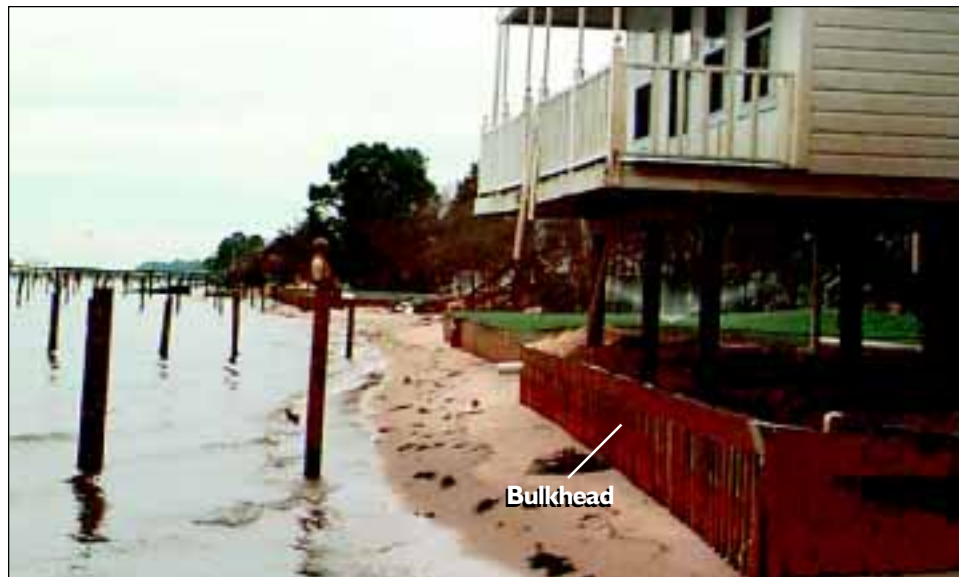
Wave action removed sand in front of bulkheads and overtopping removed much of the material from behind. Erosion was retarded by a relatively resistant, hard red clay layer located at a depth of 8 to 14 inches below grade. Following the hurricane, most bulkheads were still structurally sound as shown in Figure 4-30. Additional horizontal scour adjacent to bulkheads, caused by wrap-around/focusing of wave energy, was common along Mobile Bay.

FIGURE 4-30 Bulkheads on Mobile Bay still in place after storm.

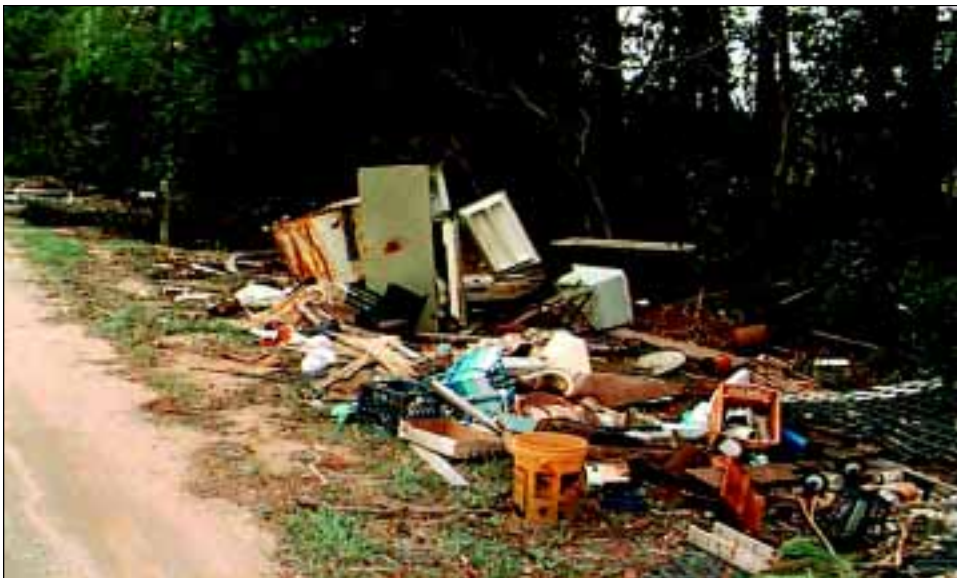
Along the lower eastern shore of Mobile Bay, approaching Weeks Bay, the damages cited were evident (Figure 4-31). Other damages included significant loss of contents and personal possessions debris from bayfront homes washed across the roadway (Figure 4-32). Properly elevated and setback structures along Mobile Bay performed well and suffered only minor damage to areas below the first floor (Figure 4-33).

FIGURE 4-32 Debris accumulation along coastal roadway.

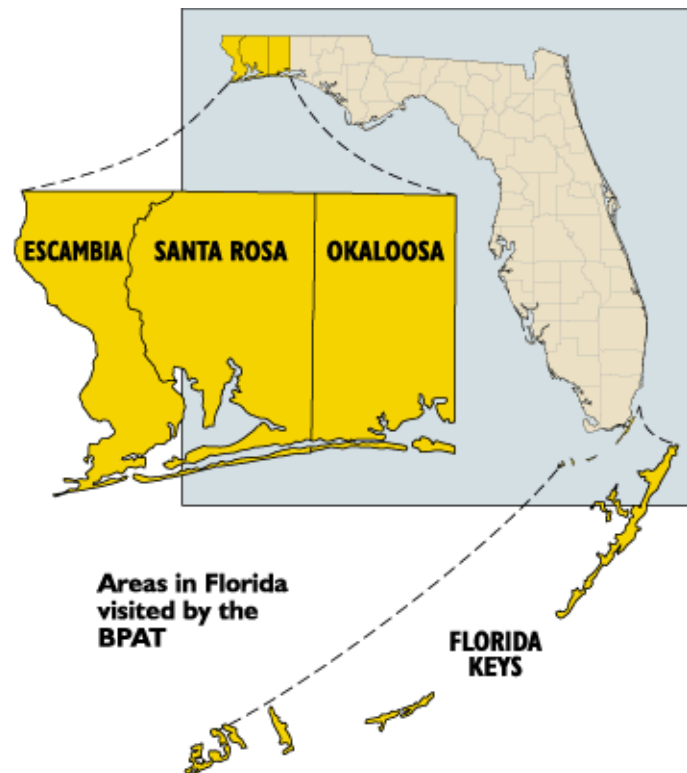
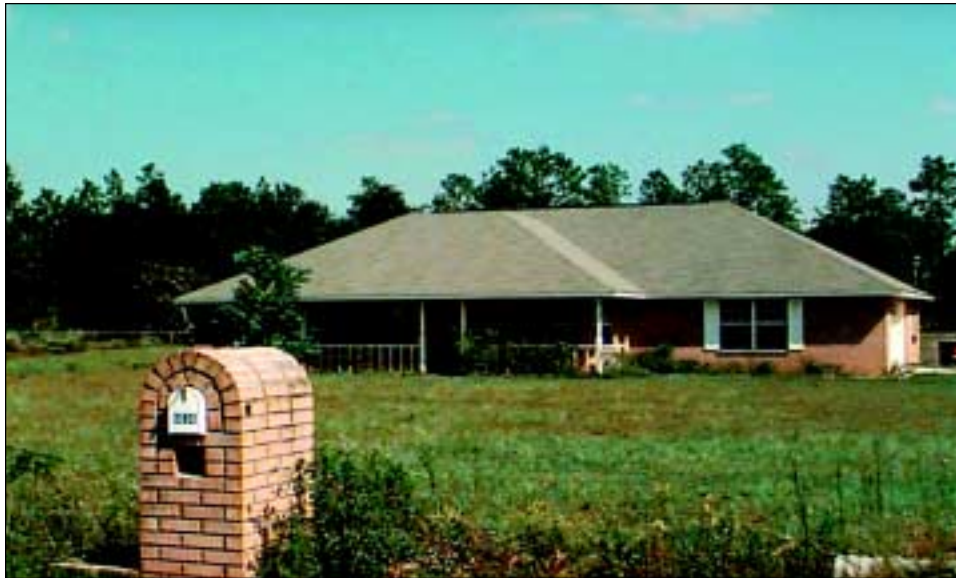
The BPAT visited sites of riverine flooding along the Yellow and Shoal Rivers in Okaloosa and Santa Rosa Counties. The home shown in Figure 5-1 was flooded by several feet of water and is typical of the pre-FIRM, at-grade houses located in these areas.

FIGURE 5-1 Repetitively flooded home slated for acquisition under FEMA’s HMGP.

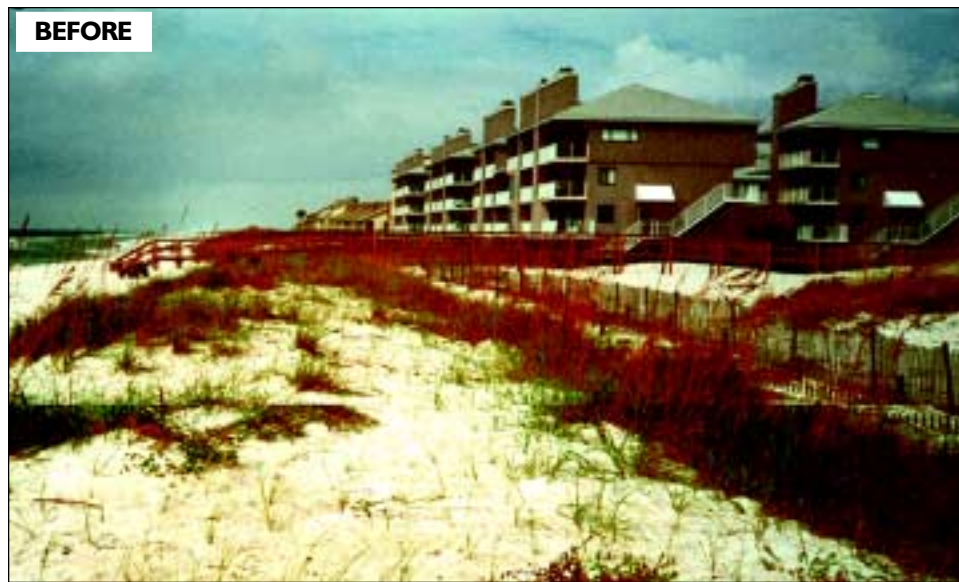
FIGURE 5-4 Pensacola Beach before Hurricane Georges.

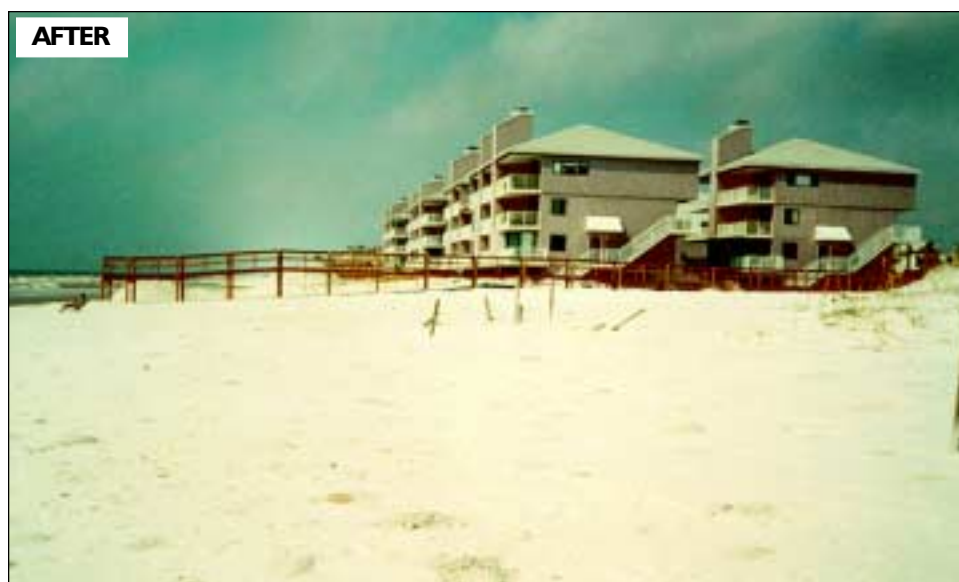
In Pensacola Beach, prolonged wave attack and storm-surge flooding associated with the hurricane eroded most of the primary dune system and narrowed the beach (Figures 5-4 and 5-5). Overwash was significant, but not as severe as experienced during Hurricane Opal. Vertical sand accretion beneath some structures was 3 to 5 feet. Even after Hurricane Georges, Pensacola Beach remains relatively wide with scattered residual dunes. Offshore sandbars were observed migrating back onto the beach in some locations.

FIGURE 5-5 Pensacola Beach after Hurricane Georges. Note the loss of dune and vegetation in the foreground of the photo.

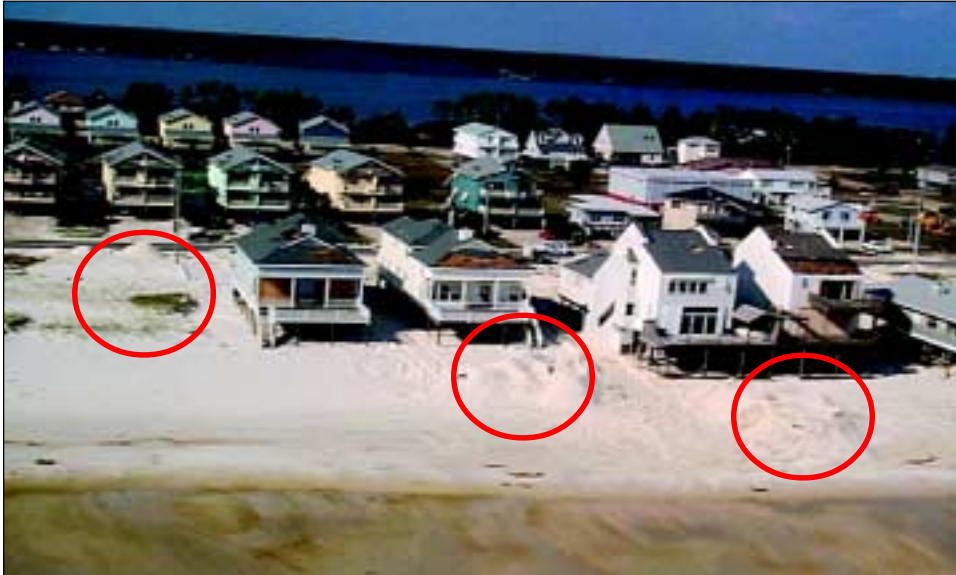
Much of the sand that was washed inland buried roads, utilities and lower areas of buildings. As shown in Figure 5-6, homeowners removed excess sand.

FIGURE 5-6 Excess sand (circled) from beneath houses and on roadways that was returned to the beach.

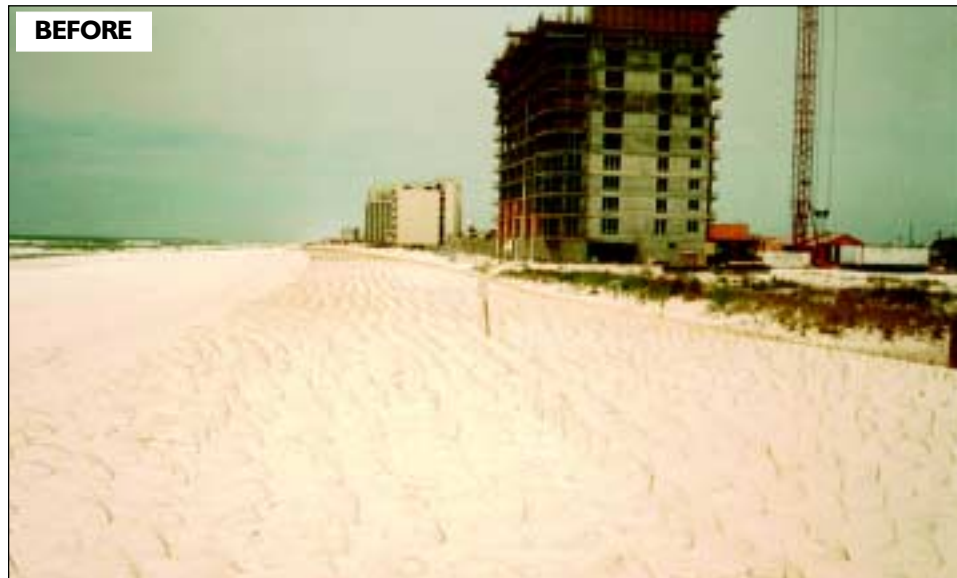
FIGURE 5-7 Navarre Beach before Hurricane Georges.

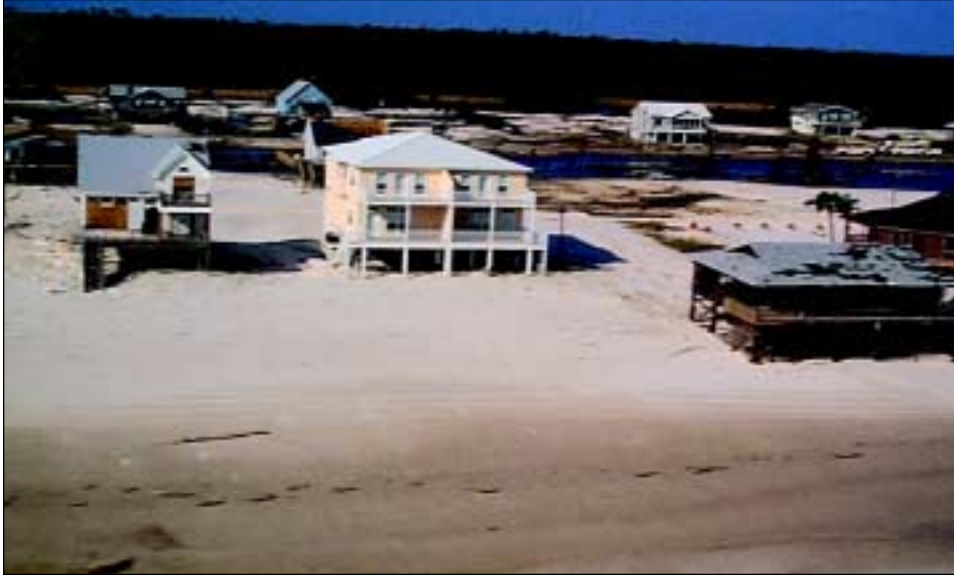
In Pensacola Beach, post-FIRM elevated structures performed well, suffering only residual damage to storage, access, and parking areas below the first floor (Figure 5-9). In V-Zone areas, the BPAT observed minimal enclosures below the first floor of elevated structures. Breakaway walls, where observed, performed as intended.

FIGURE 5-9 The structures to the left were elevated and set back and performed well.

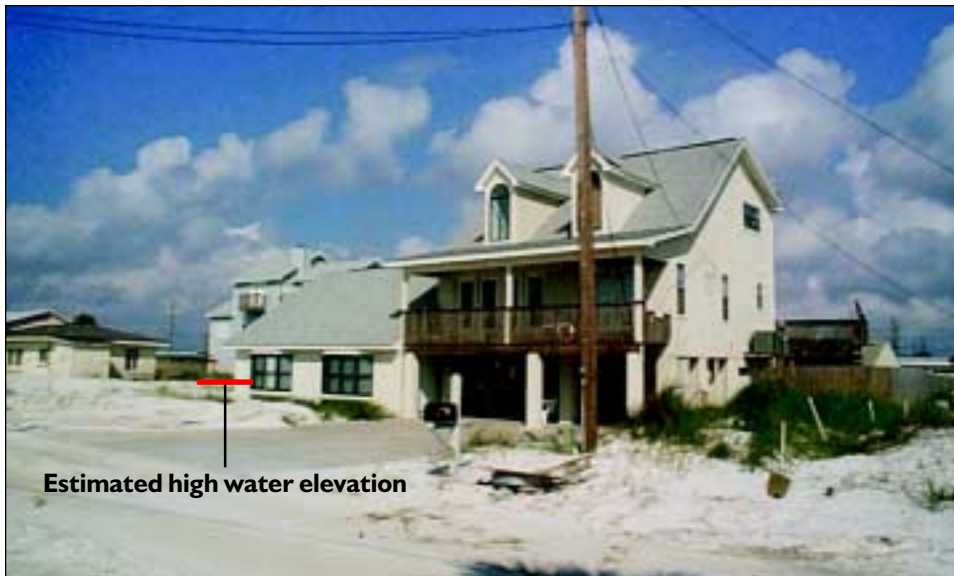
The house in Figure 5-10 clearly illustrates the reduction in flood damages that occur when homes are properly elevated. The elevated addition suffered no damage while the pre-existing, at-grade portion of the home suffered extensive flood damage from overwash.

FIGURE 5-10 An existing slab-on-grade home was expanded with a properly elevated addition.

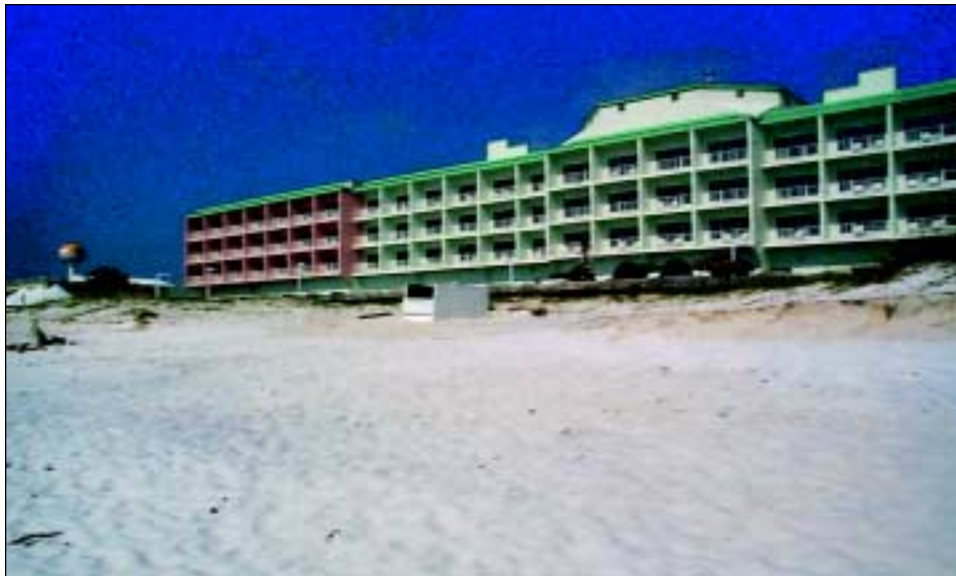
The BPAT also investigated the performance of several Pensacola Beach hotels. Older, pre-FIRM buildings, such as the hotel in Figure 5-11, suffered flood damage. Flood and rain damage forced the hotel in Figure 5-11 to close for repairs. The property management company reported that it would be closed for three to four months, forcing the layoff of approximately 50 housekeeping and support staff. In contrast, newer hotels with elevated first floors in compliance with the current floodplain management ordinance suffered minimal damage (Figure 5-12). The hotel in Figure 5-12 suffered minimal damage and was able to continue operations without disruption.

FIGURE 5-12 A newer hotel with an elevated first floor that suffered minimal damage.

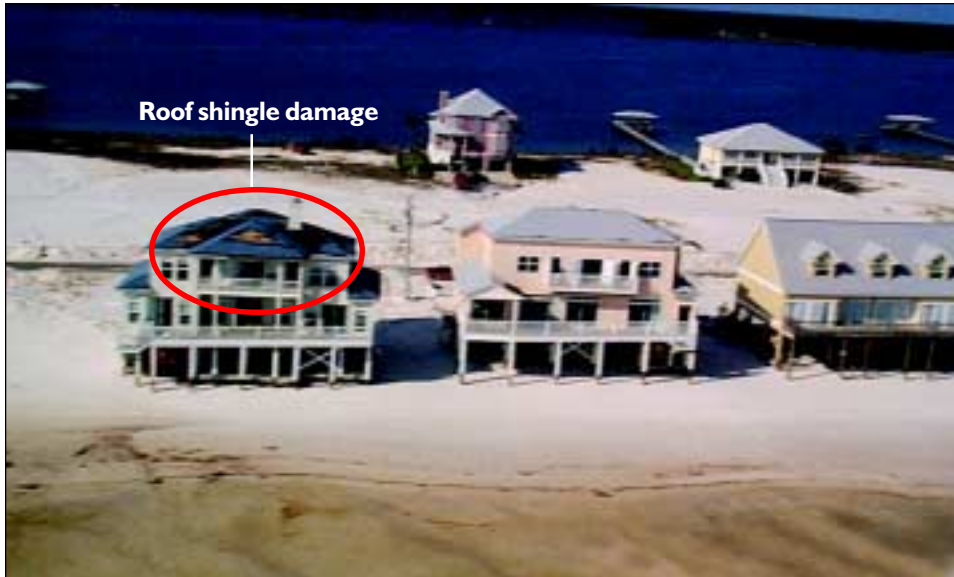
In general, Hurricane Georges caused minimal wind damage in Florida. Buildings highly exposed along the open coast suffered some wind damage, including loss of sections of composition roof shingles and small sections of siding, which allowed rain infiltration to damage building interiors and contents (Figure 5-13).

FIGURE 5-13 The house on the left suffered wind damage to roofing shingles.

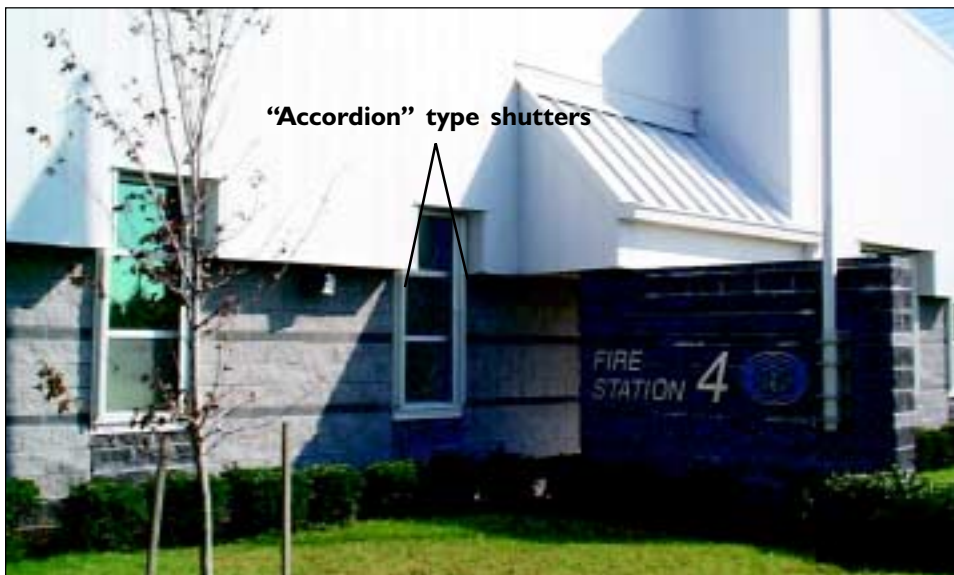
The BPAT assessed the performance of several window and door shutter projects funded under FEMA's HMGP. The shutter projects were applied to public buildings, including municipal office buildings, fire stations, and police stations. While there was little evidence that wind forces and airborne debris caused damage to windows and doors in the area, buildings with shutters showed no damage and provided a safe and secure shelter facility during the hurricane (Figures 5-14 to 5-16).

FIGURE 5-14 Window shutters on the Pensacola Fire Station No. 4.

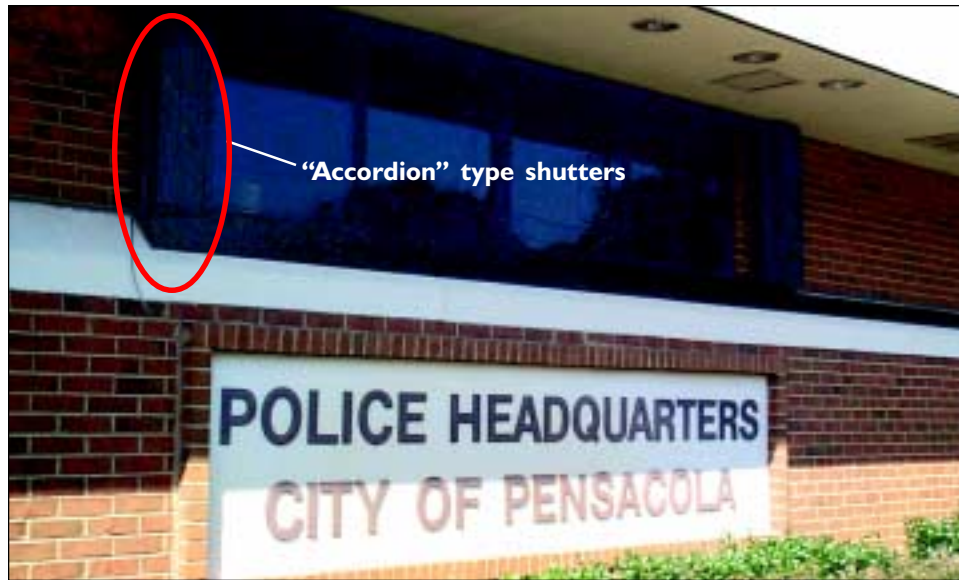
FIGURE 5-15 Window shutters on the Pensacola Police Headquarters.

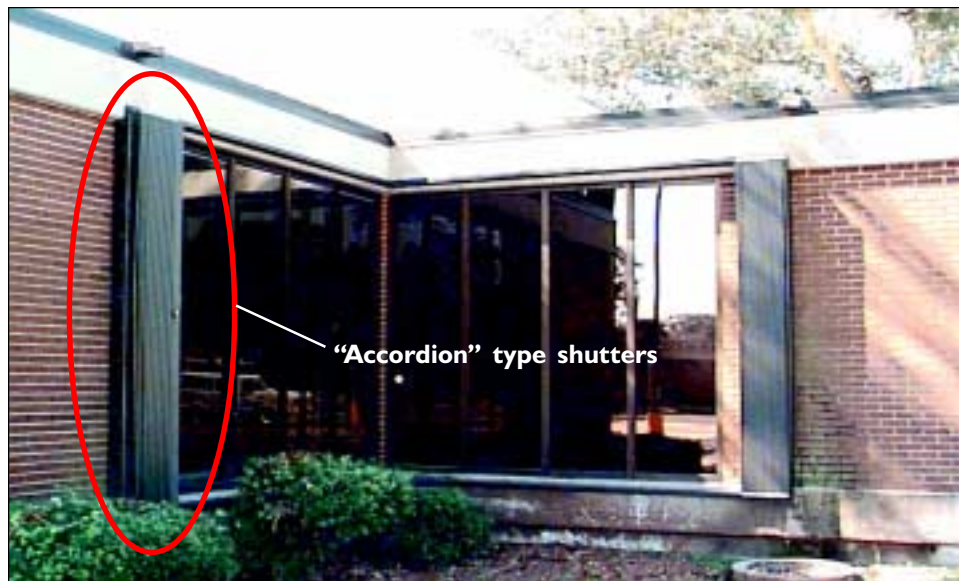
FIGURE 5-16 Window shutters on the Escambia County Administration Building.

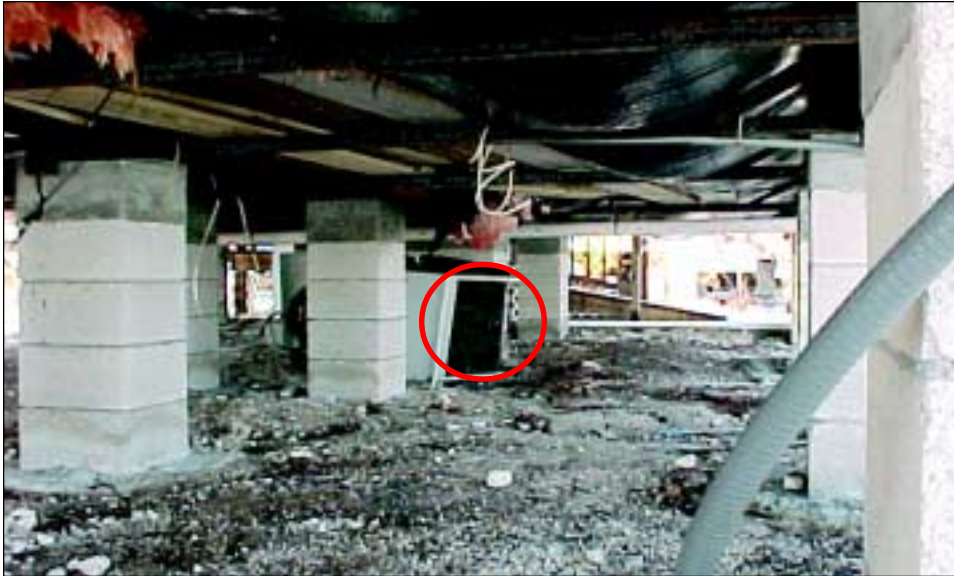
Foundation systems for the manufactured homes installed during the past four years were typically reinforced concrete or reinforced masonry piers (Figure 5-18). These homes were at or above the coastal storm surge elevation experienced during Hurricane Georges. Most of these homes experienced only non-structural damage to lower area skirting. In some cases, water damage occurred to insulation below the floor.

FIGURE 5-18 Reinforced masonry pier foundation system under a newer manufactured home that performed well. The air conditioner compressor (circled) washed under the home provides evidence of the coastal surge at this location.

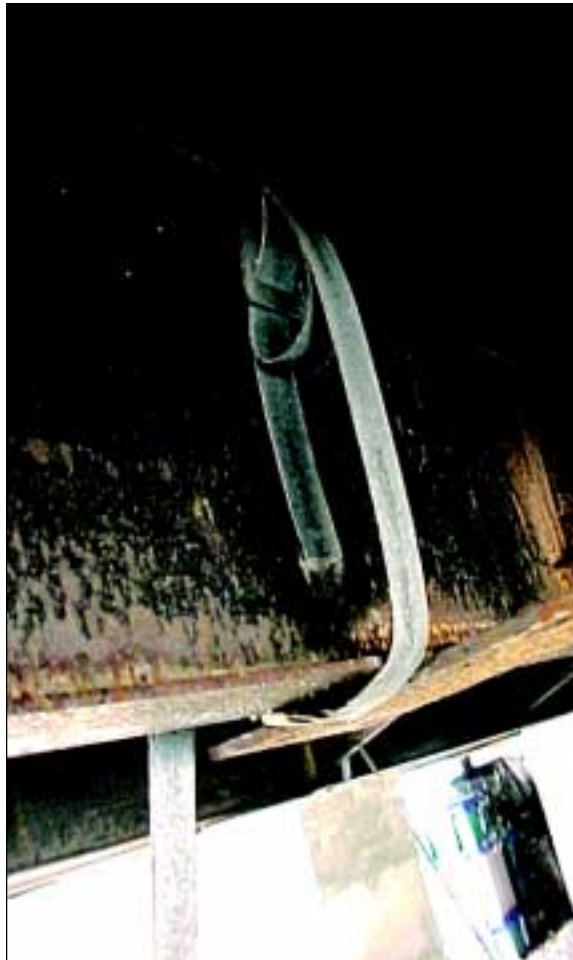
FIGURE 5-25 Proper strap installation.

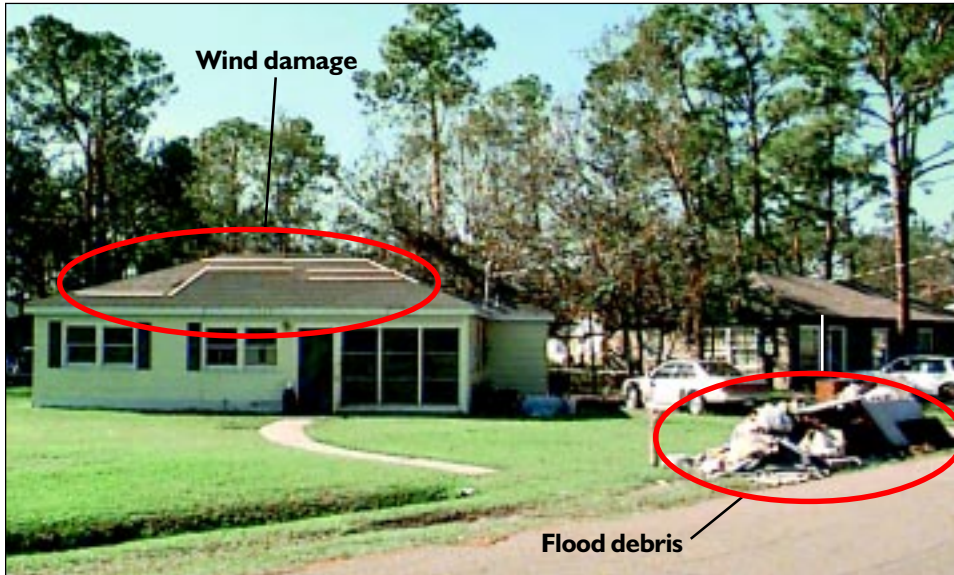
Typical of the flood damage observed in the Pascagoula area is the home shown in Figure 6-1. In addition to flood damage, some homes in this area also suffered roof damage due to high winds. Many homes in low-lying areas of Pascagoula, such as those shown in Figures 6-2 and 6-3, have been flooded previously. The frequent flooding in this area is likely a result of the inability of the storm drains to convey the rainfall runoff and the inability of the storm drainage system to discharge into the Gulf during periods of coastal surge, or a combination of both of these factors. During Hurricane Georges these homes were flooded to a depth of 3 to 4 feet. No structural damage to homes was observed; however, there were significant losses to contents, interior finishes, wallboard, insulation, and electrical systems.

FIGURE 6-1 Home in Pascagoula that sustained wind and flood damage.

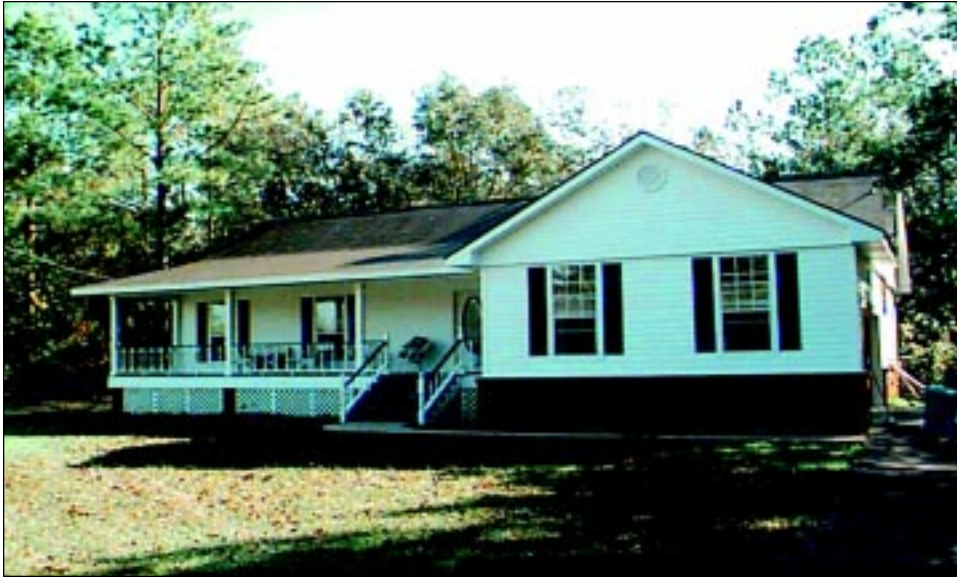
The house shown in Figure 6-4, located in the Franklin Creek watershed, was elevated in 1996 under FEMA's HMGP. It was elevated 40 inches, bringing the lowest floor to an elevation of 16 feet NGVD which is one foot above the 100-year flood elevation (approximately 15 feet NGVD). Prior to Hurricane Georges, floods have threatened the home four times since it was elevated but it has not sustained any damage. Unfortunately, flooding from Hurricane Georges inundated this house approximately 3 inches above the lowest floor (Figure 6-5). Given the estimated recurrence interval of approximately 25 years, flood elevations exceeding the 100-year flood could be attributed to backwater effects from where Franklin Creek meets the Escatawpa River.

While the 3 inches of flooding did cause damage, if the house had not been elevated it would have received 43 inches of flooding. Elevating homes has been proven to reduce flood damages; however, there is still a residual risk that a flood greater than the 100-year flood will cause damage. The only way to completely eliminate the risk is to relocate well outside the 100-year floodplain.

FIGURE 6-4 Home in eastern Jackson County elevated approximately 40 inches.

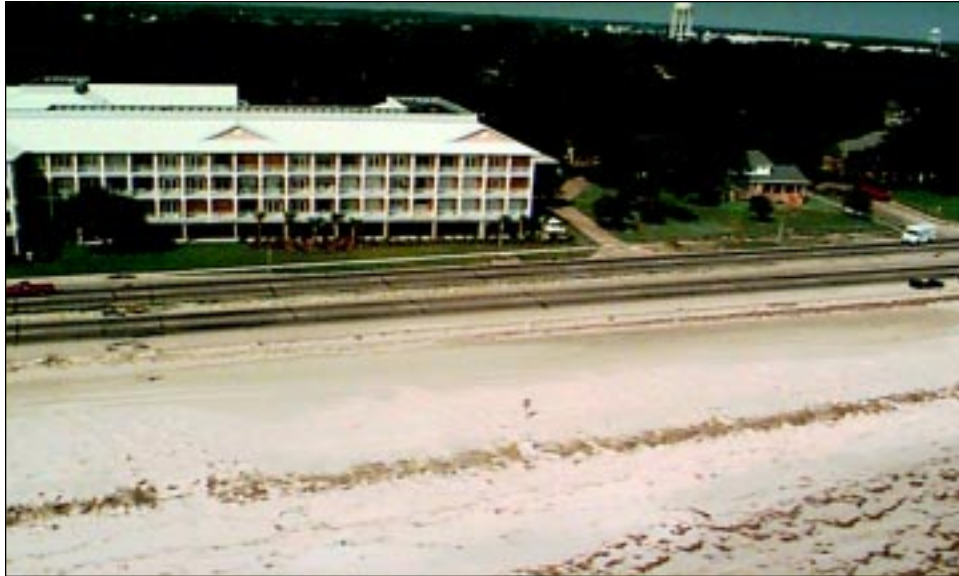
Coastal surge from Gulfport to Biloxi caused only minimal structural damage. In these areas, buildings are well set back from the shoreline as shown in Figures 6-6 and 6-7. The impacts of storm surge, wave action, erosion, and scour were reduced to set back structures. In addition, Hurricane Georges' impact on these beaches appeared to be minimal. As shown in these figures, no appreciable road damage or overwash of sand onto Highway 90 was observed where the road followed the shoreline in Gulfport and Biloxi.

FIGURE 6-6 Coastal area near Gulfport. Note how buildings are set back from the shore.

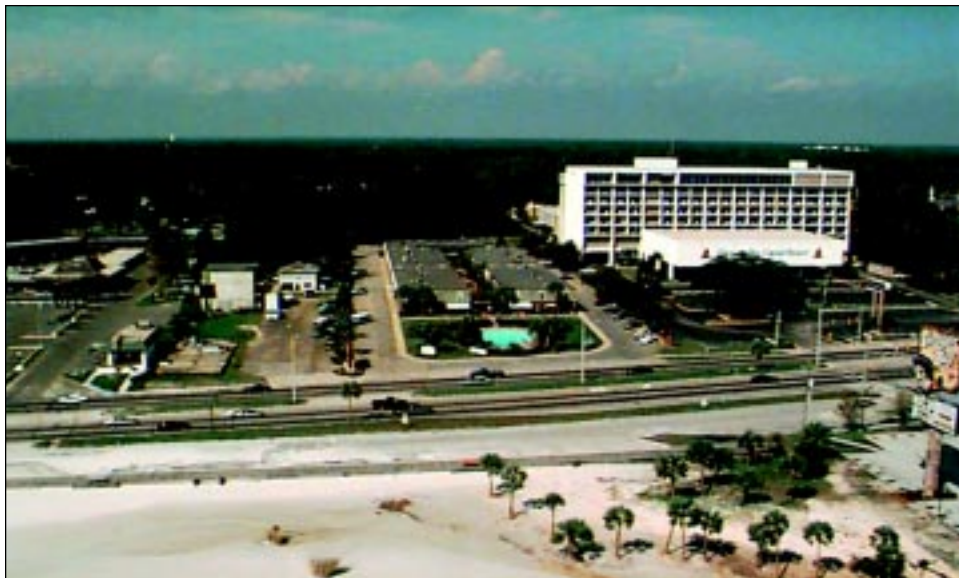
FIGURE 6-7 Another coastal area near Gulfport.

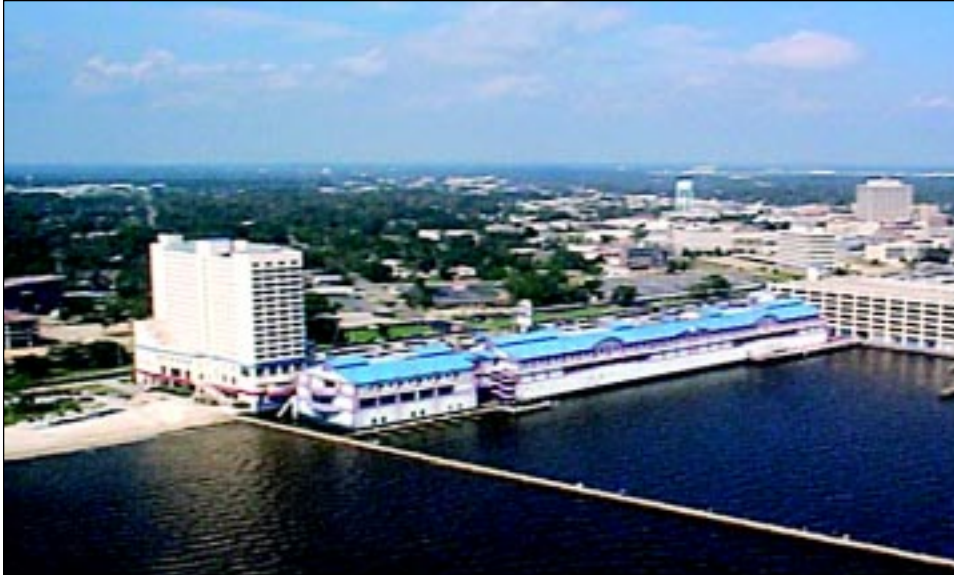
Casino barges in Gulfport and Biloxi suffered minimal damage and disruption of business from coastal surge. Some roof damage due to high winds, as discussed in Section 6.2, resulted in rain infiltration damage to some casinos (Figure 6-8). The shipyards in Pascagoula were inundated by coastal storm surge and suffered some damage (Figure 6-9). Ingalls Shipbuilders, the area’s largest employer, has already retrofitted its shipyard, thereby protecting its means of production from the effects of Hurricane Georges and making the region’s economic base more secure.

FIGURE 6-8 Casinos suffered minimal damage from coastal storm surge.

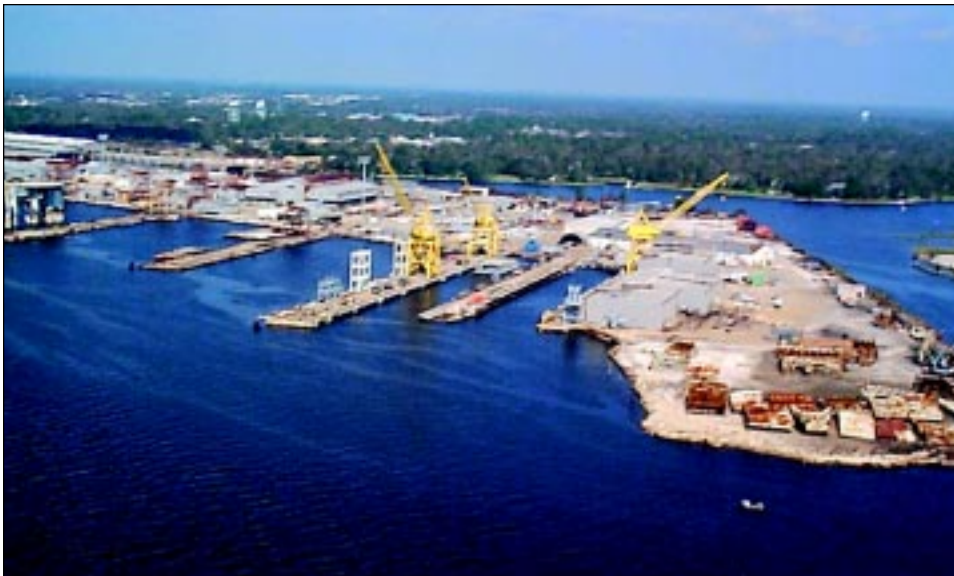
FIGURE 6-9 Ingalls shipyard only suffered minor damage due to coastal storm surge.
