Building Performance Assessment Report

Hurricane Georges...

In The Gulf Coast

**Observations,
Recommendations,
and Technical Guidance**

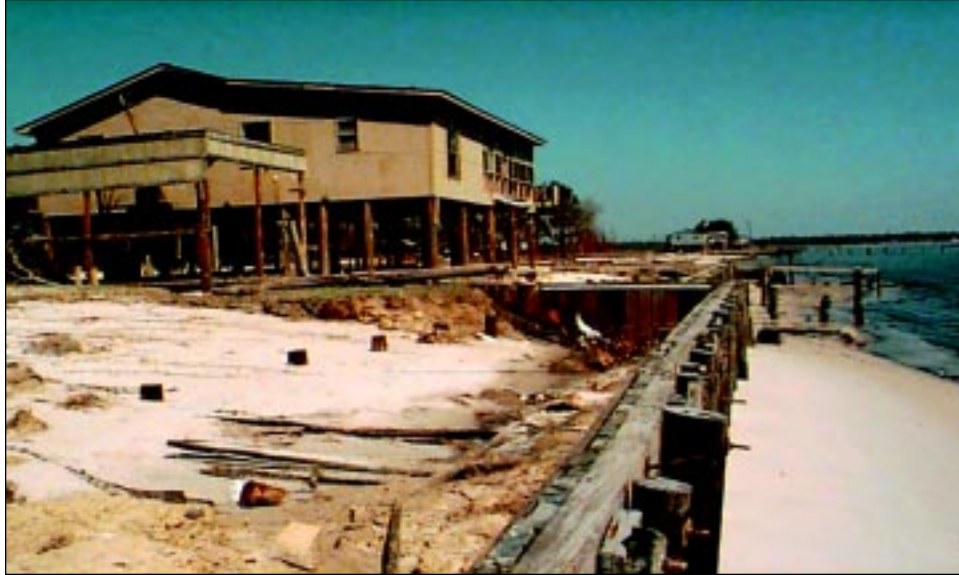
FIGURE 6-10 Scour behind bulkhead near Belle Fontaine.

Rip-rap at a public beach, old abandoned bulkheads, and old foundation piles, suggest a history of episodic and long-term erosion issues. Overwash was common, covering the roadway in the western areas. Vertical beach loss of several feet occurred, as did localized scour around bulkheads. Lack of adequate building setbacks from the shoreline in combination with inadequate foundation systems left many houses extremely vulnerable to storm surge and wave-induced damage in the Belle Fontaine/Fontaine Bleau area (Figures 6-12 to 6-16). Adequately sited and elevated homes performed well (Figure 6-17).

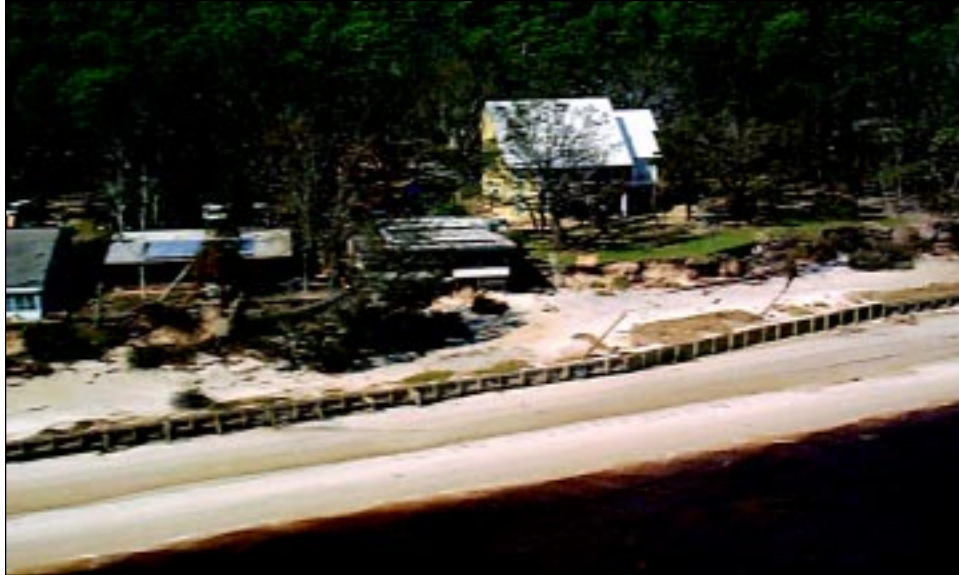
FIGURE 6-11 Severe beach erosion caused by wave action and storm surge.

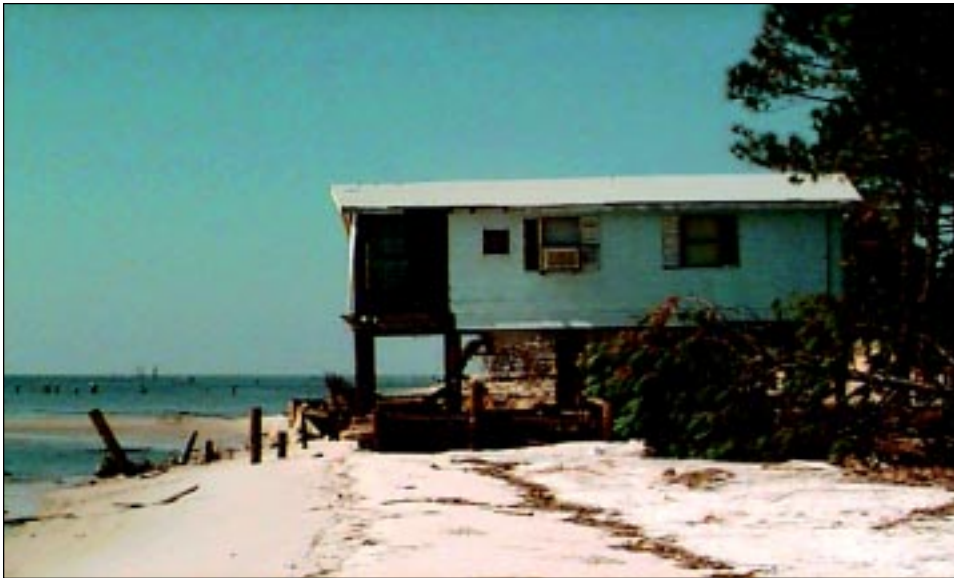
FIGURE 6-12 Highly exposed structure that suffered damage from storm surge and high winds.

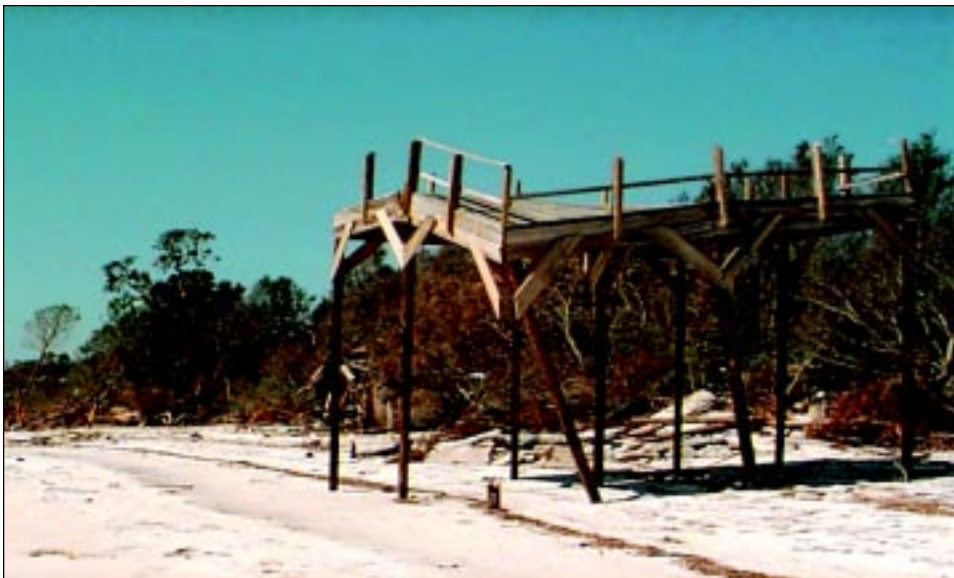
FIGURE 6-13 Only the deck remains standing on this home. House debris can be seen in the background. Storm-induced beach erosion and inadequate pile embedments contributed to the failure of this home.

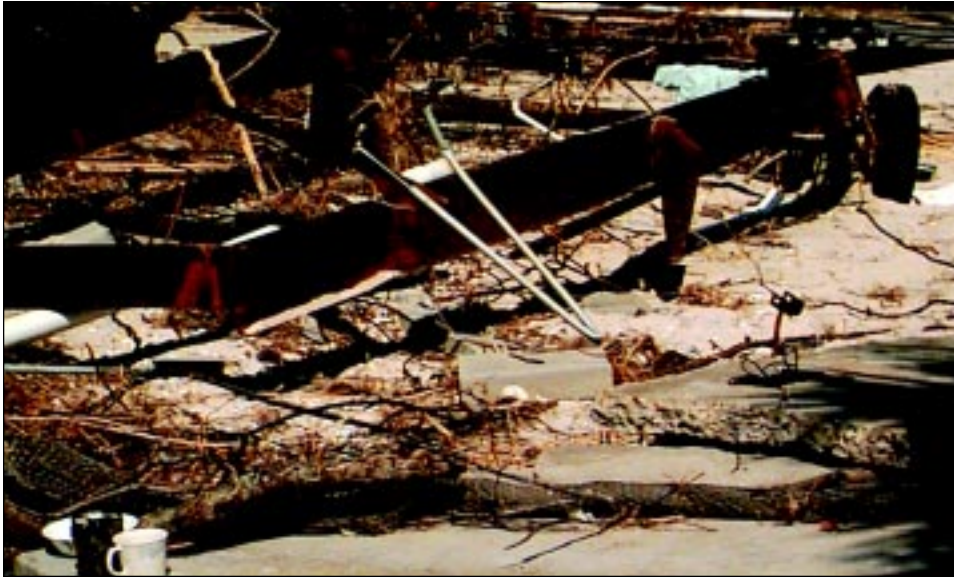
FIGURE 6-16 All that remains of this oceanfront manufactured home that was located on this lot is the bent metal frame. The foundation system was dry-stacked blocks. Tiedown anchors on the Gulf side of the home failed due to erosion and flood forces.

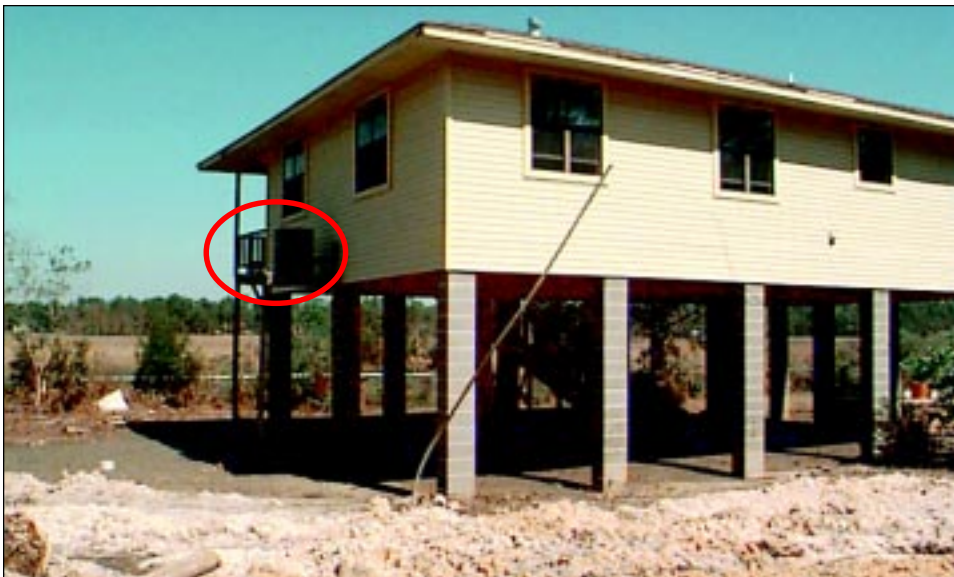
FIGURE 6-17 This house was set back 100 feet or more from the open coast out of reach of velocity flow and wave action. Note elevated utility platform.

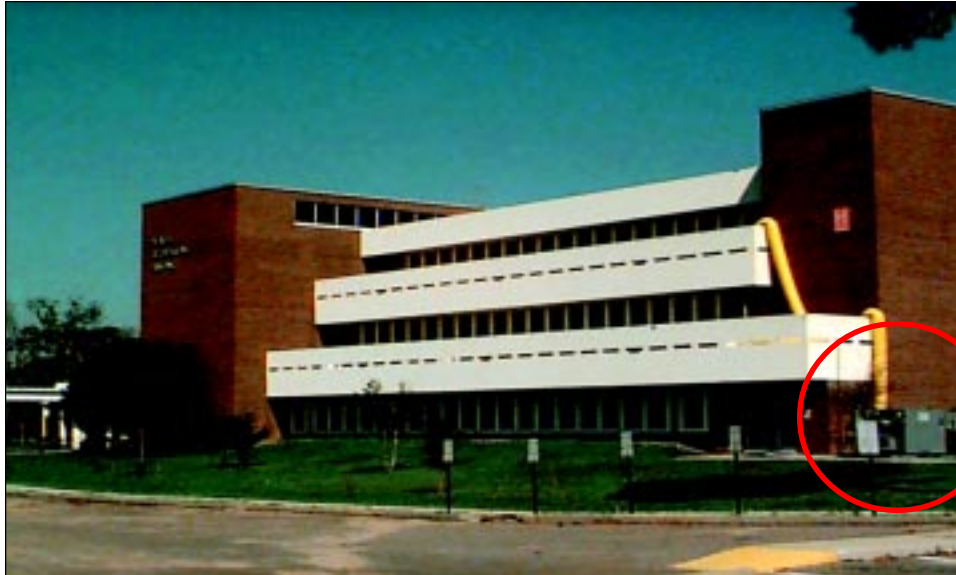
Damage occurred to the roofs of several buildings at the Mississippi Gulf Coast Community College in Gautier. Infiltration of rainwater due to the roof damage resulted in damage to interior areas (Figure 6-19). Loss of roof shingles and damage to signs was evident throughout the area (Figures 6-20 to 6-22).

FIGURE 6-19 Mississippi Gulf Coast Community College in Gautier, where restoration services are underway to dry out interior areas.

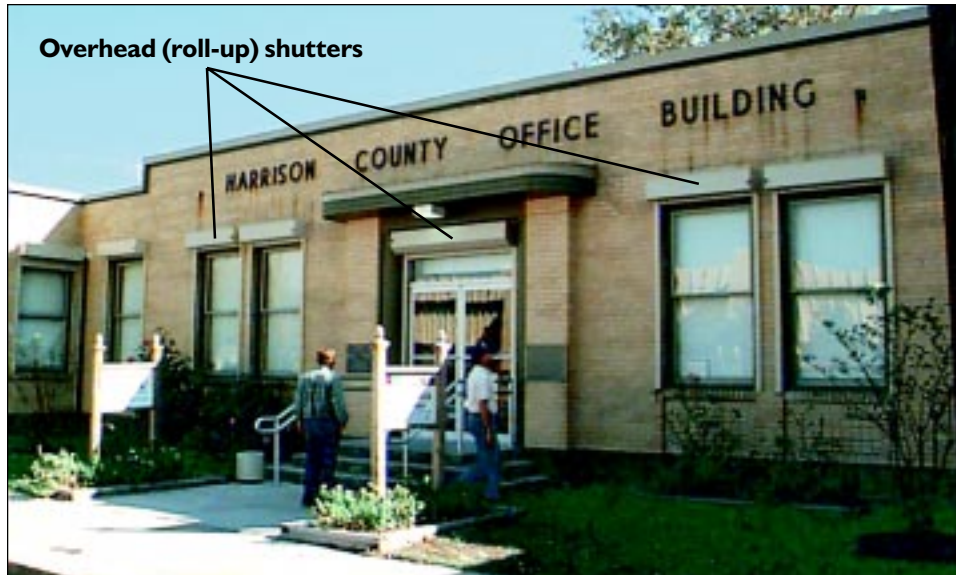
The team assessed the performance of several window and door shutter projects funded under FEMA's HMGP. The shutters were installed on public buildings. While there was little evidence of damage to the windows and doors of buildings from wind loads and airborne debris in the areas where these shutters were installed, it is worth noting that the buildings with shutters showed no damage as well and provided safe and secure shelter during the hurricane (Figure 6-23).

FIGURE 6-23 Window and door shutters on the Harrison County Municipal Building.

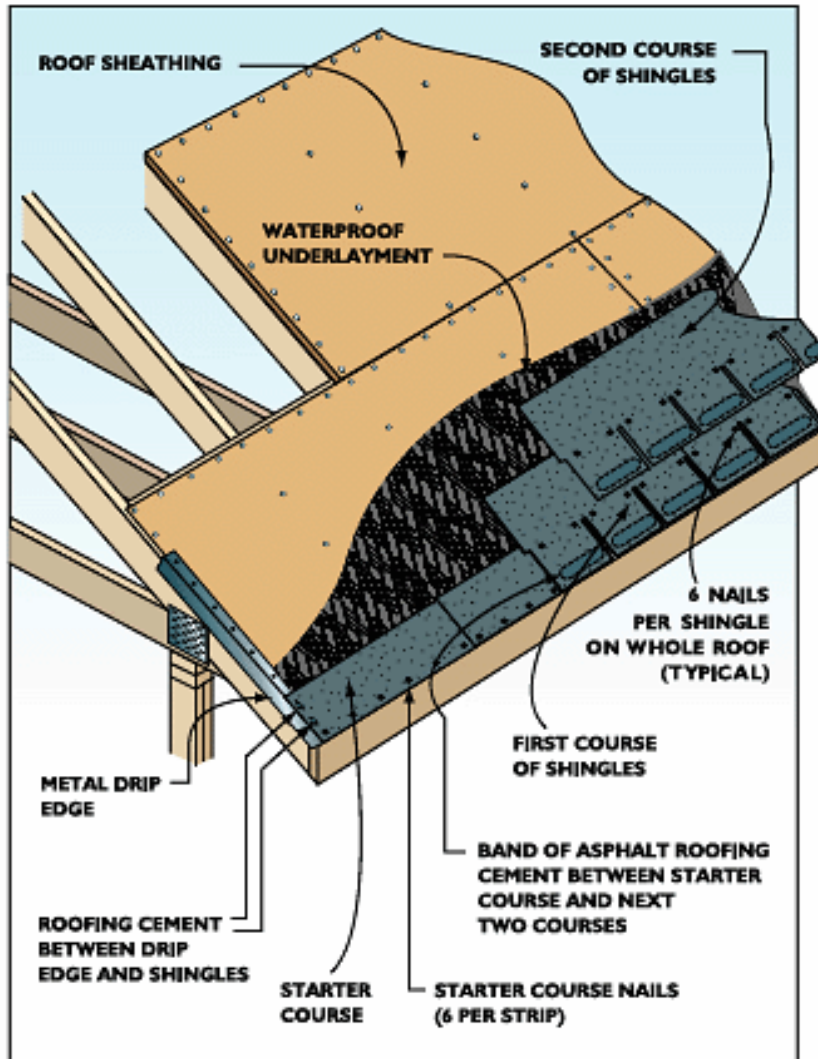
On Dauphin Island, Alabama, the implementation of more stringent local requirements for installation of asphalt/composition roofing shingles resulted in only minimal damage to roofs. The local building code requires that shingles be attached using six nails and mastic on the first two rows of shingles (Figure 7-1). In addition, the local building code requires pile embedments to extend to a minimum of 10 feet below mean sea level (msl) or to a depth equivalent to the height of the lowest floor above msl.

Figure 7-1 Shingle installation technique implemented on Dauphin Island, Alabama.

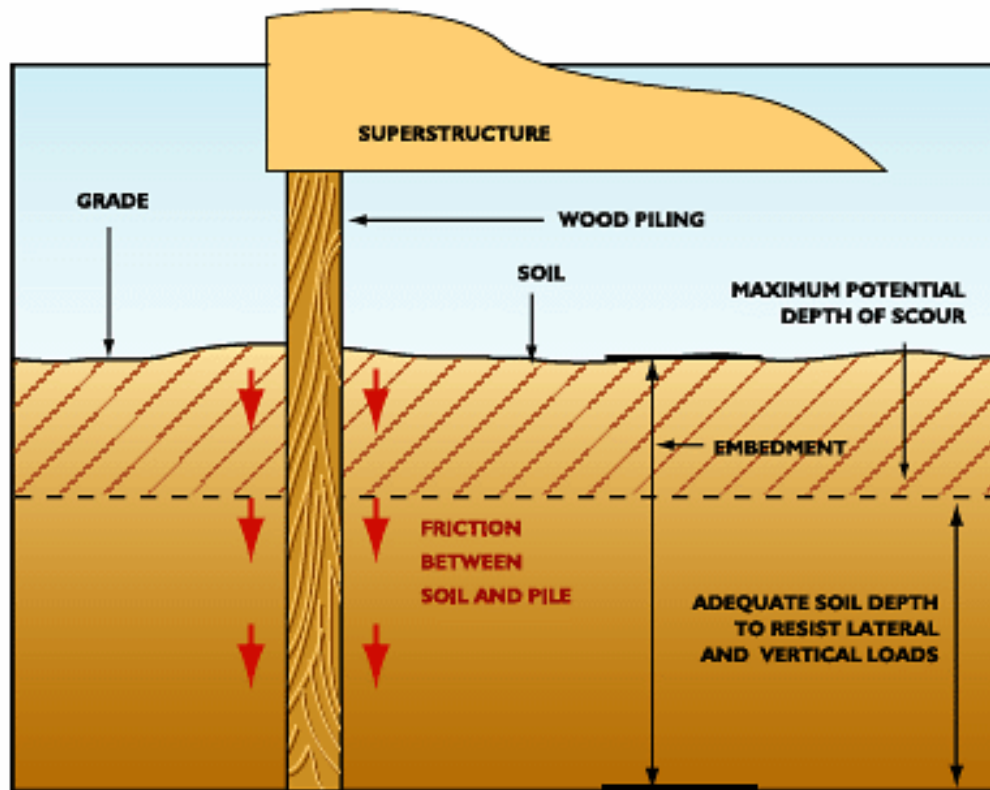
It is important that coastal foundations be designed to survive the anticipated amount of erosion and scour (Figure 7-2). Erosion and scour combine to impact coastal piling foundations in three distinct ways. First, in the absence of crossbracing, the loss of soil adjacent to a thin vertical foundation member, such as a pile, results in a longer unsupported length. The increase in unsupported length allows for greater deflection of the vertical member. Second, the loss of soil adjacent to pilings leaves less soil to counteract lateral loads applied to the pilings by the structure above, the velocity flow of the storm surge, wave action, and debris impact. Third, pilings, which rely on friction between the piling and the adjacent soil to transfer loads into the ground, lose some of the resisting friction when the adjacent soil is eroded and scoured (Figure 7-3). The loss of friction reduces the ability of the piling to resist uplift loads from wind.

FIGURE 7-3 The depth of pile embedment provides stability by enabling the pile to resist lateral and vertical loads through passive earth pressure. Soil depth below maximum potential depth of scour must be adequate to withstand lateral and vertical loads during the base flood.

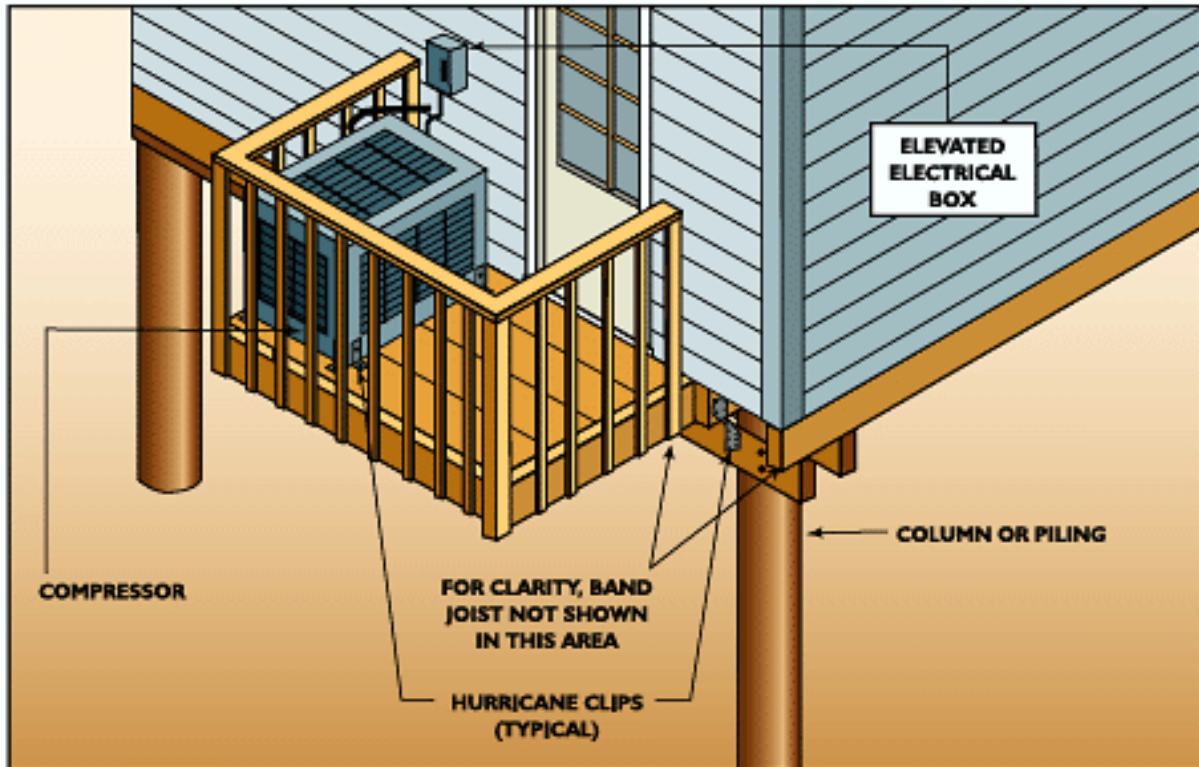
FIGURE 7-4 Cantilevered air conditioner/heat pump compressor platform.

Platforms that support air conditioner/heat pump compressors must be designed to withstand the forces associated with the base flood. In coastal V-Zones, the best way to avoid damage to these platforms is to employ the method used for the protection of buildings — elevation. Therefore, the bottom of the lowest horizontal structural member of the platform should be elevated to or above the BFE. Ideally, air conditioner/heat pump compressor platforms should be cantilevered from an elevated floor diaphragm (Figure 7-4). This design would be most appropriate for structures subjected to coastal storm surge. An alternative is to support the platform partially or completely on piling (Figure 7-5). Note that specific pile embedment depths must be implemented depending upon whether the site is subject to erosion. Vertical foundation members for platforms should meet the same requirements as the main building support system. Air conditioner/heat pump compressors in riverine areas that are not subjected to significant erosion or scour can be reasonably elevated 3 to 4 feet on a solid platform (Figure 7-6).

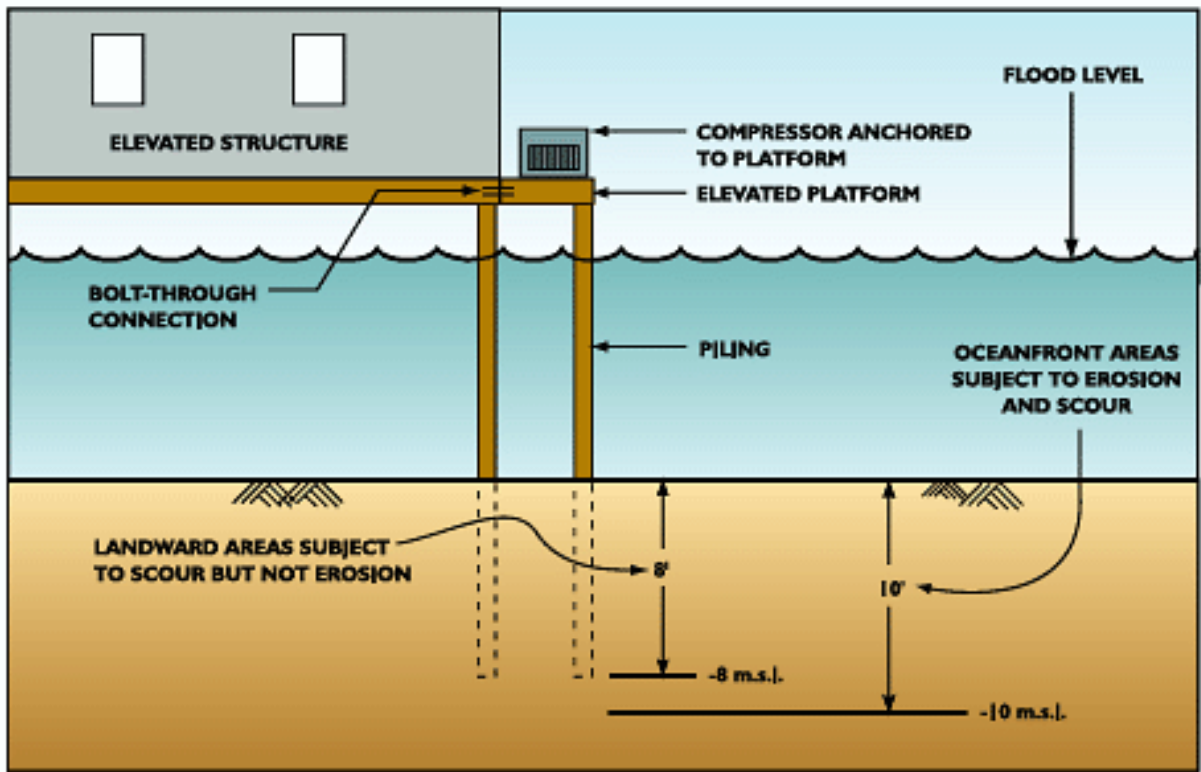
FIGURE 7-5 Air conditioner/heat pump compressor platform supported by pilings.

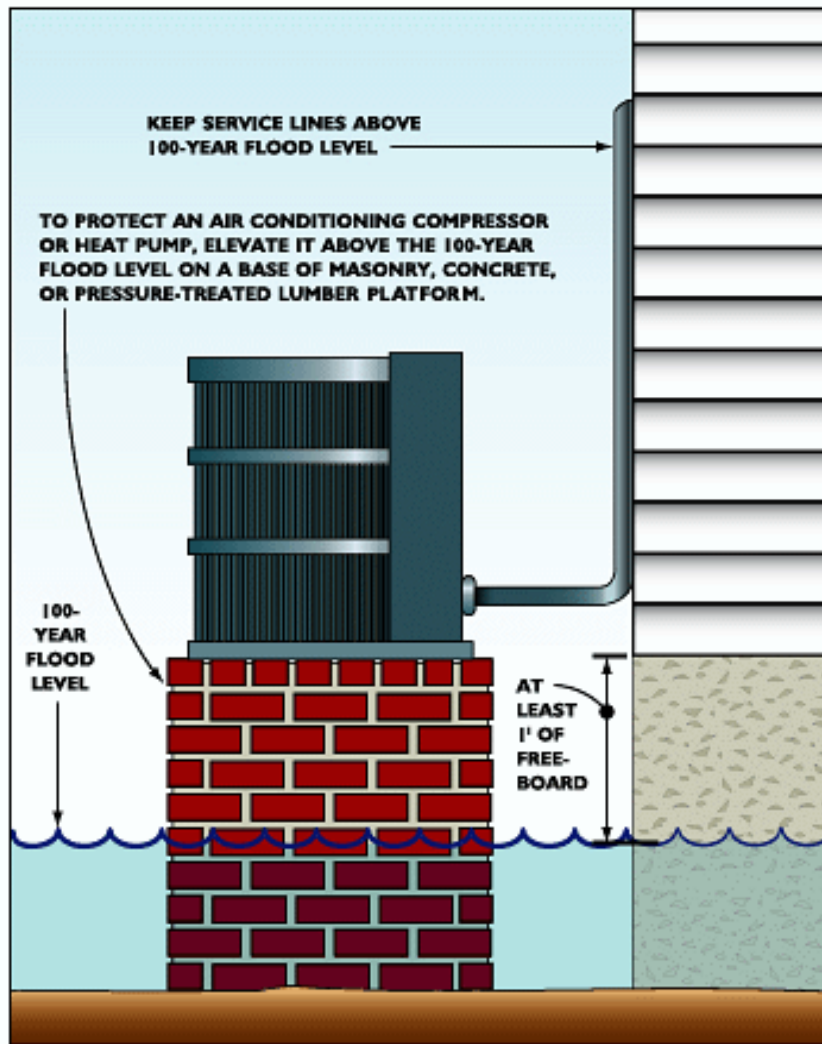
FIGURE 7-6 Elevated air conditioner/heat pump compressor in an A-Zone area not subject to significant velocity flow and debris impact.

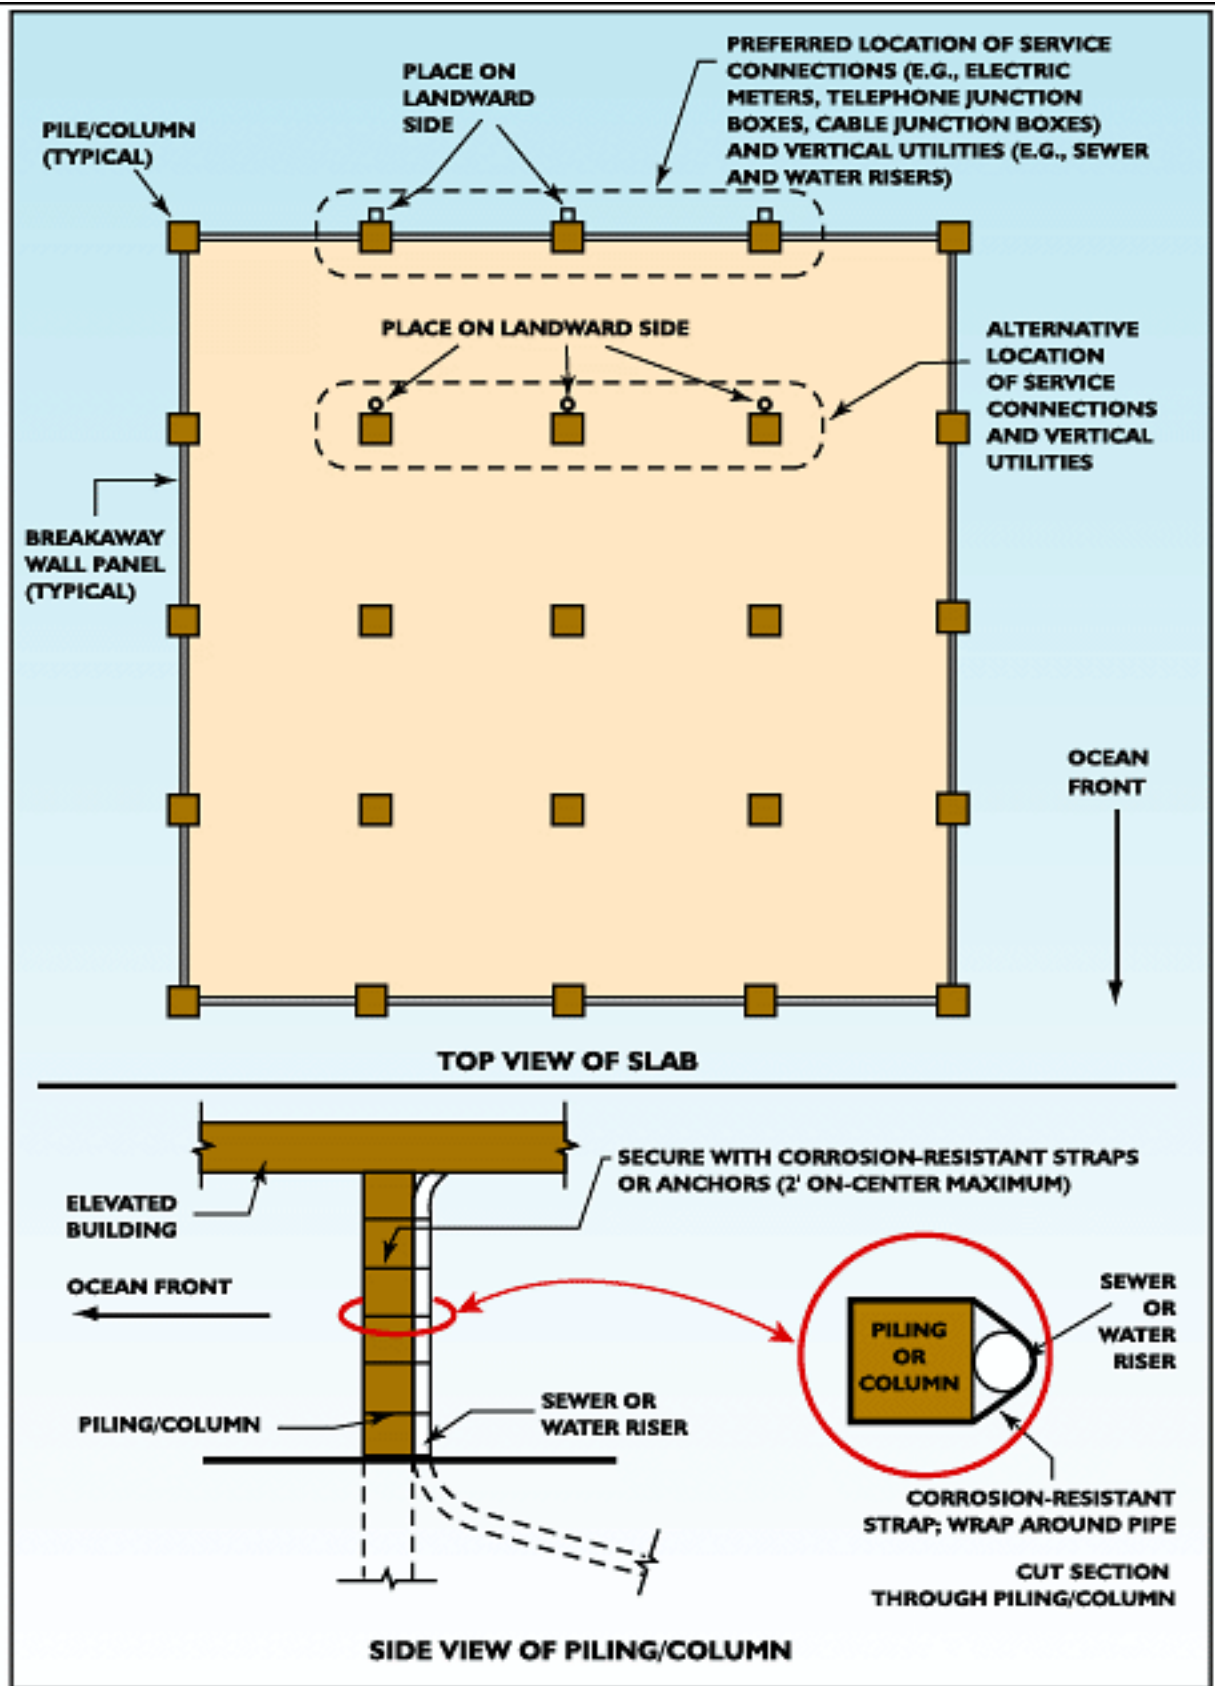
FIGURE 7-7 Proper location of utilities.

Utilities installed on the landward side of vertical foundation members are shielded by the foundation members against damage from velocity flow and debris impact. Service connections such as electrical meters, telephone junction boxes, and cable junction boxes that must be exposed to flooding should be placed on the landward side of the most landward vertical foundation member (Figure 7-7). Vertical utilities such as sewer and water risers should also be placed on the landward side of vertical foundation members.

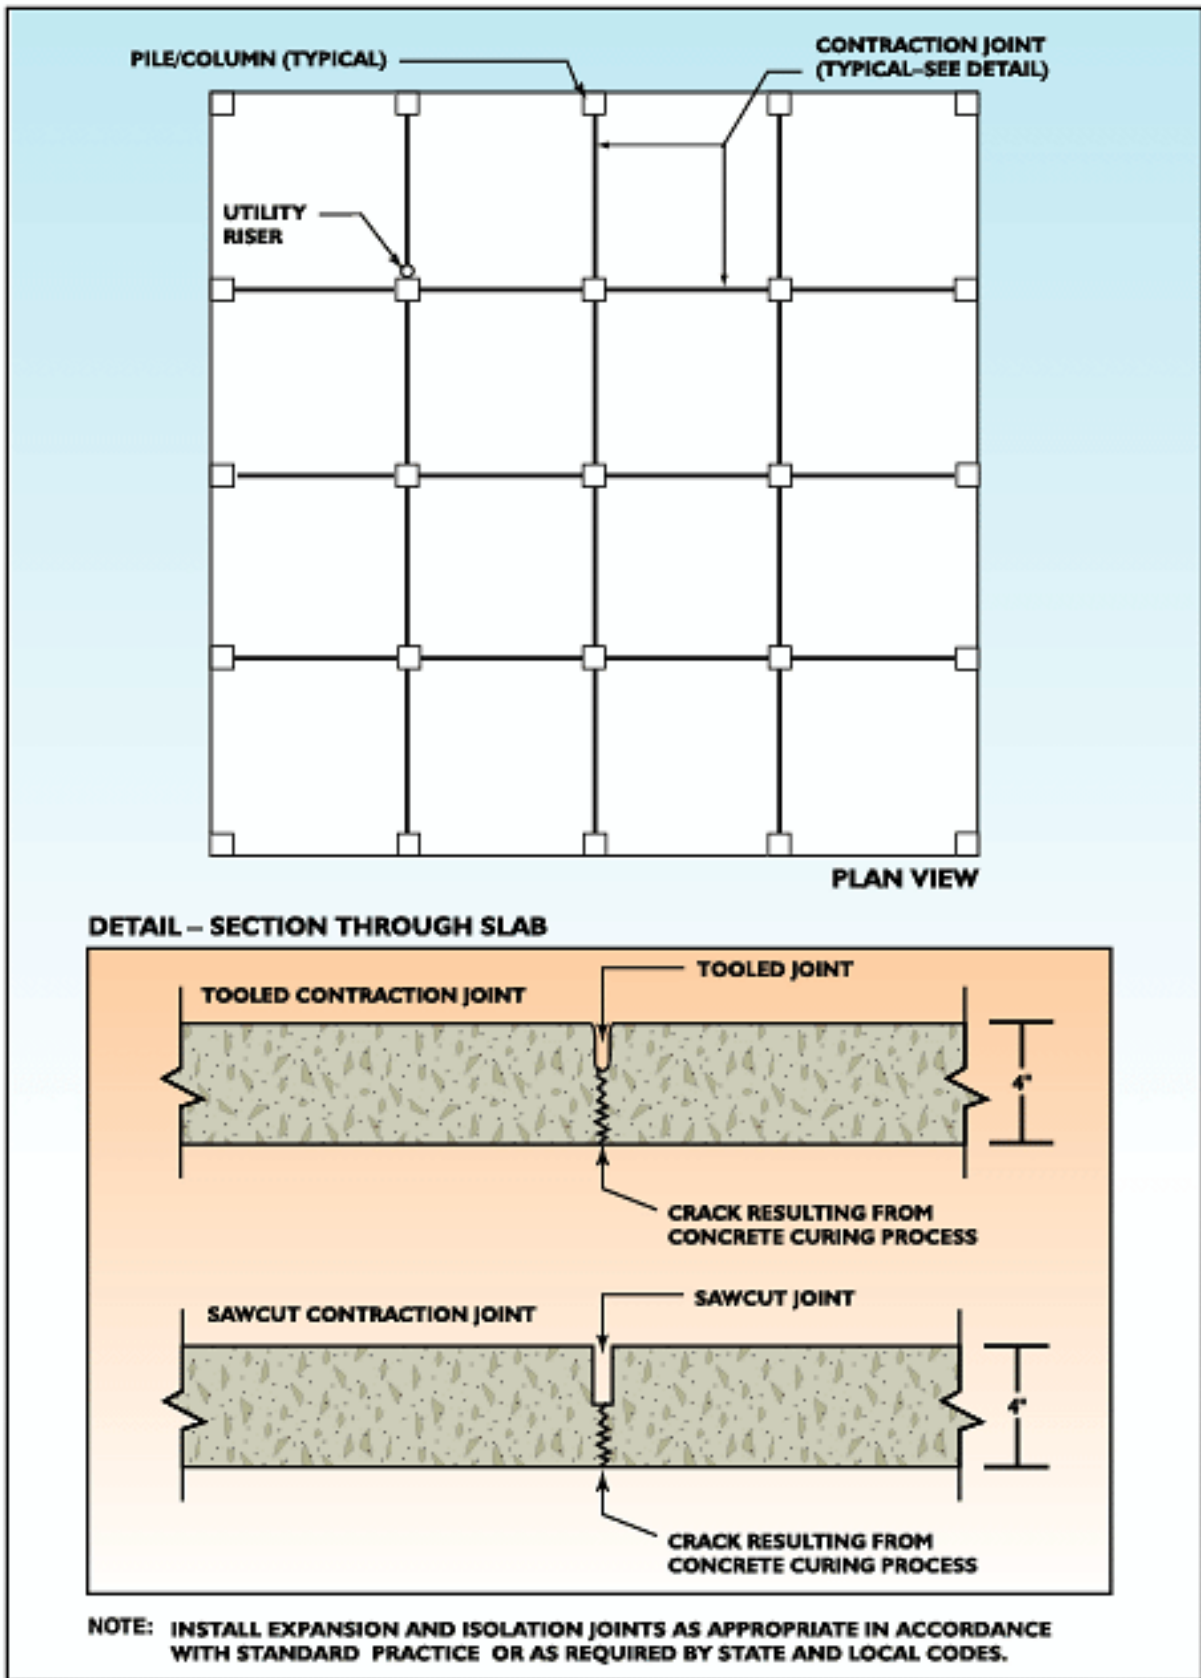
When a slab-on-grade is constructed below an elevated building in a coastal area subject to wave action, it should be designed and constructed in such a way that it will not damage the building foundation when acted on by flood forces (Figure 7-8). Issues requiring special consideration include the thickness of the slab, slab joints, and construction practices that are not appropriate for coastal flood hazard areas subject to erosion and scour:

FIGURE 7-8 Recommended contraction joint layout for frangible slab-on-grade below elevated building.

- **Slab joints** - Contraction joints are the most important for ensuring the fragility of below-building slabs. As shown in Figure 7-8, contraction joints should be cut into the surface of the slab from piling to piling in both directions across the entire slab. Expansion and isolation joints should be installed as appropriate in accordance with standard practice or as required by State and local codes.

- **Casting concrete grade beams and slabs-on-grade monolithically** - Grade beams and slabs-on-grade should never be cast monolithically in areas subject to erosion and scour. In these areas, grade beams must be designed to be self-supporting (to account for the loss of supporting soil from erosion and scour) and to withstand velocity flow and debris impact as well as stiffen the foundation system. All slabs-on-grade must be designed to act separately from grade beams.

- **Concrete collars** - In areas subject to erosion and scour, concrete collars should not be placed around foundation pilings.

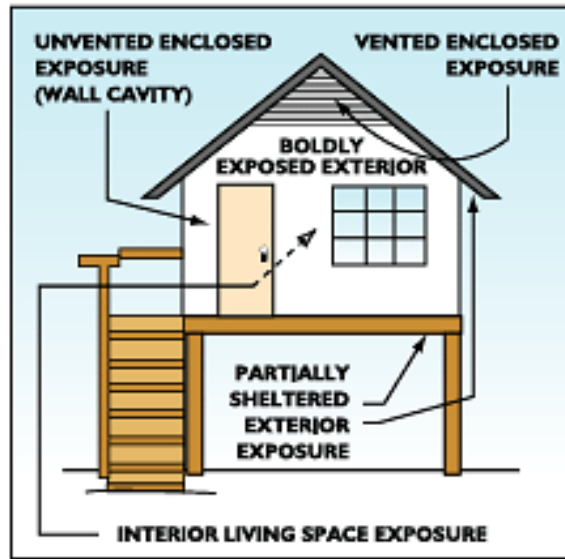
For many connector applications in corrosion-prone buildings, the use of corrosion-resistant materials is the best choice for new construction. The choice of alternative connector material or coating specifications should be guided by the location of the building relative to the observed corrosion hazards in each community and by the class of exposure in the building (Figure 7-9). Recommended materials for a typical community are listed in Table 7-1.

FIGURE 7-9 The locations of the five classes of exposure.

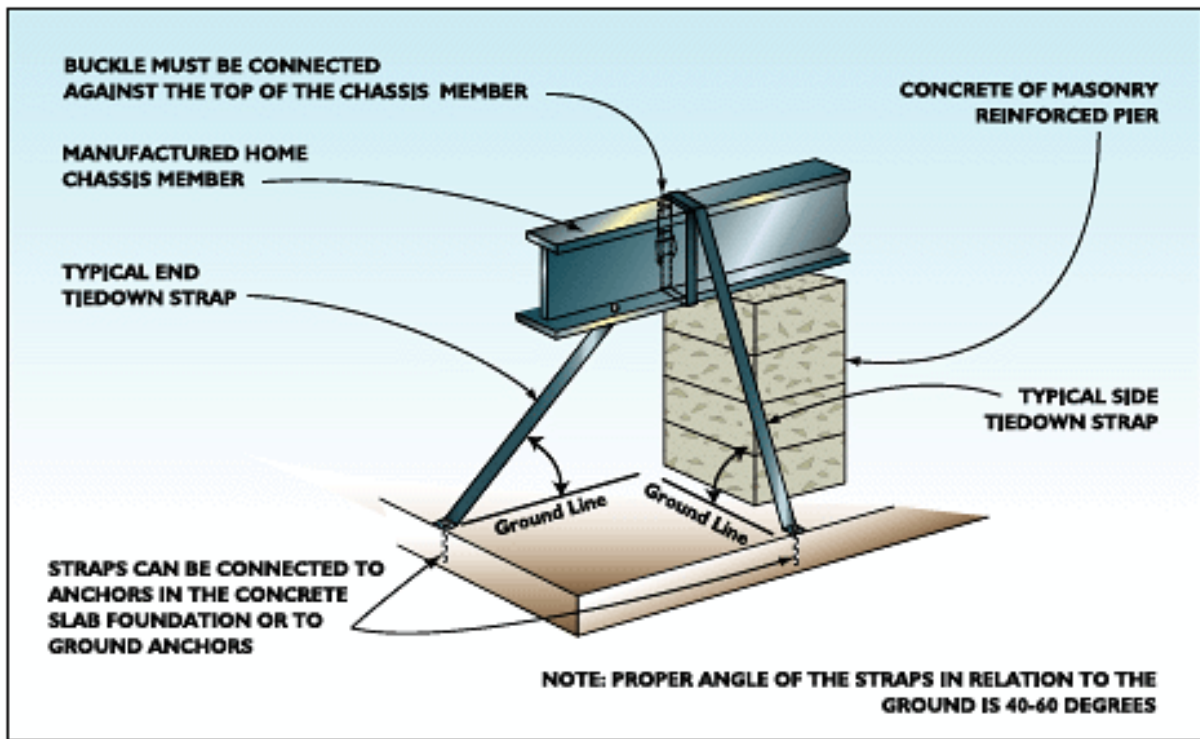
Manufactured homes in SFHAs must be placed on foundation systems that will resist flotation, collapse, and lateral movement. There are several ways to anchor the homes to these foundation systems. The support chassis of the home can be connected directly to the reinforced concrete or masonry piers by using metal "L" brackets or the home can also be anchored using straps. It should be noted that anchoring using straps would not be appropriate for homes elevated more than 3 to 4 feet where an engineered, permanent foundation may be required. Figure 7-10 shows the attachment of typical anchoring straps. Anchoring straps can be connected to the chassis by being wrapped around the support beam or the straps can be bolted to the support beam. The straps are connected to the ground by attaching to anchors encased in the concrete foundation or by attachment to earth auger or cross drive rock anchors.

FIGURE 7-10 Typical manufactured home anchoring straps.

Chassis configuration varies among manufactured home manufacturers. Installation in a SFHA area may require manufactured homes to be installed on permanent, engineering foundations. Therefore, selection and installation of all anchoring systems must be performed in accordance with the manufacturer's installation instructions and/or engineered design criteria. In addition, anchoring straps must be properly installed by a qualified installer and in accordance with the strap manufacturer's installation instructions. As mentioned earlier straps may not be appropriate if the home is elevated more than 3 to 4 feet. Straps must also be properly tensioned and require periodic maintenance to ensure that proper tension is maintained. For these reasons it is preferred that the manufactured home be connected directly to the support piers using metal connectors. Any metal connectors used should be adequately protected from corrosion. Finally, metal connectors used in anchoring systems must be adequately protected from corrosion.
