U.S. CHEMICAL SAFETY AND HAZARD INVESTIGATION BOARD

# INVESTIGATION REPORT

## DUST EXPLOSION

**WEST PHARMACEUTICAL  
SERVICES, INC.**

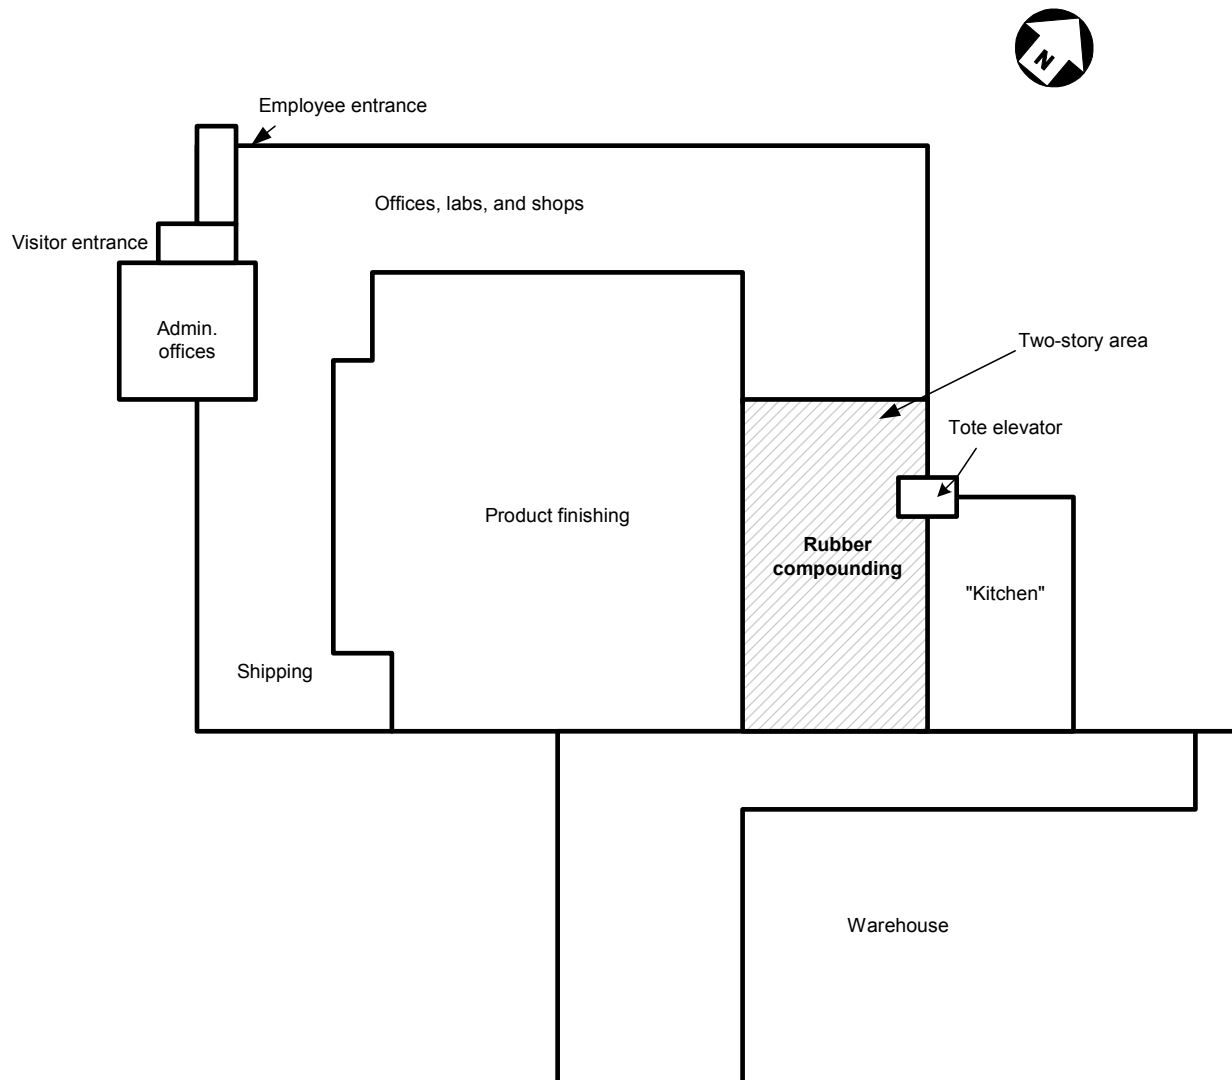
**Figure 1. Layout of West Pharmaceutical Services Kinston facility.**

Fires developed throughout the facility. The explosion broke feeder lines to the fire sprinkler system, disabling it. The largest and most persistent fire—which burned for 2 days—developed in the warehouse (Figure 1) and involved the large volume of stored baled and strip rubber. Some of the rubber continued to smolder and flare up for about a week.

Rubber and other raw materials were stored in a warehouse southeast of the kitchen and compounding area (Figure 1). The thermal effect from the explosion likely reached this area, igniting incipient fires. Eventually, the entire warehouse was fully engulfed in flames. Heat from the fire caused most of the steel framing to yield and collapse.

West stored mineral oil—a Class IIIB combustible liquid—in two 7,000-gallon plastic tanks and two 300-gallon plastic tanks located inside the building, near the warehouse (Figure 1). The tanks were surrounded by dikes constructed of concrete masonry units. However, because the tanks were installed before North Carolina adopted IFC, there was no legal requirement for West to seek approval of the local authority.
