I-70 Overpass Beam Failure Lakeview Drive Bridge

Washington County, PA

NHI Real Solutions Seminar *July 2008*

**Field Inspection and Forensic Investigation
of the
SR 1014 Lake View Drive Bridge
over
Interstate 70**

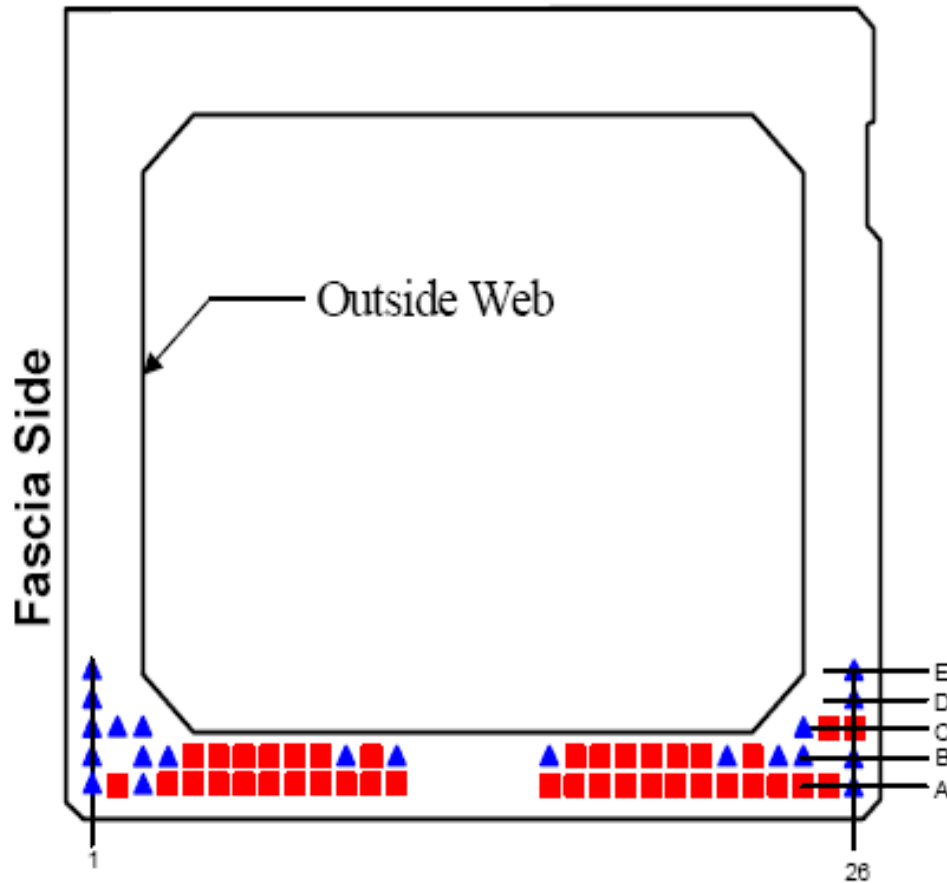
Forensic Evaluation of Materials

■ Primarily Corrosion Failure

▲ Primarily Overstress Failure

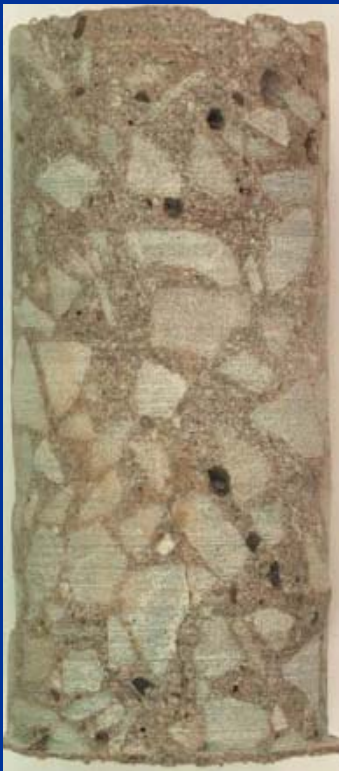
Concrete Strength f'_c

Tested concrete and prestressing strands met the design criteria

Design:
5900 psi

Measured:
6200 psi min
8400 psi max

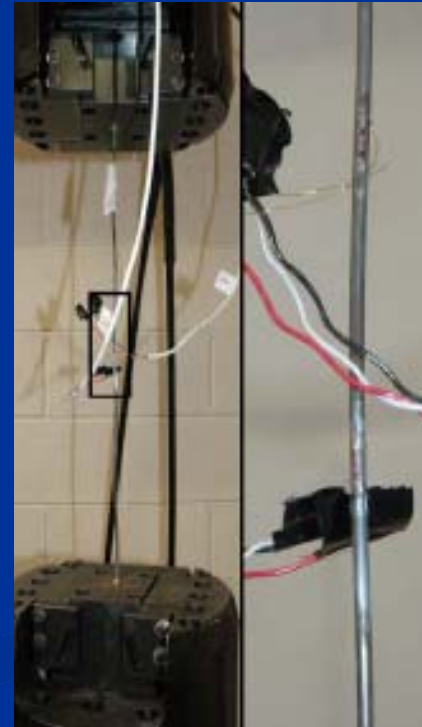
Strand Strength F_y

Design:
250 ksi

Measured:
276.6 ksi

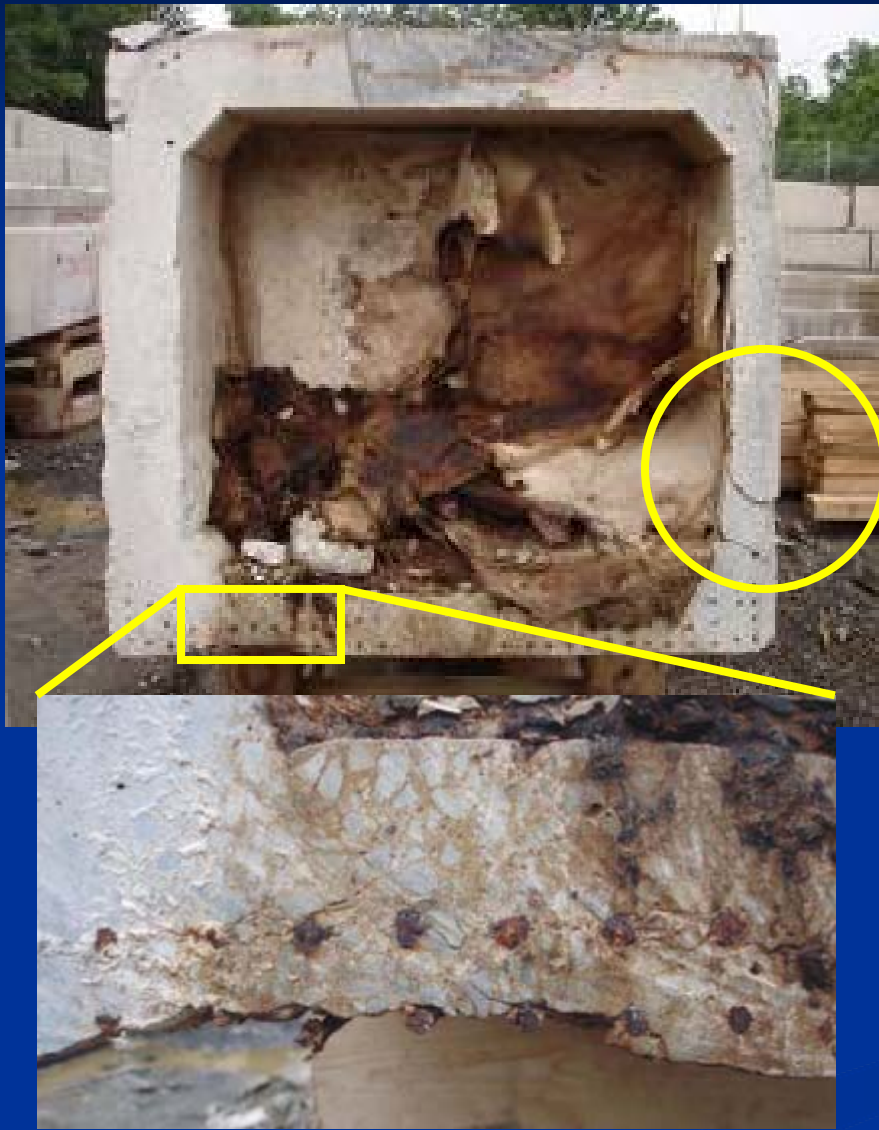
Unforeseen Fabrication Problems

- Bottom flange thickness
- Bottom concrete cover
- Wall thickness
- Lateral post-tensioning tie rods and shear keys
- Vent holes and drain holes
- Prestress Loss

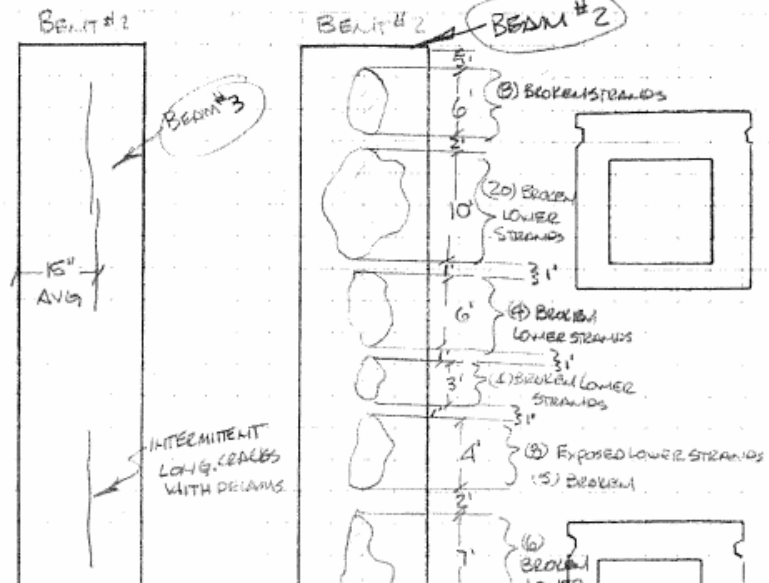
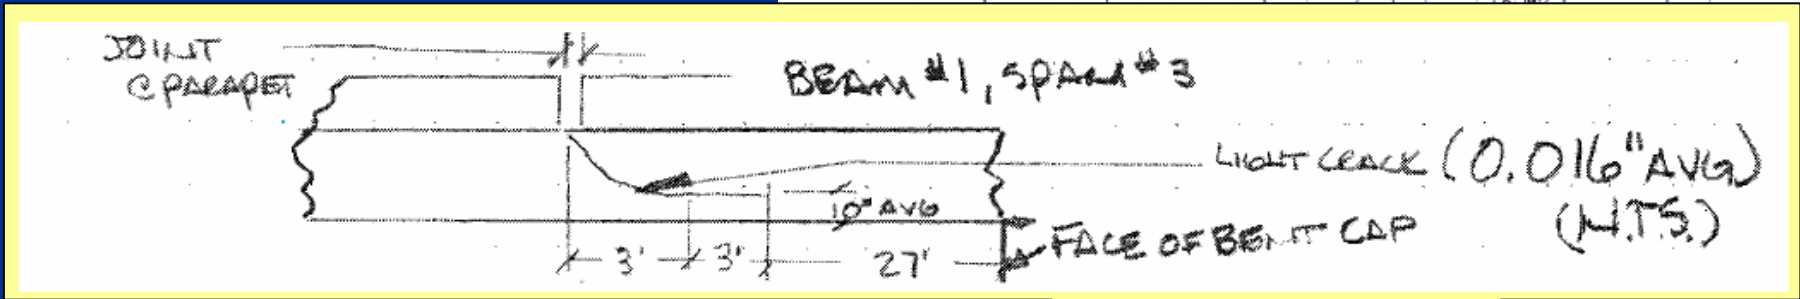
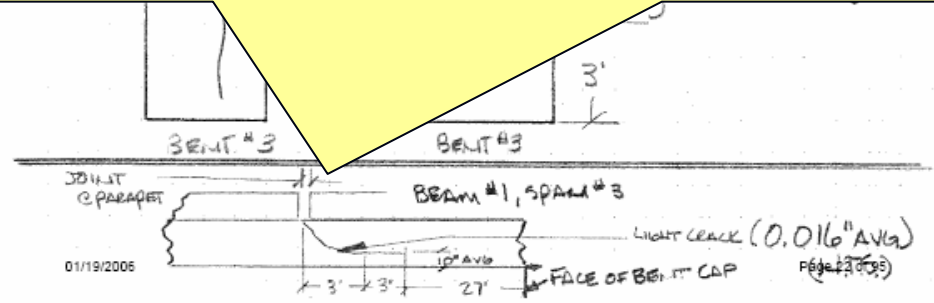
CD 62
S.R. 4049
SEQ. 0030 OFFSET 1265
SUBJECT PRE-STRESSED BEAM
Span #3 / #3 AND #2
SHEET NO. 3 OF 6
BY JAC/CLK
DATE
CHKD BY
DATE

Cracking Near Barrier Joints
