U.S. Department
of Transportation
**Federal Railroad
Administration**

Documentation of Deformation from Passenger Rail Two-Car Impact Test

DOT/FRA/ORD-03/08

Final Report
November 2003

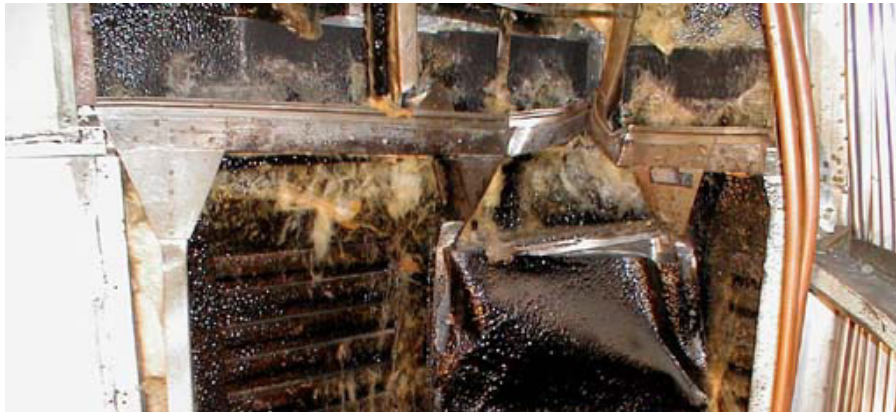
Figure 20. Left-side Cant Rail Between Window Frame (left) and Bulkhead Wall (right)

Like the side sills, the cant rails of the two-car test suffered more damage than in the single car test. However, unlike the side sills, the response of both sides was largely symmetric. As shown in Figure 18, the left side cant rail buckled out about 12 inches (0.305 m), which reduced the length by 13 inches (0.330 m). Similarly, Figure 19 shows that the right-side cant rail buckled outward 8 inches (0.203 m), reducing the length by 13 inches (0.330 m) as well. The right-side cant rail exhibited more longitudinal crush than the left and, therefore, buckled out slightly less. The corresponding inside view photographs of the left and right-side cant rails are shown below in Figure 20 and Figure 21, respectively.

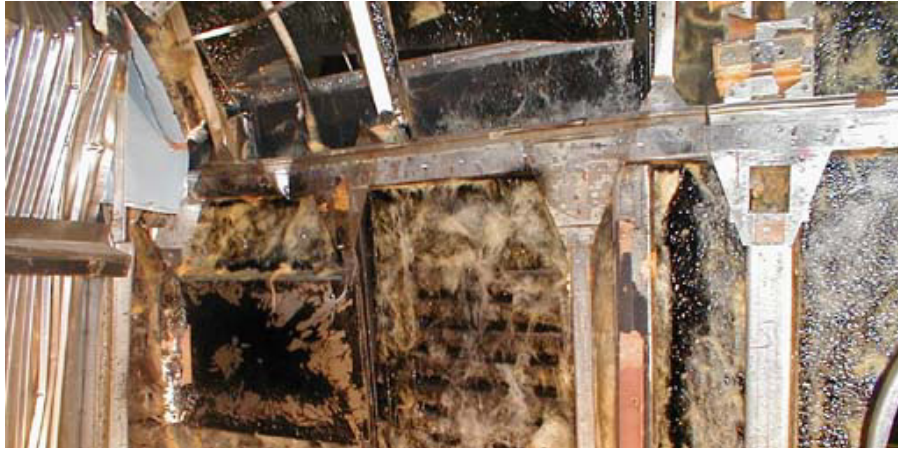
Figure 21. Right-side Cant Rail Between Window Frame (right) and Bulkhead Wall (left)

Figure 18 and Figure 19 show that both right and left side cant rails developed fractures just forward of the window frame. The fractures developed at a point of high bending stress as the sidewalls aft of the bulkhead buckled out and the stiffer window frame sections remained straight. A close-up photograph of the fracture on the right-side cant rail is shown in Figure 22. It appears that the crack runs through a spot weld, at which there was probably a stress concentration that initiated the failure. The fracture on the left side cant rail was nearly identical in character and location.

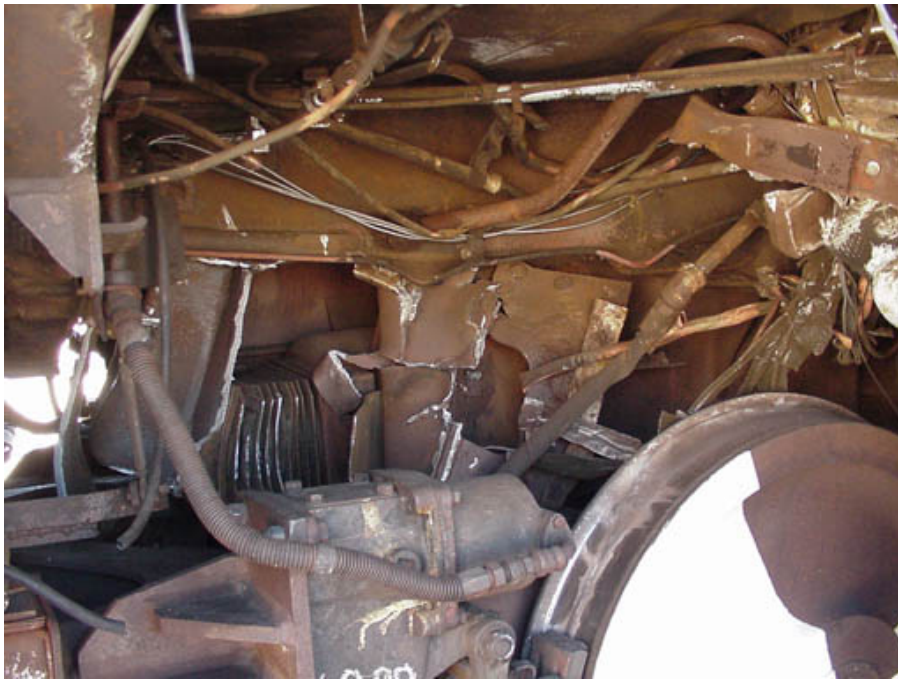
Figure B1-2. Right Side of Draft Sill Just After Test—Prior to Any Material Removal

The right side of the aft draft sill folded back on itself and fractured off from the forward section, as the forward part was driven down and back. This fractured section is noted in Figure 4 above (note the right side is shown on the left side of the sketch since it is viewed from below) and may also be seen in Figure 5. The fractured welds and torn steel surfaces in Figure 5 appear as light gray lines, in contrast to the otherwise rust-colored steel.

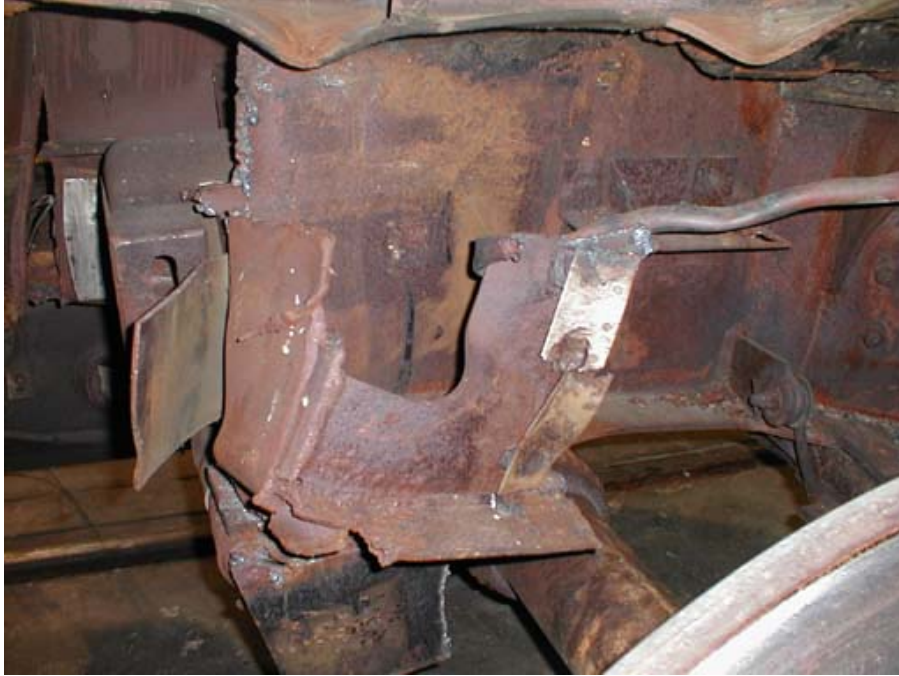
Figure B1-7. Draft Sill Collapse Detail with Truck Attached, From Right Side (note pilot attachment hardware aft and below center line of front axle)

Also seen in the figures and sketches is the bent pilot attachment hardware, attached to the bottom of the draft sill below the draft gear. Prior to the detailed postmortem some material was cut away from this component as well and was not available for inspection. The post-test inspection of the pilot attachment hardware found evidence of interaction with the front axle on the forward truck. Normally, this hardware would sit well above and forward of the axle but, as the draft sill collapsed, it was driven down and rode over and behind the axle. Figure 11 shows a detailed photograph of the mark made on the pilot attachment hardware by a drive gear on the most forward truck axle.

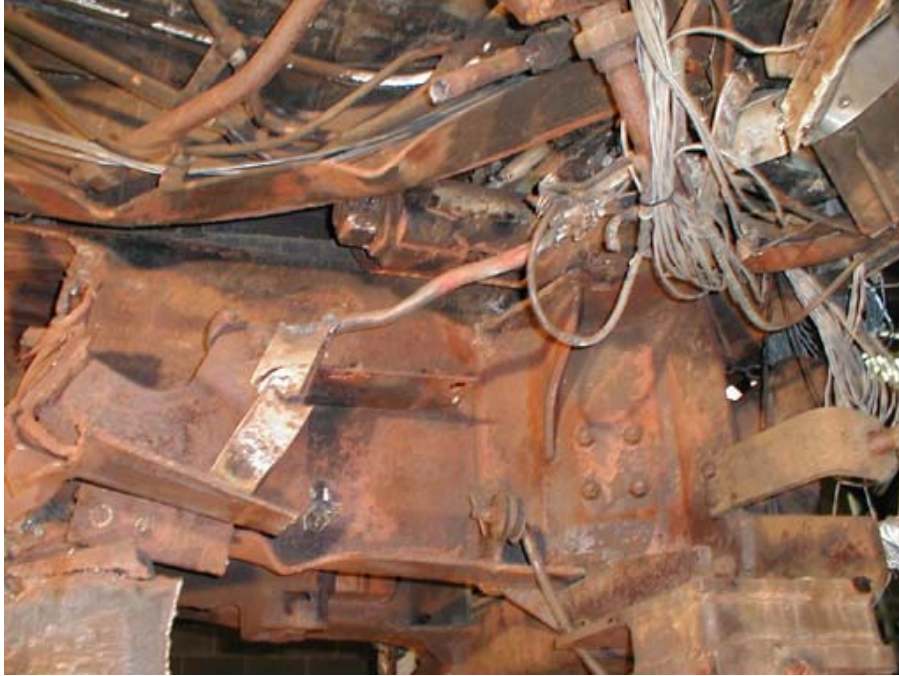
Figure B1-11. Forward Draft Sill, from Right Side Looking Slightly Upward

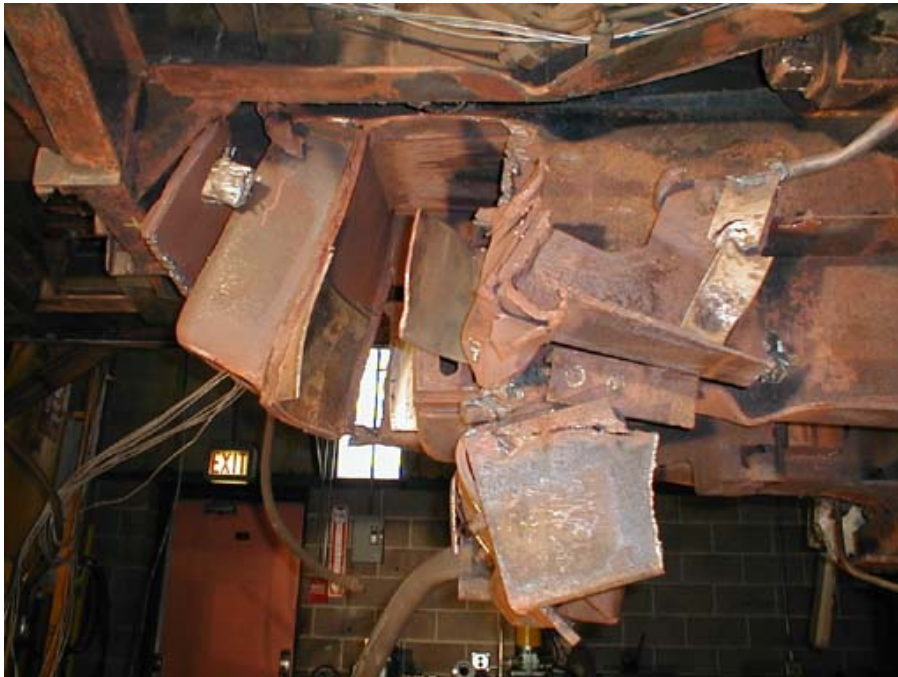
Figure B1-12. Aft Part of Draft Sill and Body Bolster Connection, from Right Looking Slightly Upward

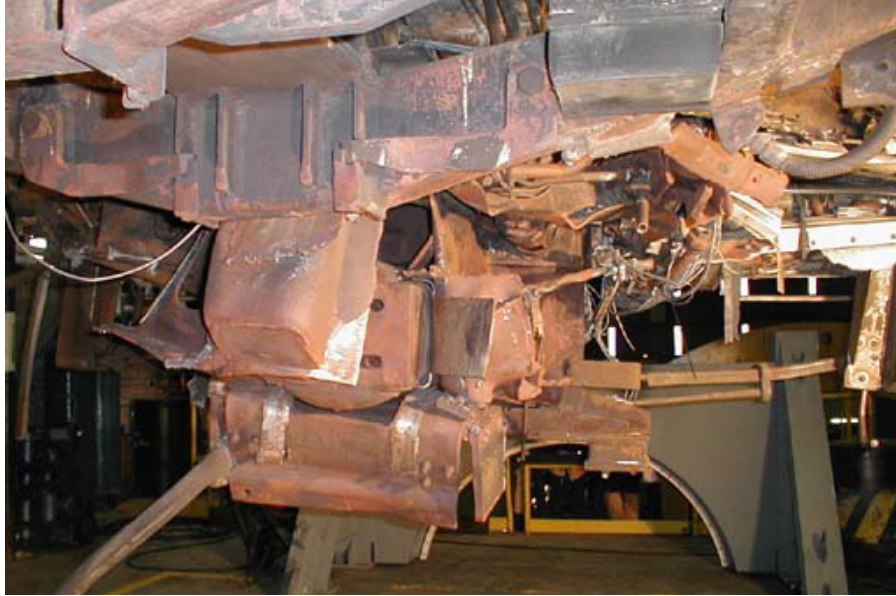
Figure B1-13. Draft Sill Collapse from Behind, Slightly on Right Side, Aft Looking Forward

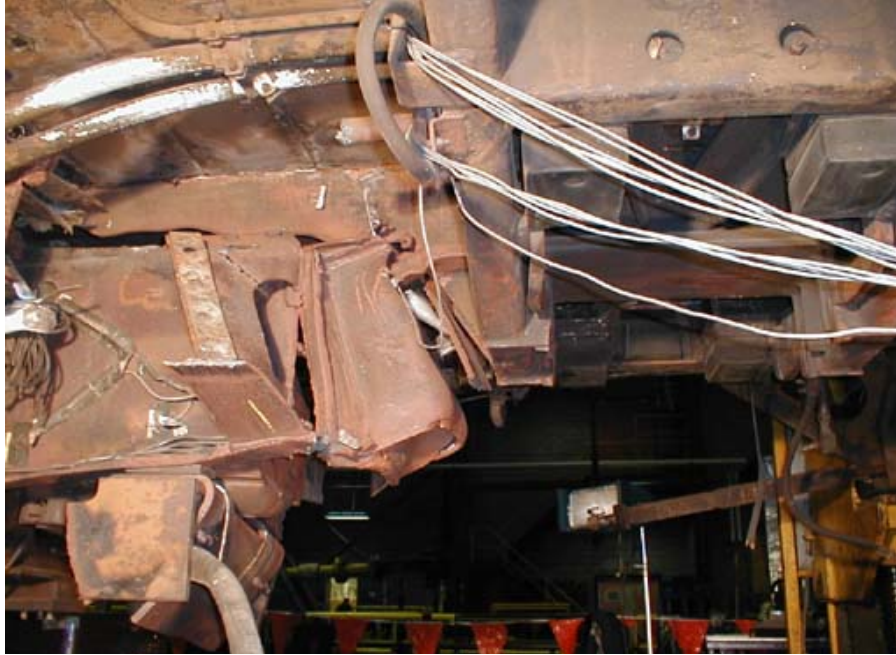
Figure B1-15. Aft Part of Draft Sill and Body Bolster Connection, from Left Looking Slightly Upward

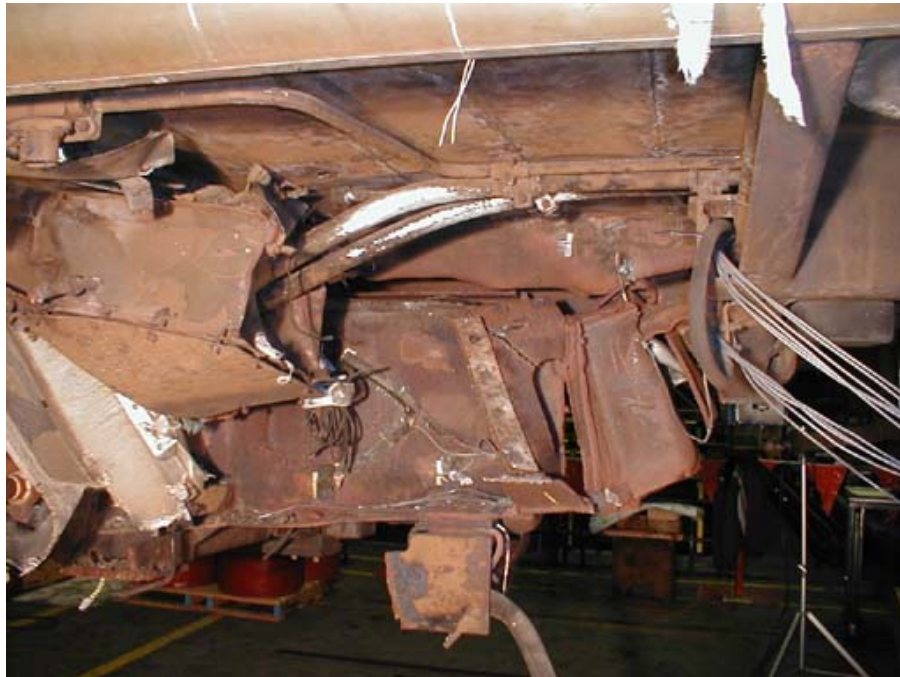
Figure B1-16. Left-side Draft Sill Between Body Bolster and Vestibule Wall Bolster

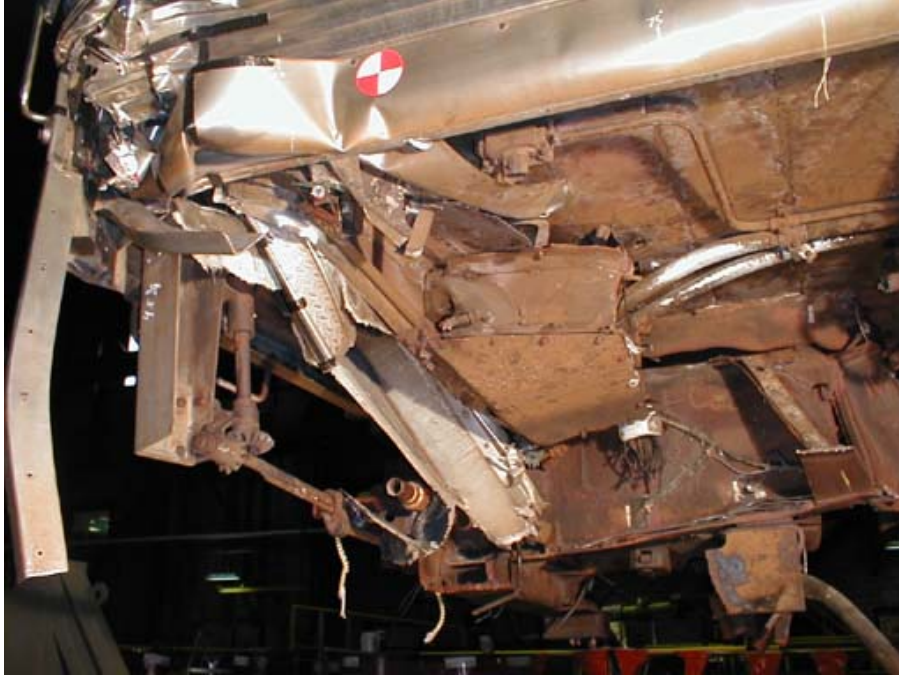
Figure B1-17. Front Draft Sill Collapse, Left Side

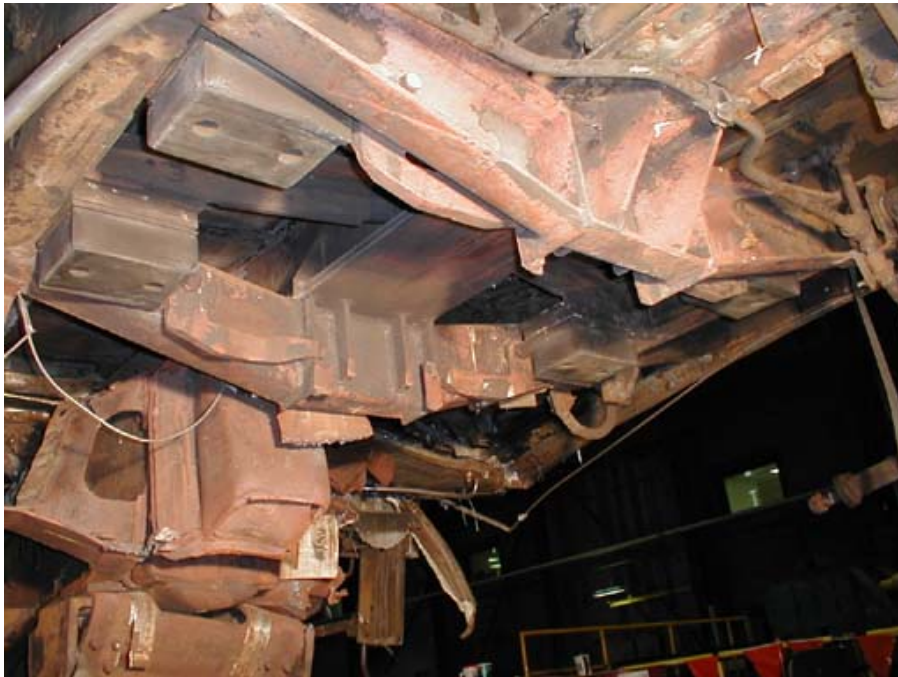
Figure B1-18. Detail of Body Bolster Without Bolster Beam. Aft Looking Forward from Left Side

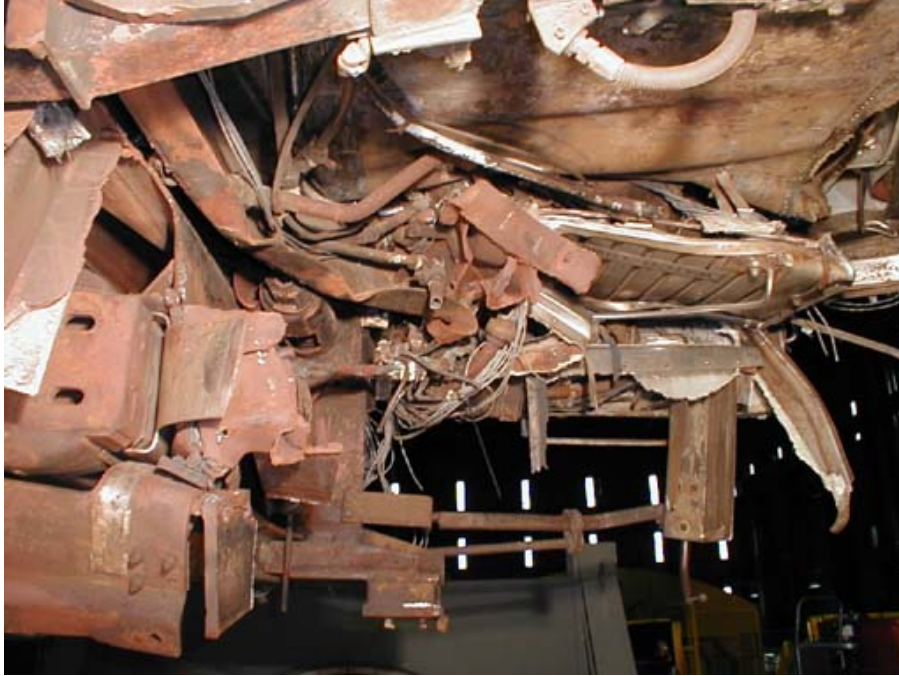
Figure B1-19. Right-side Draft Sill Collapse and Forward Underframe Before Removing Trap Door, Aft Looking Forward

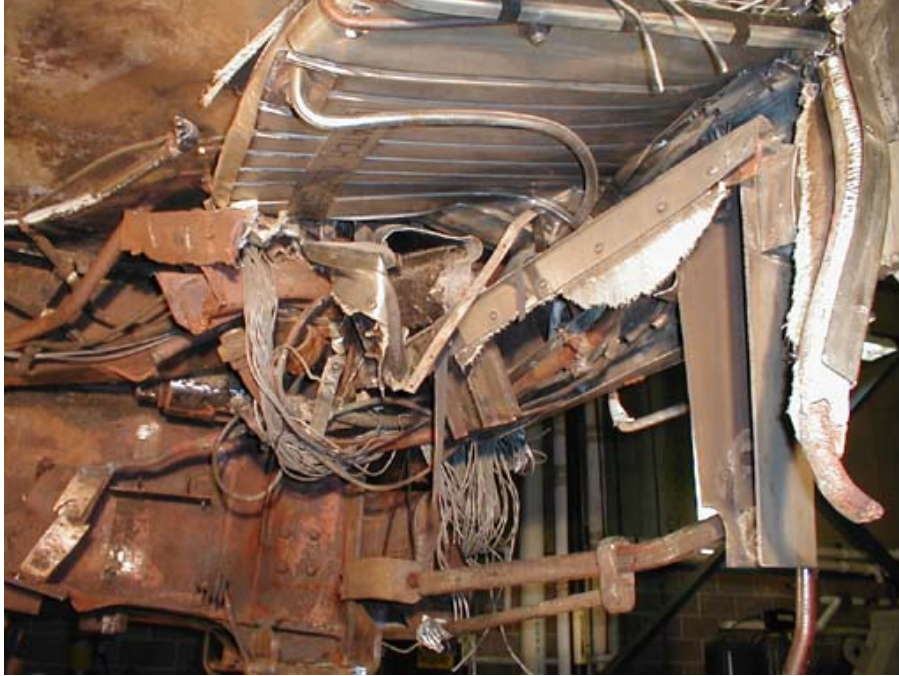
Figure B1-21. Right-side Forward Draft Sill and Underside of Floor Prior to Removing Trap Door

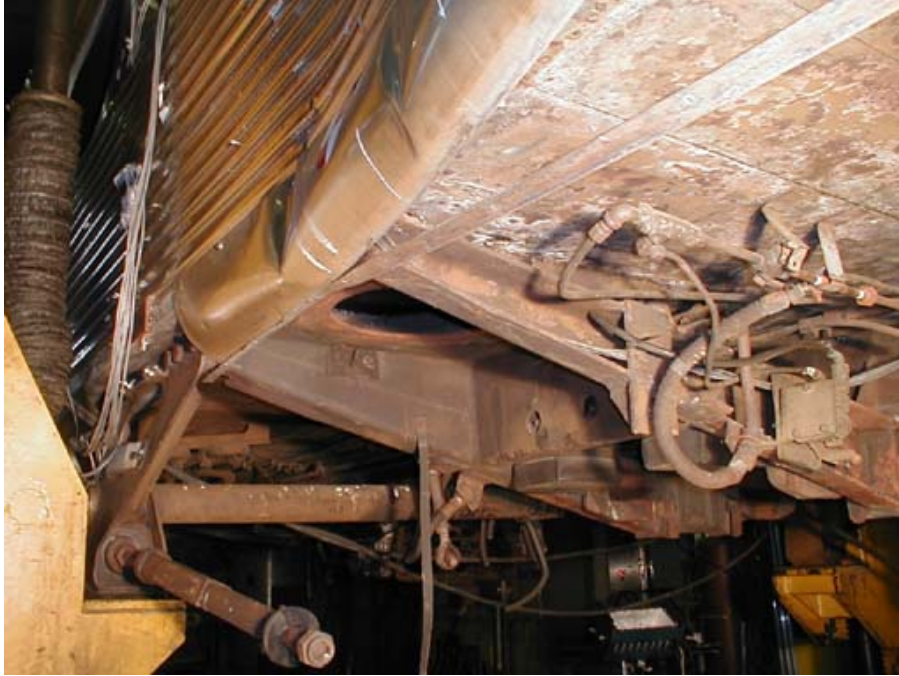
Figure B1-23. Right-side Bolster Beam Detail Showing Two Small Buckles, Forward Looking Aft

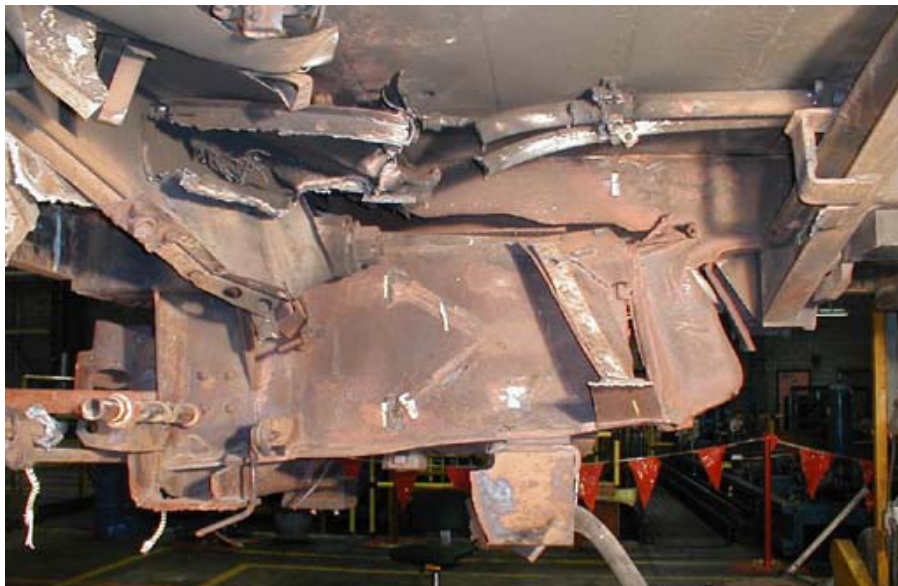
Figure B1-24. Left Side of Draft Sill After Material Removal

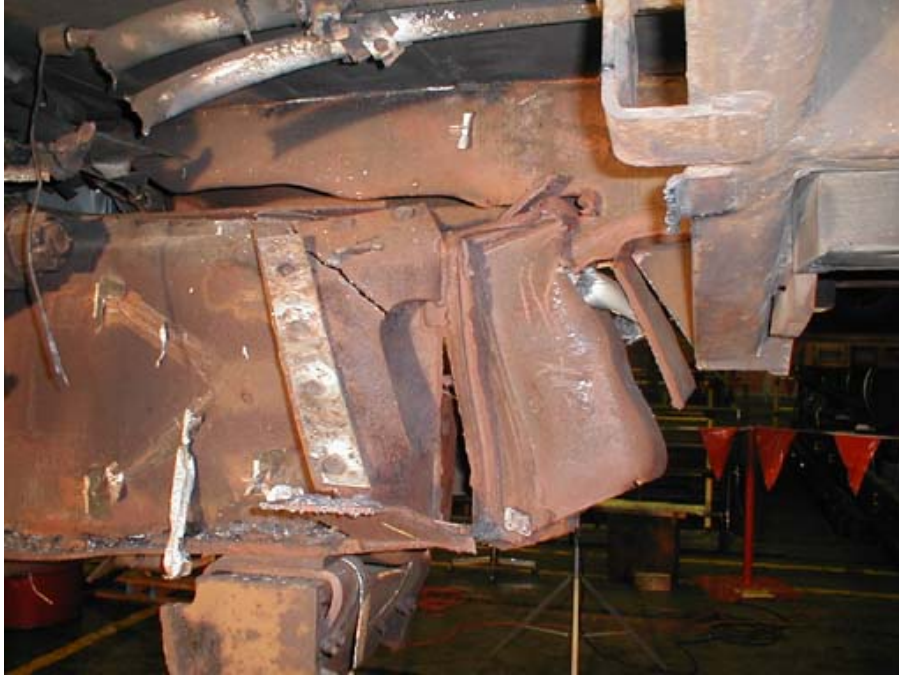
Figure B1-25. Left Side of Draft Sill - Impact of Buff Stop Against Body Bolster

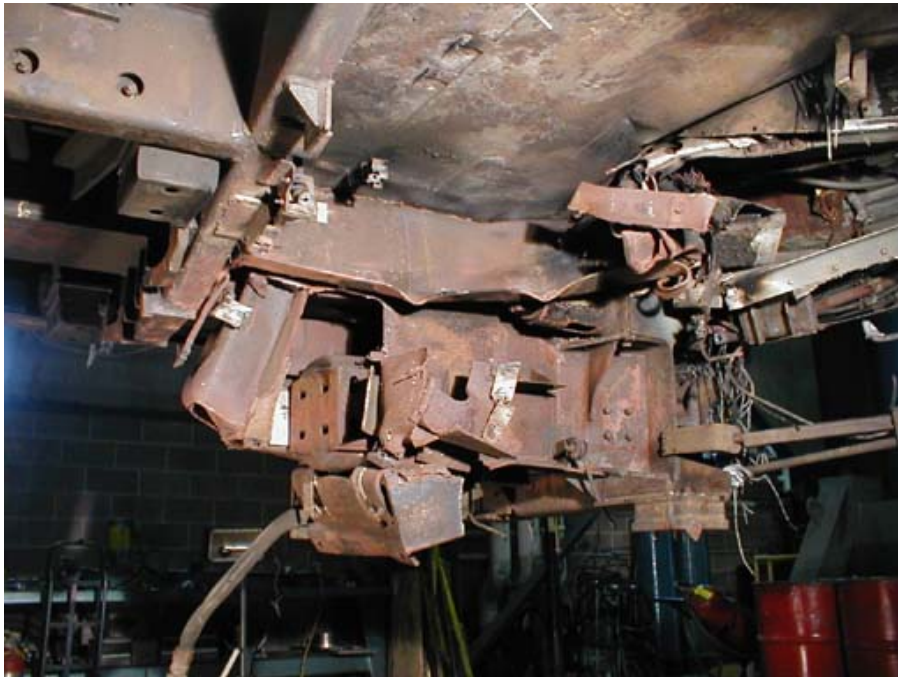
Figure B1-26. Draft Sill - Right-side Deformations

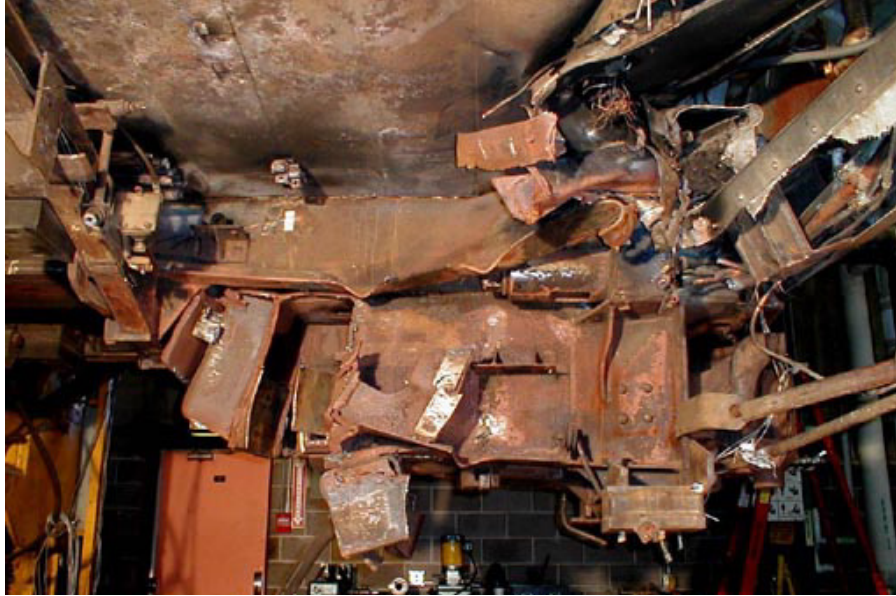
Figure B1-27. Right-side Draft Sill, From Side, After Non-Structural Material Removal

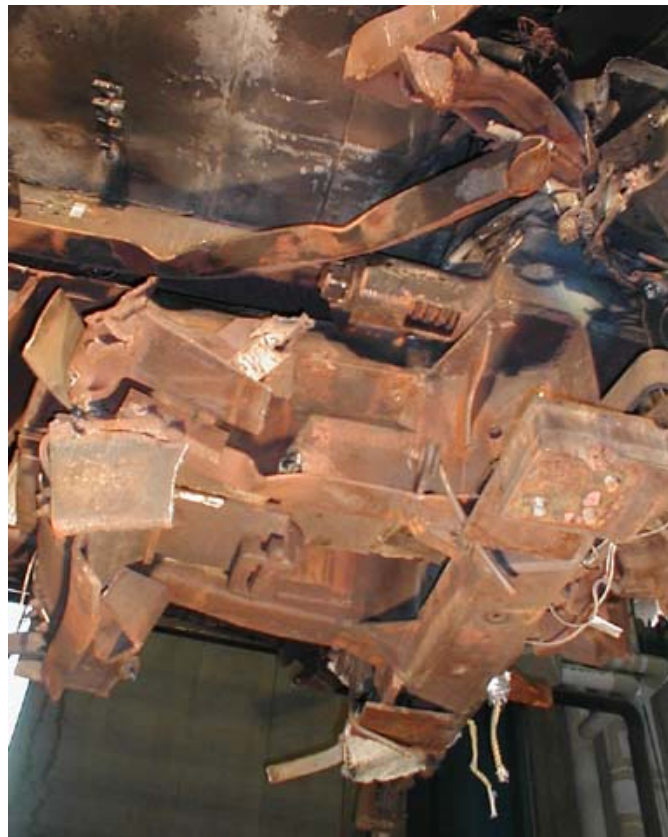
Figure B1-28. Forward Draft Sill - Right-side Deformations

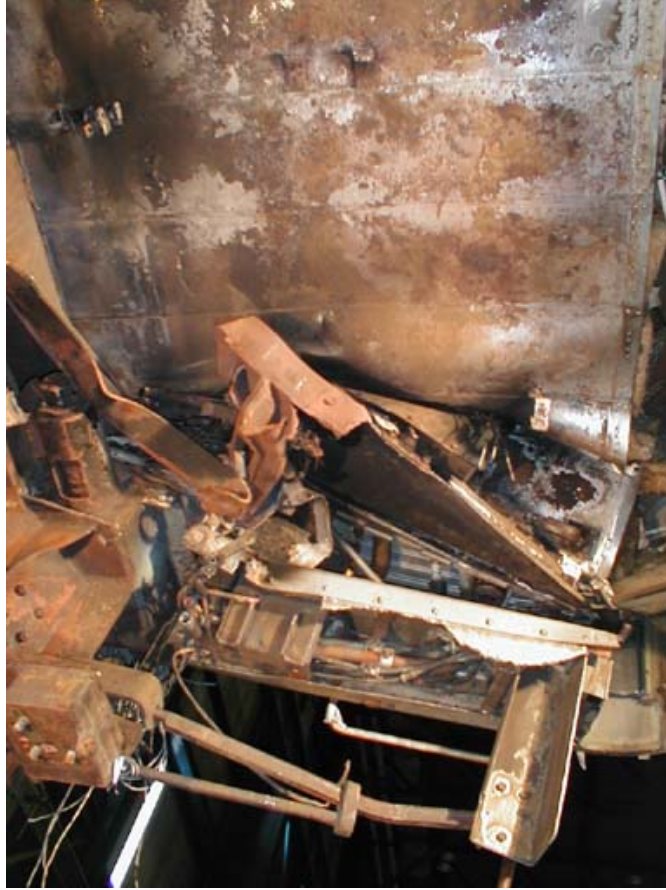
Figure B1-29. Forward Right-side Deformations - Buckling of the Floor Panels

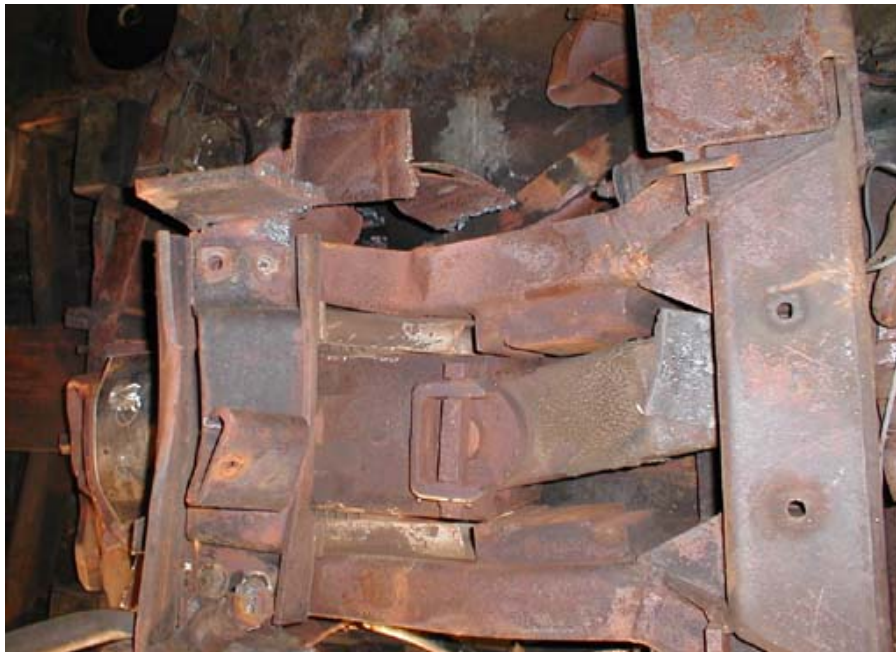
Figure B1-30. Forward Draft Sill, Coupler Shank, and Pilot Attachment From Below

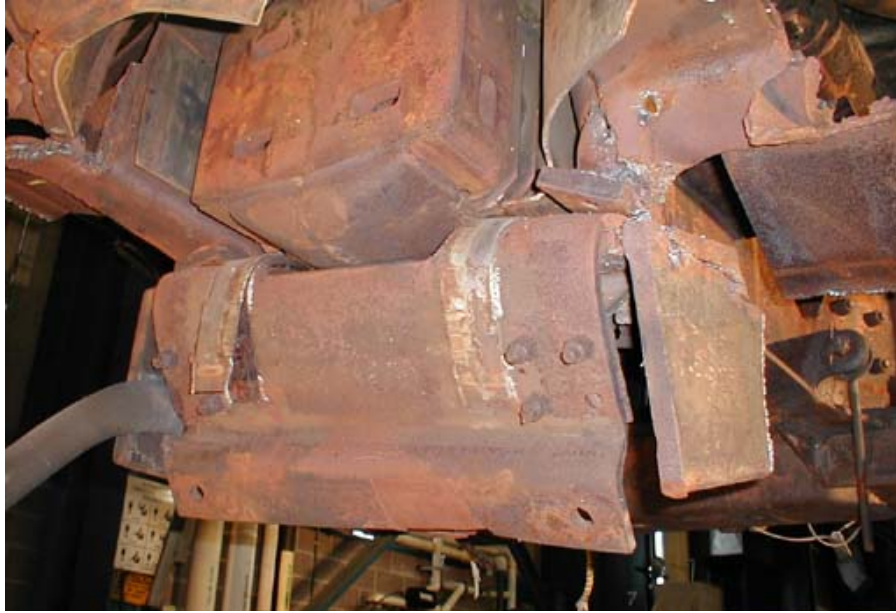
Figure B1-31. Forward Draft Sill Detail - Deformation of Pilot Connection Plate Under the Draft Gear

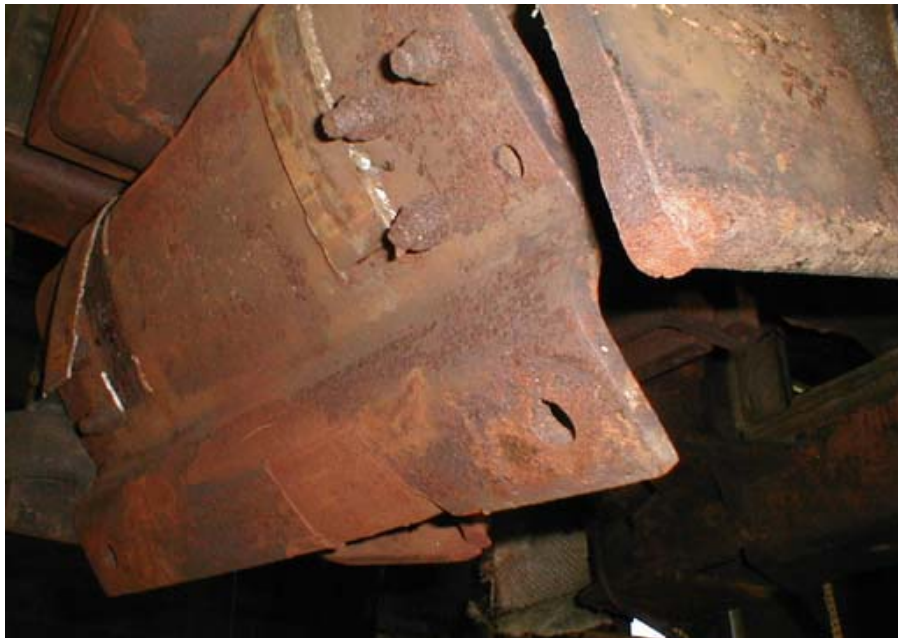
Figure B1-32. Forward Draft Sill Detail Showing Effects of Impact with the Front Axle

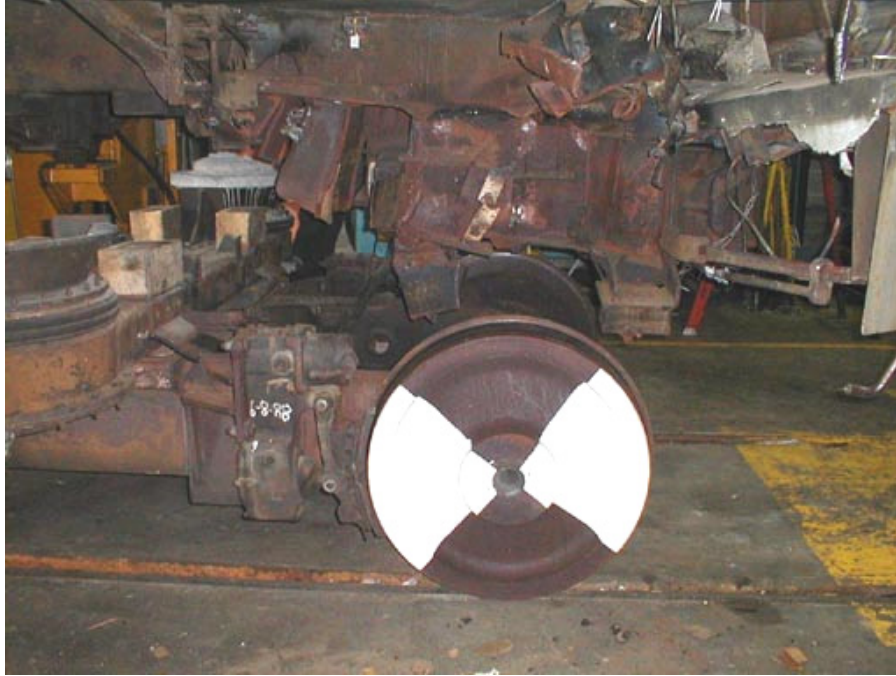
Figure B1-33. Draft Sill Position Relative to Truck—As Car was Being Lowered Back Onto Truck

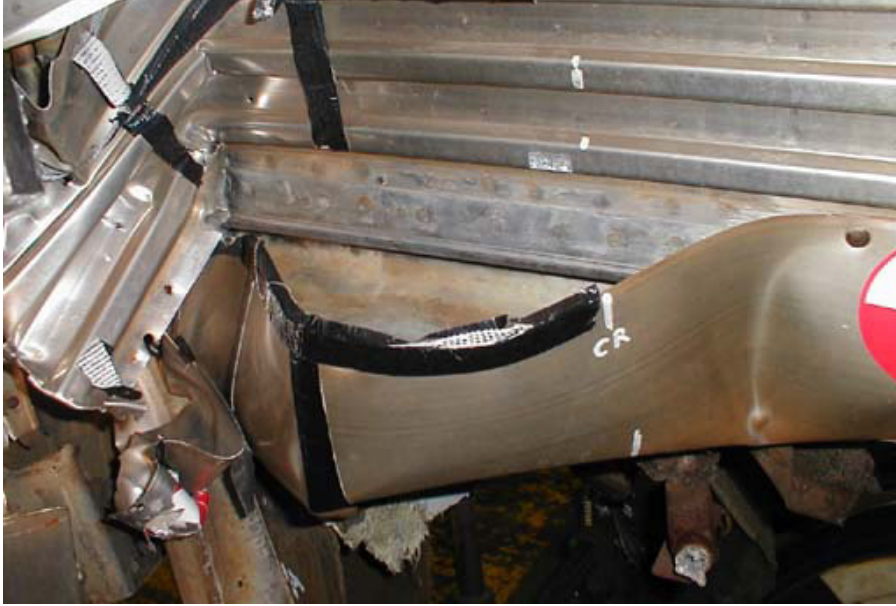
Figure B2-1. Detail of Deformed Side Sill Cover from Left Side Aft of Crushed Face (View of Side Sill is Obstructed by Cover)

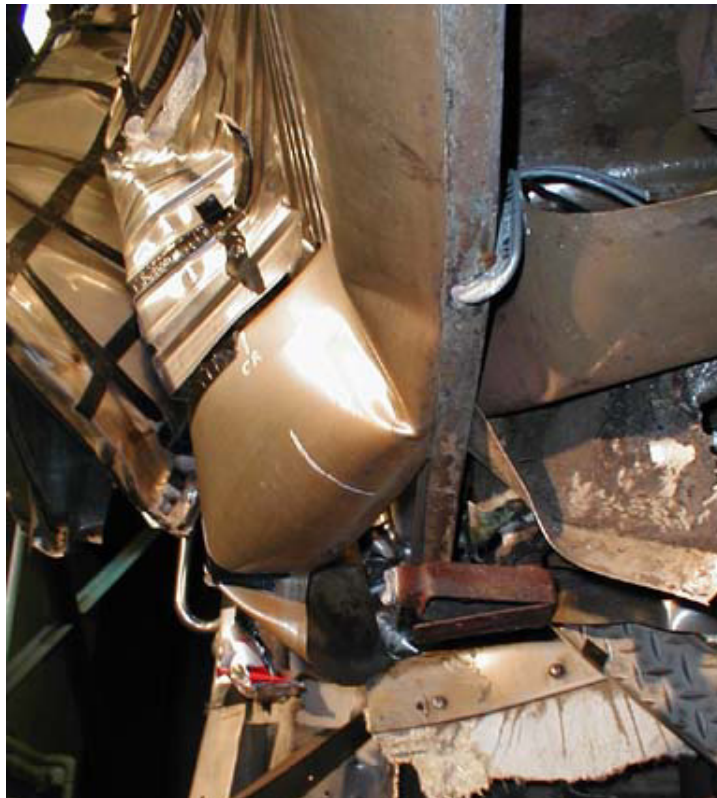
Figure B2-2. Left-side Sill Collapse Detail, from Below Looking Forward

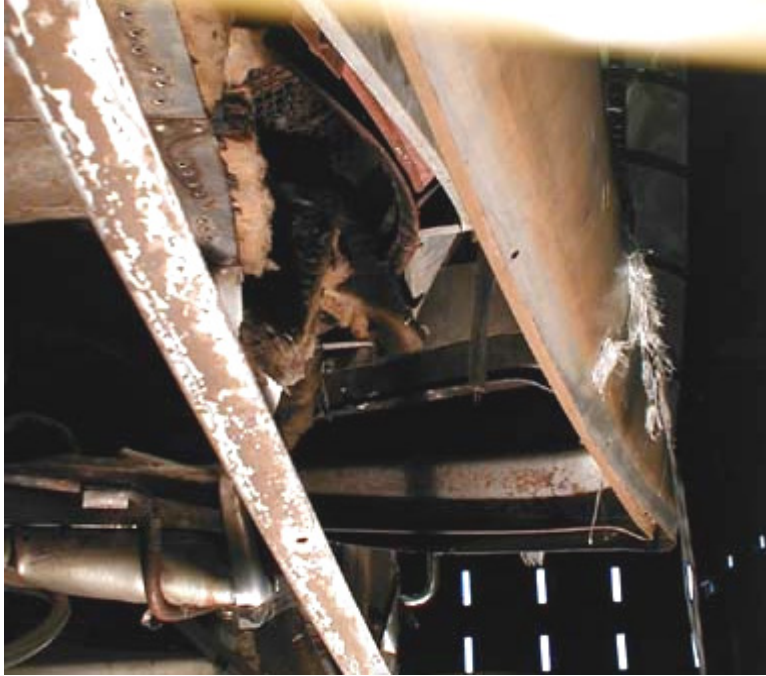
Figure B2-3. Right-side Sill Collapse Detail, from Below Looking Forward

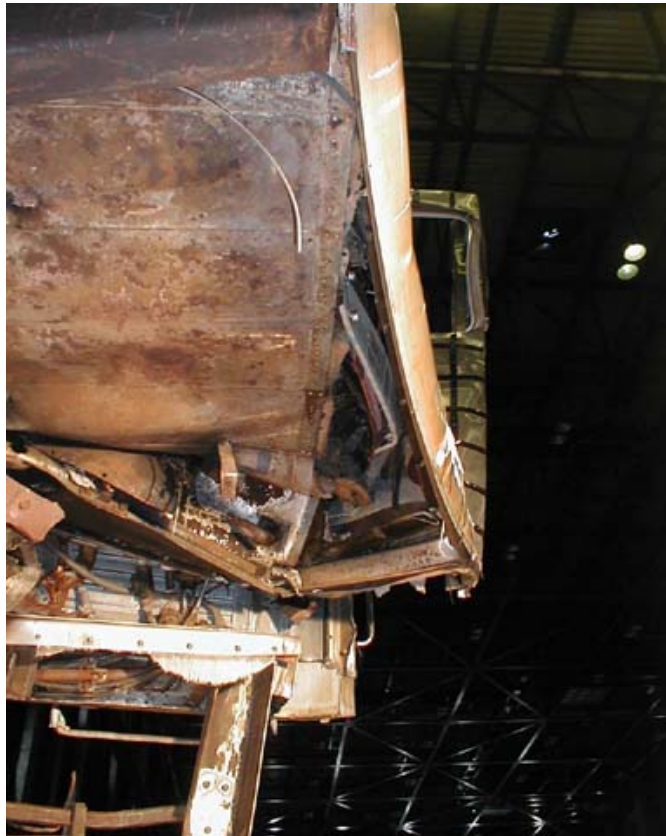
**Figure B2-6. Forward Right-side Deformations - Buckling of the Side Sill and Floor Panels
(Note Trap Door and Other Debris has been Removed)**

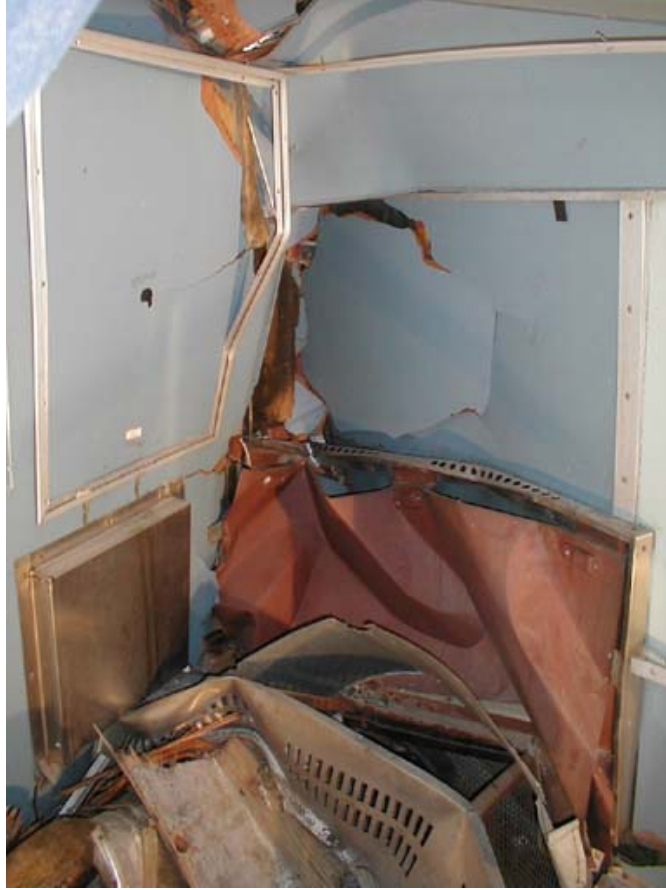
Figure B3-5. Inside Detail of Right Buckled Corner Aft of Bulkhead

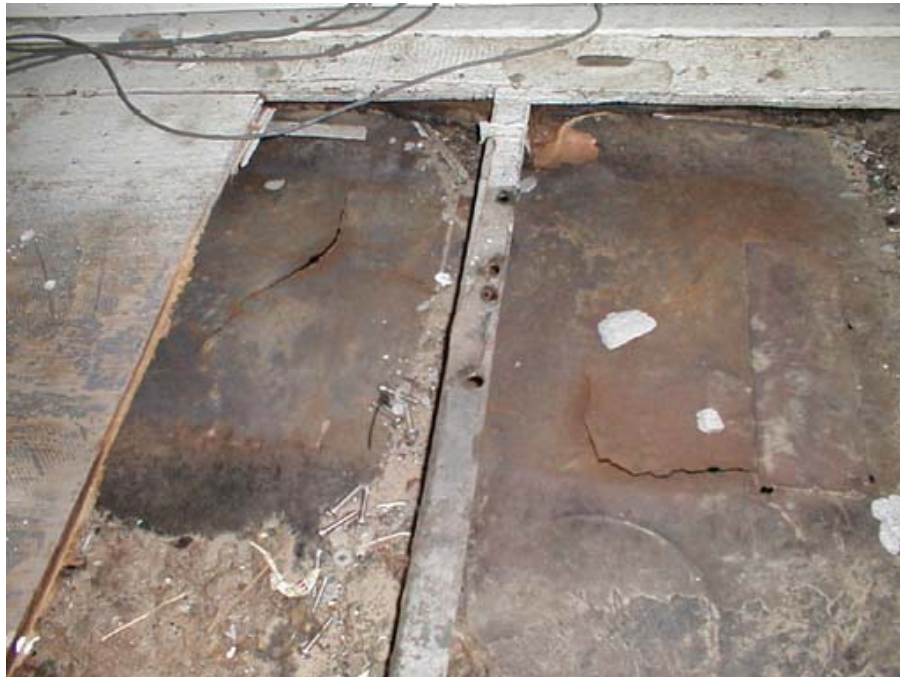
Figure B3-8. Cracks in Floor Sheathing Under Removed Floor Panels

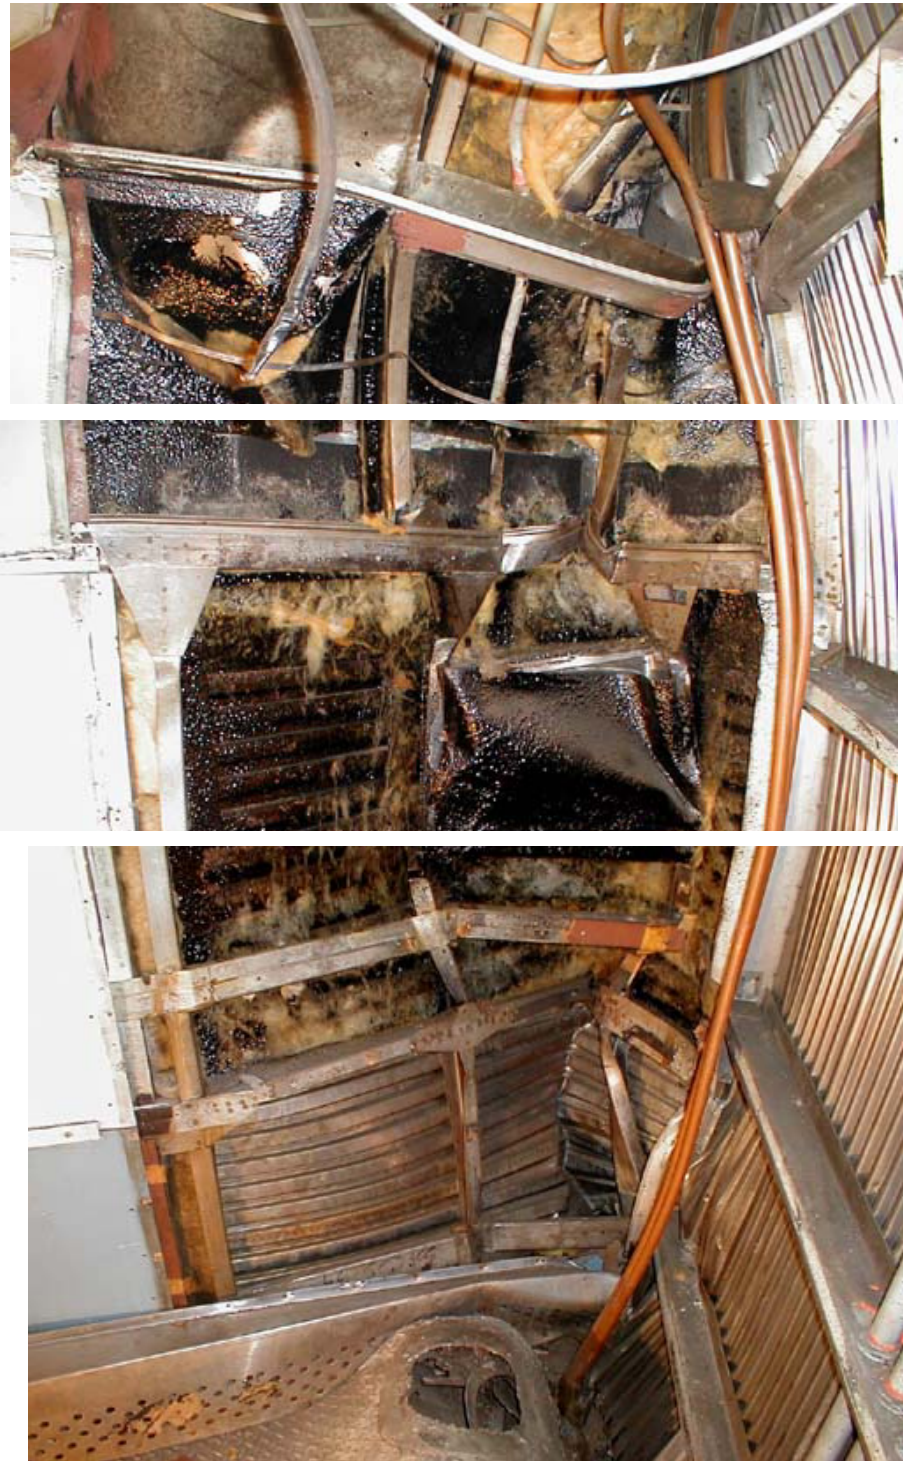
Figure B3-10. Composite Showing Forward Left-side Wall Between Bulkhead Wall and First Window Frame

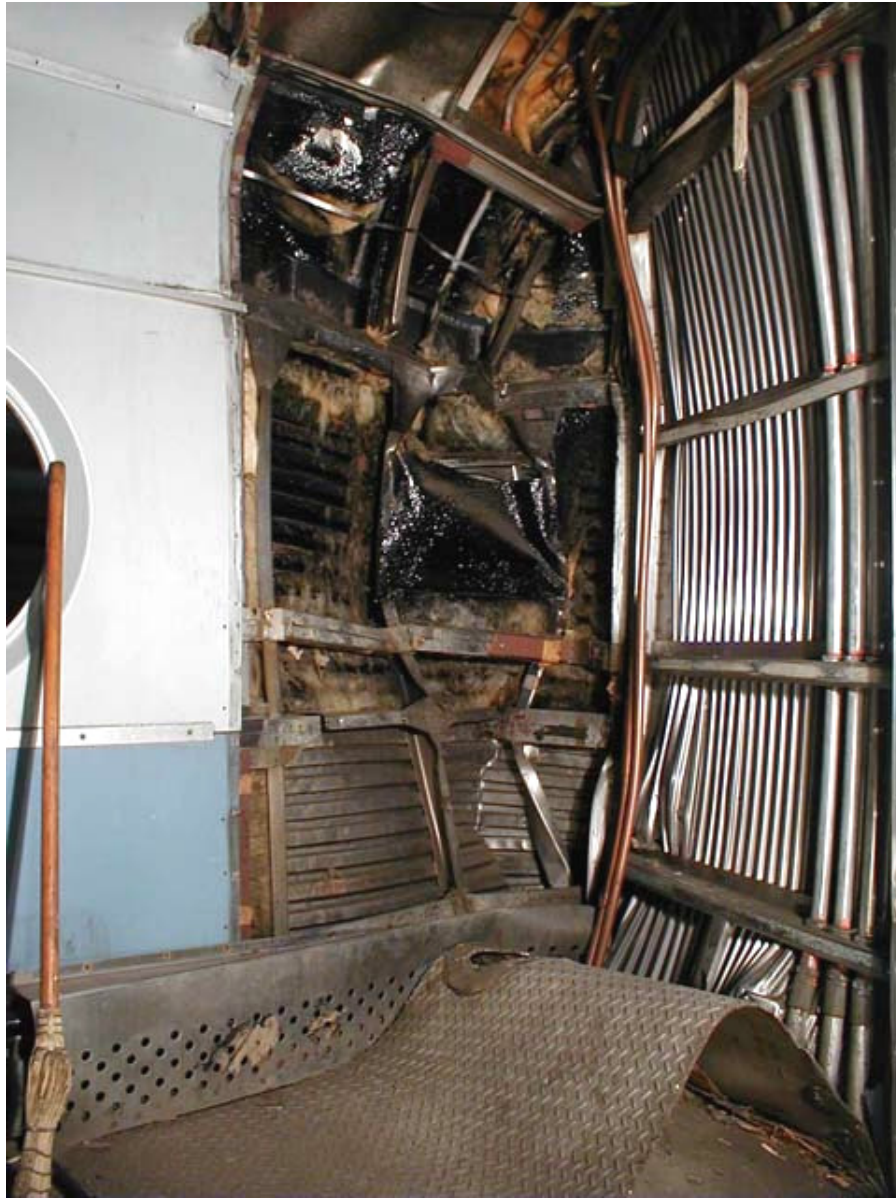
Figure B3-11. Left-side Front Corner Aft of Bulkhead Wall

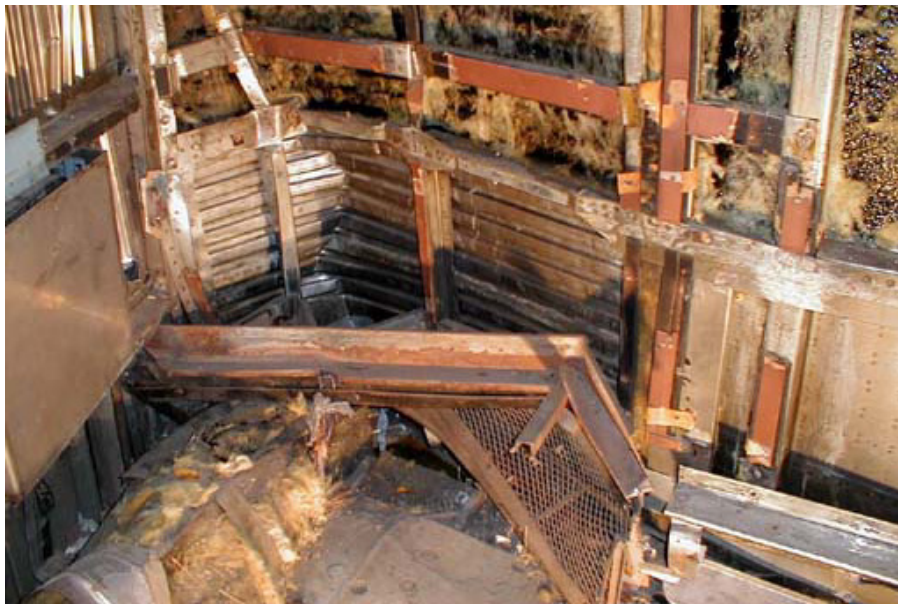
Figure B3-12. Composite Showing Forward Right-side Wall Between Bulkhead Wall and First Window Frame

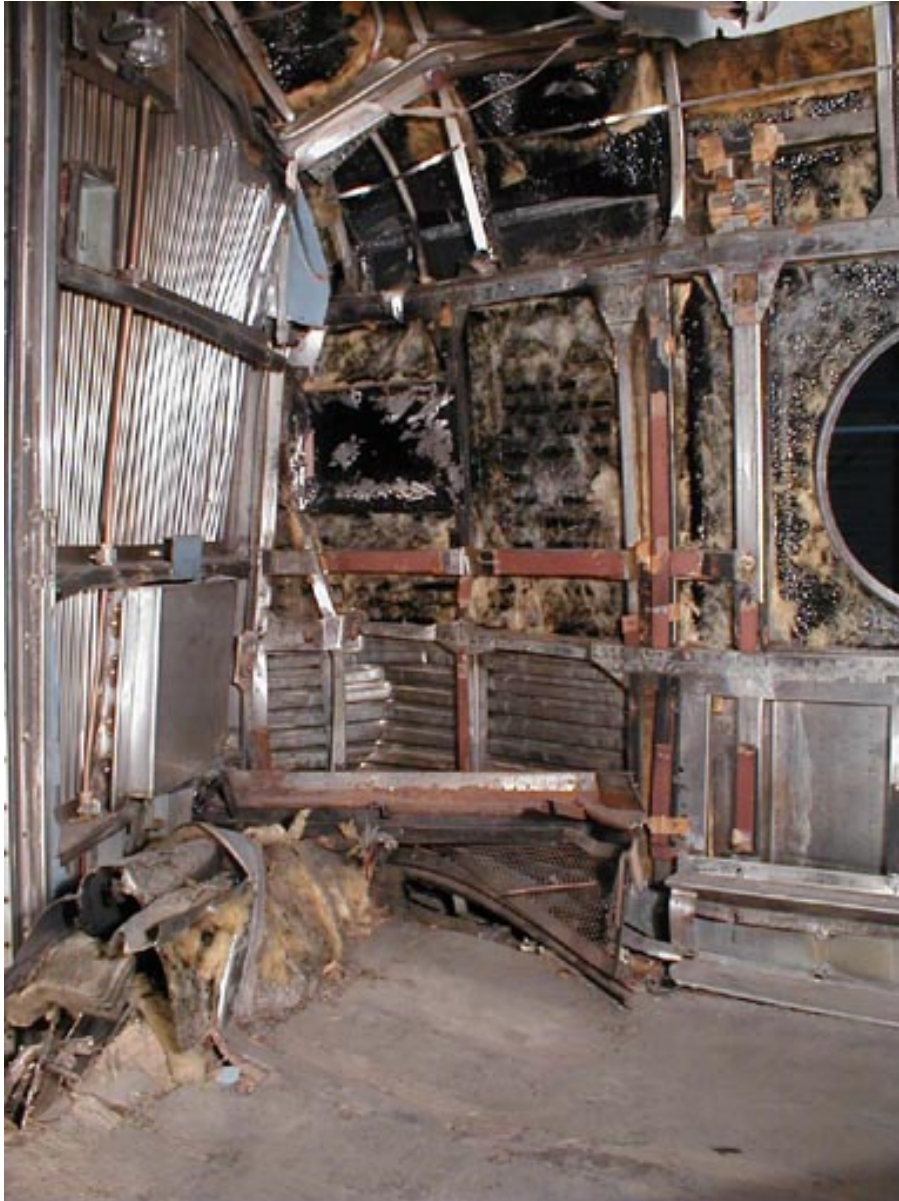
Figure B3-13. Right-side Front Corner Aft of Bulkhead Wall
