U.S. Department
of Transportation
**Federal Railroad
Administration**

Documentation of Deformation from Passenger Rail Two-Car Impact Test

DOT/FRA/ORD-03/08

Final Report
November 2003

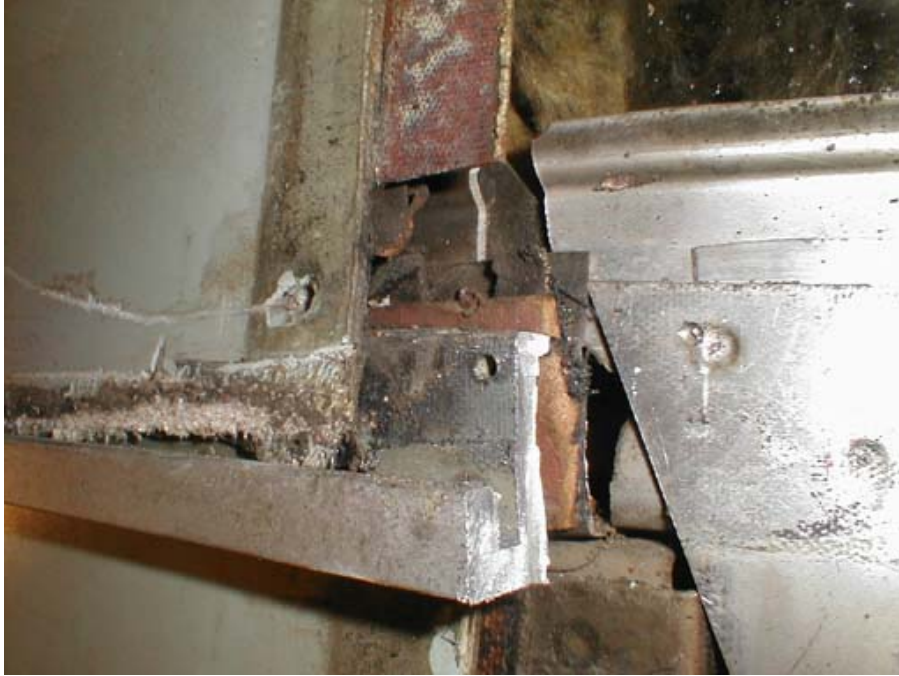
- The left- and right-side cant rails both buckled outward, which reduced both of their lengths by 13 inches (0.330 m). Like the belt rails, the cant rails fractured just forward of the first window frame and collapsed relatively symmetrically.

Figure B3-14. Left-side Cant Rail—Crack Detail Just Forward of Window Frame

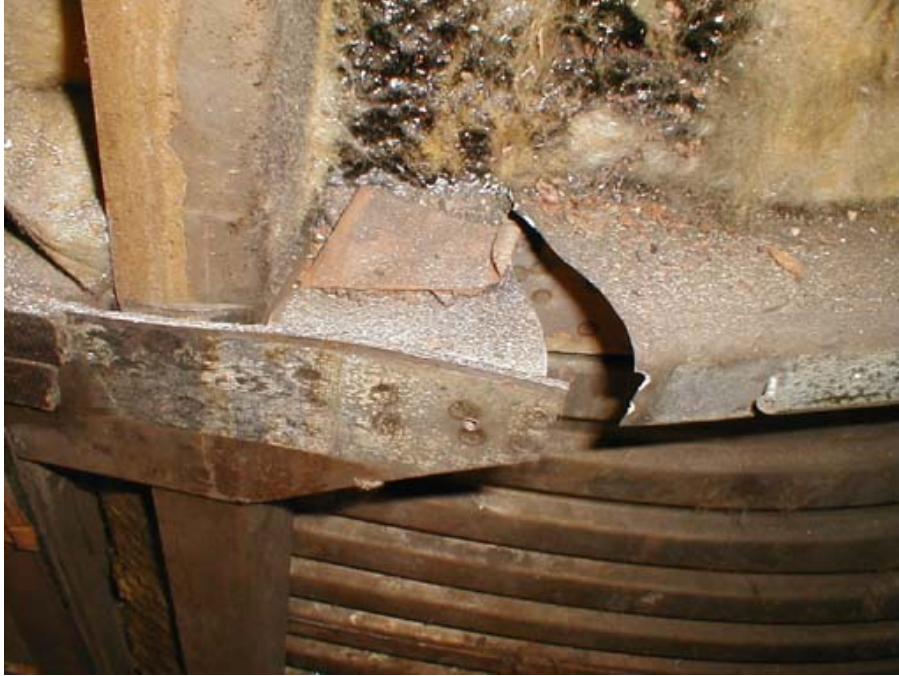
Figure B3-16. Left-side Belt Rail—Crack Detail Just Forward of Window Frame

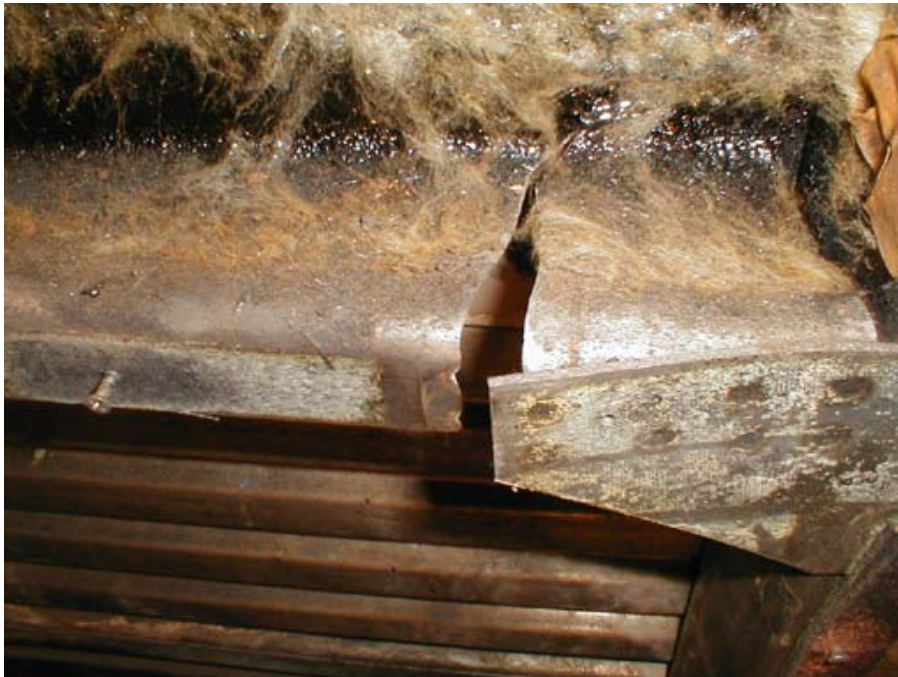
Figure B3-17. Right-side Belt Rail—Crack Detail Just Forward of Window Frame

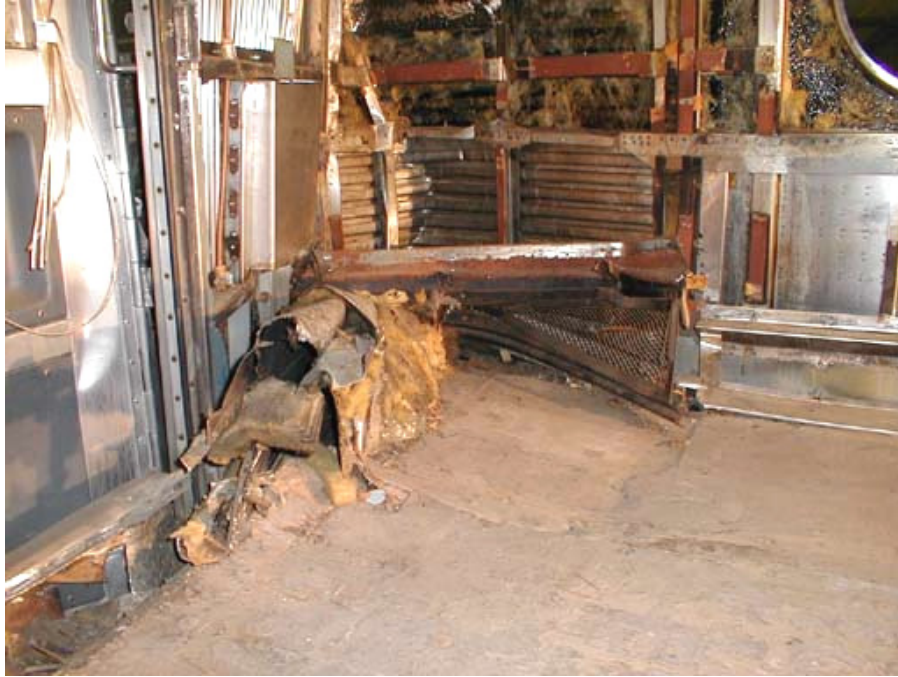
Figure B3-18. Right-side Floor Buckling and Seat Frame Aft of Bulkhead Wall

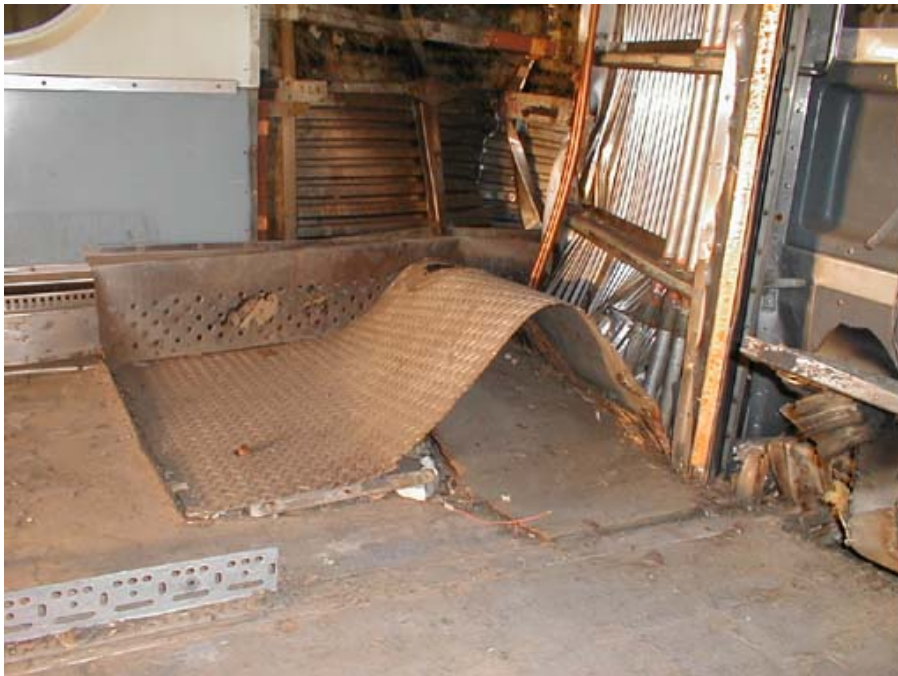
Figure B3-19. Left-side Floor Buckling Aft of Bulkhead Wall

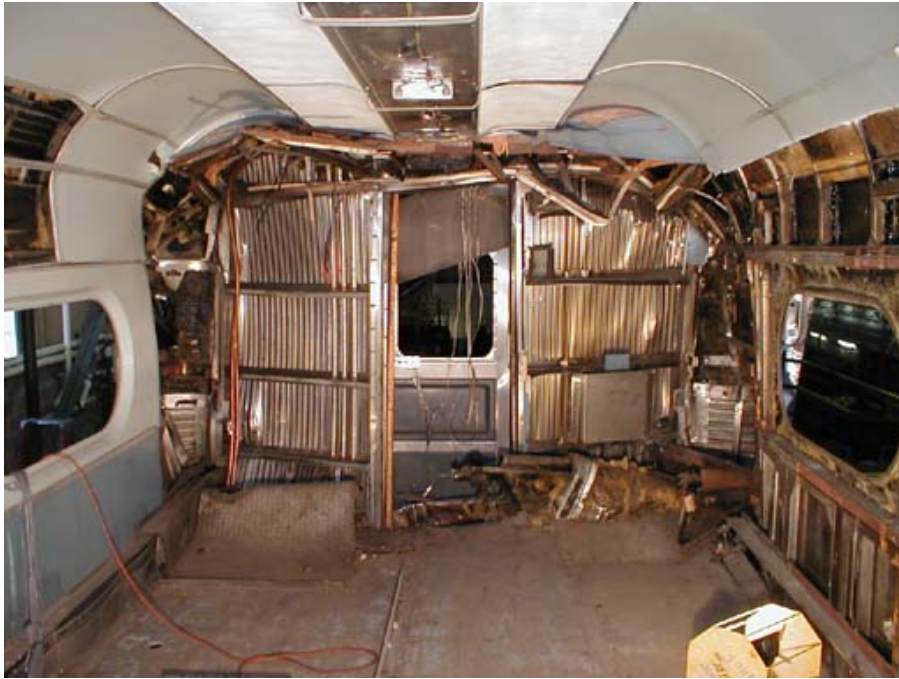
Figure B3-20. Internal View Looking Forward of Crushed End After Material Removal

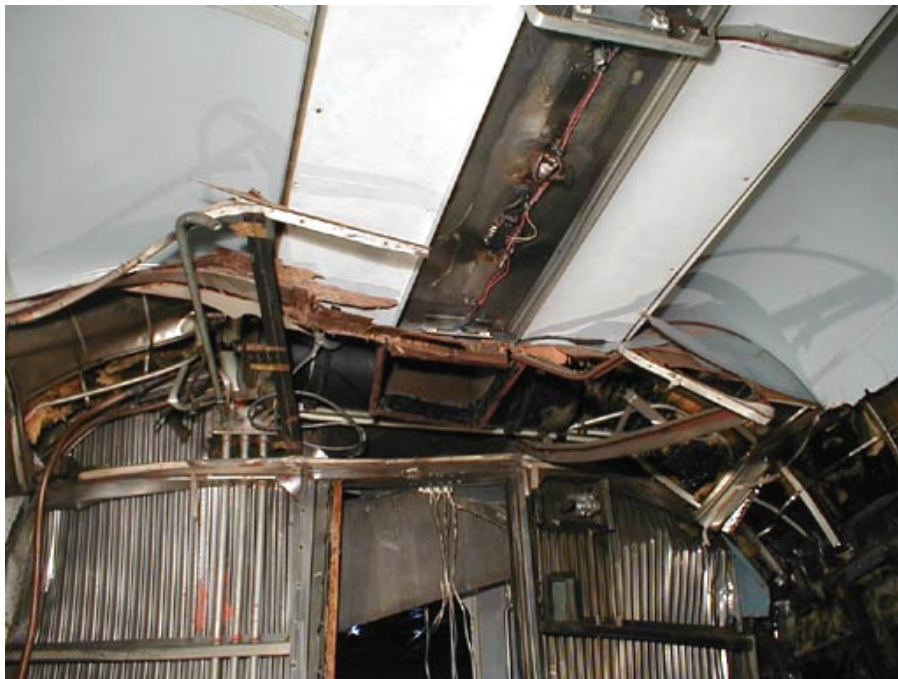
Figure B3-21. Upper Damage aft of Bulkhead Wall—View After Material Removal

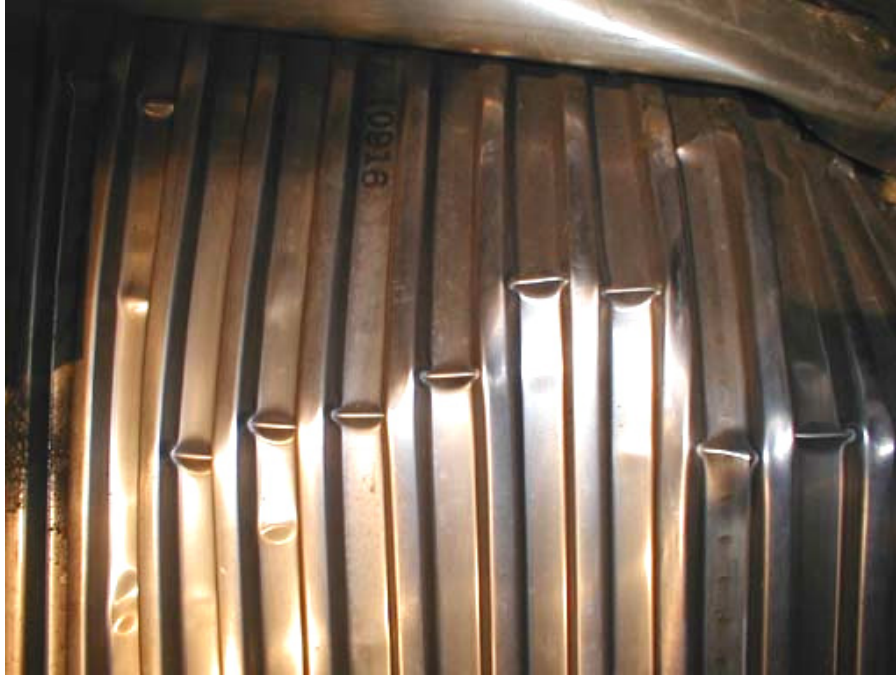
Figure B3-22. Skin Buckle on Upper Right-side of Bulkhead Wall—Typical Buckle Pattern of Superstructure Corrugated Skin

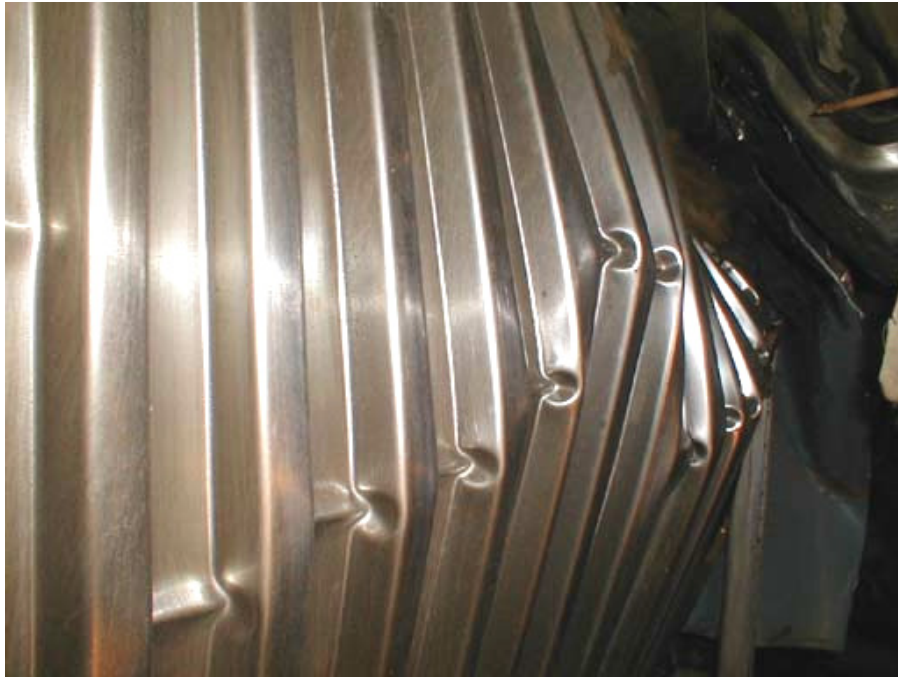
Figure B3-23. Same Buckle as Previous Picture from Slightly Different Point of View

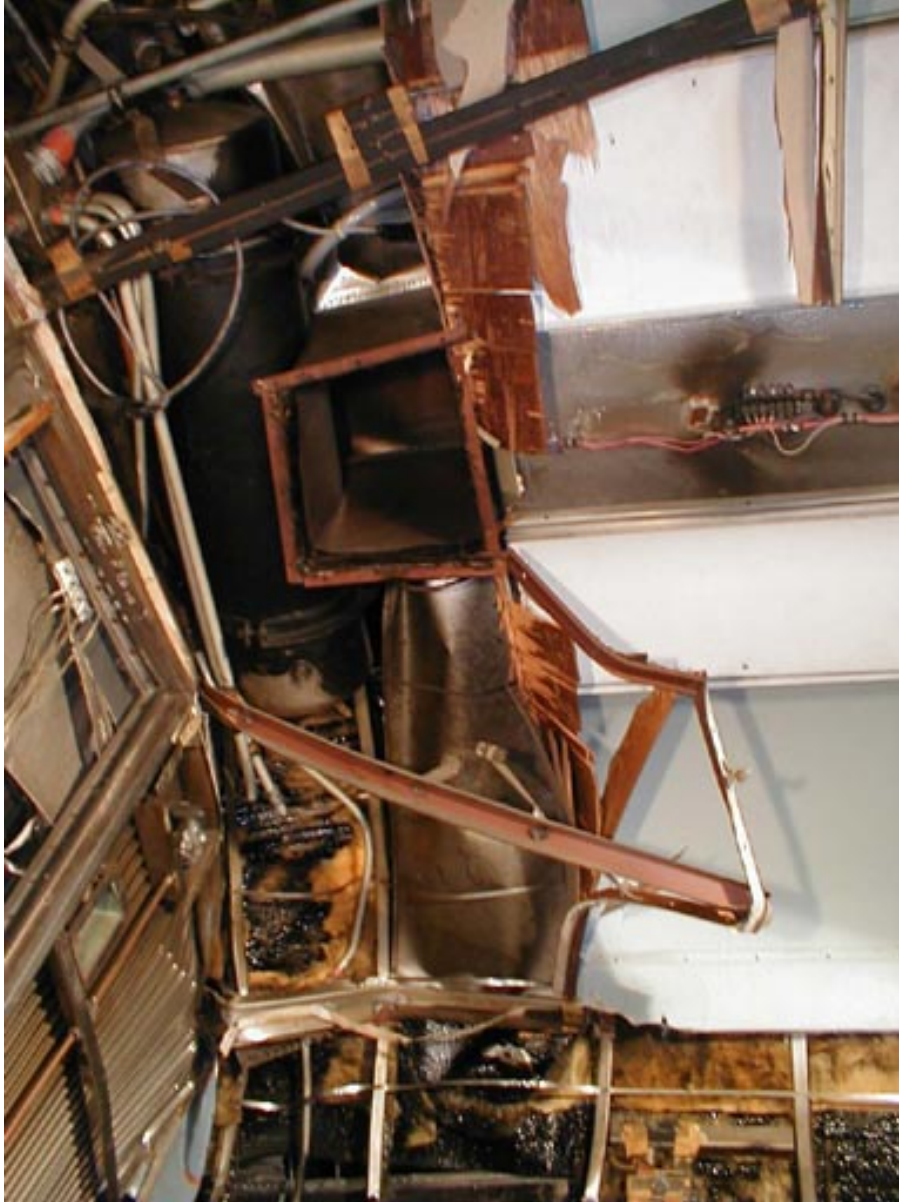
Figure B3-24. Ceiling Damage Aft of Bulkhead Wall—View from Below

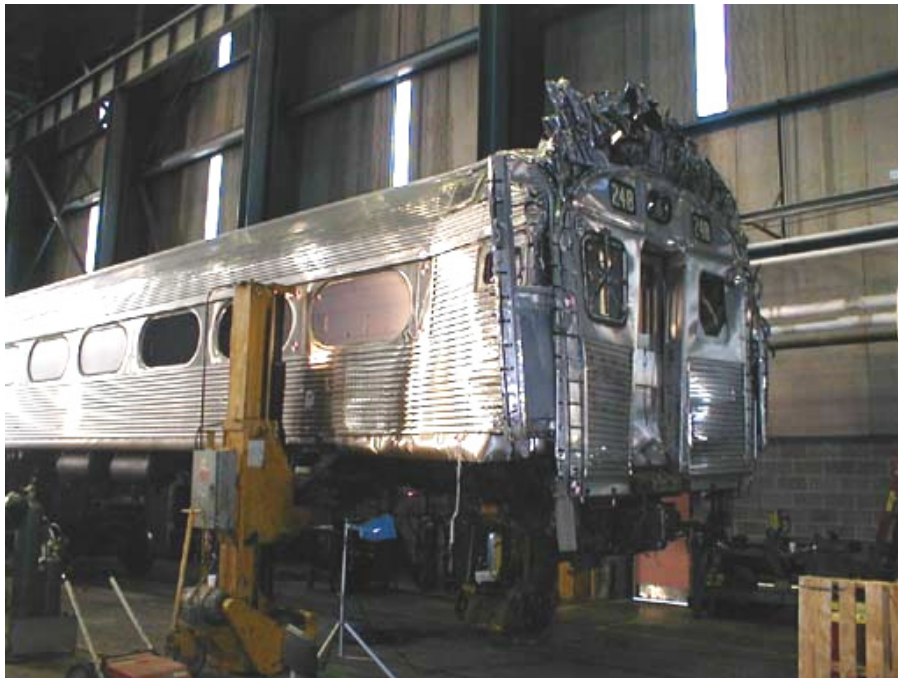
Figure B4-2. Right Front Corner of Damaged End—Car Jacked in Air in TTC RDL Building

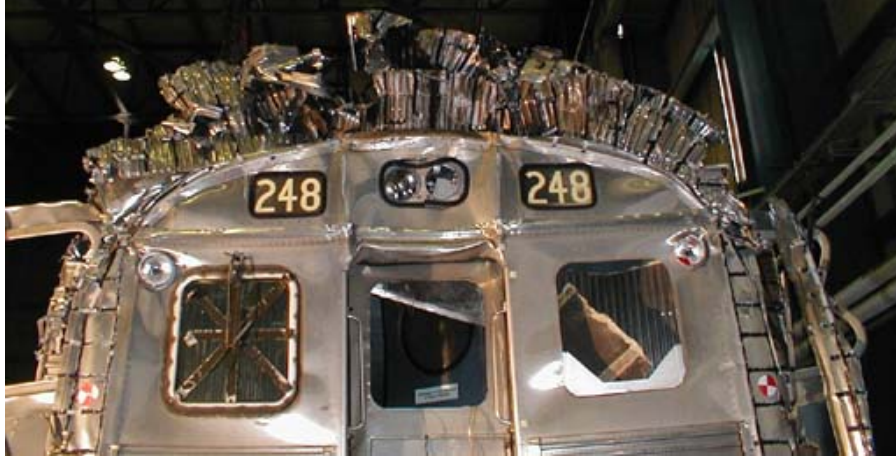
Figure B4-3. Front Top Face of Vestibule, Looking Up

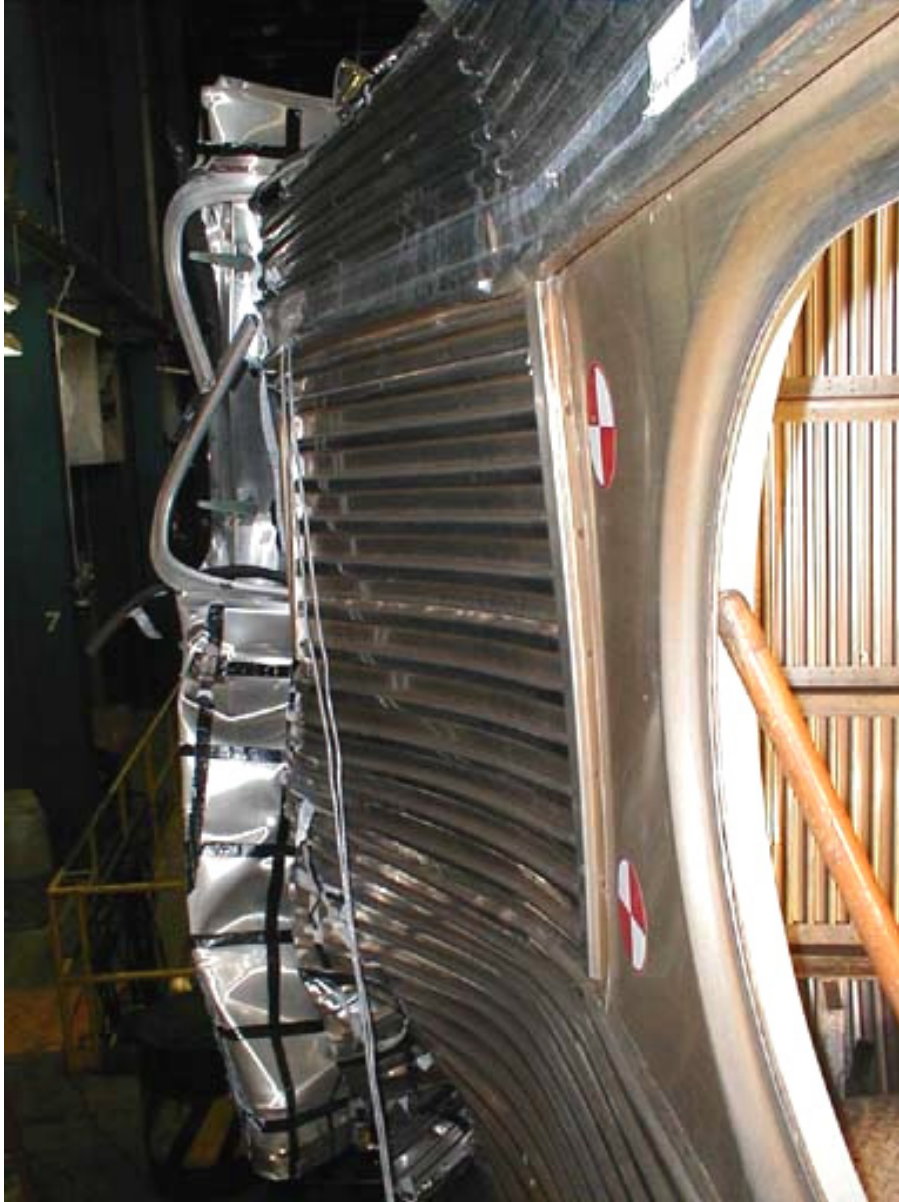
Figure B4-9. View of Left-side Superstructure from First Side Window, Looking Forward

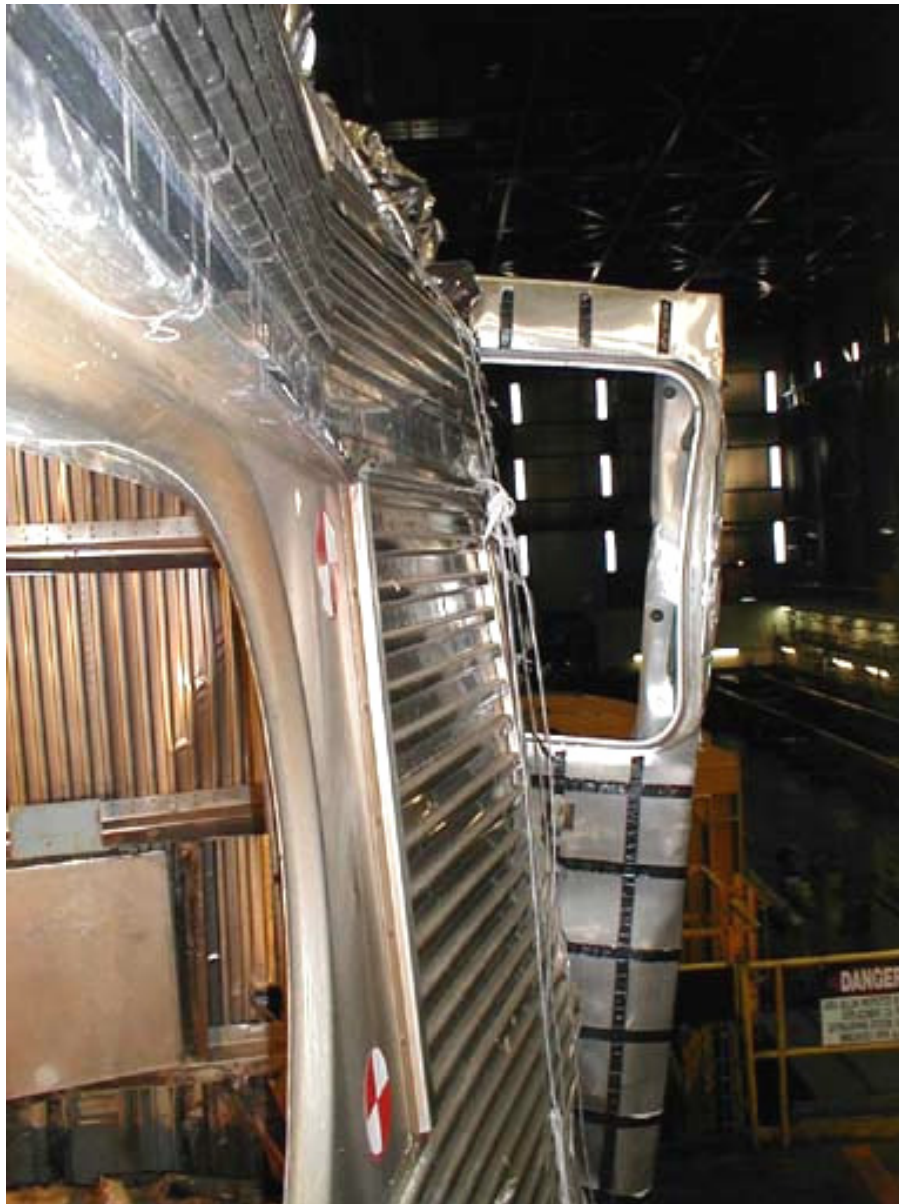
Figure B4-10. View of Right-side Superstructure from First Side Window, Looking Forward

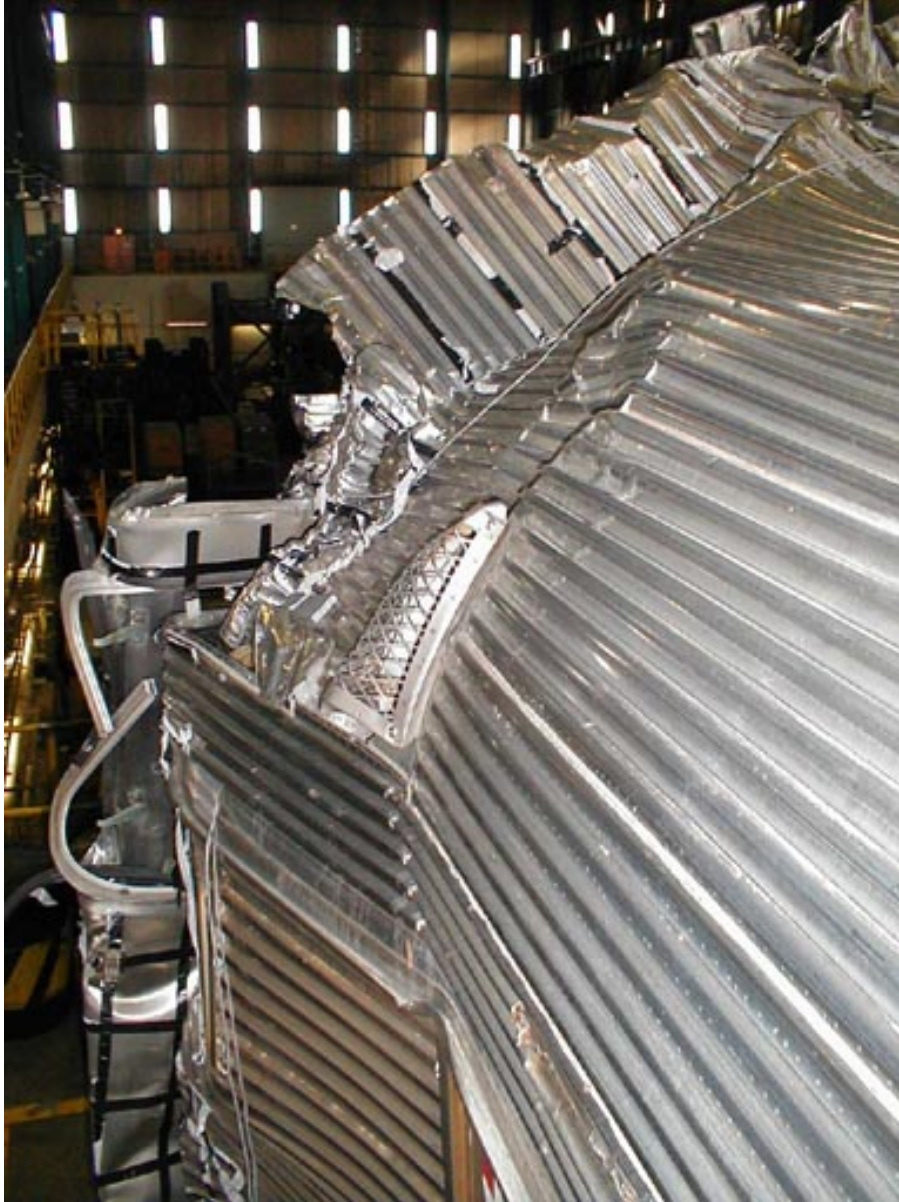
Figure B4-11. View of Upper Left-side Superstructure in Crush Zone, Looking Forward

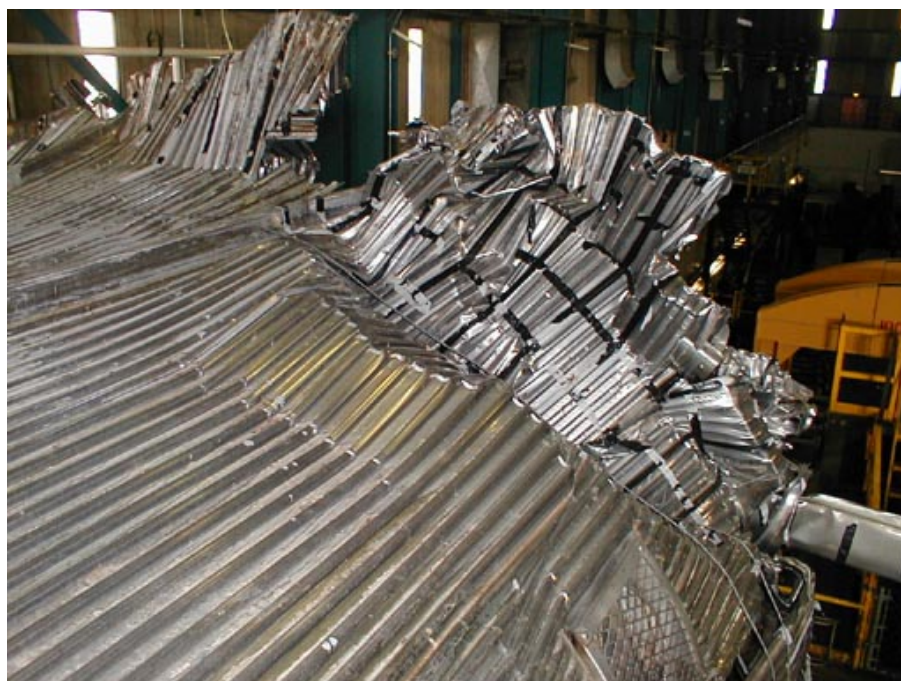
Figure B4-13. View of Upper Superstructure in Crush Zone, Looking Forward from Right

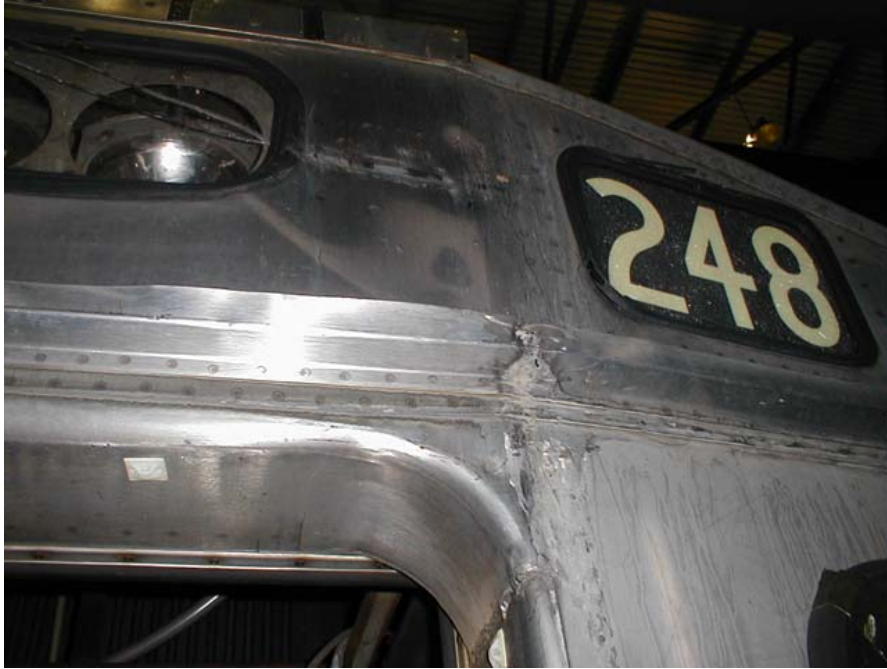
Further evidence of damage was seen on the B-end face above the gutter rail, as shown in Figure 34. The mark in the steel seems to be from a step plate or some other horizontal surface. At first it was suspected that steps on the opposing face of the trailing car impacted the lead car. However, upon further investigation, this could not have been the case. First, the cars were coupled with the B-end of the lead car facing the A-end of the trailing car and the A-end of Pioneer cars do not have steps. Second, review of the high-speed film and video did not show evidence of contact at the top of the car bodies. For these reasons, it is believed that the damage was pre-existing or occurred subsequent to the test as the vehicles were re-railed and moved.

Figure B5-1. Damage above Rear Center Door - Impact of Rear Car Upper Step

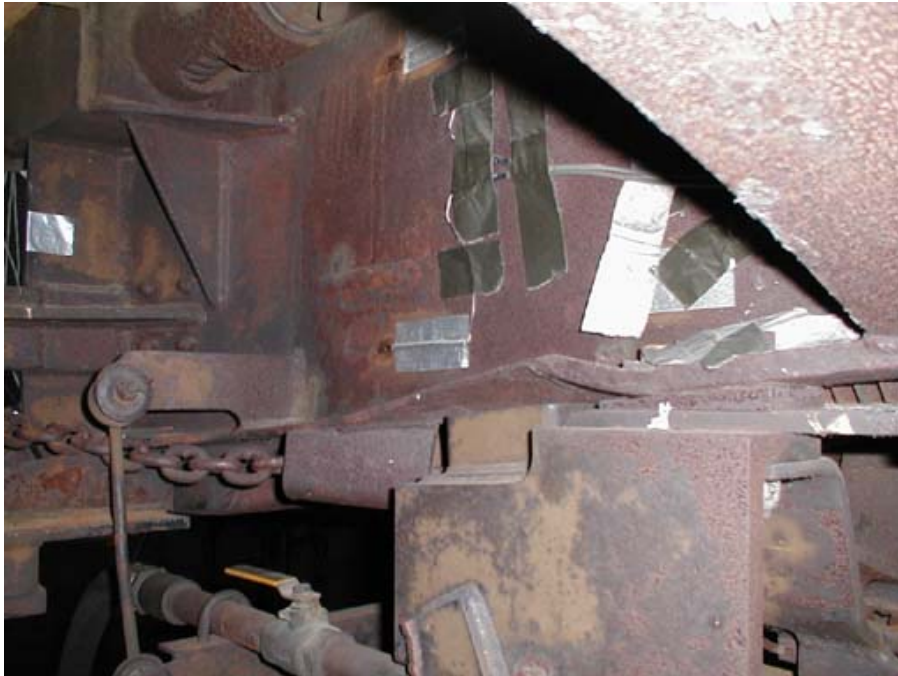
Some minor buckling was found on the right-side draft sill flange. From the nature of the damage, it appeared to have been induced prior to the test. Review of photographs taken of the draft sill before it was crash tested confirmed this observation.

Figure B5-2. Aft Draft Sill - Buckle of the Draft Sill Flange Above Pilot Connection Plate

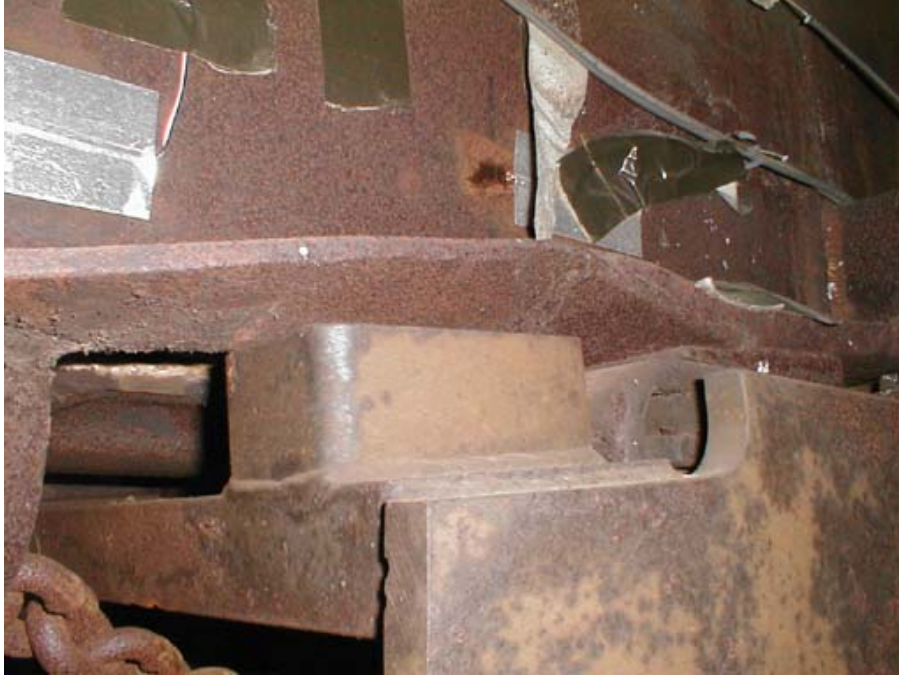
Figure B5-3. Aft Draft Sill - Buckle of the Draft Sill Flange Above Pilot Connection Plate

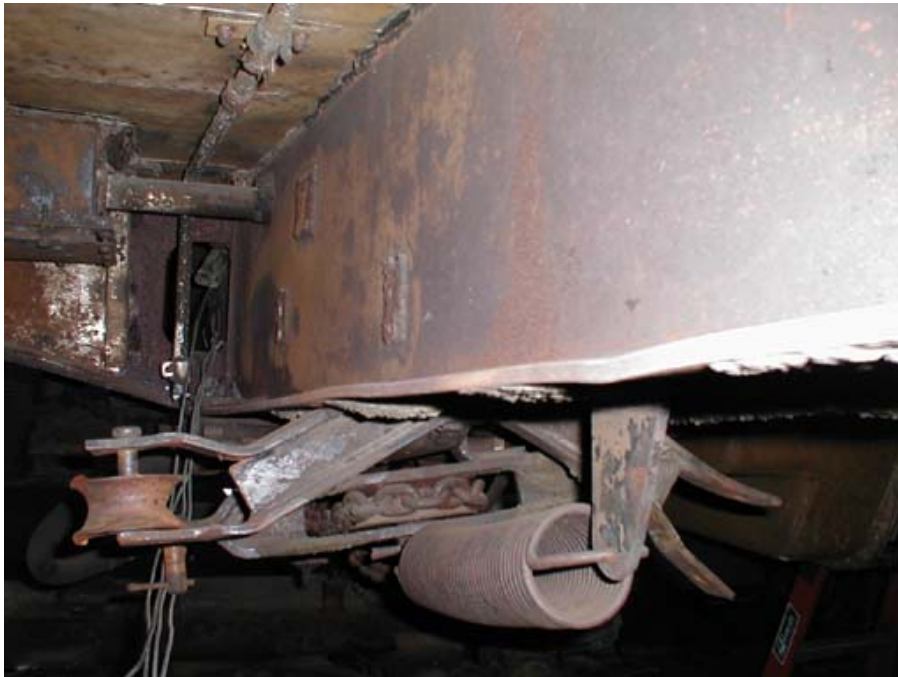
Figure B5-4. Aft Draft Sill - Slight Buckling of the Draft Sill Flange

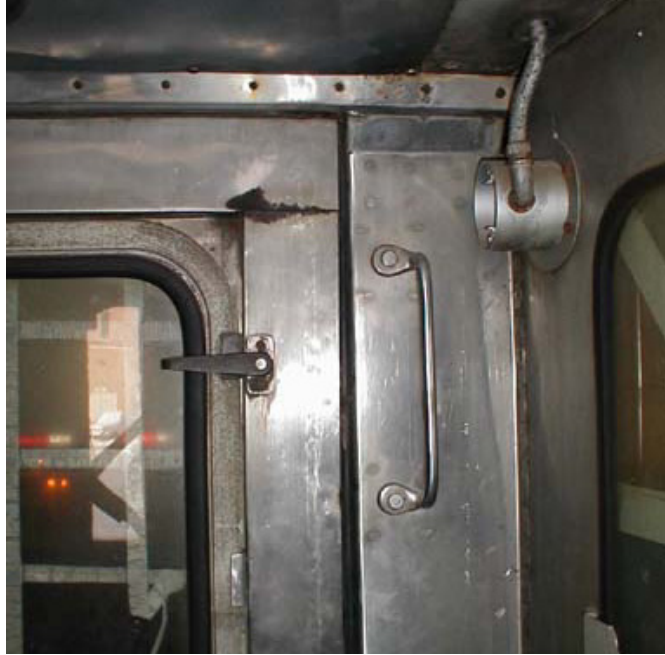
The right-side vestibule door was also found to be stuck in its frame. There was evidence on the doorframe of some distortion, including a small buckle on the rain gutter above the doorframe. After applying a considerable amount of force, a person could open the door and shut it fully again in the doorframe. It is unclear whether this damage was a result of superstructure distortion induced during the crash test or if the damage was pre-existing. Review of the high-speed film showed some twisting of the carbody during the test but it is not clear if this impact response was sufficient to cause the door to jam in its frame.

Figure B5-5. Detail - Door Frame Deformation in Right-Rear Door

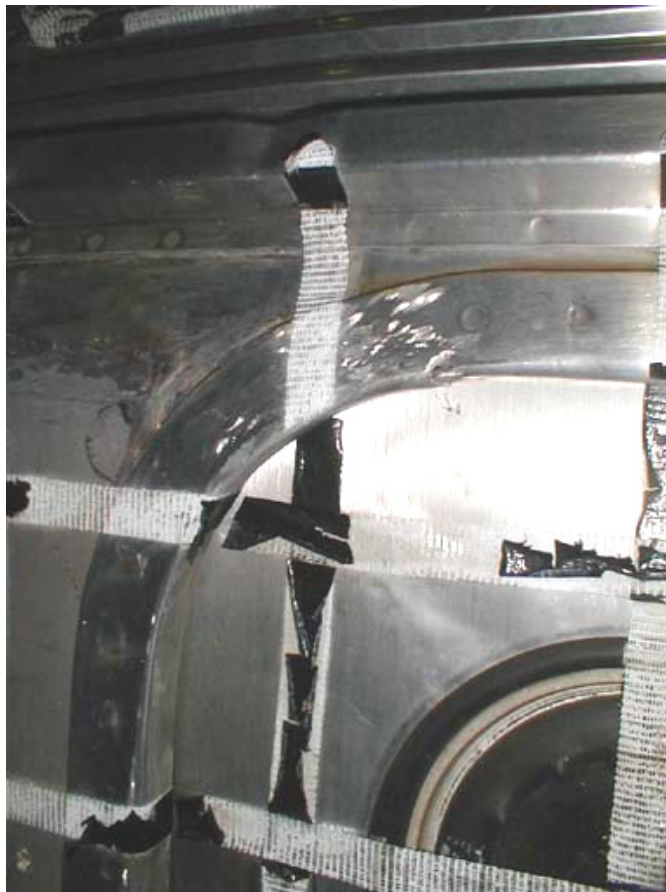
Figure B5-6. Buckle in Rain Gutter Above Top Left Corner of Right-Rear Door Frame

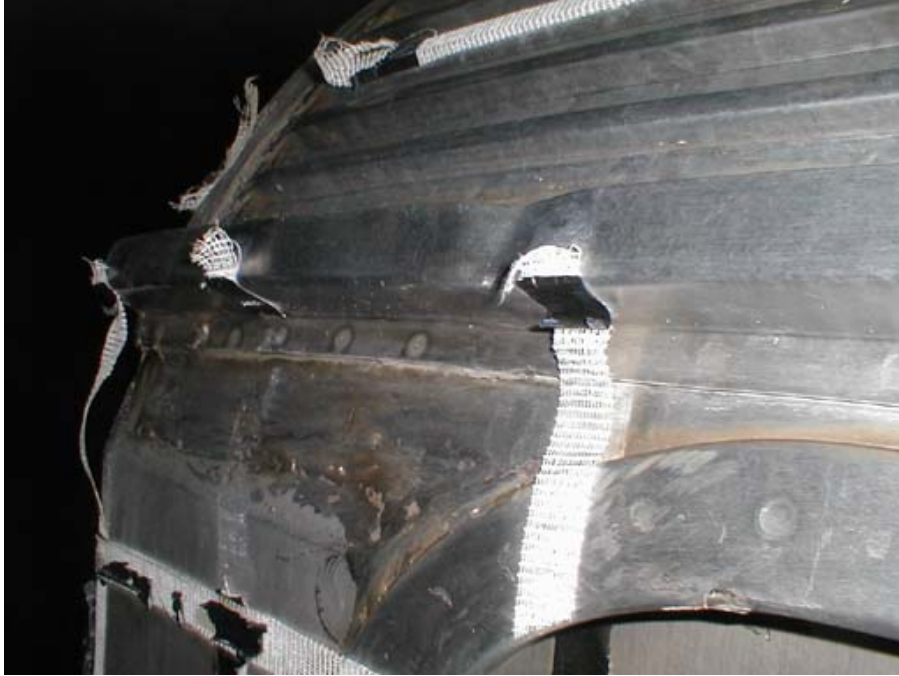
Figure B5-7. Buckle in Rain Gutter Above Top Left Corner of Right-Rear Door Frame

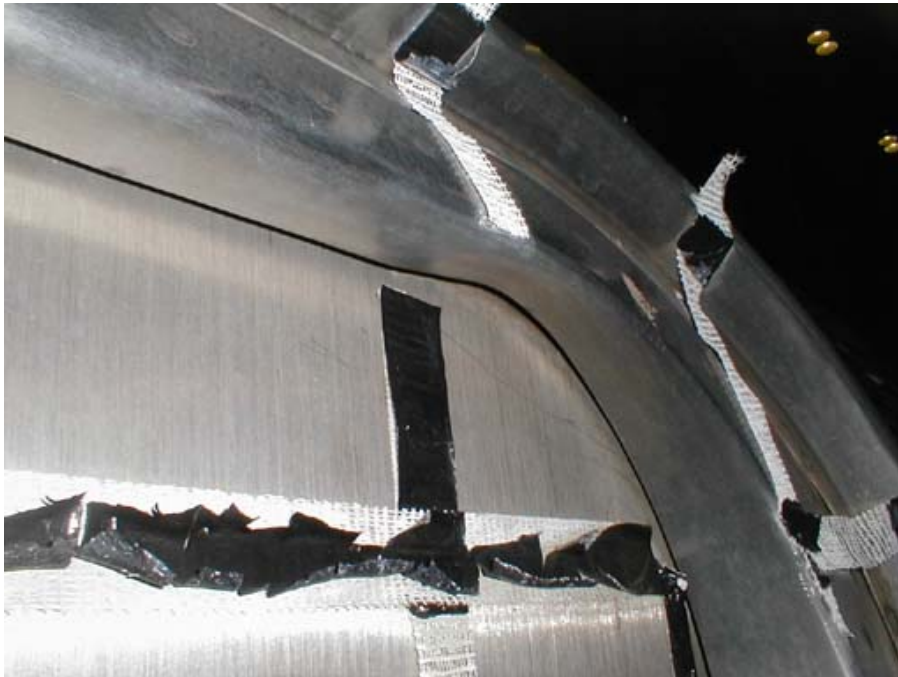
Figure B5-8. Buckle in Top Right Corner of Right-Rear Door Frame – Outside

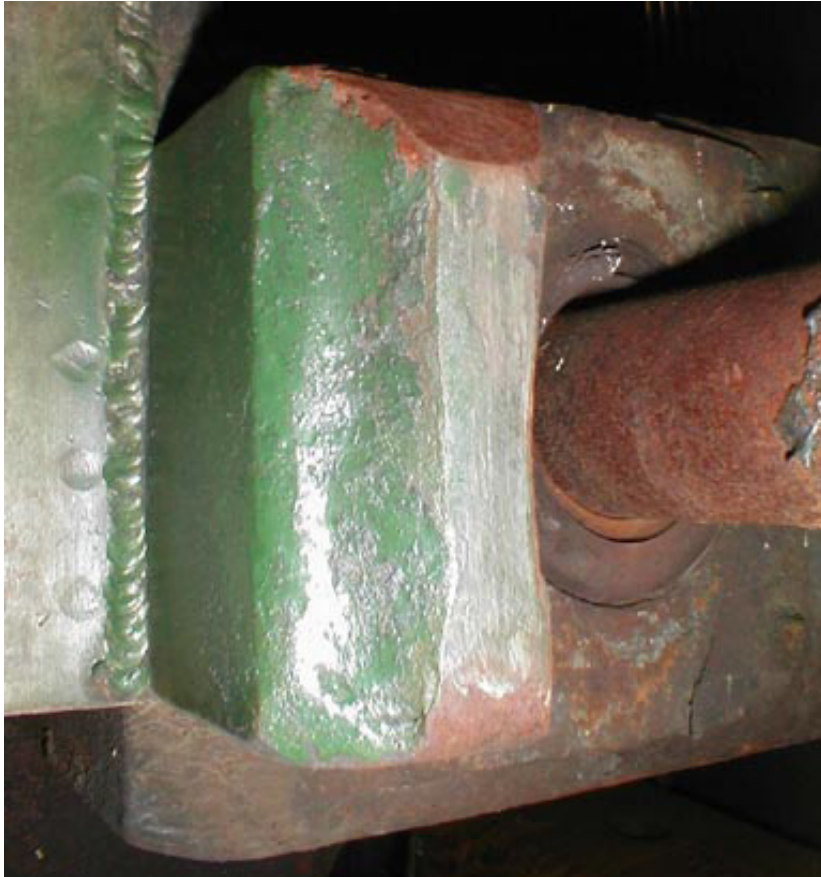
Figure B5-11. B-End Buff Stop—Collision Marks from Impact with Trailing Car

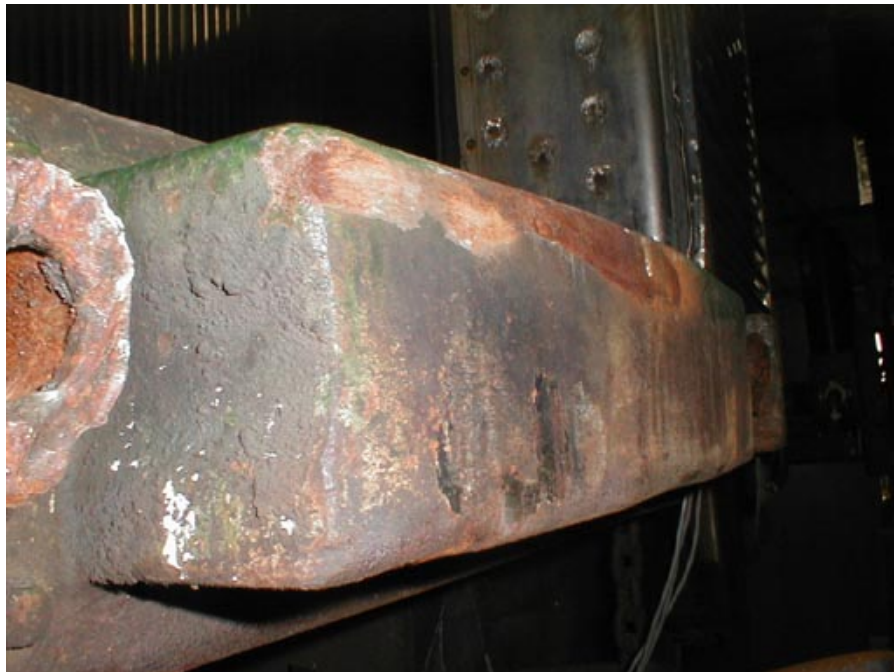
Figure B5-12. B-End Buff Stop—Collision Marks from Impact with Trailing Car

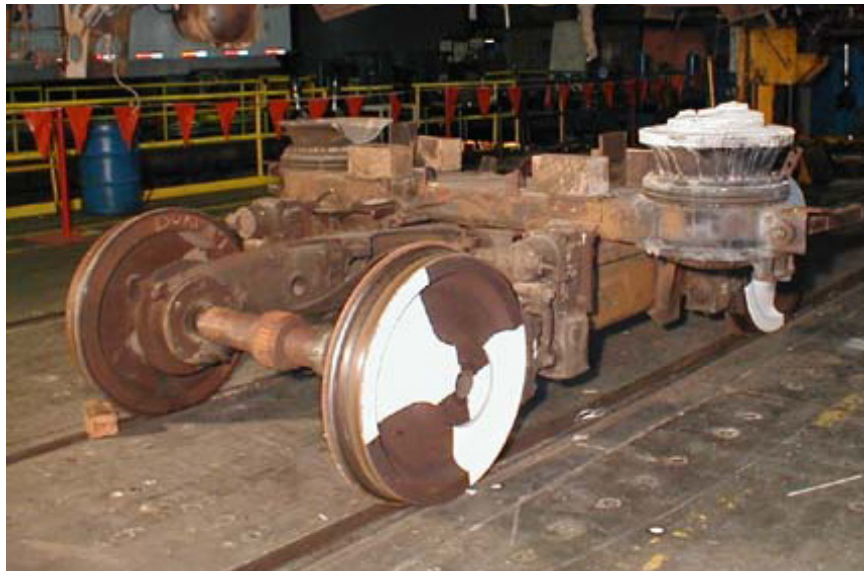
Figure 38 below shows the detached front truck. Note that the left-side suspension bell was filled with concrete, as were both bells on the rear truck. A fracture in the right-side bell may also be seen in the figure. There was evidence of past repairs to the bell in the form of welds. It is not clear if this damage was a result of the collision test.

Figure B6-2. Forward Truck (Detached) from Left Side Looking Aft

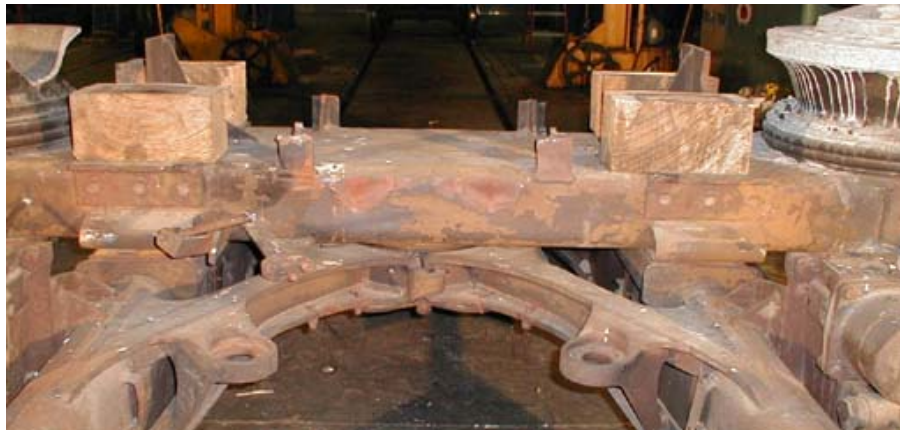
Figure B6-4. Forward Truck Detail Showing Indents from Bolster Beam Bracket Impact, Forward Looking Aft

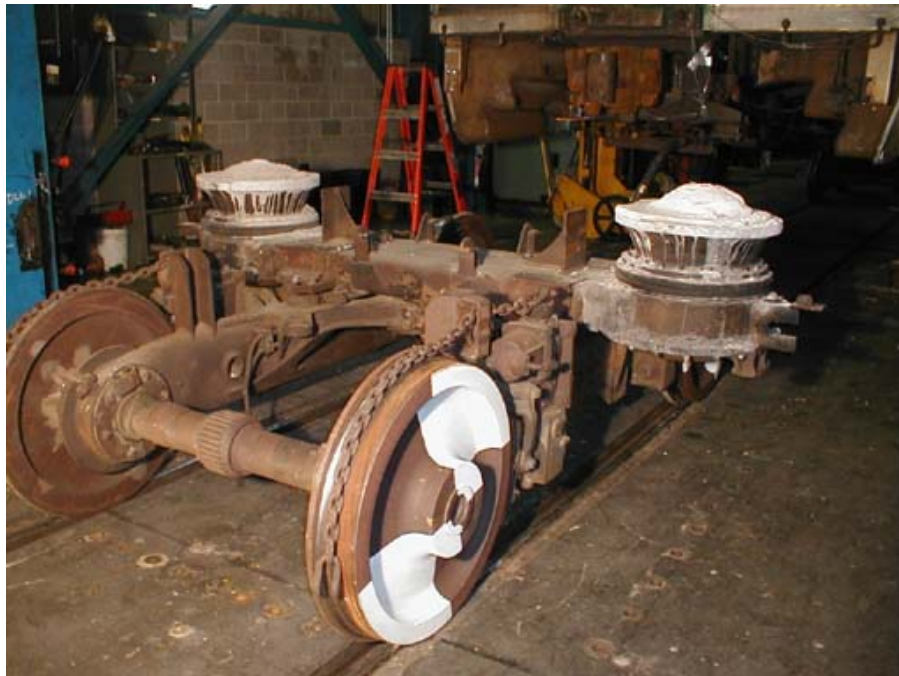
Figure B6-5. Rear Truck from Right Side, Aft Looking Forward

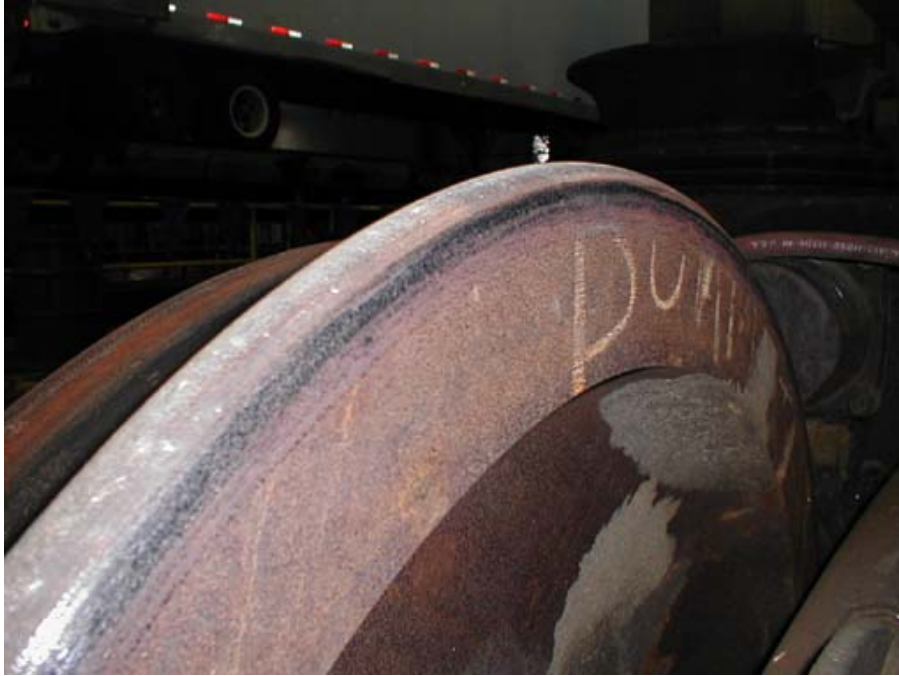
Figure B6-7. Wheel Burn - Polished Inside Surface on Right Front Wheel of the Forward Truck

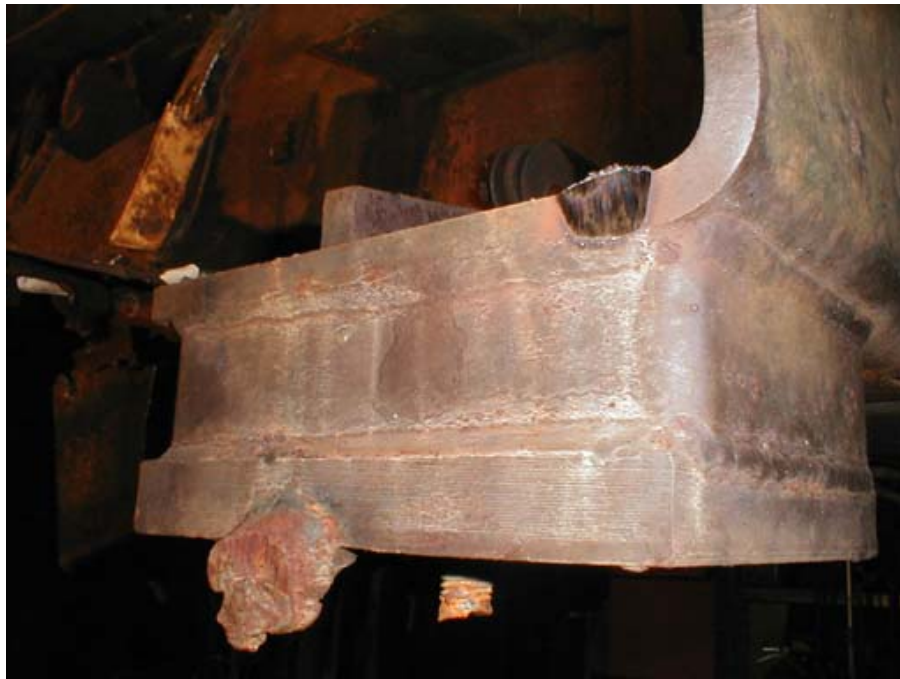
Figure B6-8. Wheel Burn on Lower Forward Draft Sill - Right Side
