U.S. Department  
of Transportation

**Federal Railroad  
Administration**

## **In-Track Demonstration of Laser-Treated Rail to Reduce Friction and Wear**

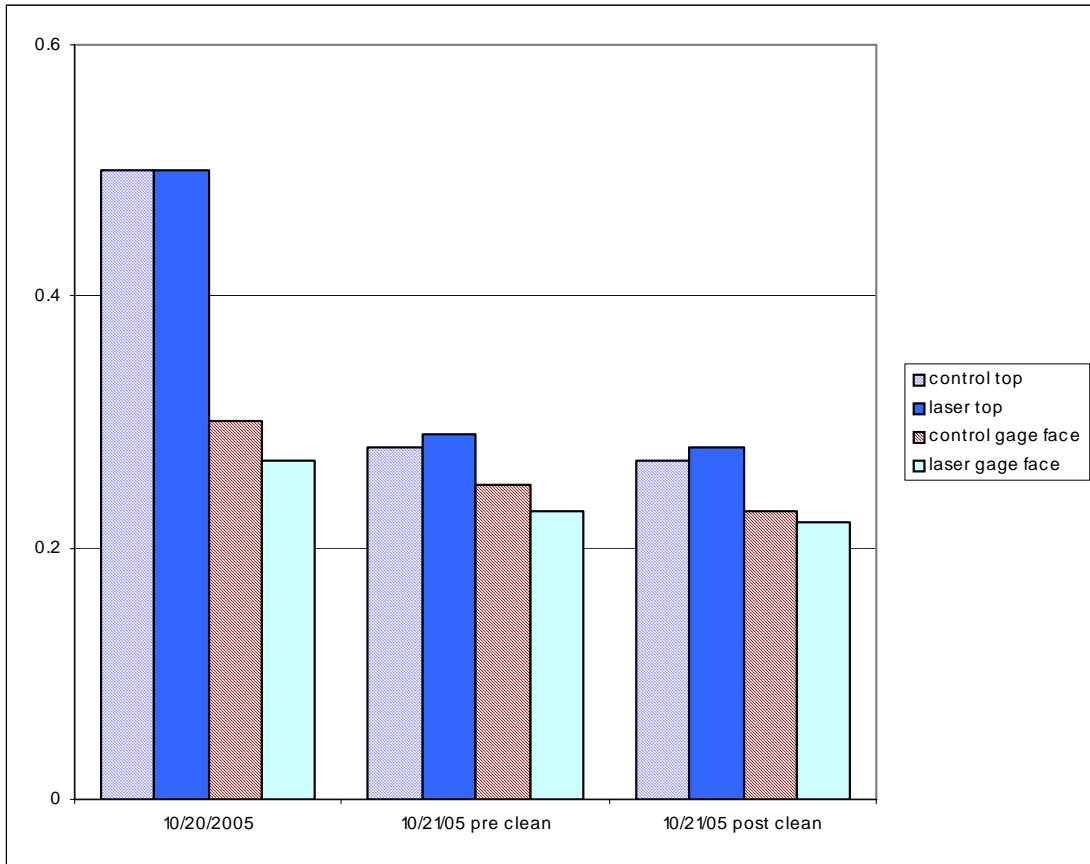
During the initial 5.6 MGT, tribometer data indicated almost no significant difference between the laser-treated and untreated surfaces, as summarized in Figure 13.

**Figure 13. Summary of Tribometer/Friction Data Showing Only a Slight Reduction or No Change Between the Laser-Treated and Untreated Surfaces**

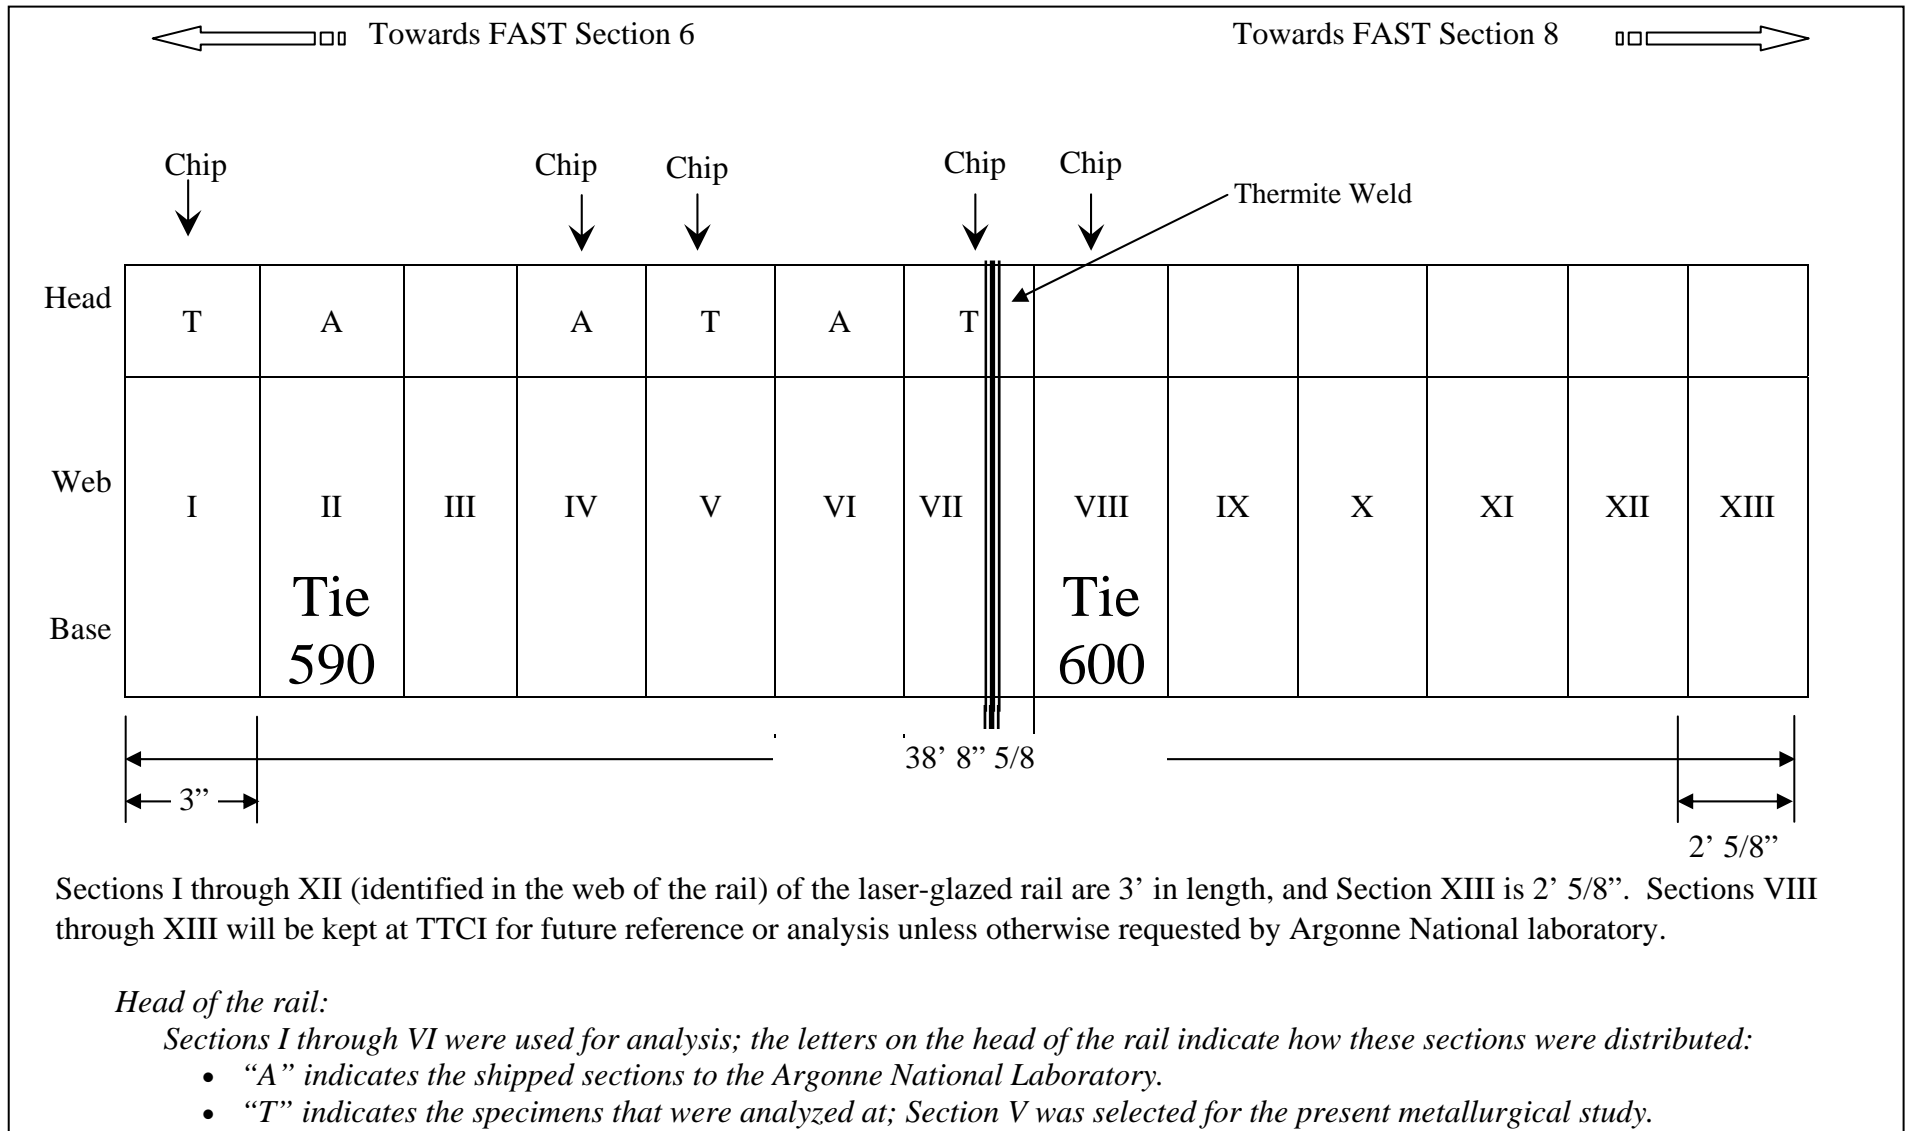
**Figure A-4. Sketch Showing Segments of Rail Used for Analysis at TTC, as Well as Sections Sent to Argonne National Laboratory**

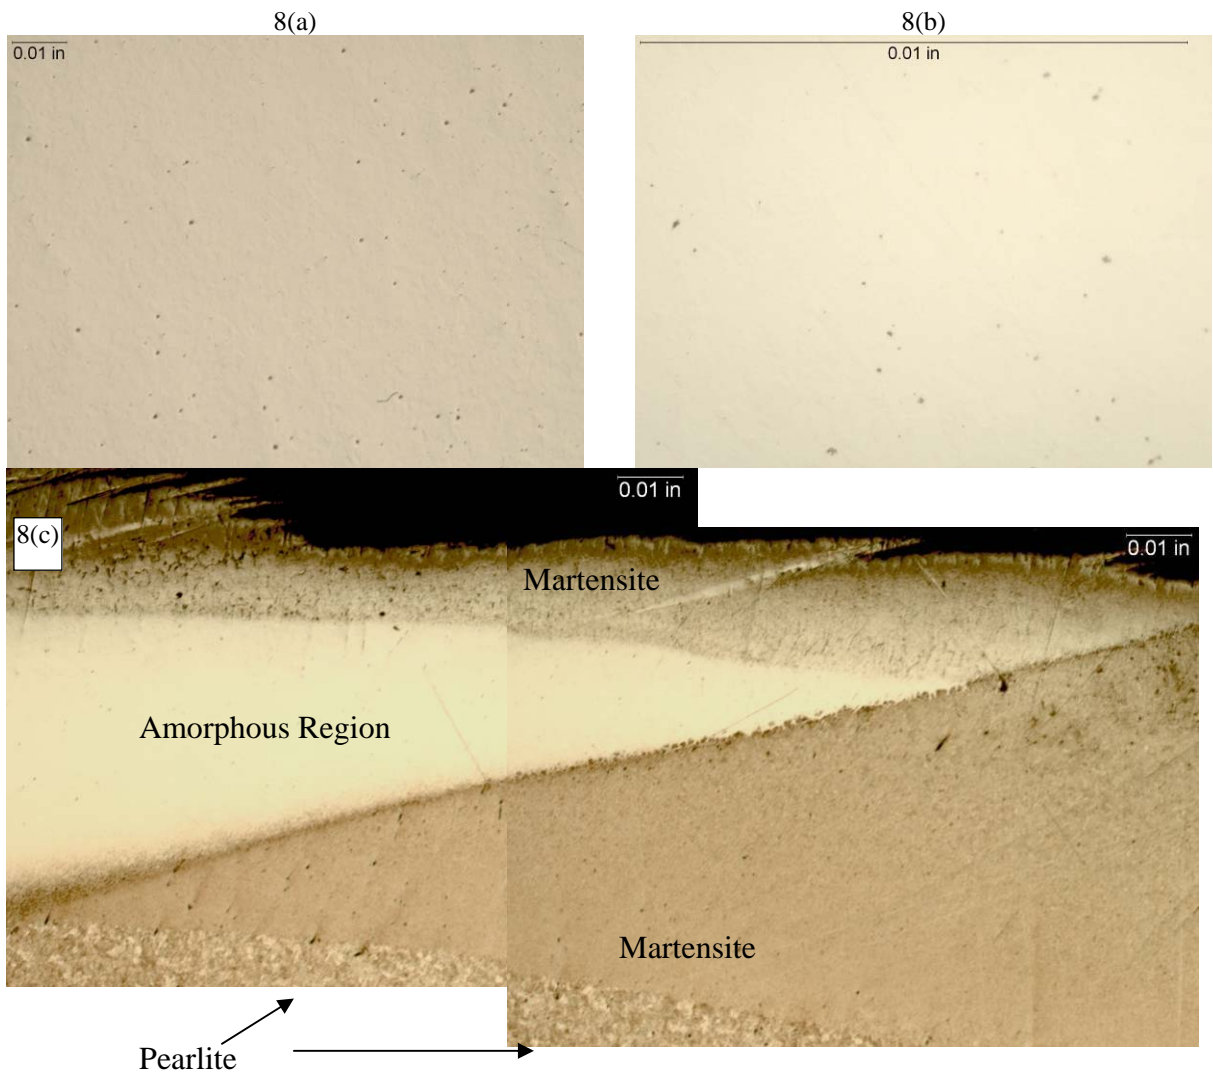
The microstructures of the laser-glazed samples were observed under various magnifications on both the polished and etched samples. The etching reagent used was NITAL 2 percent for ~3 seconds at room temperature. The polished surface for the non-service tested (gage and field) microstructures contained a limited number of inclusions (probably sulphurs) visible at low and high magnification (Figures A-8(a) and 8(b) respectively). Figure A-8(c) shows the etched microstructure where various regions can be identified as in agreement with a previous report conducted on laser-glazed rails [Ref.1]. These regions contain martensite, amorphous areas (presumably the white zones in Figure A-8(c)), and, in the lower part of the sample, the unaffected (non-glazed) region showing the fully pearlitic structure.

**Figures A-8(a) and 8(b). Microstructure of the Laser-Glazed Region After Polishing. Figure A-8(c). Micrograph of the Various Regions Observed at the Glazed Regions**

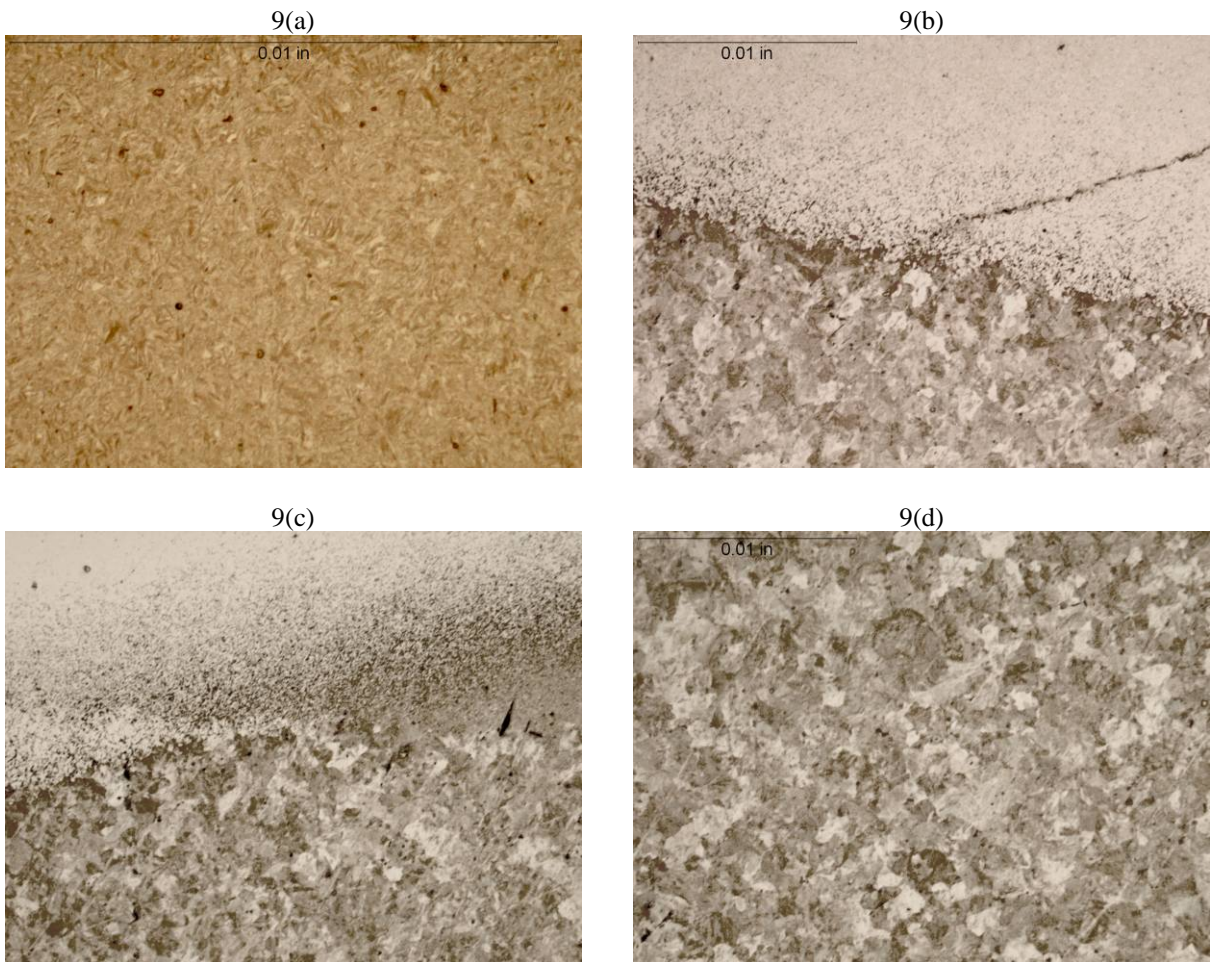
Figure A-9 shows the etched microstructure of the glazed regions and parent rail material for the non-service tested rail. It shows the various microstructures presented by different zones of the rail in the glazed region (selected areas from Figure A-8). Figure A-9a shows the presence of martensite that is evident at magnifications of 200x and 500x. At 200x it can also be observed that the cracks end at the interface between the glazed region (martensite) and the unaffected parent material (pearlite; Figure A-9(b)). Figure A-9(c) shows overlapping of the two glazing treatments. Some porosity along the interface of both regions can be observed at 200x in (Figures A-9(b) and 9(c)). The porosity was presumably created during the glazing treatment and is detrimental to the integrity of the rail. Figure A-9(d) at 200x shows a fully pearlitic region found in the parent rail material.

**Figure A-9. Etched Microstructure of the Glazed Regions and Parent Rail Material for the Non-Service Tested Glazed Rail. Figure A-9(a). Martensite (500x). Figure A-9(b). Crack Stopped at Interface Between Glazed Region and Unaffected Parent Rail (200x). A-9(c). Overlapping of Two Glazing Treatments (200x). Figure A-9(d). Peralitic Region in Parent Rail Material (200x)**

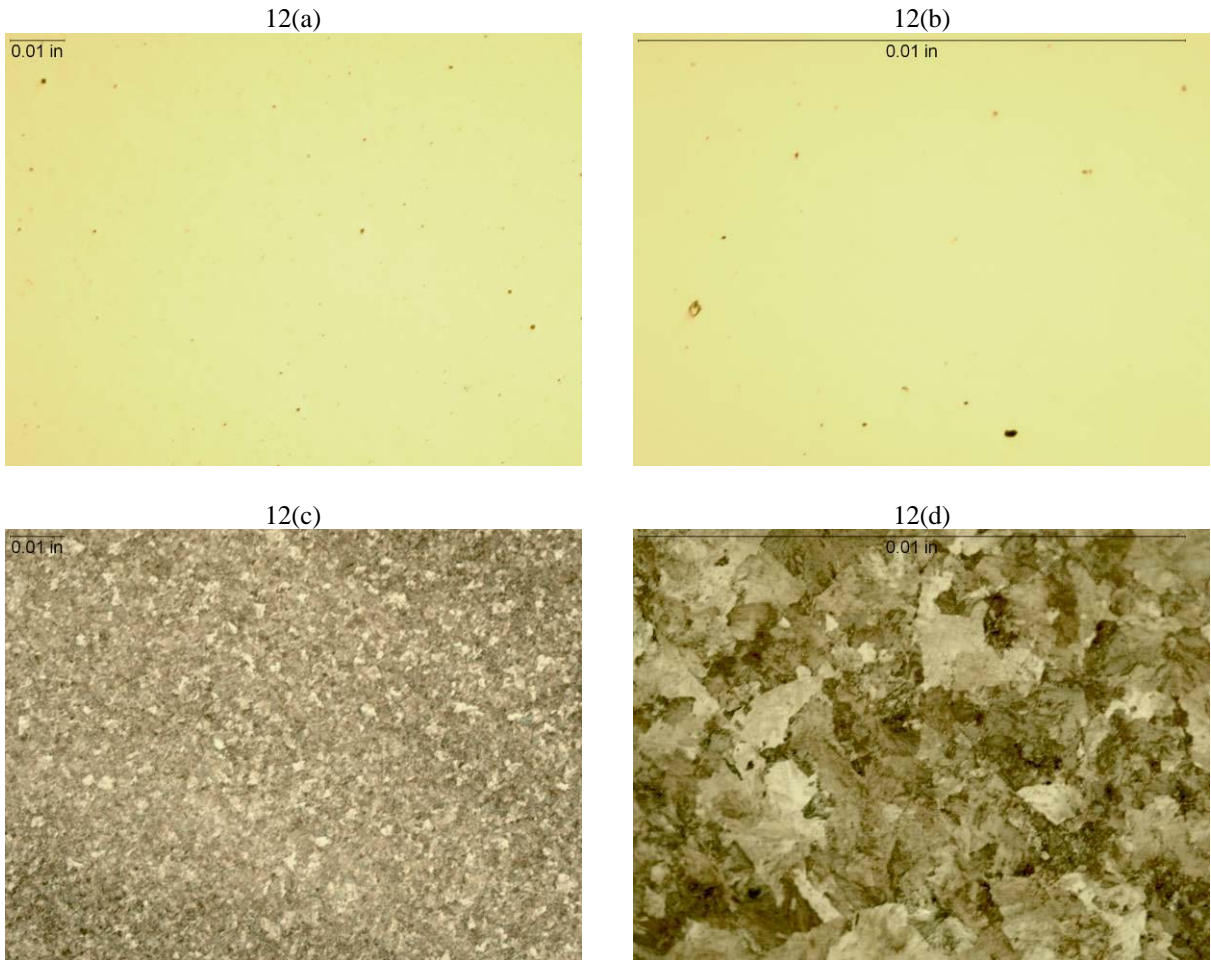
Figure A-12 shows the microstructures of the rail's field sections. For the field regions, only a set of pictures for the non-service tested and the service-tested rails is presented since the microstructure in either case shows no significant differences under various magnifications up to 500x. After polishing, the microstructure shows a low amount of inclusions, probably sulphurs; on the other hand, the etched microstructure is fully pearlitic as expected.

**Figures A-12(a) and 12(b). Microstructure for the Laser-Glazed Rail Showing as Polished Surface.**

**Figures A-12(c) and 12(d). Etched Microstructure.**

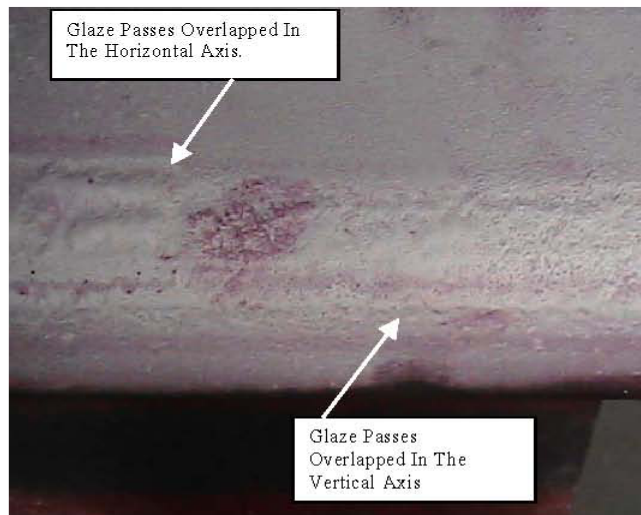
Photograph 4: Dye Penetrant Testing Of Overlapping Sections

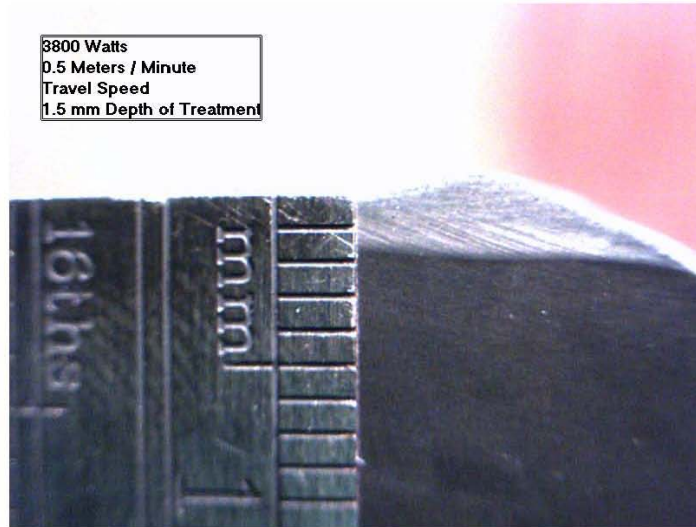
Photograph 5: Cross Section of Glazed Section Required 1-1/2 mm Treatment Depth.

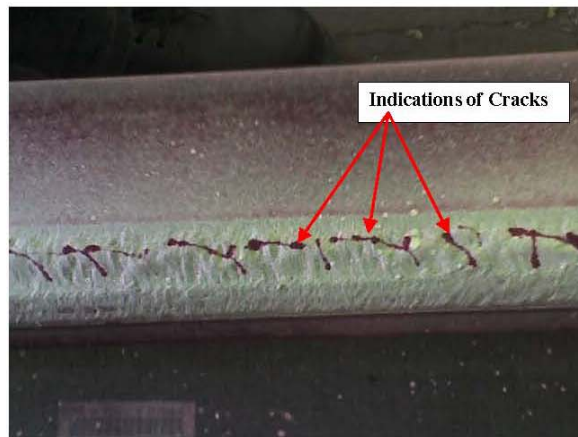
- The entire glazed section of rail was checked for cracks by using the Dye Penetrant method of inspection. Cracks were found along the entire length of the rail in the pass one area of the glaze. Photograph 11 shows the type of cracking that was found along most of the length of the rail section. Although the center of the rail section appeared to have some slight indications of cracking, the indications were less than (as can be seen in Photograph 12) the indications observed on the rest of the rail. It should be noted that the center section of the rail is where the rails had been previously welded together and ground smooth. The rest of the rail had mill scale on it. It was cleaned with a power wire brush prior to the laser glazing process.

Photograph 11: Dye Penetrant Inspection of 40’ rail section.

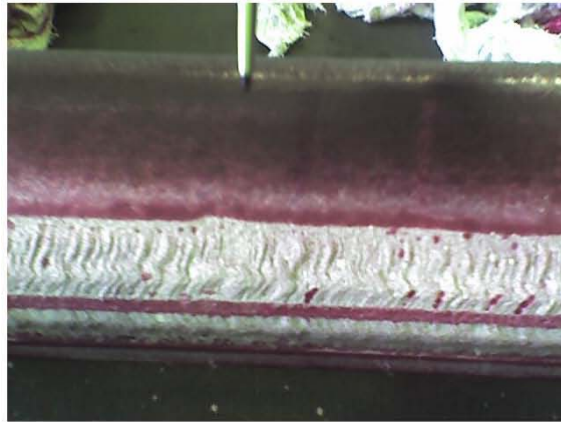
Photograph 12: Dye Penetrant Inspection Showing Center Section of Rail With Clean Ground Surface.
