HISTORY OF COAL MINE ELECTRICAL FATALITIES SINCE 1970

Richard L. Reynolds
Mine Safety and Health Administration
Pittsburgh, Pennsylvania

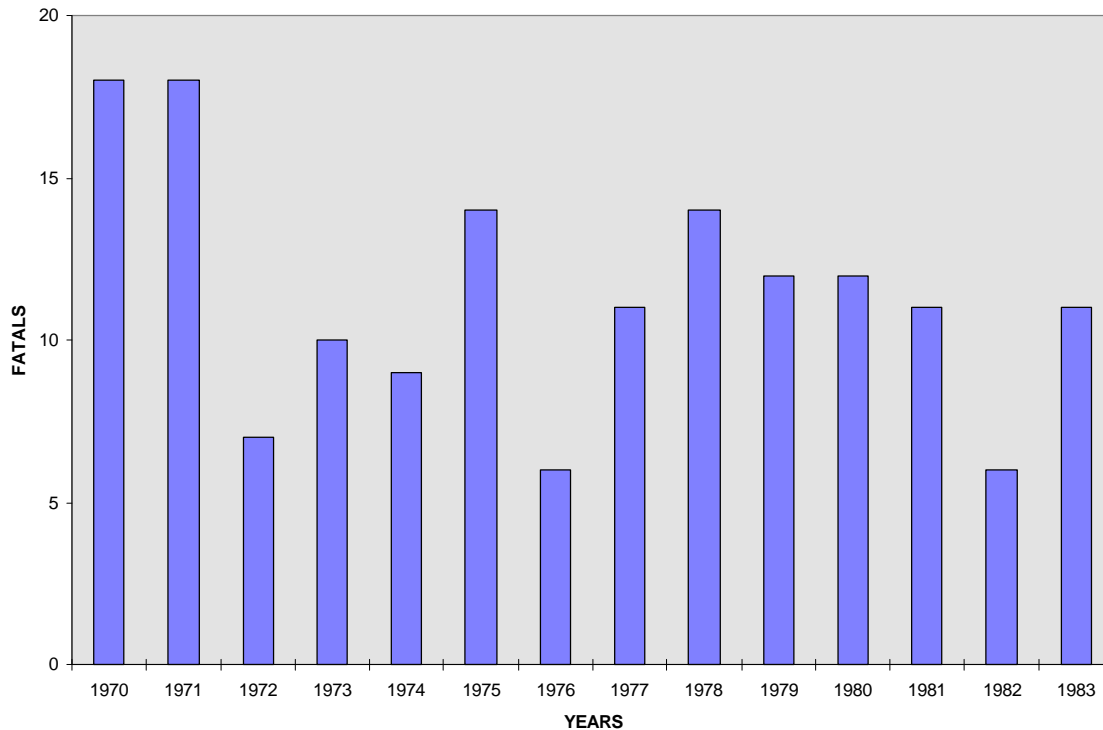
Figure 1. Electrical Fatality Distribution

Figure 1 shows a year by year plot of the electrical fatalities. It can be seen from this figure that electrocutions have been as low as 5 in 1976 and as high as 18 in 1970. The average for the 14 year period is 11.3 or approximately 11 fatalities per year.

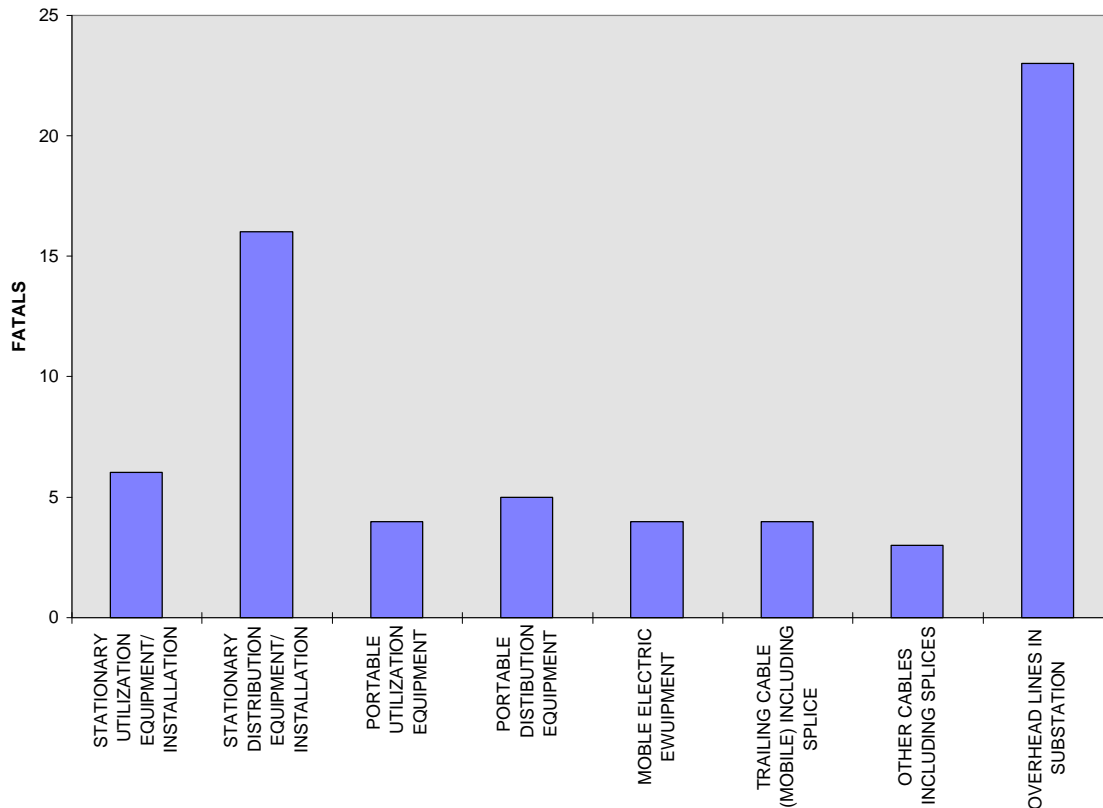
Figure 2. Equipment Involved

By looking at the 66 surface fatal accidents as a separate group from the underground fatalities, emphasis can be placed on the areas within the four categories of interest which could result in the largest reduction in fatalities. Figure 2 below graphically shows the 66 surface fatalities with relation to the type of equipment involved.

This figure shows that the two types of equipment involved in the most fatalities are stationary distribution equipment and overhead power lines.

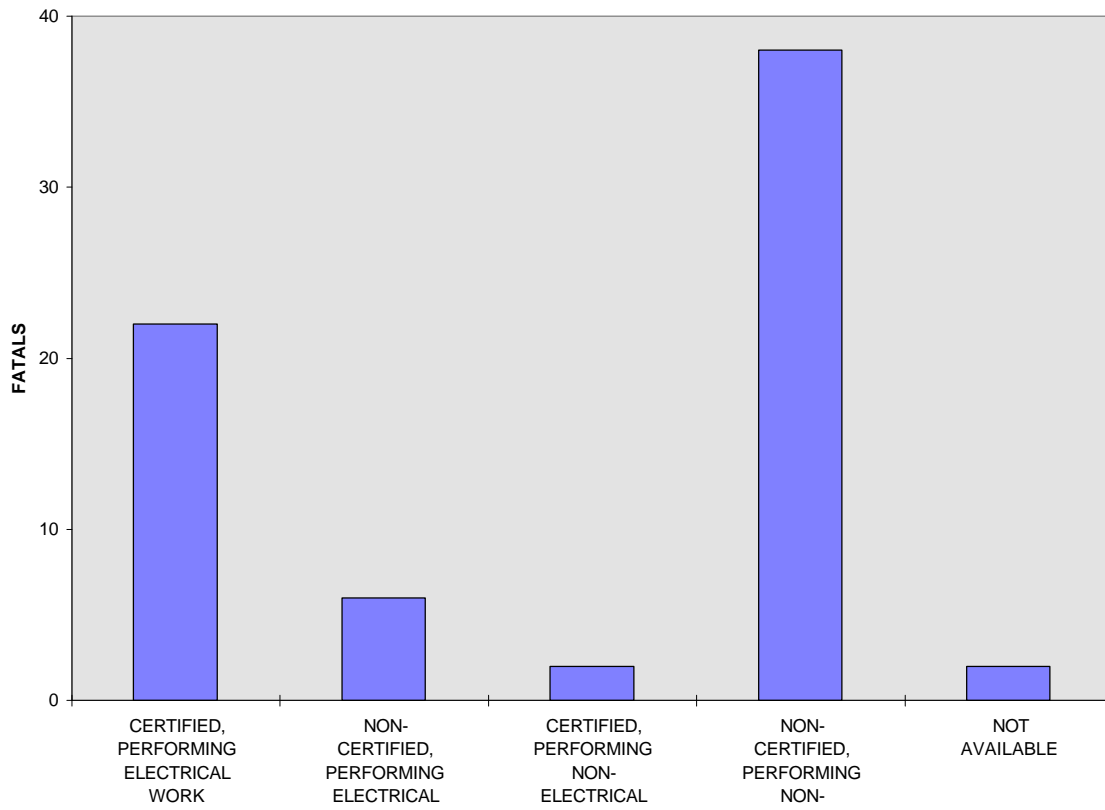
Figure 3. Victim Status

The second category of interest was victim status and is shown in Figure 3.

Two groups, certified persons performing electrical work and non-certified persons performing nonelectrical work, are the victims in the majority of electrocutions.

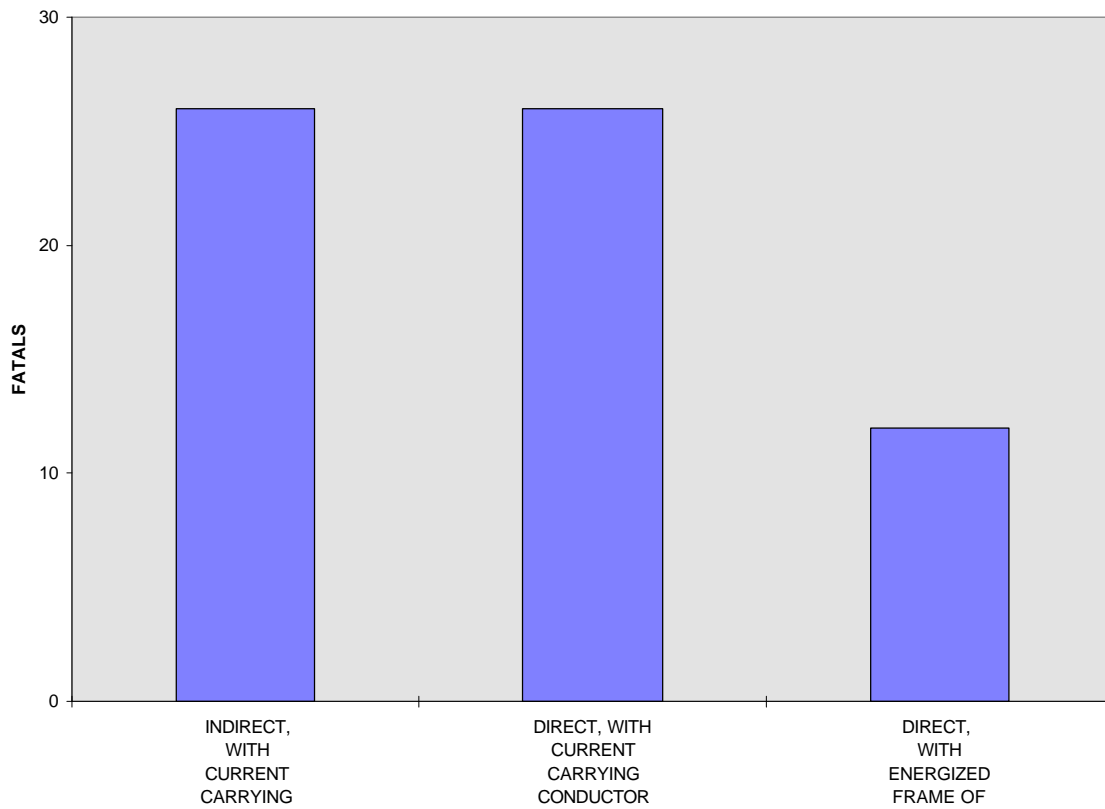
Figure 4. Contact Type

The third category of interest was the type of contact made with the circuit and is shown in Figure 4.

Direct contact with energized conductors implies possible problems with work procedures which expose workers to energized conductors, while indirect contact with current carrying conductors implies possible accidental contact.

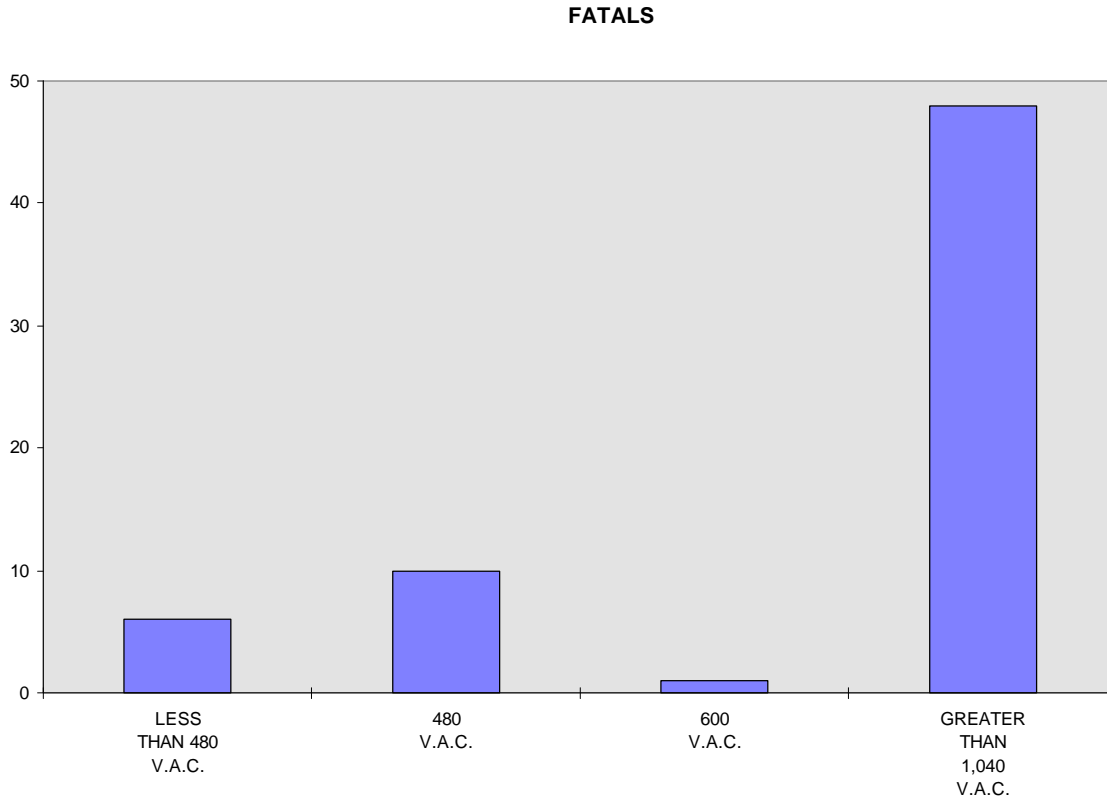
Figure 5. System Voltage

Figure 5 shows that high voltage is involved in the overwhelming majority of electrocutions on the surface. Also it is surprising that almost as many persons were killed from voltages less than 480 Vac as were killed by 480 Vac.

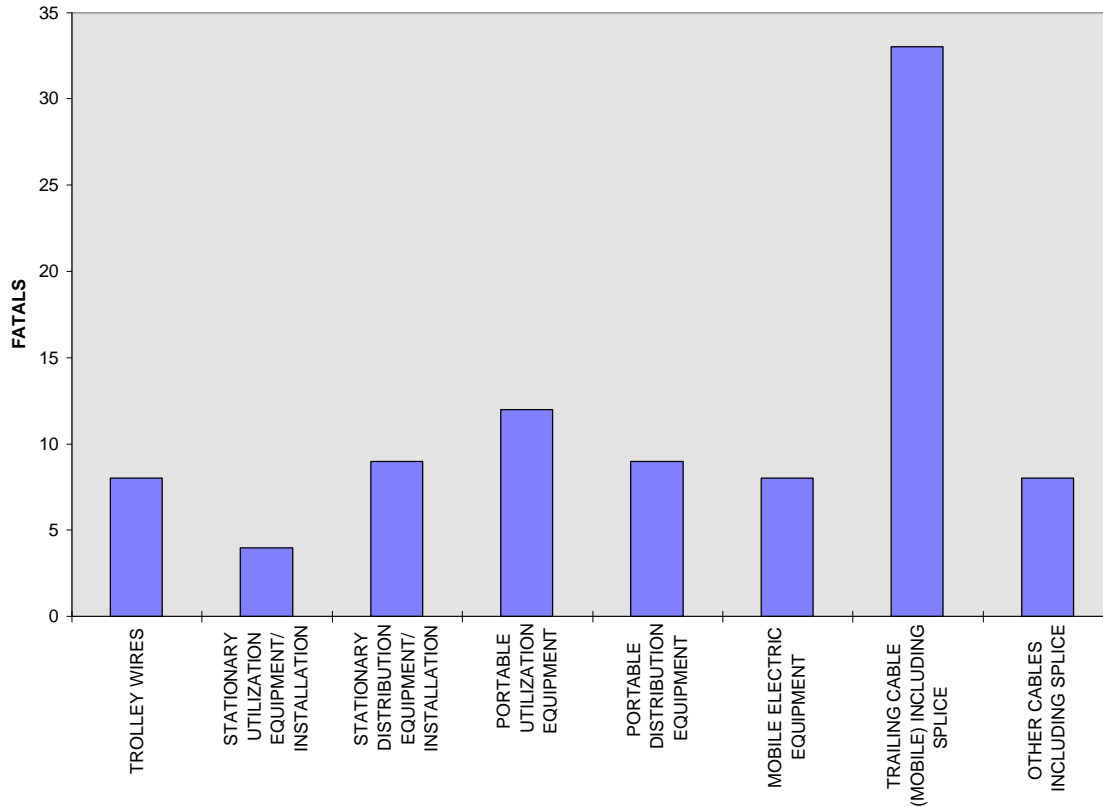
Figure 13. Equipment Involved

The first category is the “Equipment Involved” and is shown in Figure 13.

It is easy to see from Figure 13 that trailing cables and splices are involved in over one third of the fatalities underground. This is without a doubt an area that needs more attention in order to reduce fatalities.

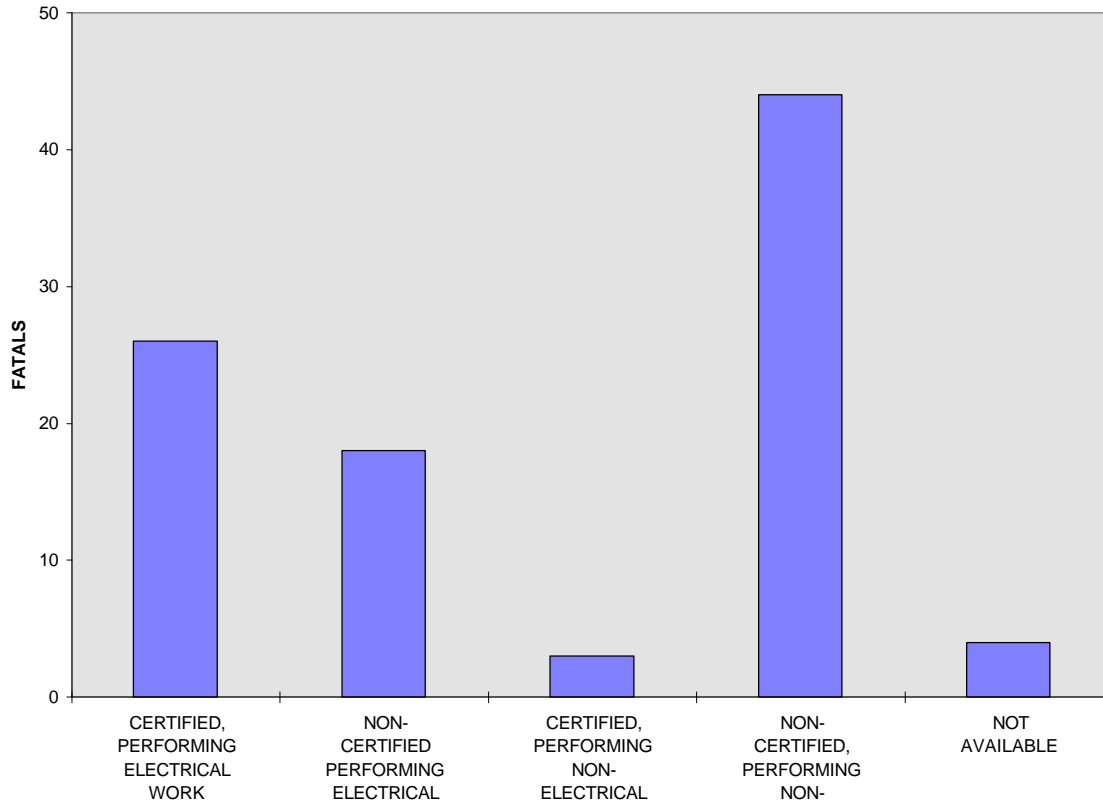
Figure 14. Victim Status

The second category is the “Victim Status” as shown in Figure 14.

The group “certified, performing electrical work” being high indicates inadequate work procedures or persons certified who should not be. The group of non-certified persons performing non-electrical work indicates a great deal of accidental contact possibly resulting from unnecessarily exposing persons to energized parts.

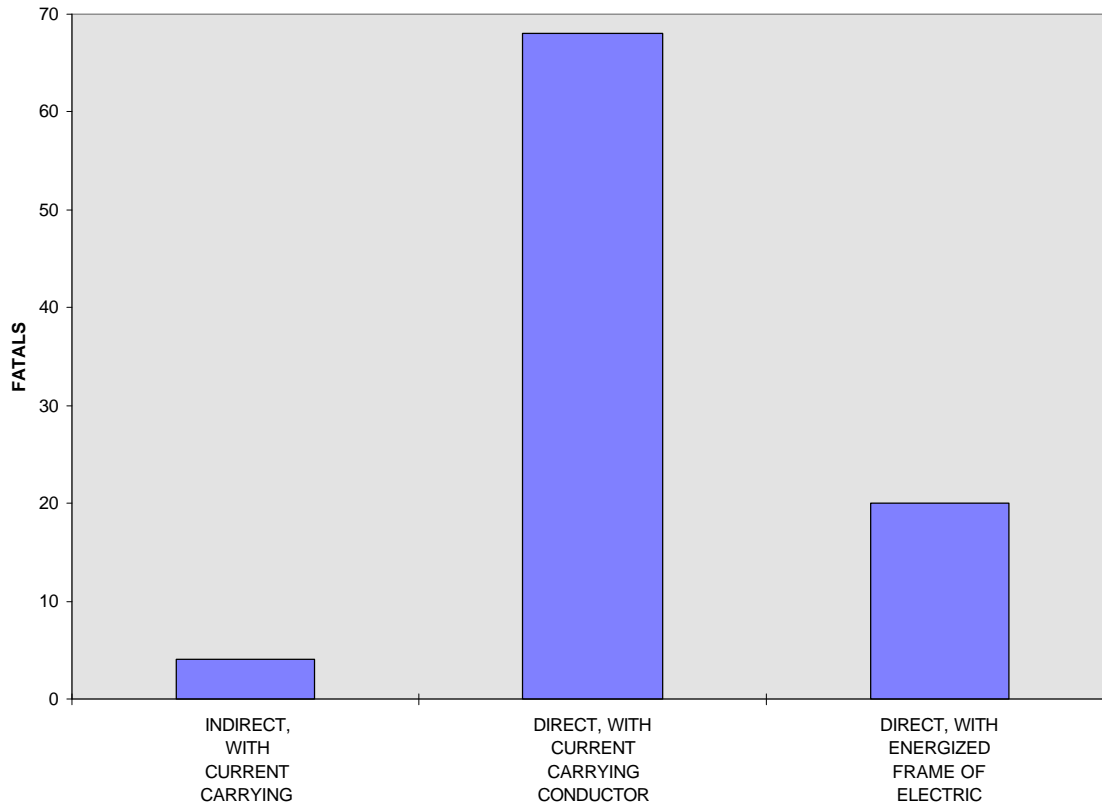
Figure 15. Contact Type

The third category separates the fatalities as to the type of contact and is displayed in Figure 15.

Direct contact with current carrying conductors points to the possible problem of unnecessary exposure to energized parts.

Sixty-eight of 92 underground fatalities were related to the type of contact “direct, with a current carrying conductor or part” as can be seen from Figure 15. These types of accidents can occur from unintentional contact due to improper equipment and circuit design or intentional contact when repairs are being performed and the victim is not aware that it is energized.

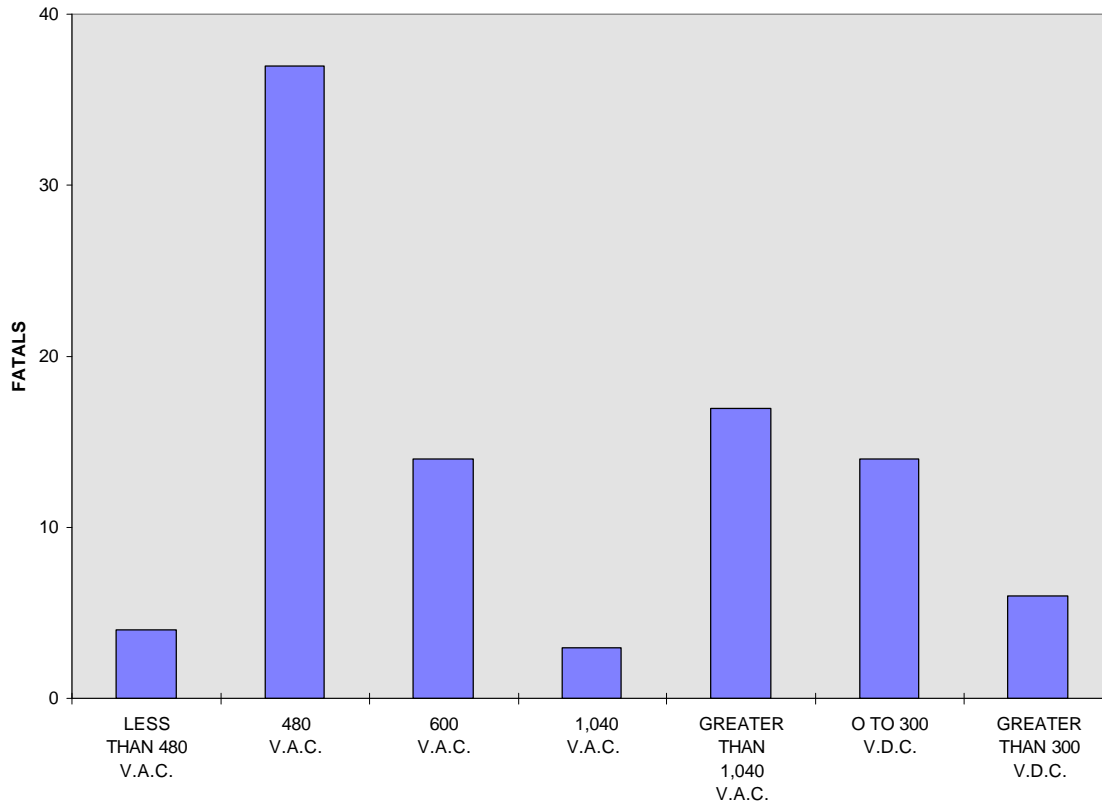
Figure 16. System Voltage

The fourth category is system voltage and is shown in Figure 16.

One revealing fact in this charts is that there have been almost as many fatalities on 300 Vdc as on high-voltage (greater than 1040 Vac) circuits and that there have been more fatalities from all direct-current systems than from high-voltage systems. The not surprising fact is that the utilization voltages of 480 Vac and 600 Vac account for more than half of the underground electrocutions.
